Is Your Dam Safe?

An281	Andriolo, Francisco Rodrigues; Moreira, José Eduardo
	Is Your Dam Safe? – Vol. 1 / authors: Francisco Rodrigues Andriolo e José Eduardo Moreira. São Carlos, 2022.
	1394 p. il. color
	ISBN – 978-65-5668-011-8
	DOI – http://dx.doi.org/10.26626/9786556680118/2022B001
	1. Dams. 2. Training. 3. Quality. 4. Repairs. 5.Controls. 6. Cement. I. Orgs. II. Title.
	CDD 370

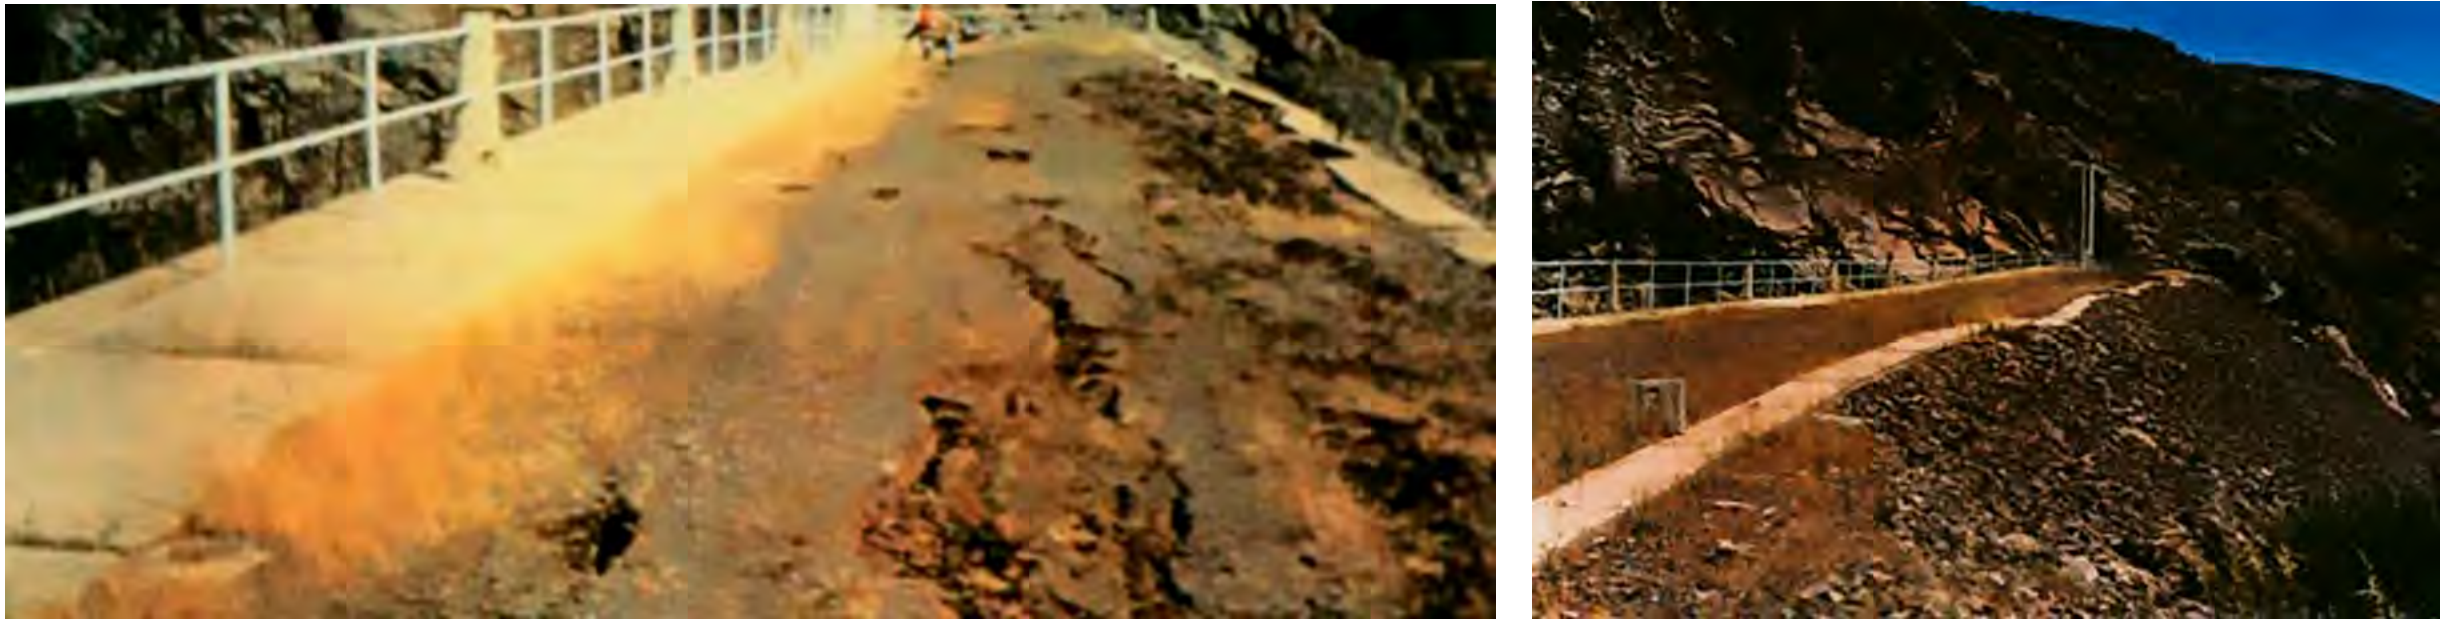
Cogoti CFRD in Chile before (top) and after the 14 October 1977 Punitaqui earthquake (middle); cracks on dam crest (bottom) (Photographs courtesy G. Noguera, Chile)

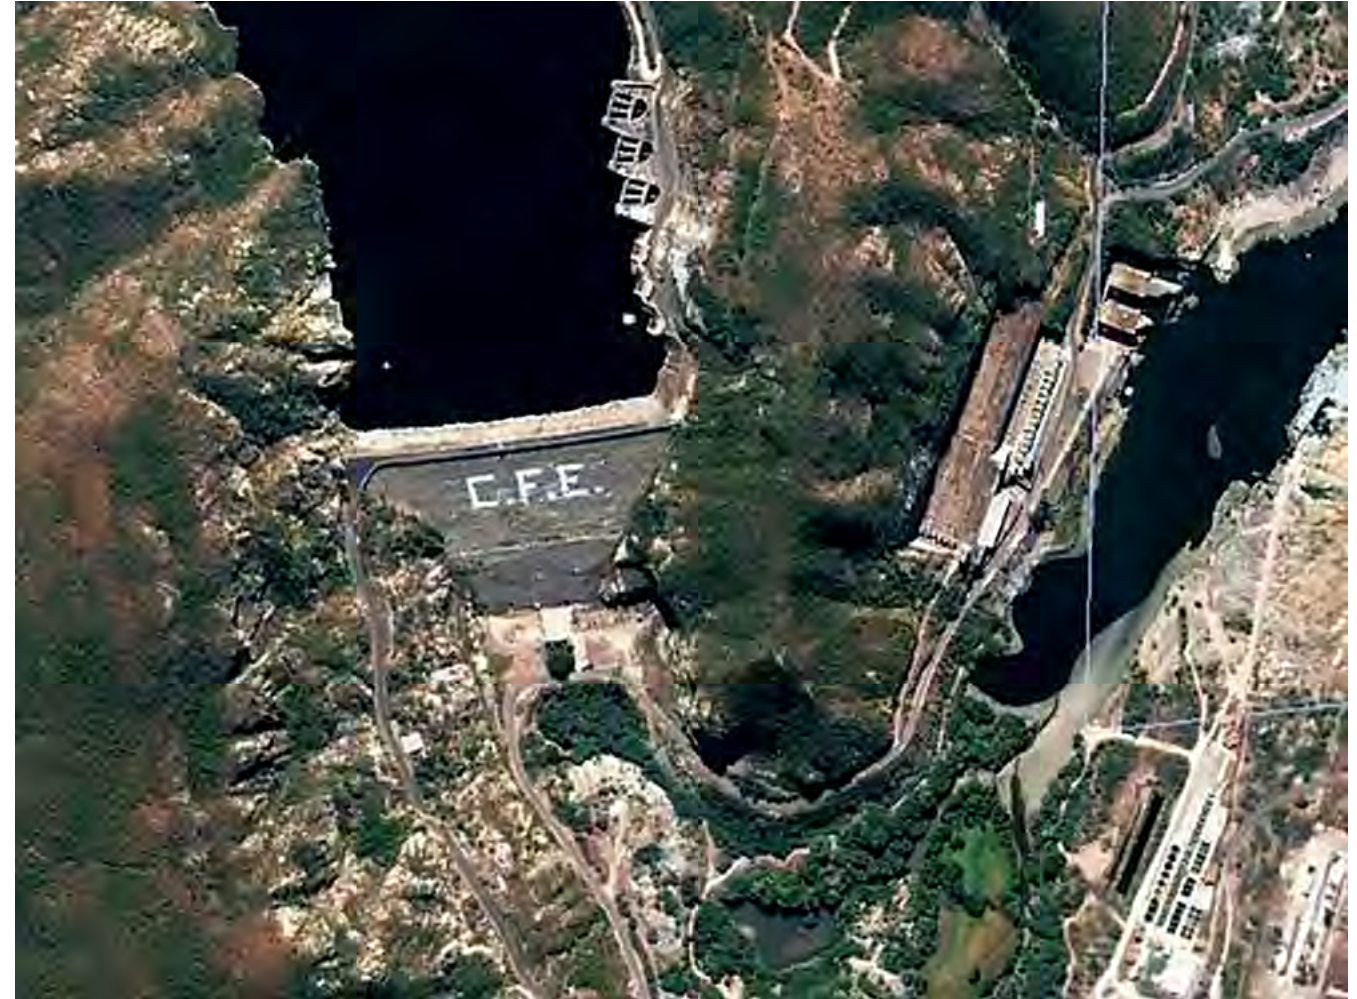
The Infiernillo (**Adolfo López Mateos**) Dam was subjected to a second earthquake in 1985 (first one in 1979), to about 60 seconds of strong ground motion during the earthquake, with probable crest accelerations of the order of 0.50g. Overall, the dam performed extremely well and the earthquake effects appeared to be insignificant. Two longitudinal cracks formed on either side of the dam crest along its entire length. The cracks intersected the base layer of the pavement at the top of the dam, immediately above the interface between the impervious core and the upstream and downstream shells. Additional minor longitudinal cracks formed on the crest along the abutments.

Infiernillo Dam also known as Adolfo López Mateos Dam, is an embankment dam near Guerrero, Mexico

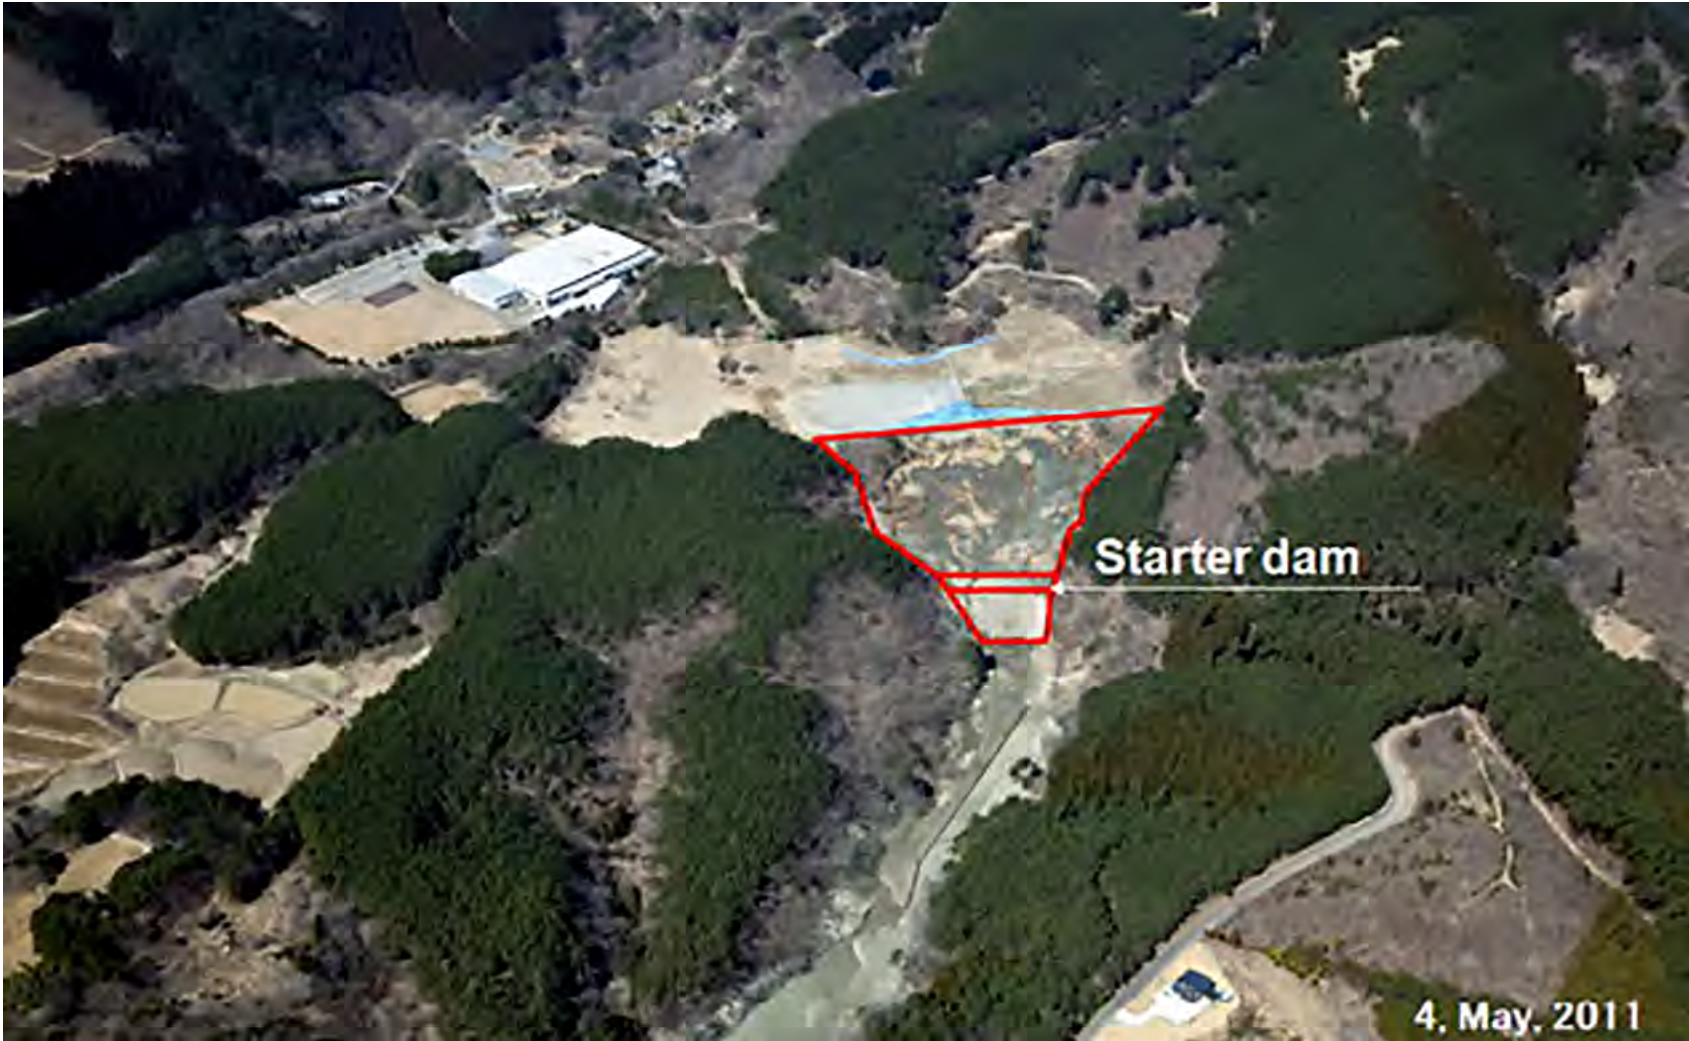
A great earthquake occurred in eastern Japan in 2011, with magnitude M=9,0. The Kayakari dam at the Ohya mine liquefied because of the tailing's material, releasing a large amount of clay and causing damage to the downstream environment. Studies have shown that liquefaction leads to a significant reduction in the safety factors of tailings dams. In addition, the construction method of the dam body, the particle size of the tailings, and the magnitude of the earthquake affect the stability of the tailings dam during an earthquake.

Kayakari dam at the Ohya mine - Japan^[01-21]

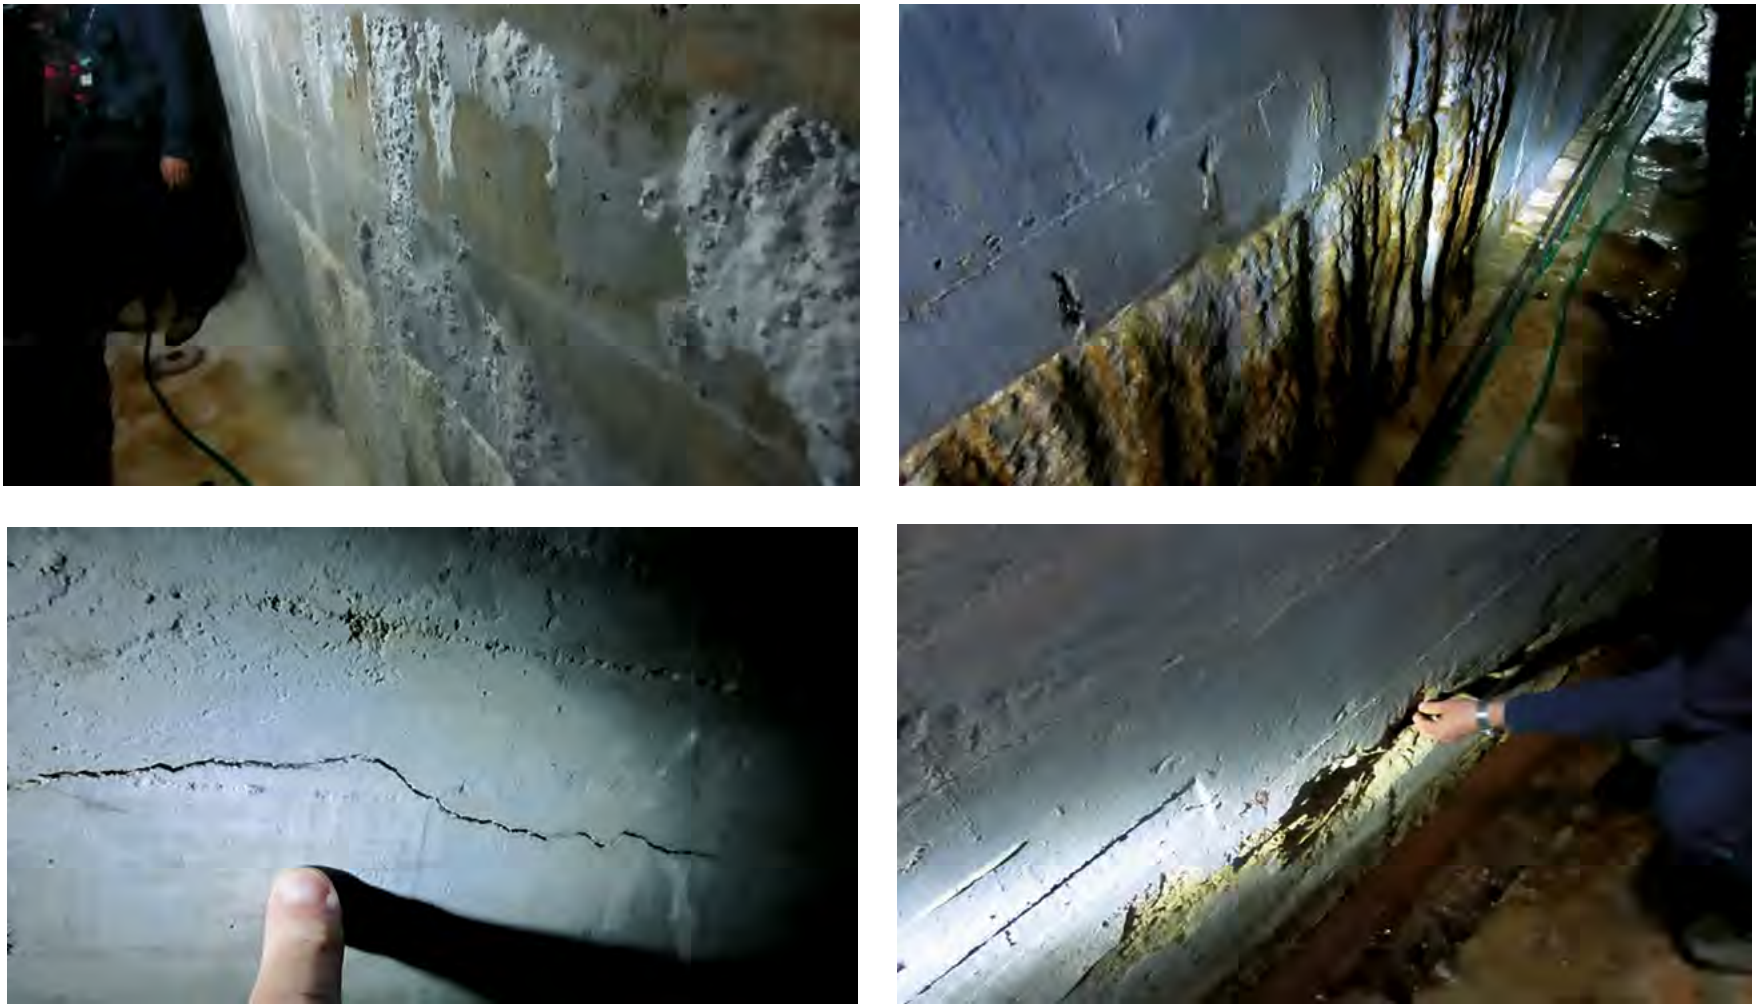
Aspects of the inner part of the dam gallery. Evidence of Alkali Reaction Aggregated, observed inside the gallery of the Ribeirão do Campo Dam-SABESP-SP, Brazil-Built in 1962 (Andriolo’s Archive)

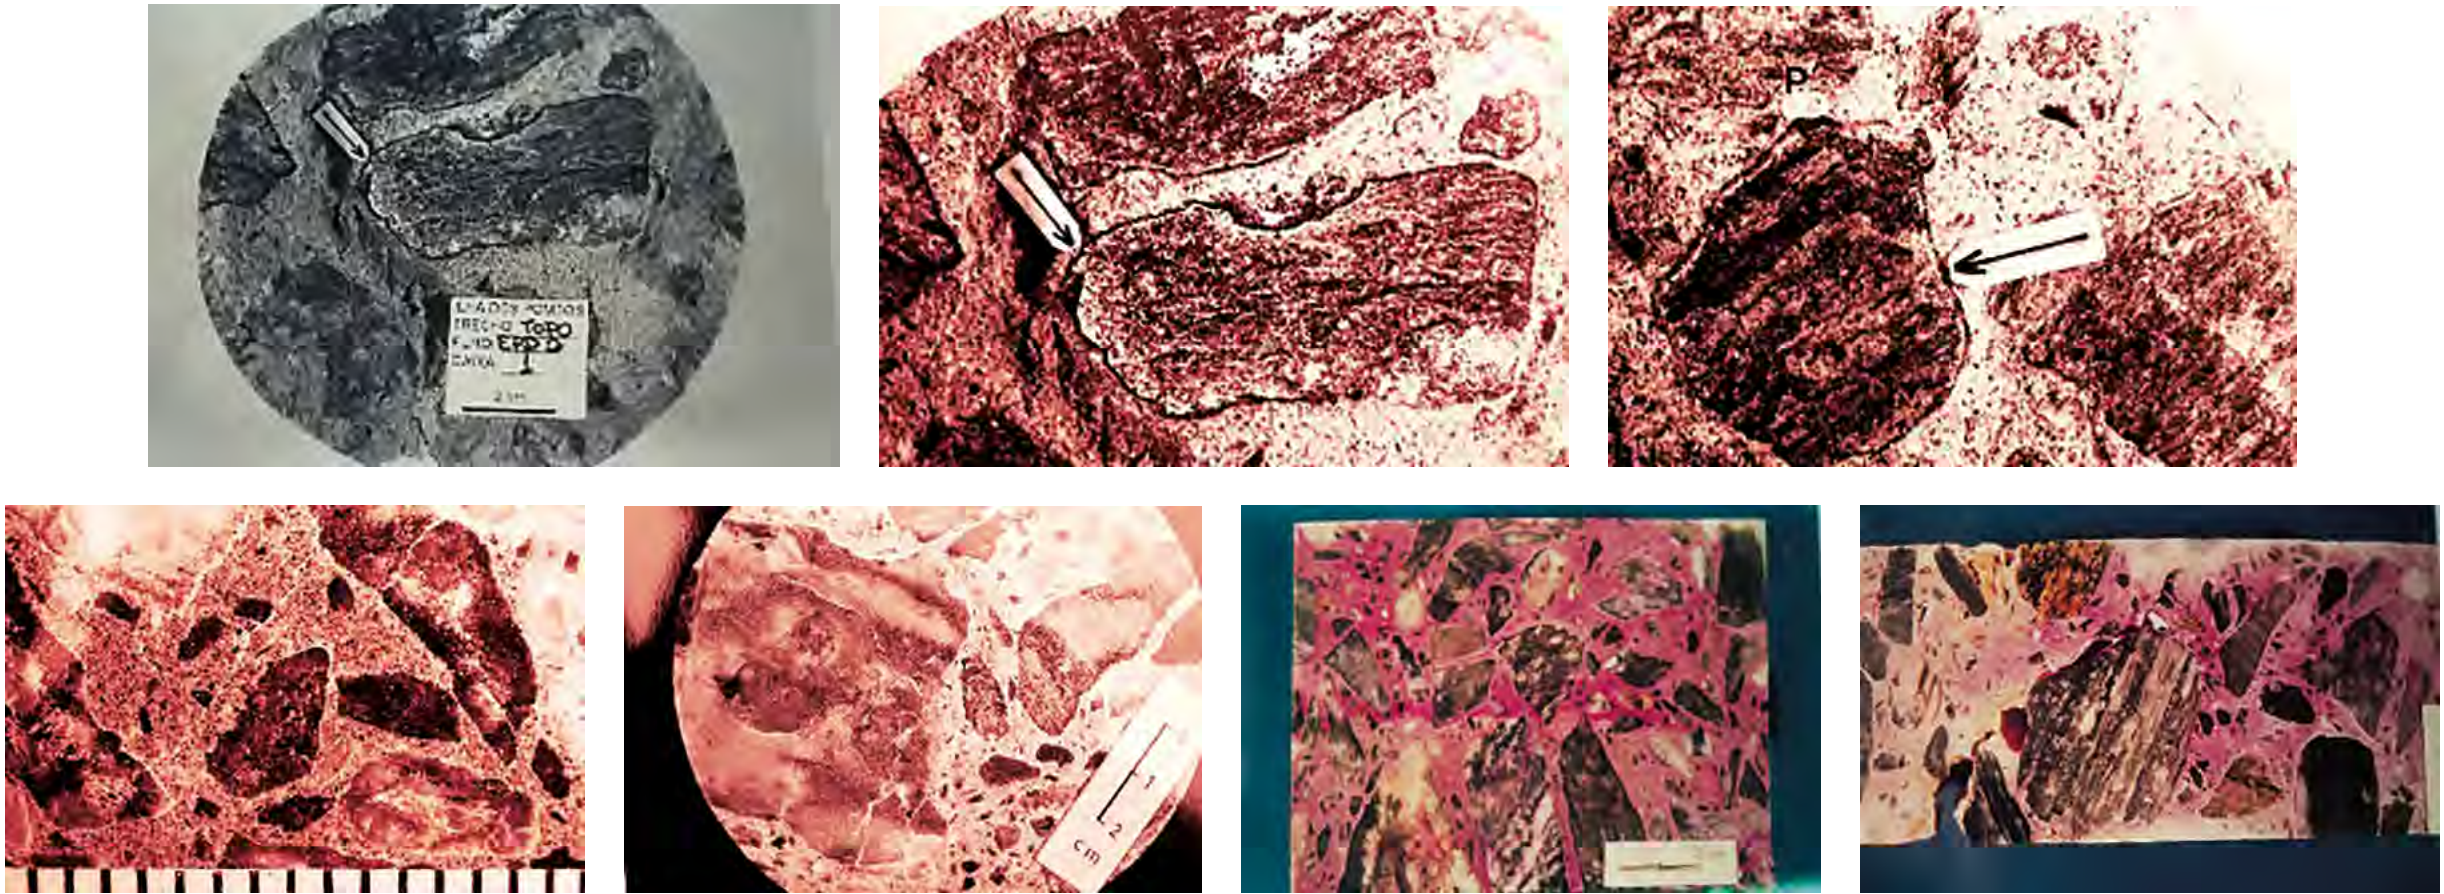
Aspects of the RAA observed on the specimens from drilled cores from the Ilha dos Pombos Dam (Andriolo's archive)

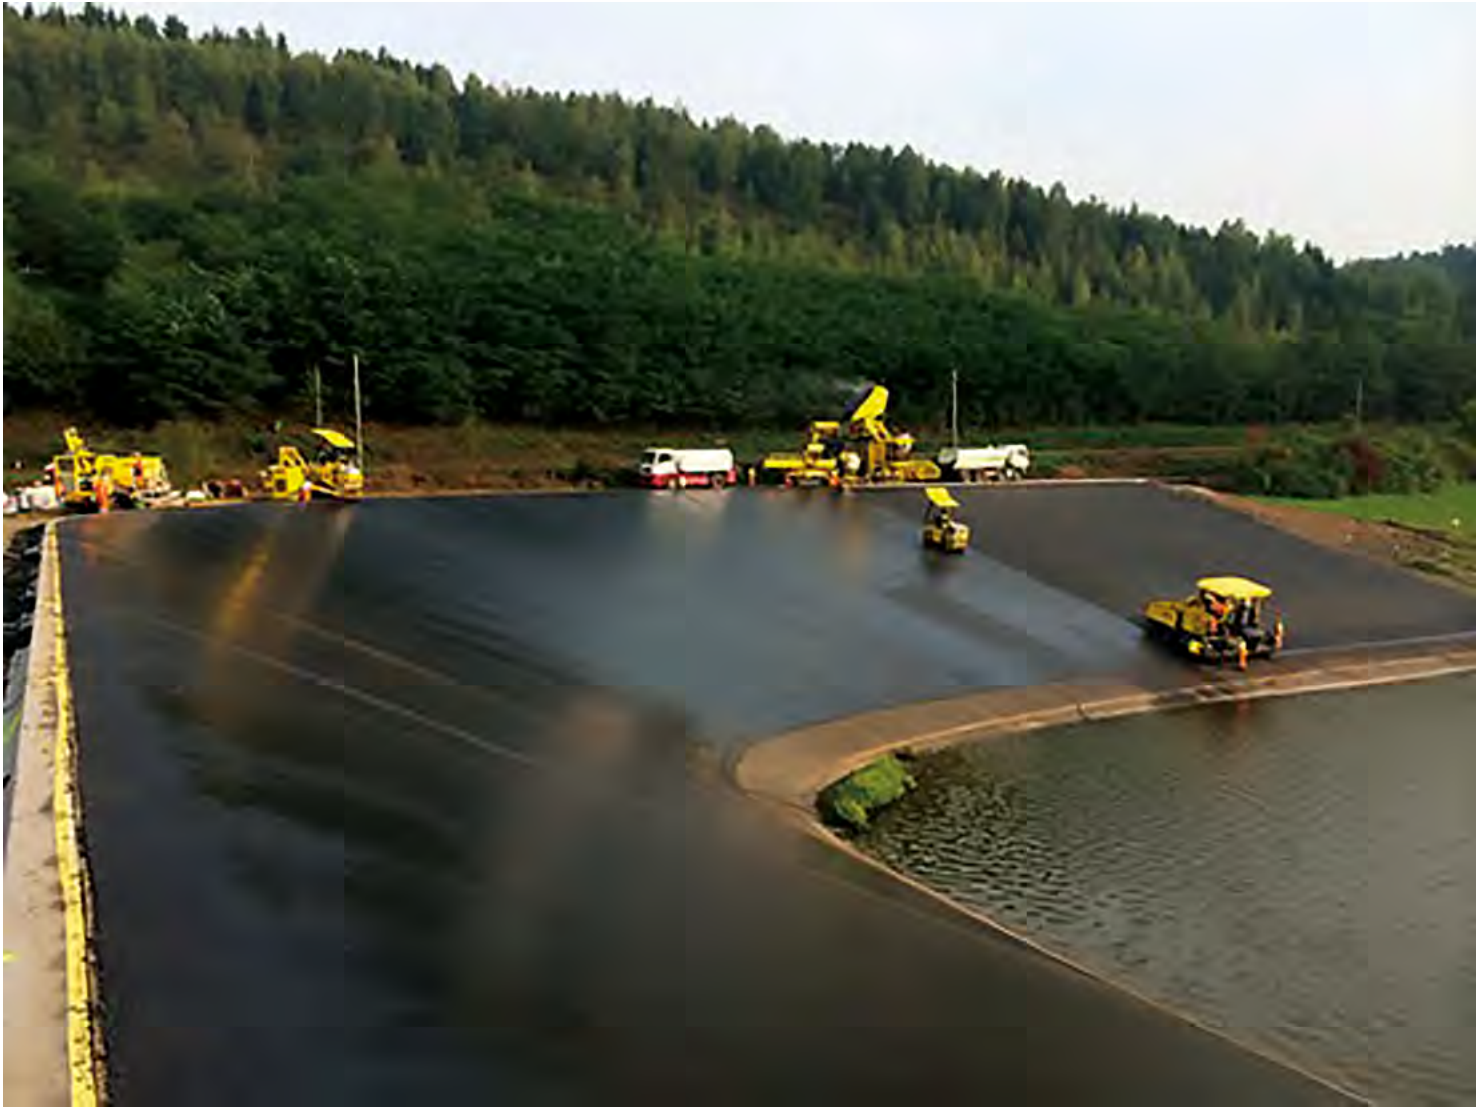
The Kinzig Dam in Main Kinzig area - east Frankfurt - was built in between 1976-1981. A regular inspection had revealed cracks in the asphalt lining and damage to the mastic protection layer. A new 100 mm bituminous layer was poured after surface preparation.

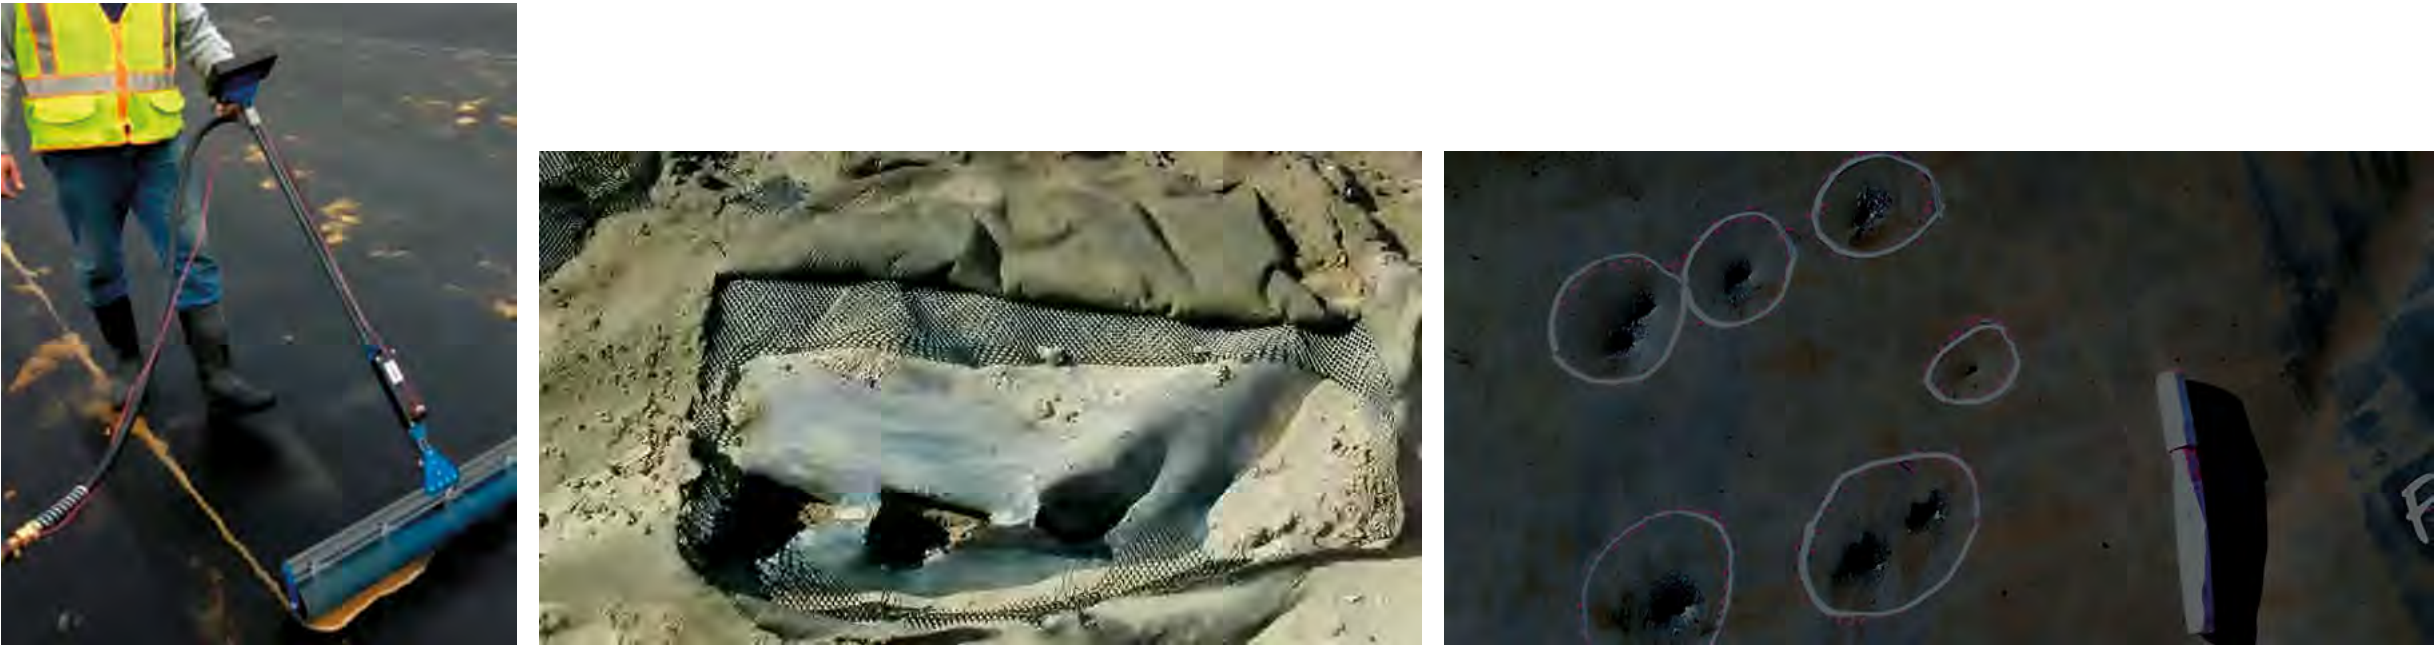
Poor preparation of the subgrade or, in the case of a covered geomembrane, the wrong selection of the type of cover and/or its placement can heavily damage a geomembrane

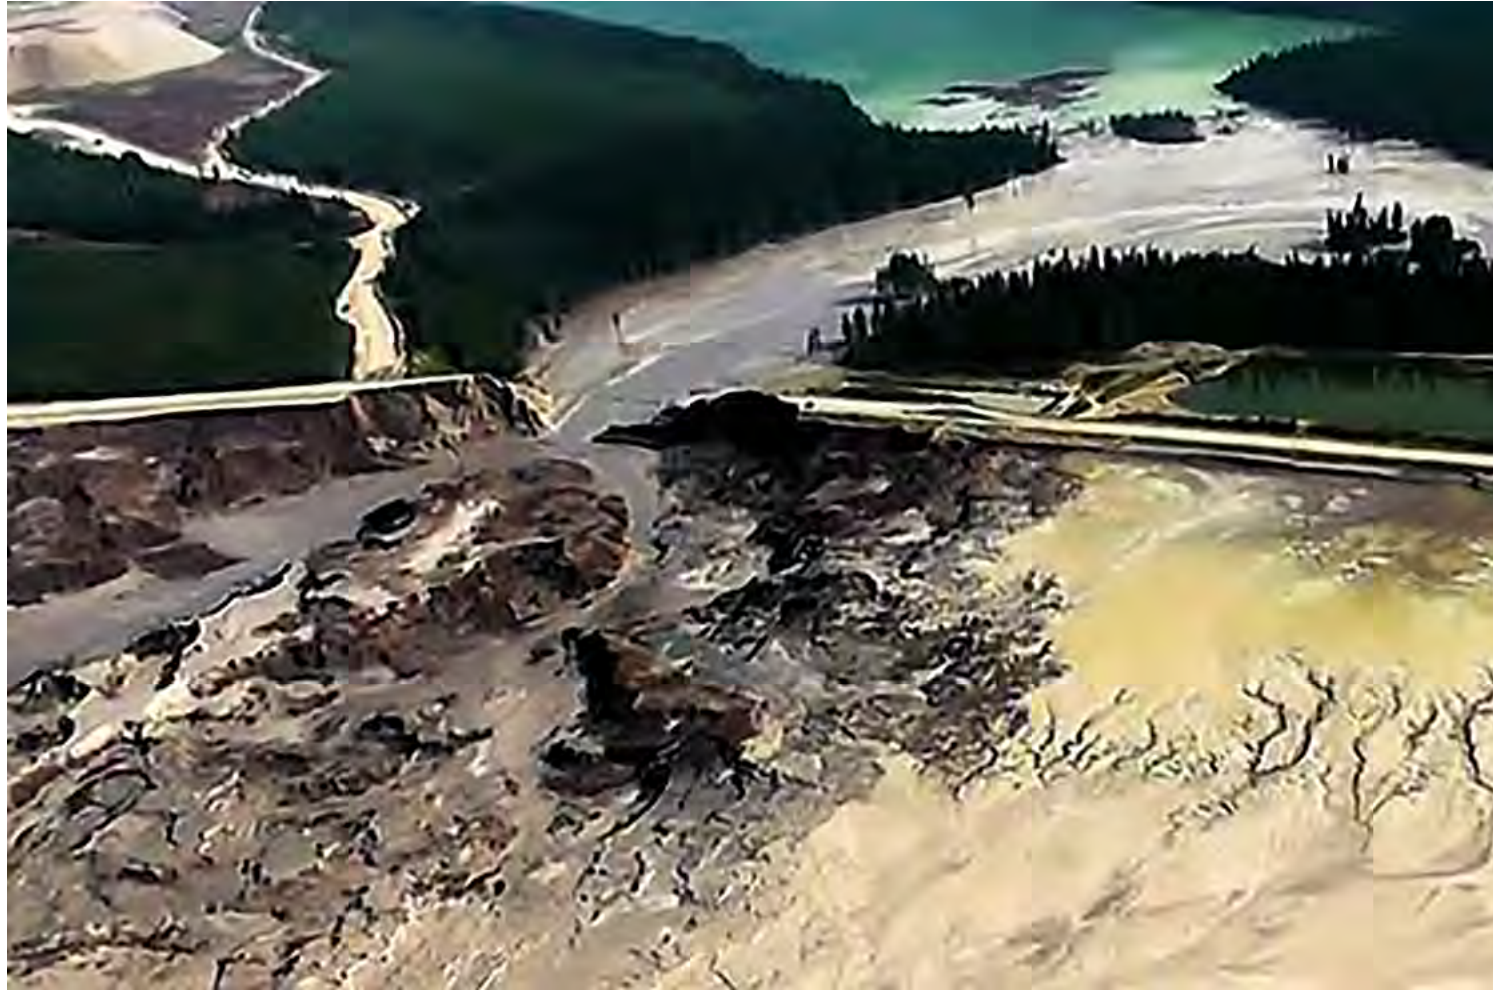
The disaster of Mount Polley mine happened in British Columbia, Canada. It began with a breach of the Imperial Metals-owned Mount Polley copper and gold mine tailings pond, releasing its water and slurry with years’ worth of mining waste into Polley Lake.

Mount Polley mine disaster – Alchetron, the free social encyclopedia

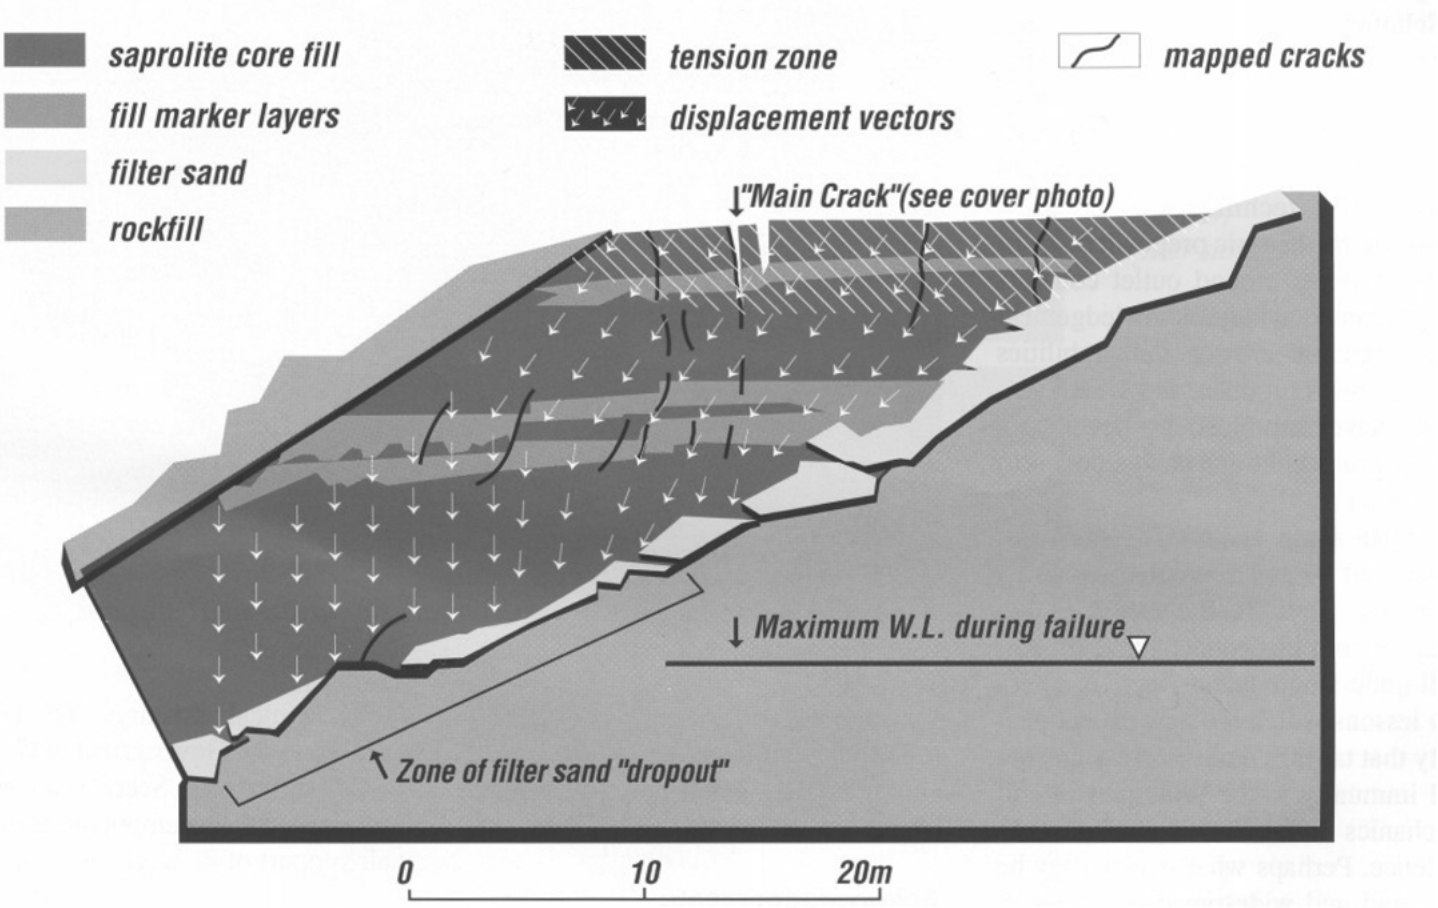
In 1994, the Omai tailings dam in Guyana broke down due to internal erosion which resulted in the release of sewage into nearby rivers. The dam contained an upstream sloping core and a downstream rockfill section, with foundation materials having the classic weathering profile of residual saprolite soils derived from parent andesite/diabase rocks. These clayey, low-permeability soils provided fill material for the dam core, and they also comprised a major component of the mine waste materials excavated as pit overburden. This saprolite mine waste was deposited in a wide zone adjacent to and contiguous with the downstream rockfill section of the dam, extending outward 400 m to the Omai River and confining the rockfill zone in all except the two limited areas near the abutments where the failure discharges emerged.

The Omai Tailings Dam case demonstrates yet again that no dam, tailings or otherwise, without adequate seepage protection around conduits or without adequate filters can be expected to survive for long. Even with the factors specific to the Omai situation, these failure mechanisms are by no means unique or new.

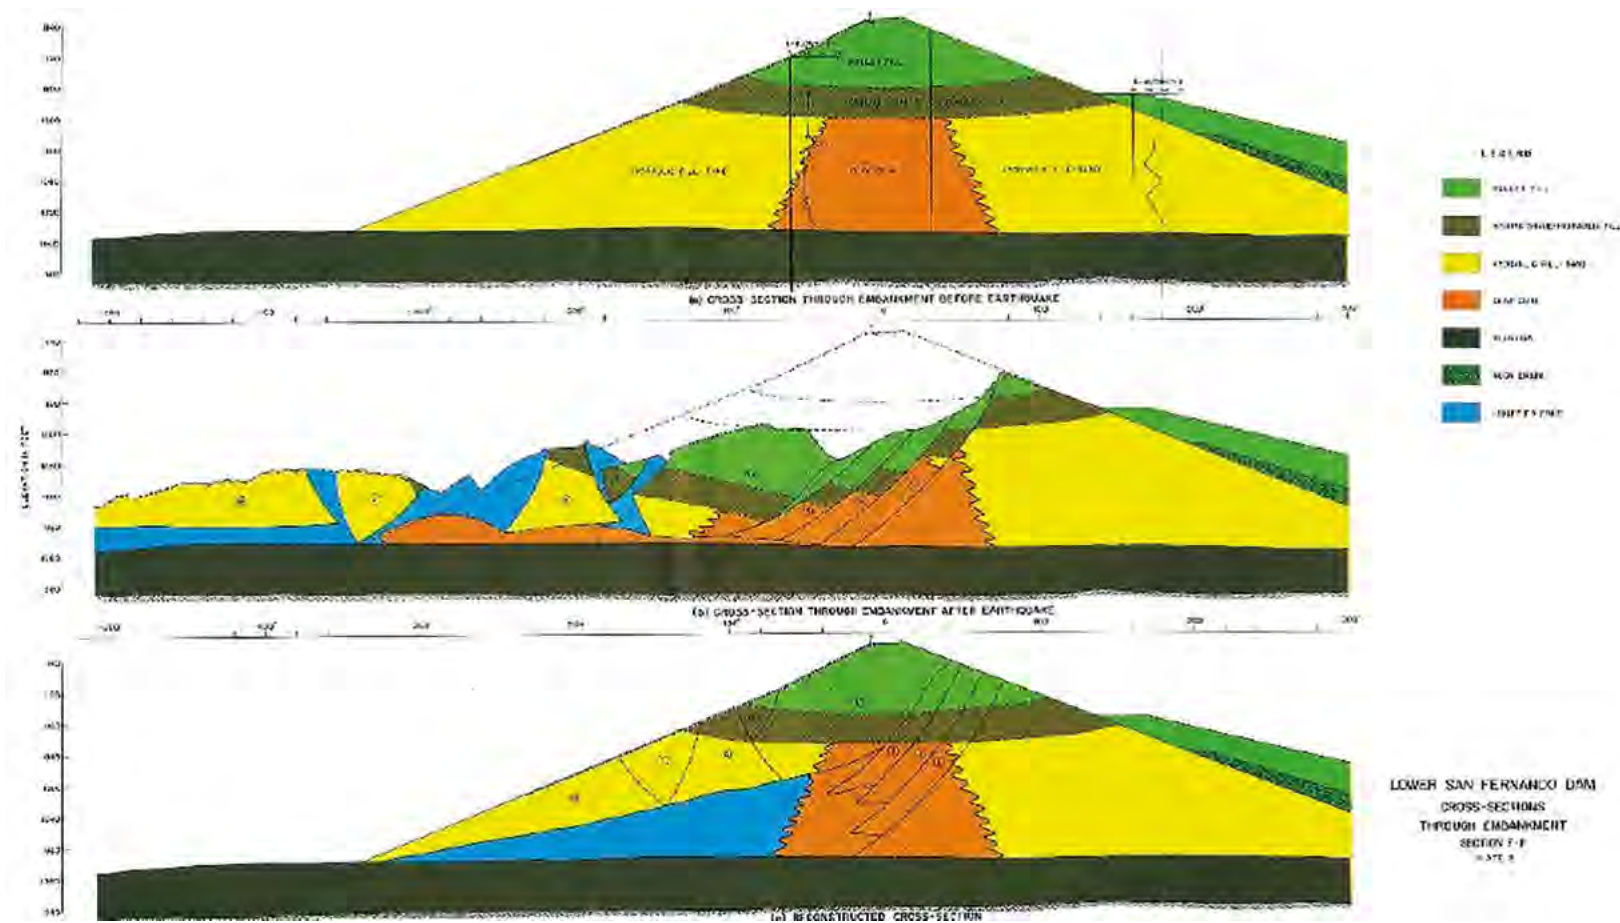
The LSFD was a hydraulic and rolled fill dam constructed beginning in 1912 at the northeast corner of the San Fernando Valley near Granada Hills. At the time of design and construction, hydraulic fill techniques were considered to produce “soundly engineered” earth dams. The embankment failed during the Feb 9, 1971, Mw6.7 San Fernando Earthquake, but no water was released.

Careful forensic evaluations by the geotechnical engineering group at U.C. Berkeley unraveled the dam's failure by liquefaction of a zone of low density sandy hydraulic fill (shown in blue) in the above sections. The relative density of hydraulic sand fill was later determined to be between 40 and 70 percent. The hydraulic fill section was capped, and the dam raised with rolled earth fill in four epochs.

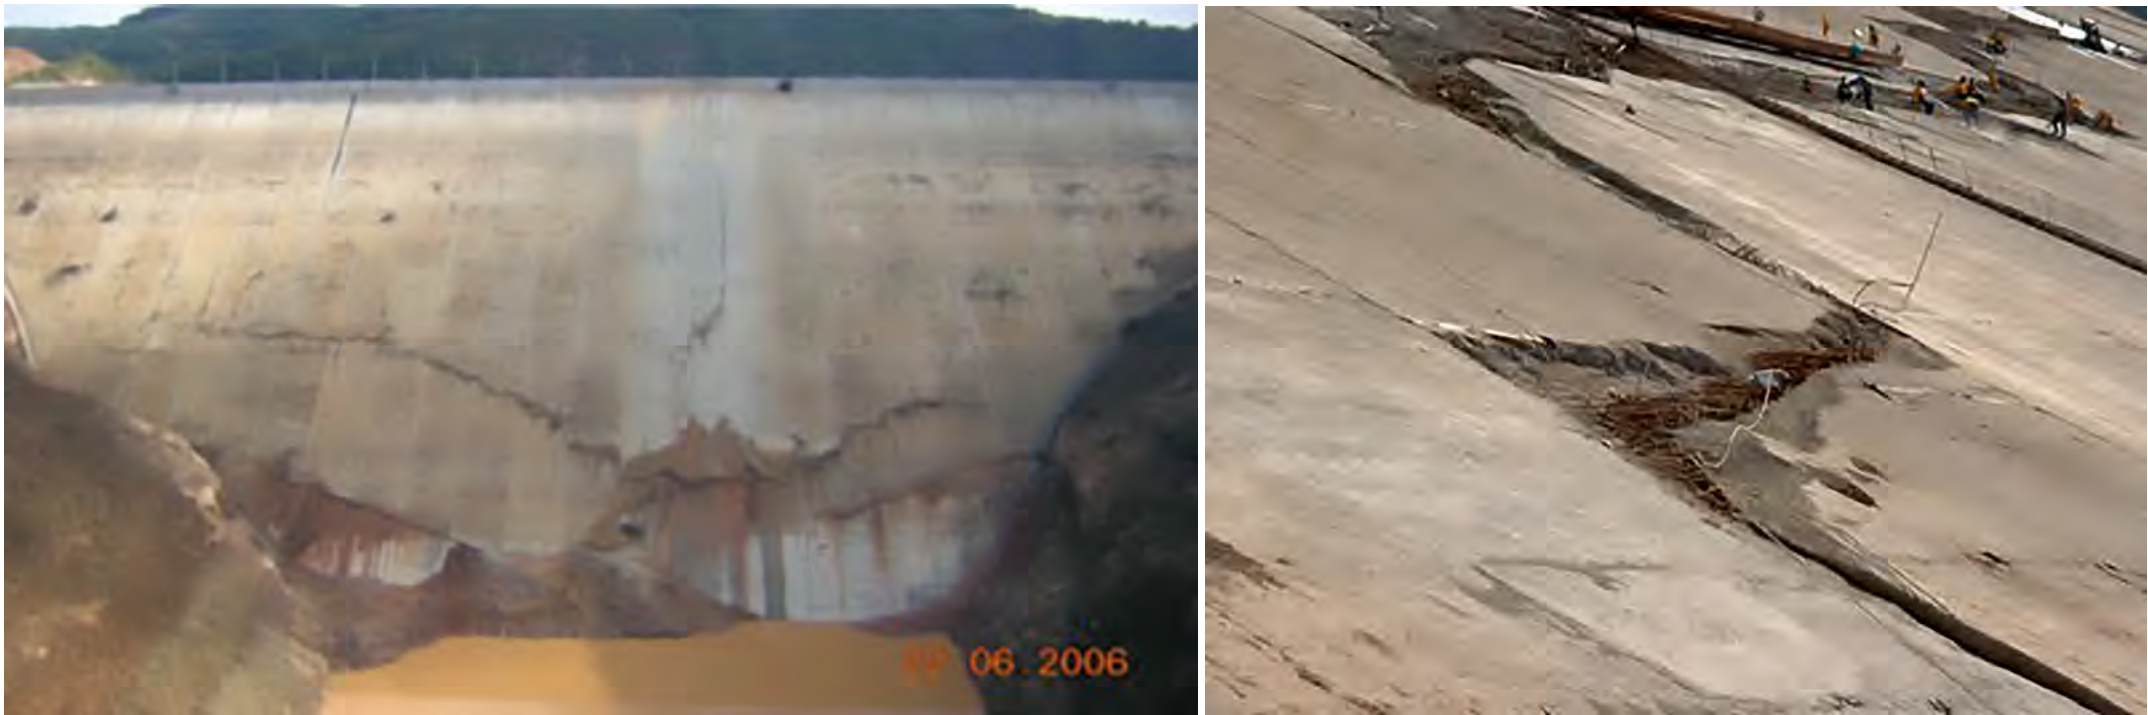
As in Barra Grande Dam, some serious cracks, squeezed ruptures and horizontal overlaps of concrete face slabs also occurred at Campos Novos Dam (202 m high).

The damages at Campos Novos CFRD

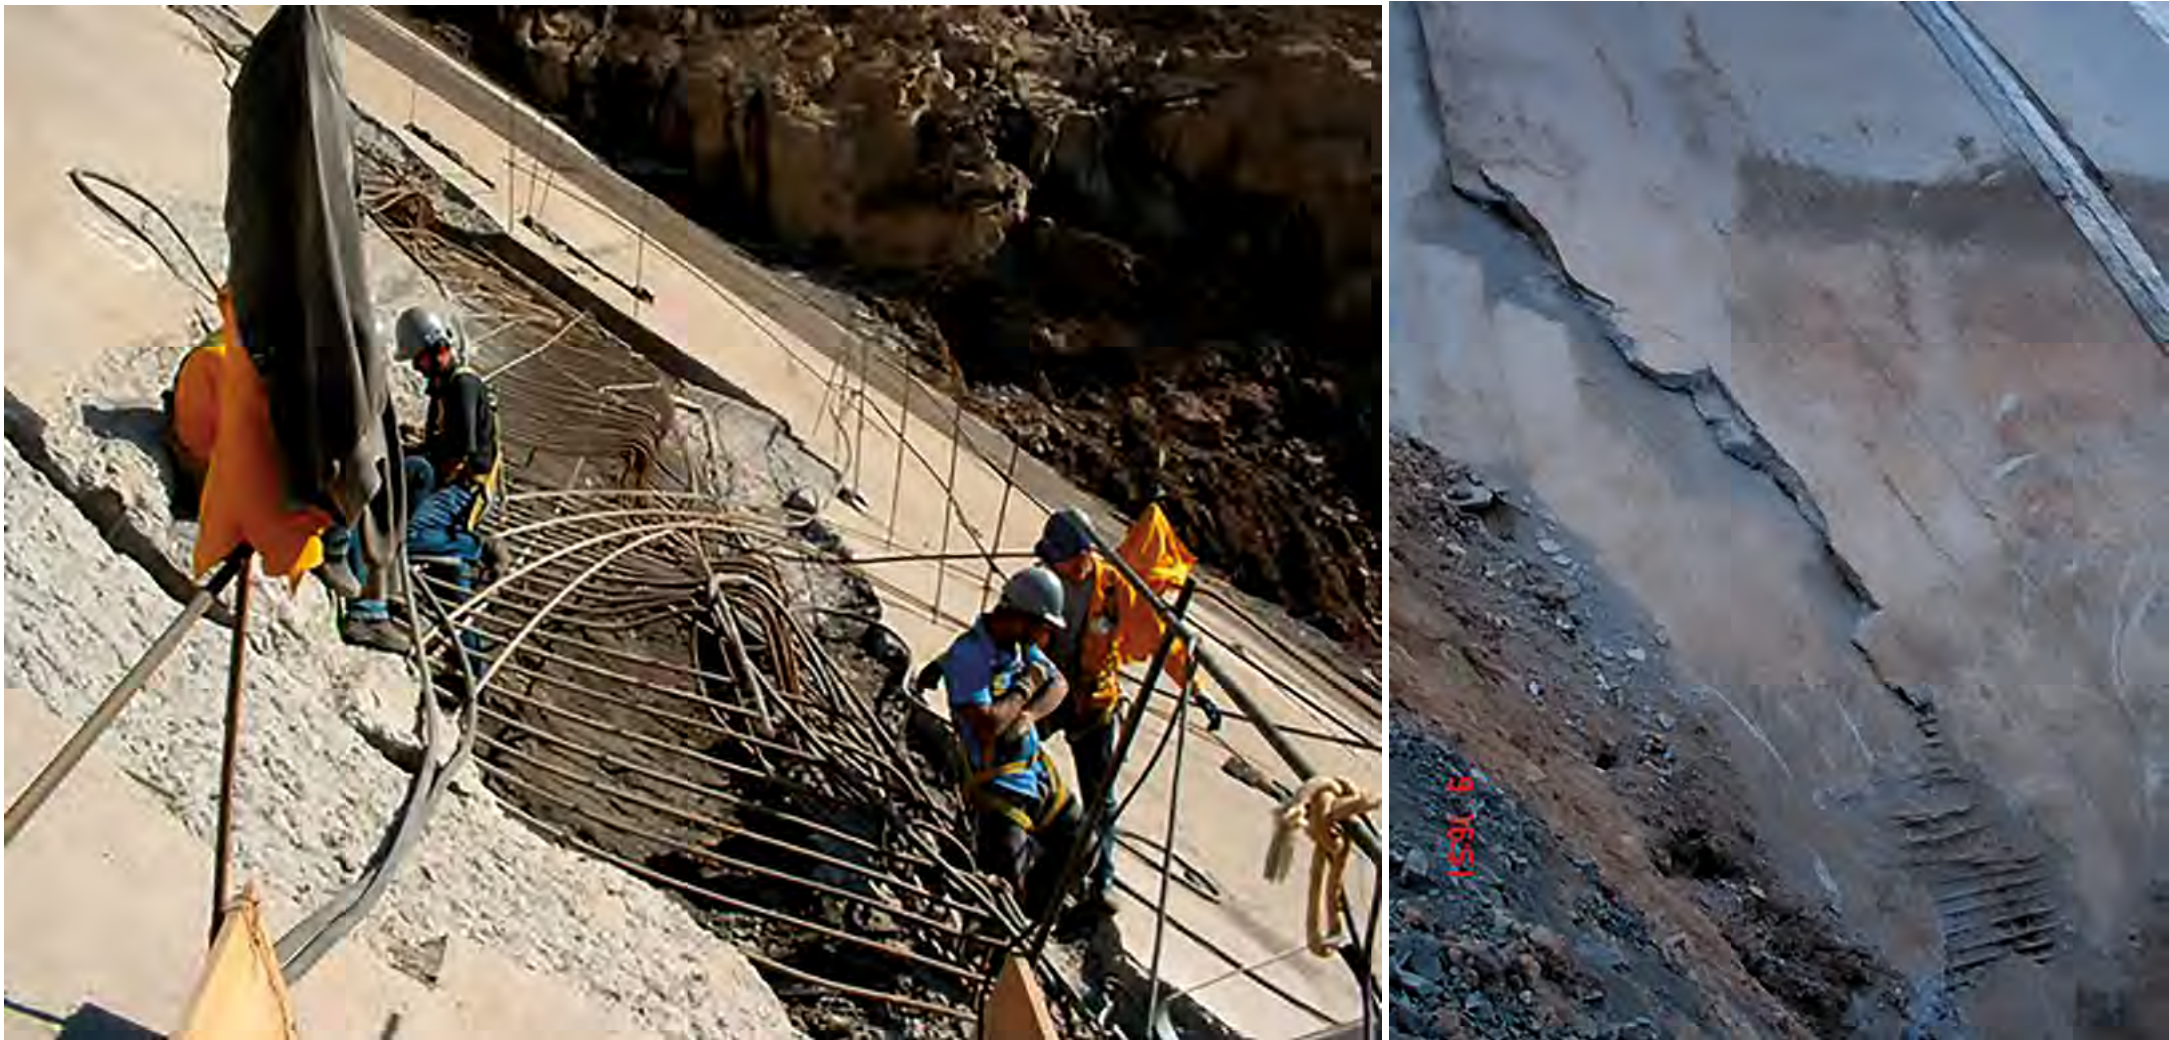
The damages at Campos Novos CFRD

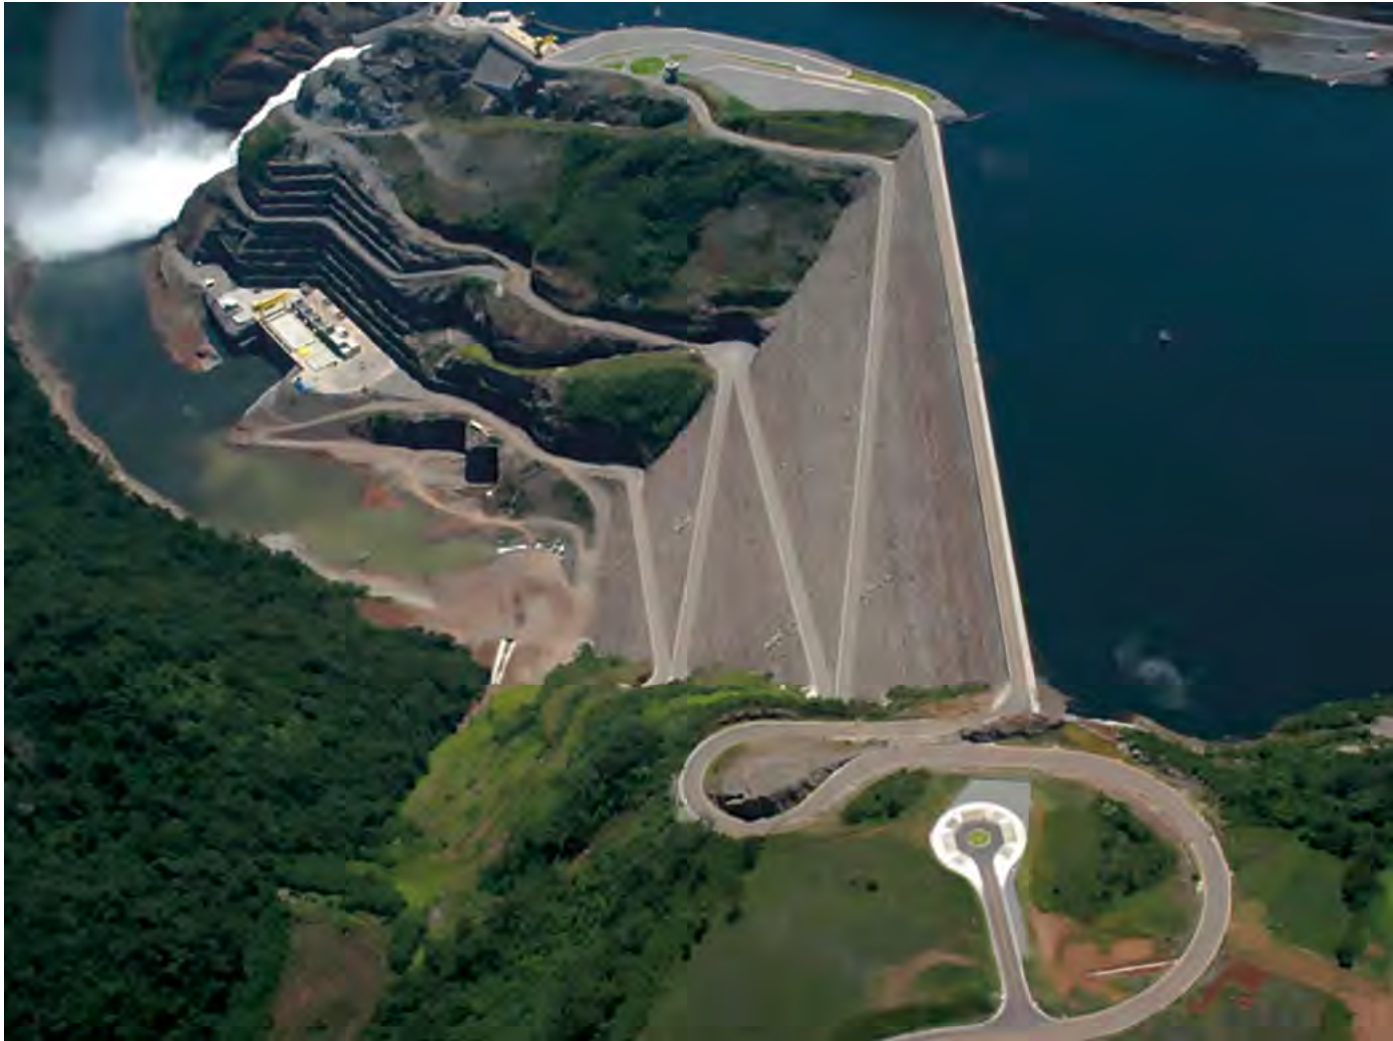
The damages at Campos Novos CFRD
