Is Your Dam Safe?

An281	Andriolo, Francisco Rodrigues; Moreira, José Eduardo
	Is Your Dam Safe? – Vol. 1 / authors: Francisco Rodrigues Andriolo e José Eduardo Moreira. São Carlos, 2022.
	1394 p. il. color
	ISBN – 978-65-5668-011-8
	DOI – http://dx.doi.org/10.26626/9786556680118/2022B001
	1. Dams. 2. Training. 3. Quality. 4. Repairs. 5.Controls. 6. Cement. I. Orgs. II. Title.
	CDD 370

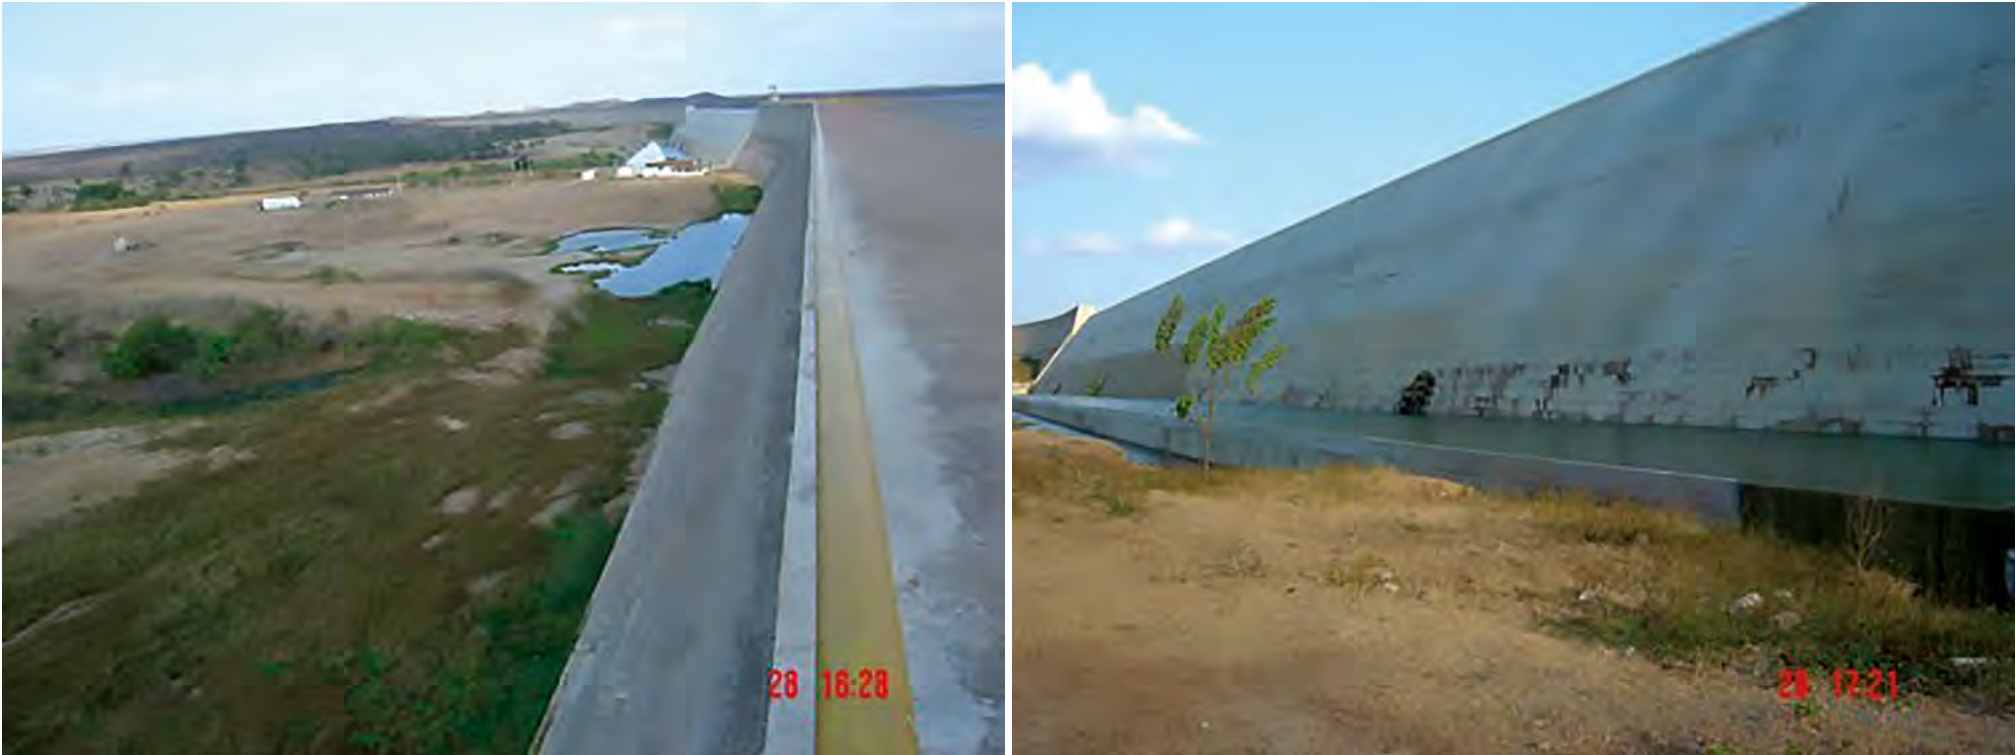
The same as 4.5.10-B, the inspections showed the face of the CCR dam executed simultaneously with CVC, with porosities, honeycombs and infiltrations to the downstream face, **resulting from methodology and execution of poor quality.**

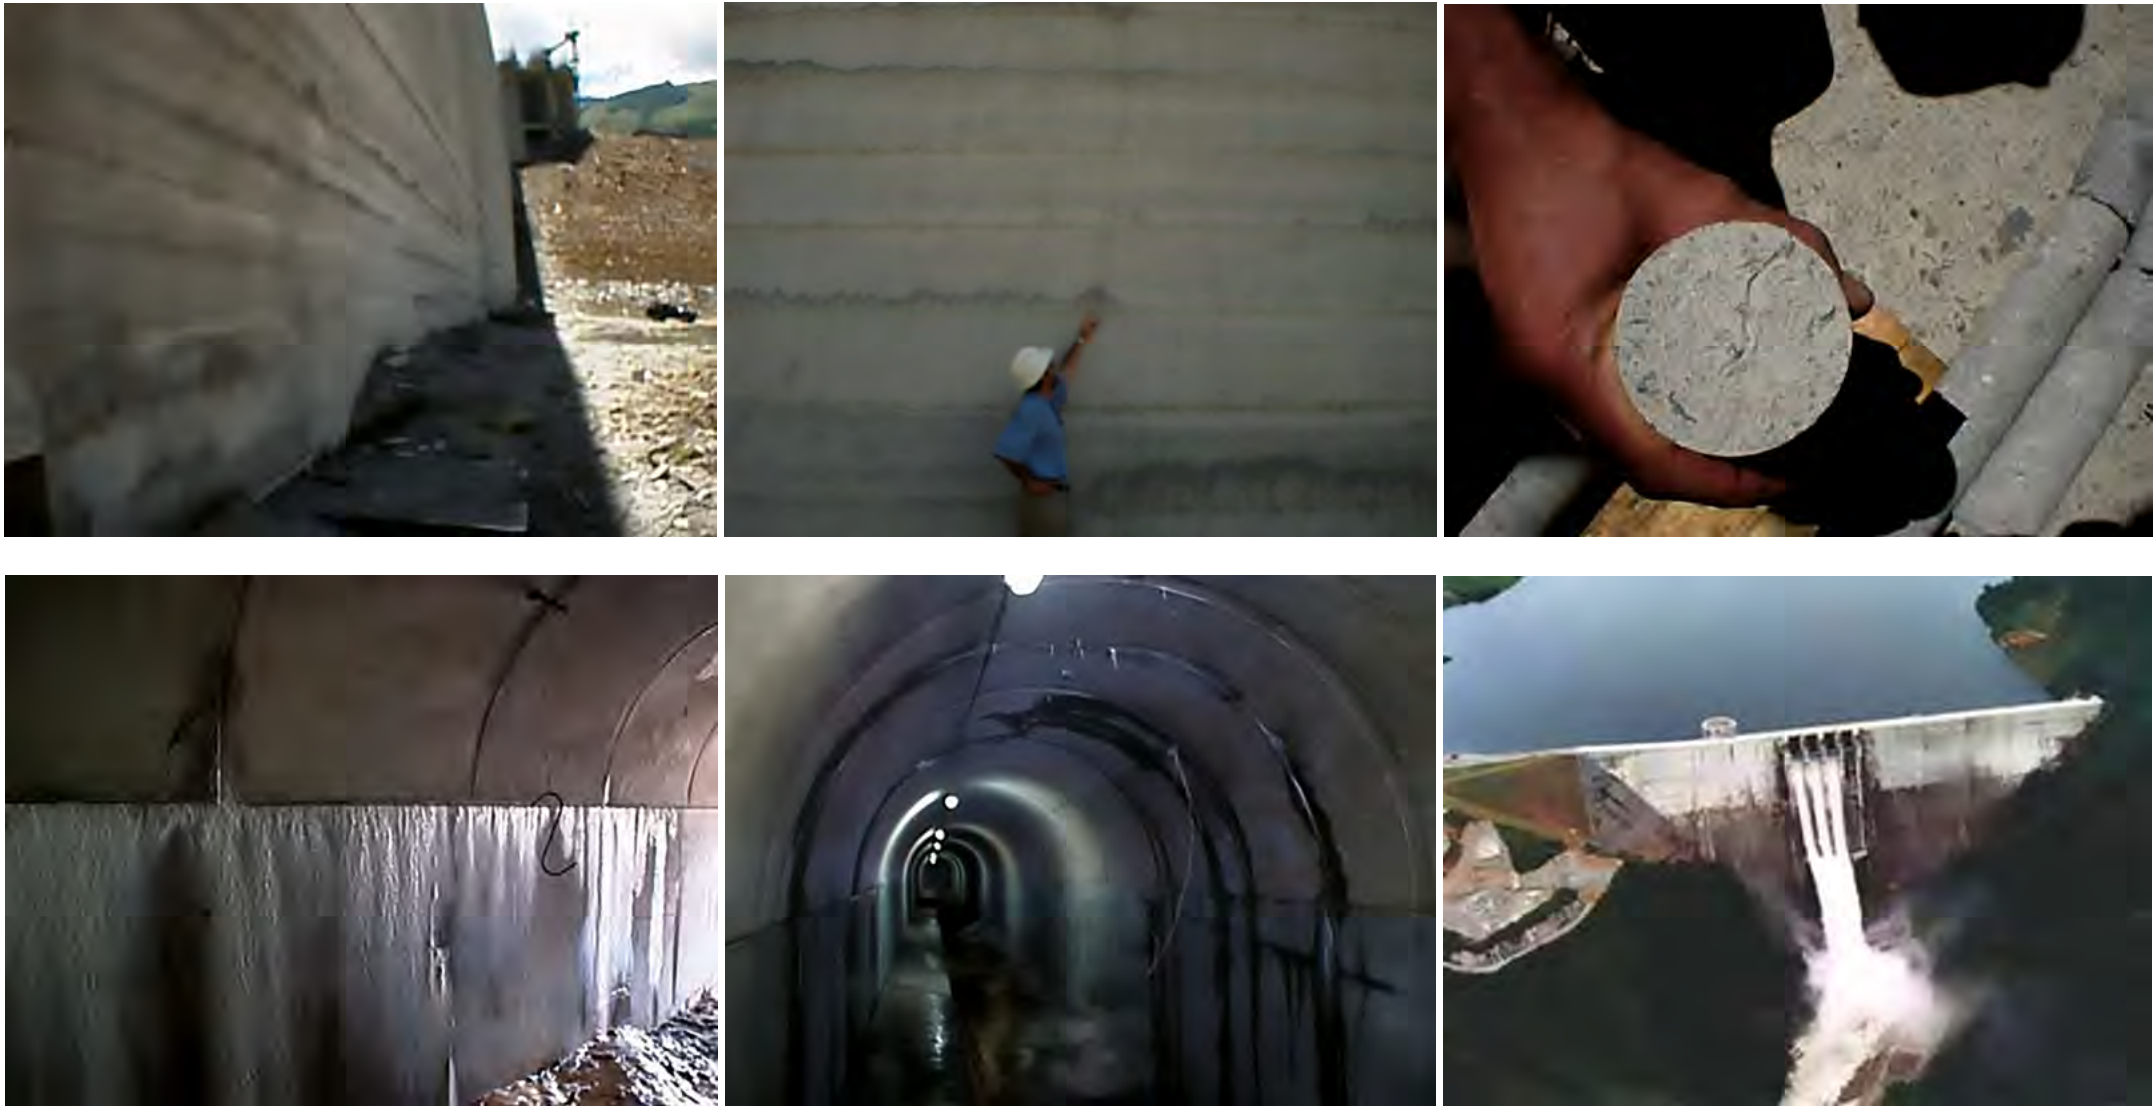
The author's technical visit (by October/1999) may observe, even yet just during the construction, that there was seepage due to cracks in the elements of the face, together with poor contact between layers of the RCC.

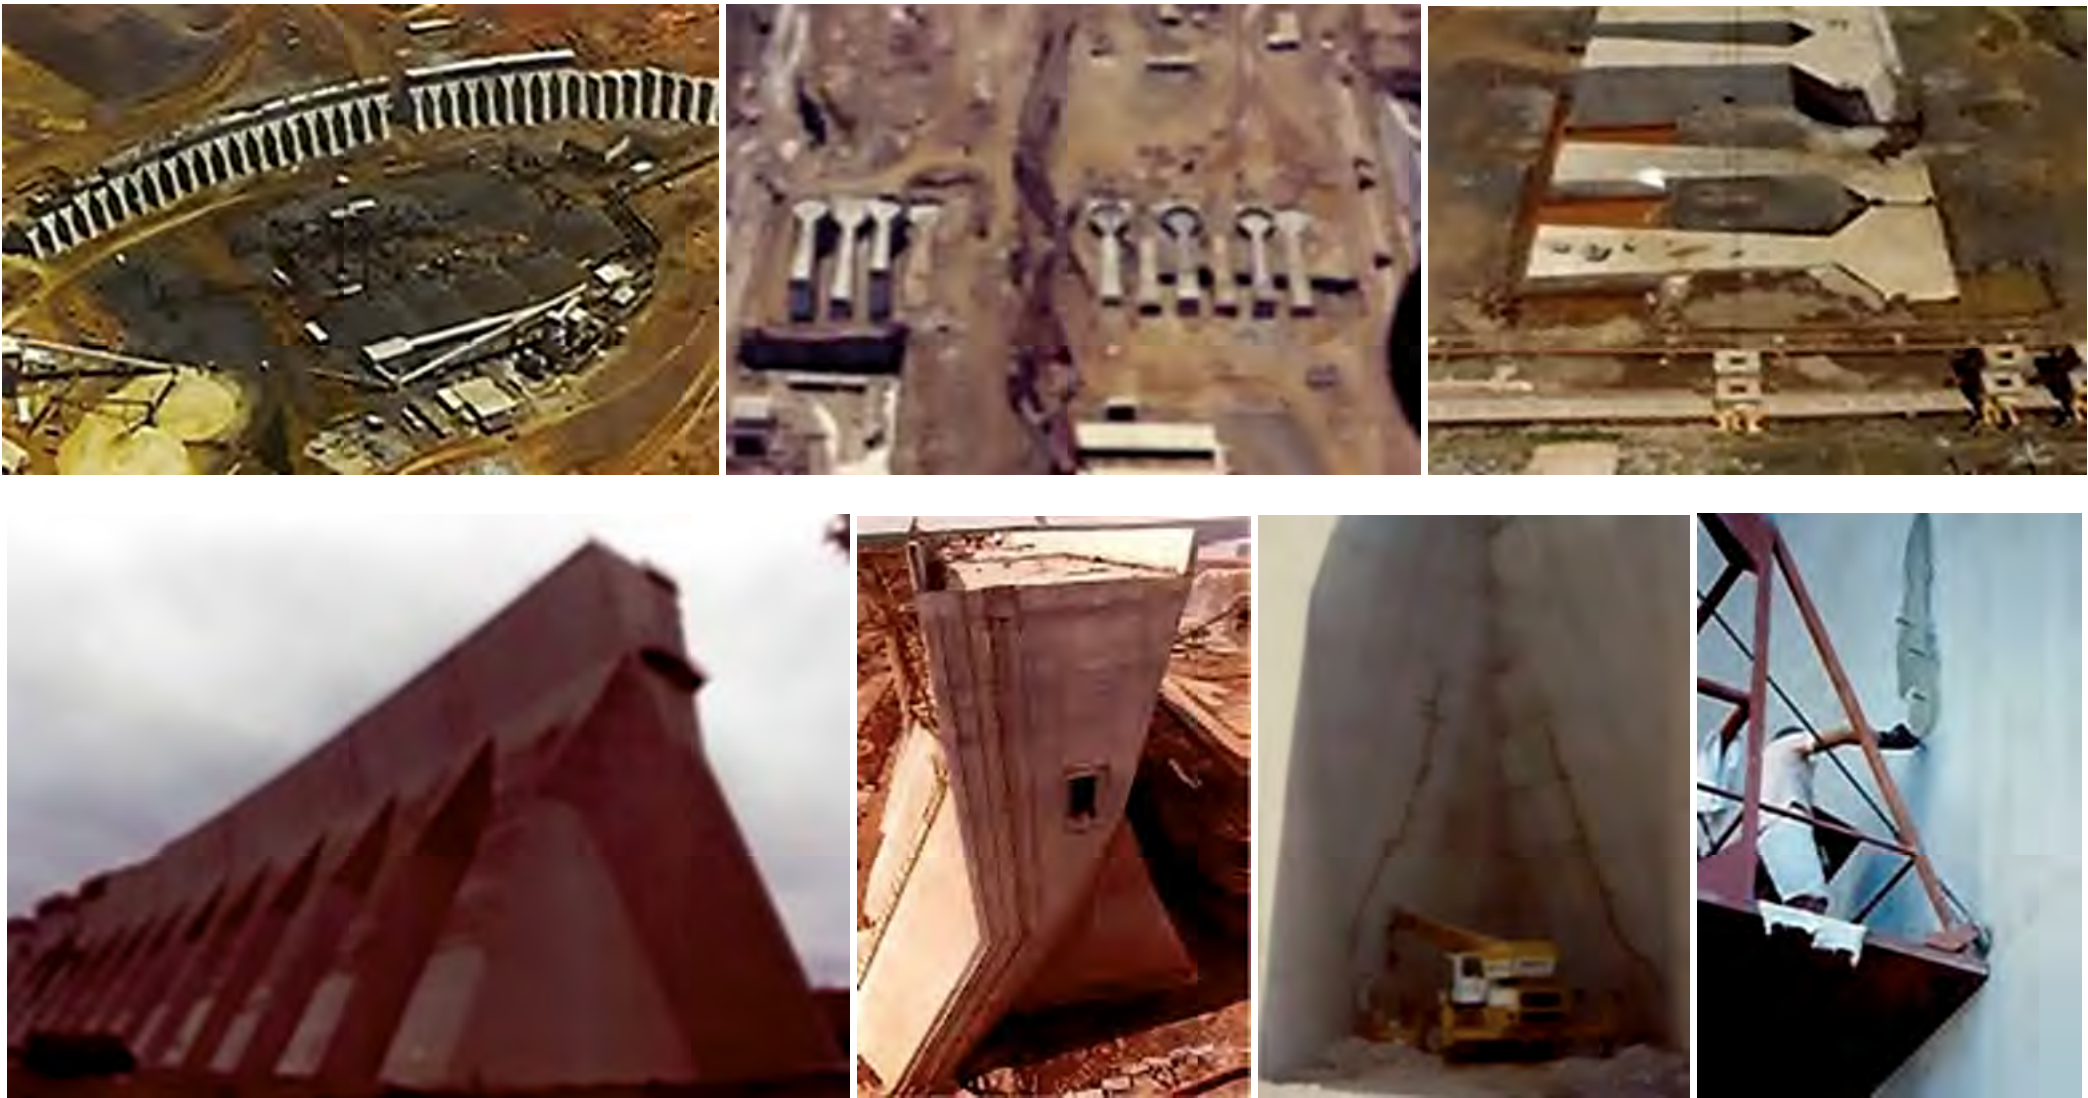
Virtually all cracks were verticals or sub-verticals and began at the foundation. If the cracks were characterized from micro-cracks of small depth and extension, they were even between 10 and 20 m in length. The opening media of these cracks were around of 0,3 and 0,9 mm, and some cross the entire buttress, but none achieved the complete separation of the foothills and the head of the blocks. The cracks were injected with resins and special equipment.

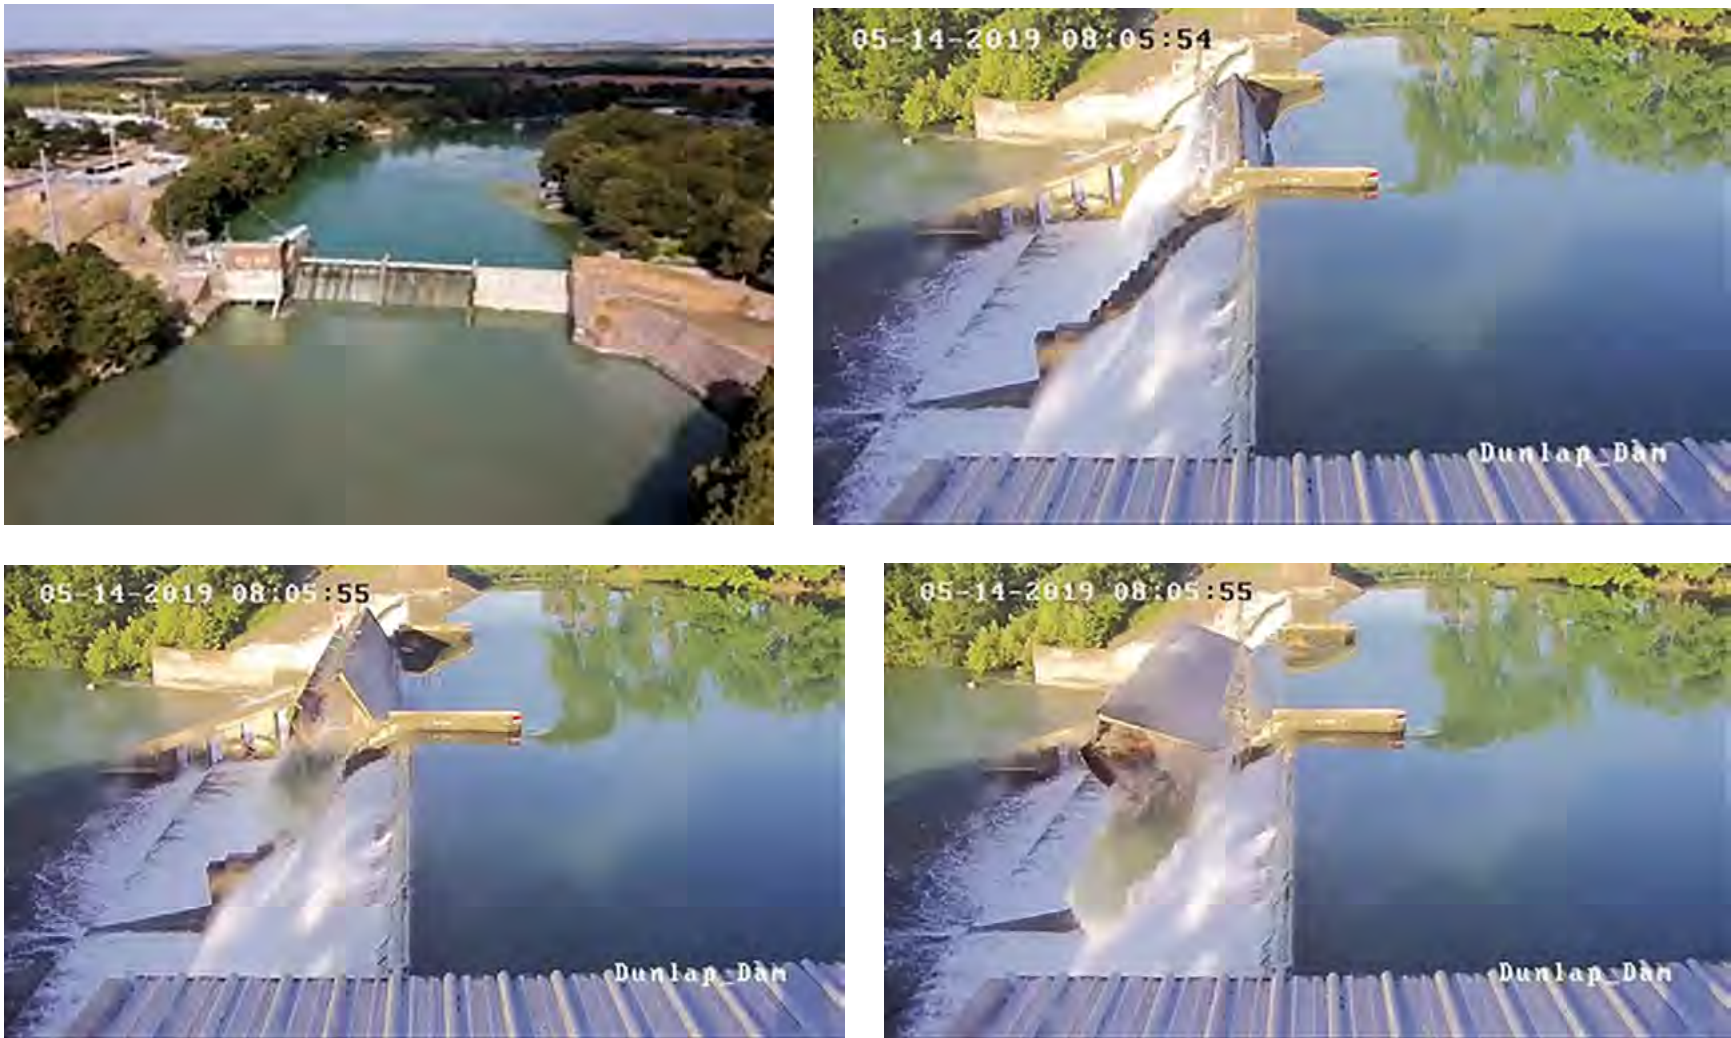
Lake Dunlap dam spillway gate damage sequence (Disponível em: <https://youtu.be/WrTp3JDG9Fs> - Access: 17 jan. 2022)

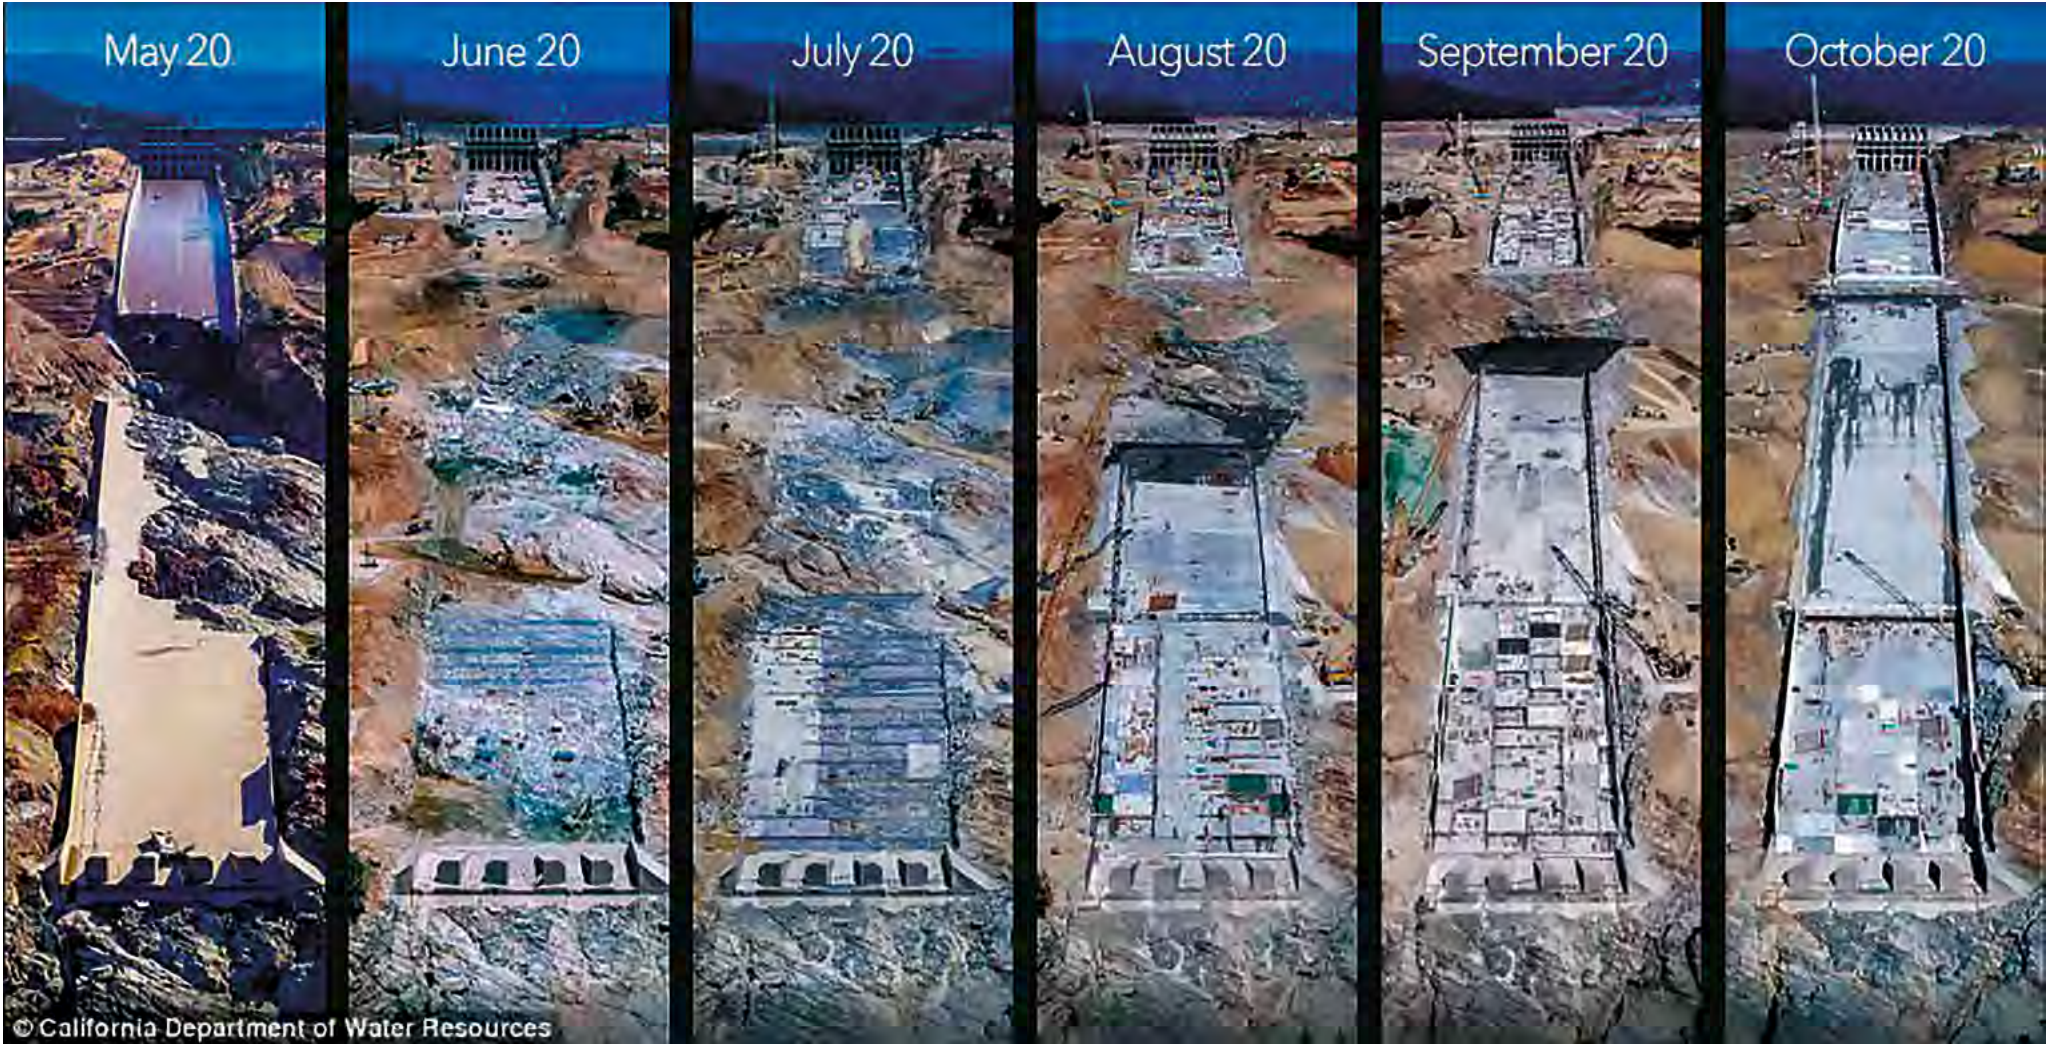
Oroville Spillway repair development since the damage (Courtesy from California Department of Water Resources)

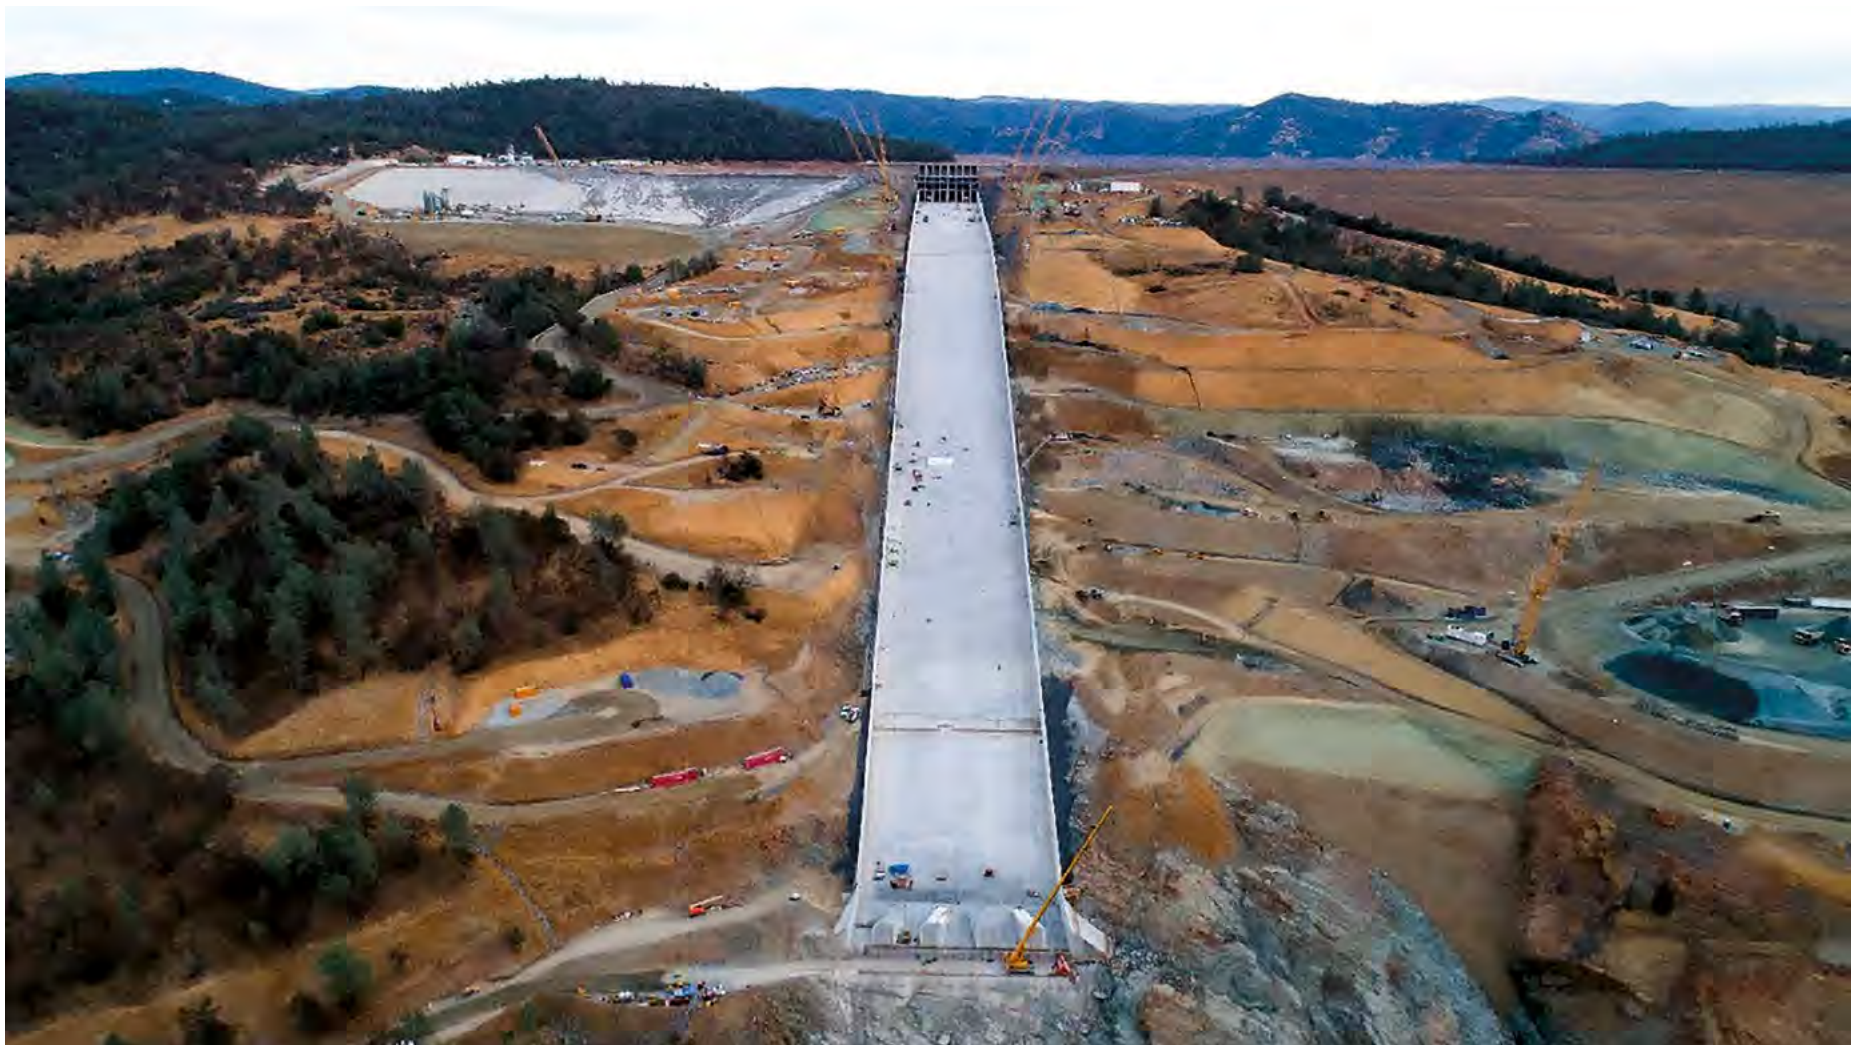
Oroville Spillway view after repair (Courtesy from California Department of Water Resources)

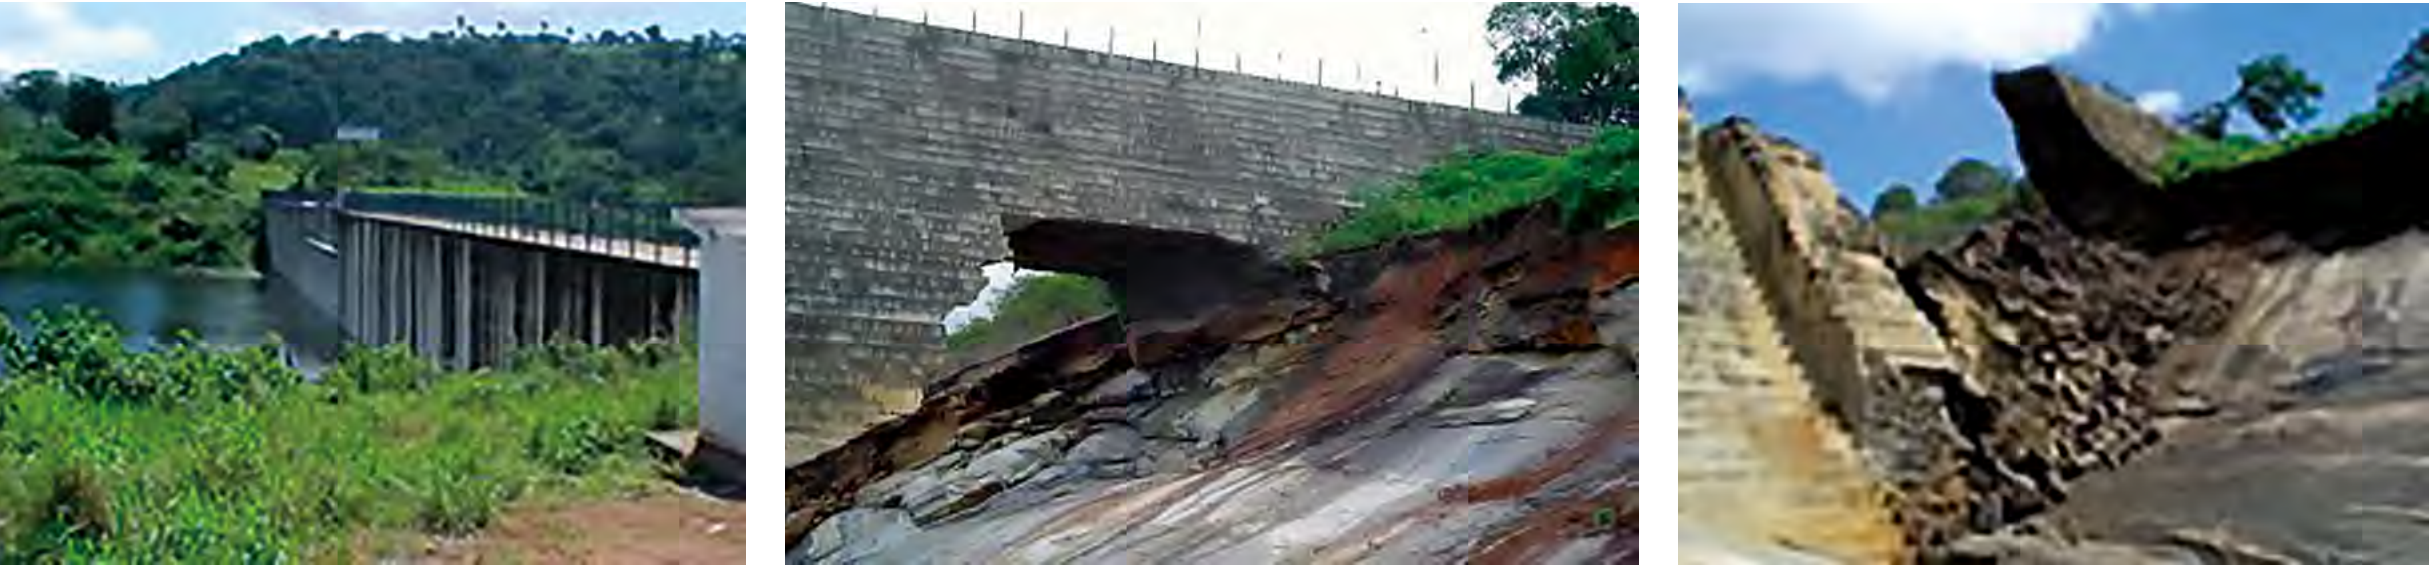
The Camará Dam as was constructed (at left above) and the damages due to the foundation collapse (Pictures from the Reference)

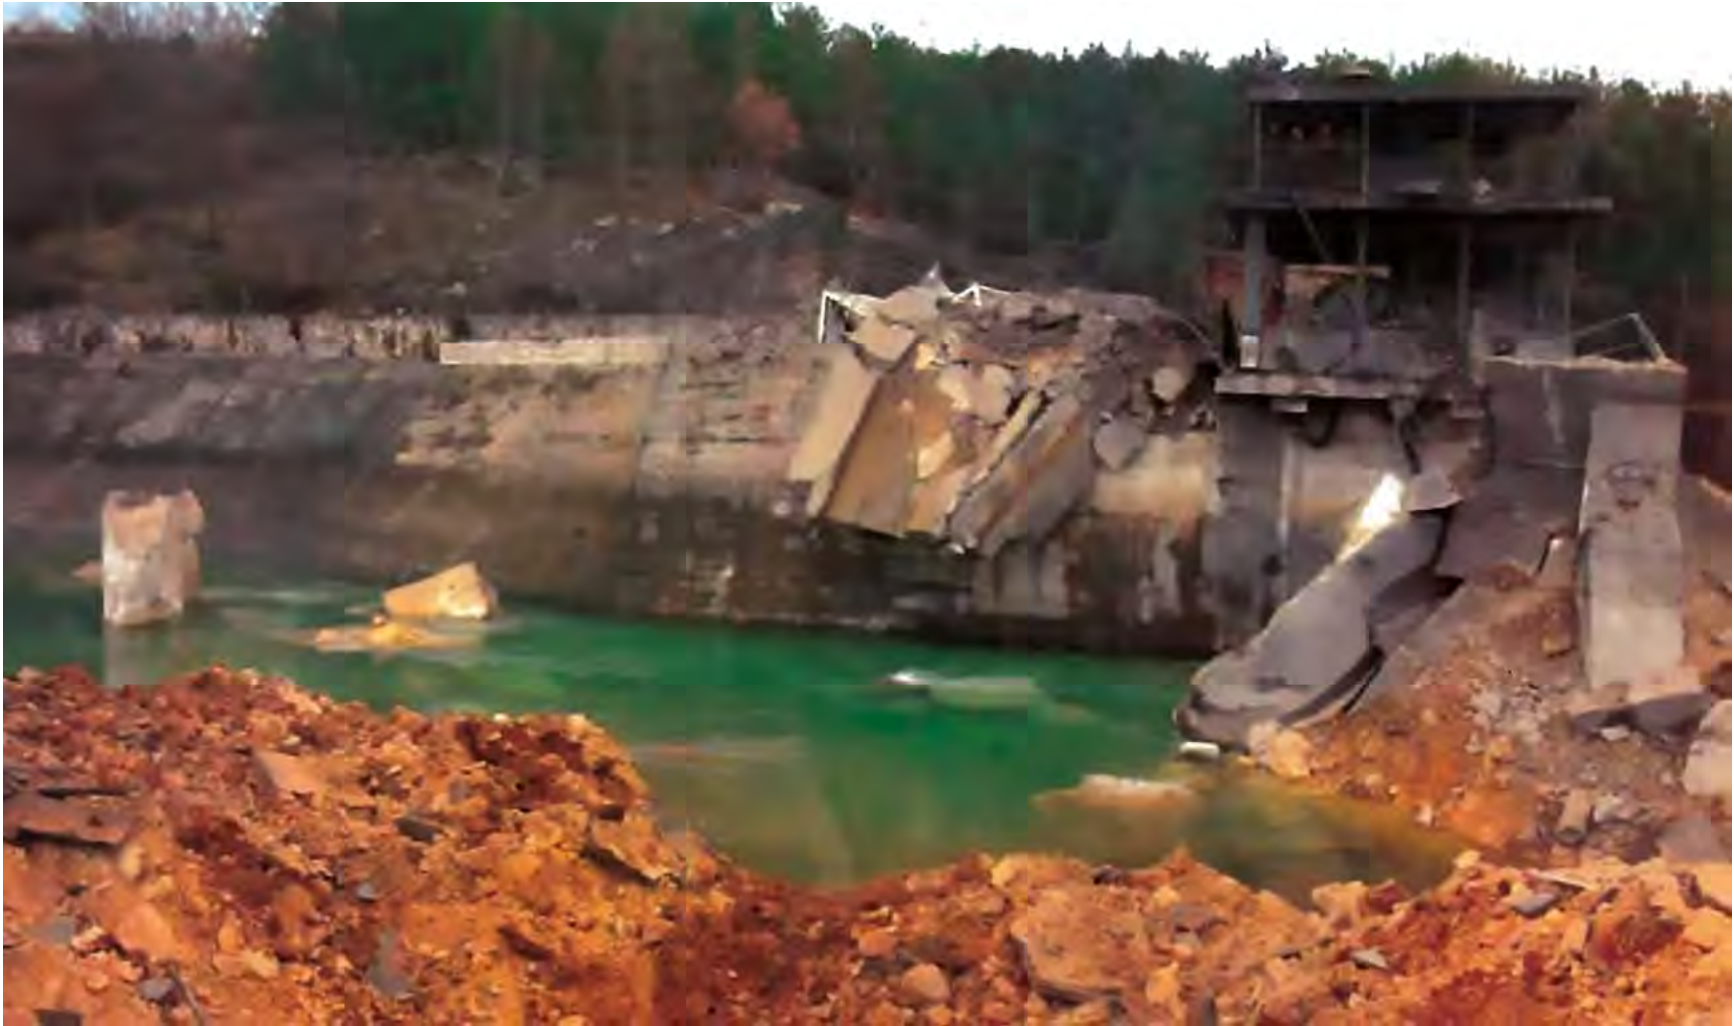
Peruca dam damages due to war^[07-69]

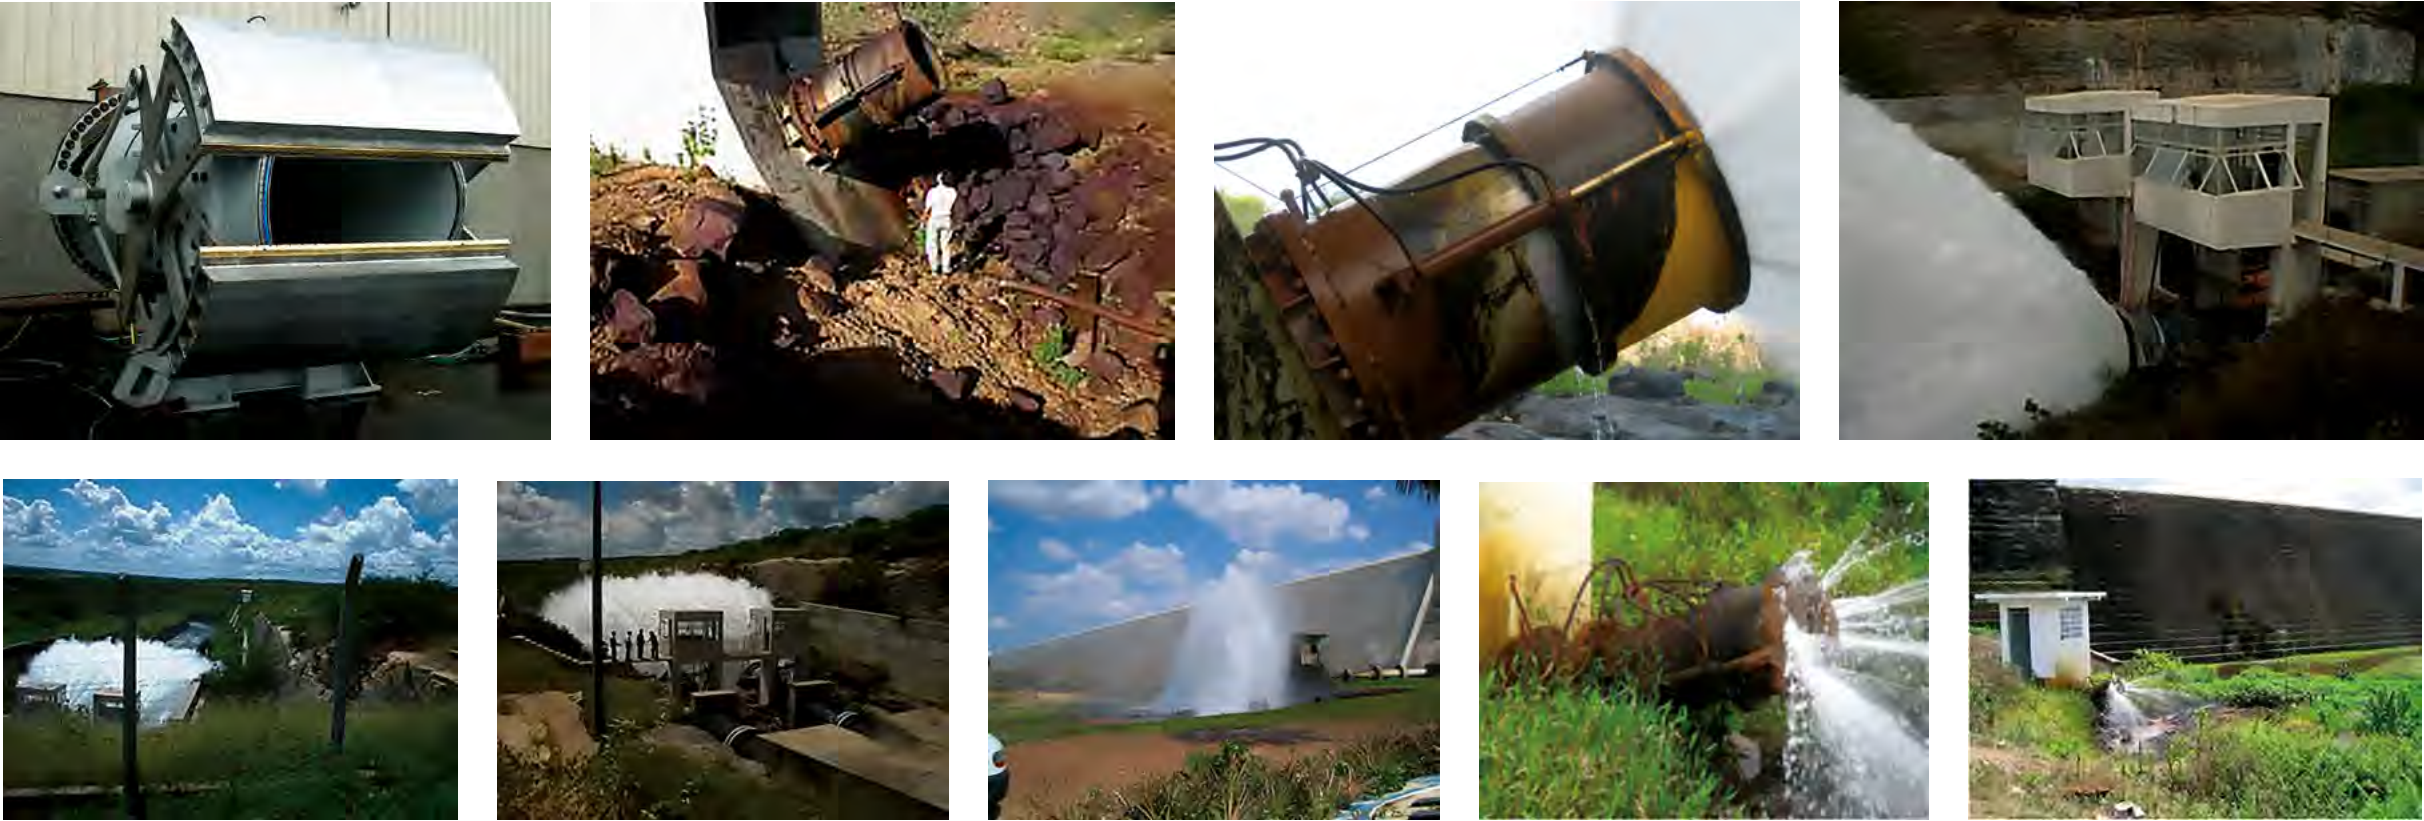
Diffuser Valve Types in good operational condition and in poor maintenance (pictures from Andriolo’s archives)

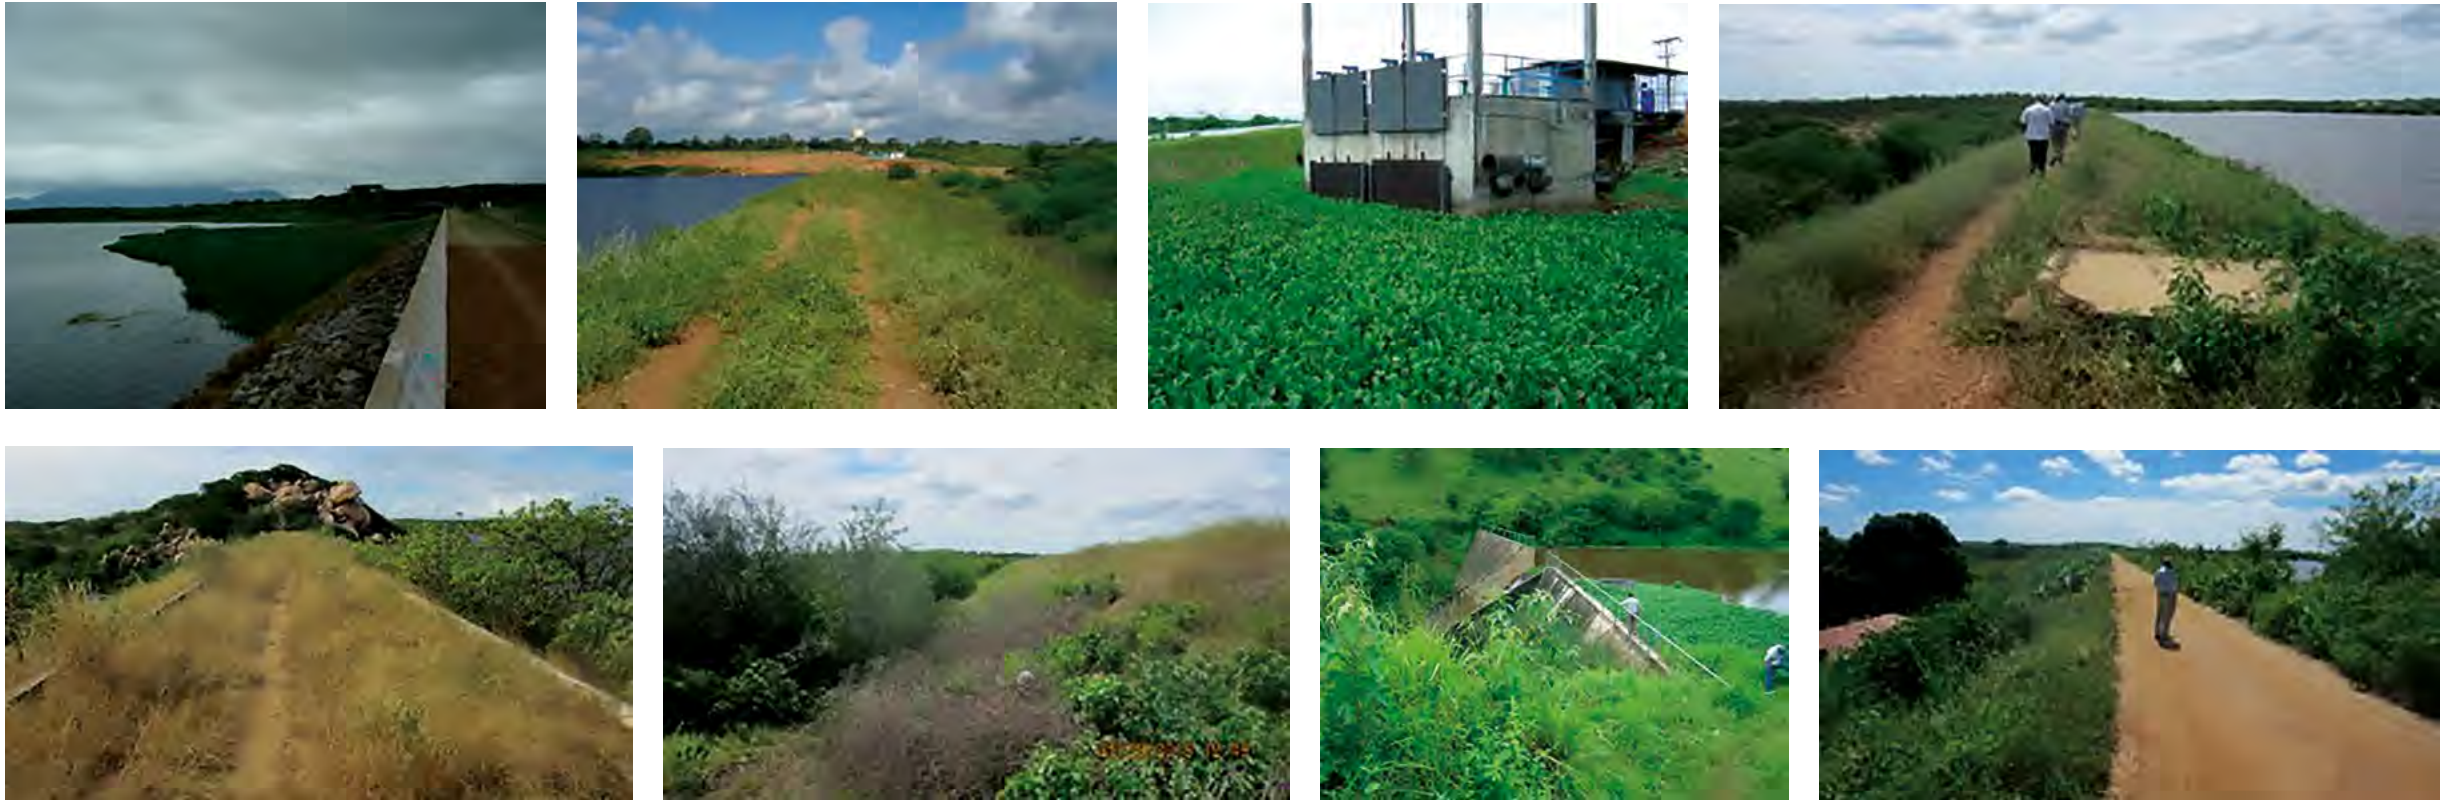
Figures showing unacceptable vegetation control on a dam. Downstream slope with trees growing and waist-high grass making visual inspection nearly impossible. Upstream slope is mowed, but trees and tall grass growing along the toe of dam above normal pool reservoir. Most of downstream slope is mowed, but trees and tall grass remain on slope and at the toe of dam. Mature trees growing on slopes and knee-high grass, hindering visual inspection (Pictures from Andriolo's archives)

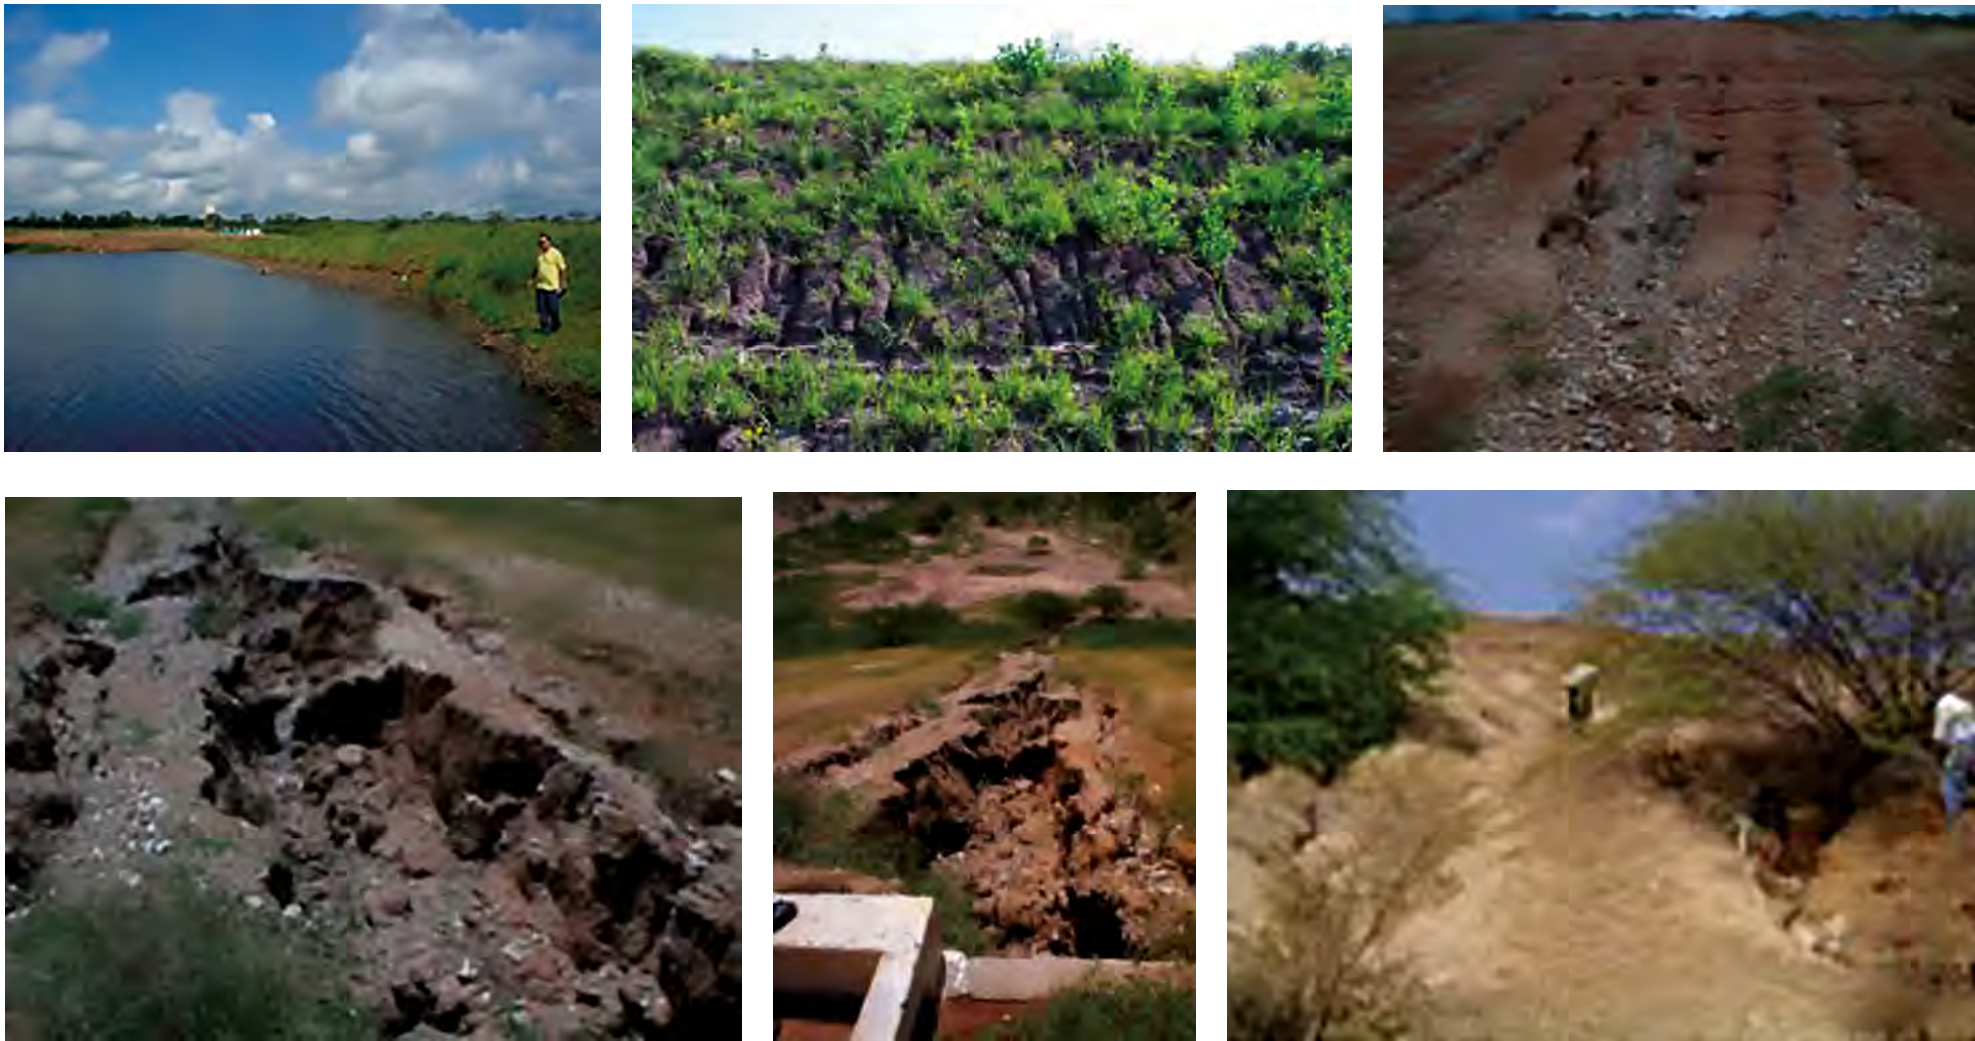
Figures showing sparse vegetation and erosion downstream of an embankment slope (Pictures from Andriolo’s archives)
