Is Your Dam Safe?

An281	Andriolo, Francisco Rodrigues; Moreira, José Eduardo
	Is Your Dam Safe? – Vol. 1 / authors: Francisco Rodrigues Andriolo e José Eduardo Moreira. São Carlos, 2022.
	1394 p. il. color
	ISBN – 978-65-5668-011-8
	DOI – http://dx.doi.org/10.26626/9786556680118/2022B001
	1. Dams. 2. Training. 3. Quality. 4. Repairs. 5.Controls. 6. Cement. I. Orgs. II. Title.
	CDD 370

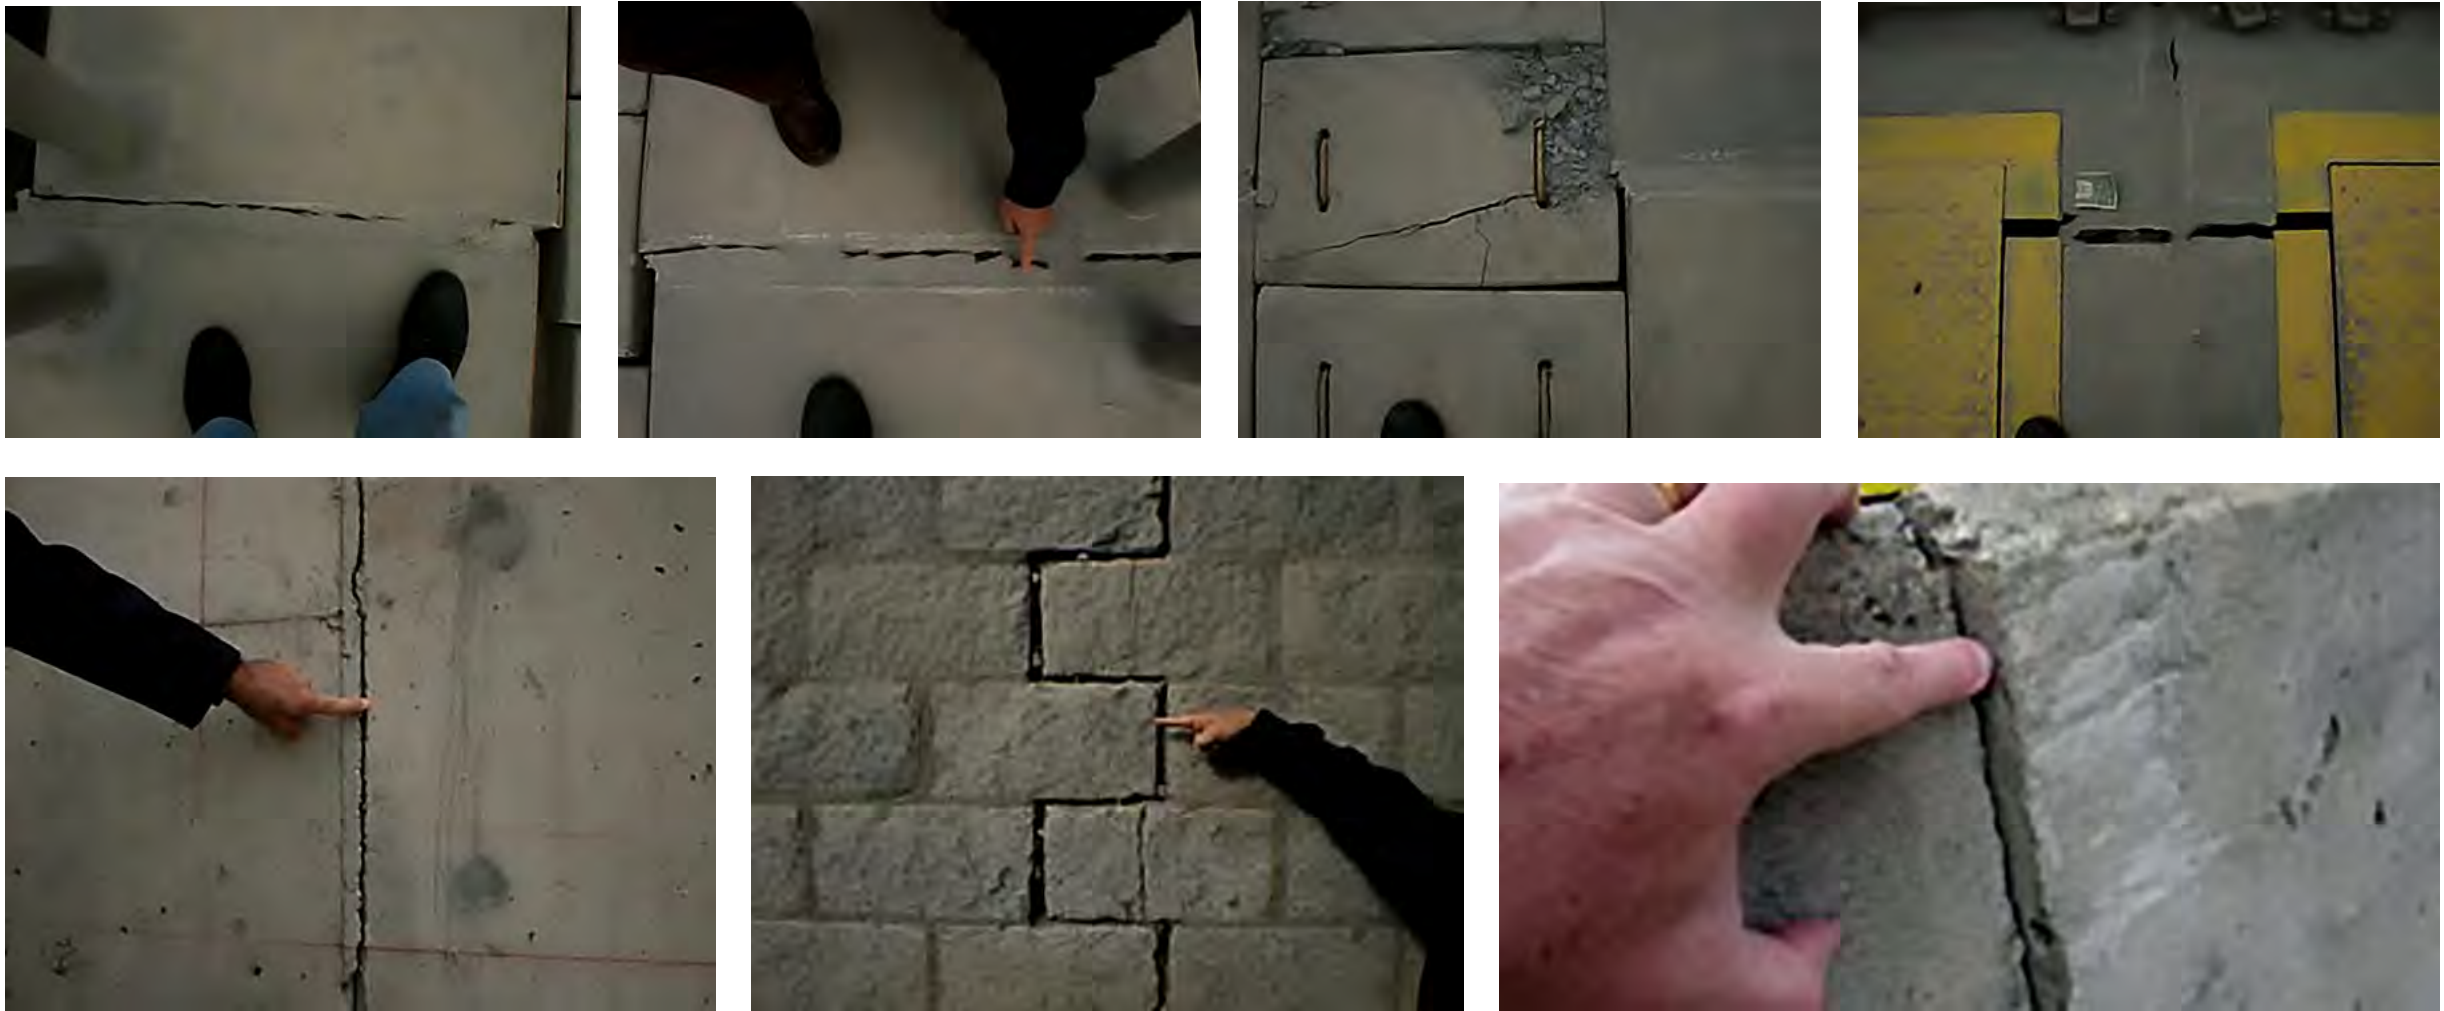
Structural cracks due to differential settlement of the foundation (Pictures from Andriolo's archives)

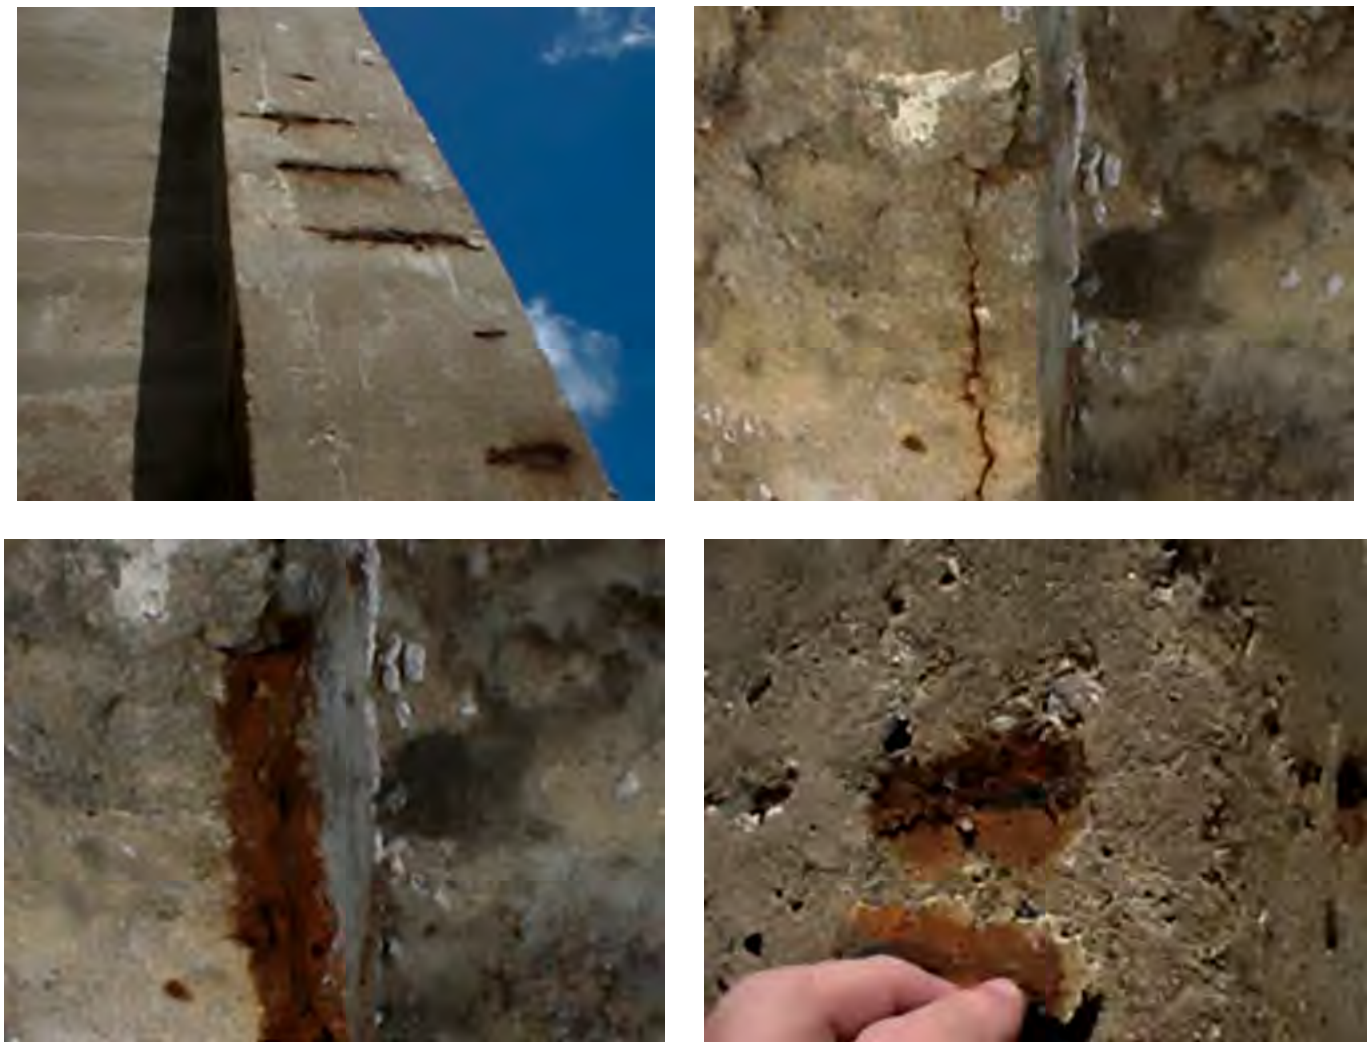
Concrete pop-out due to reinforcement corrosion resulting from poor covering (Pictures from Andriolo’s archives)

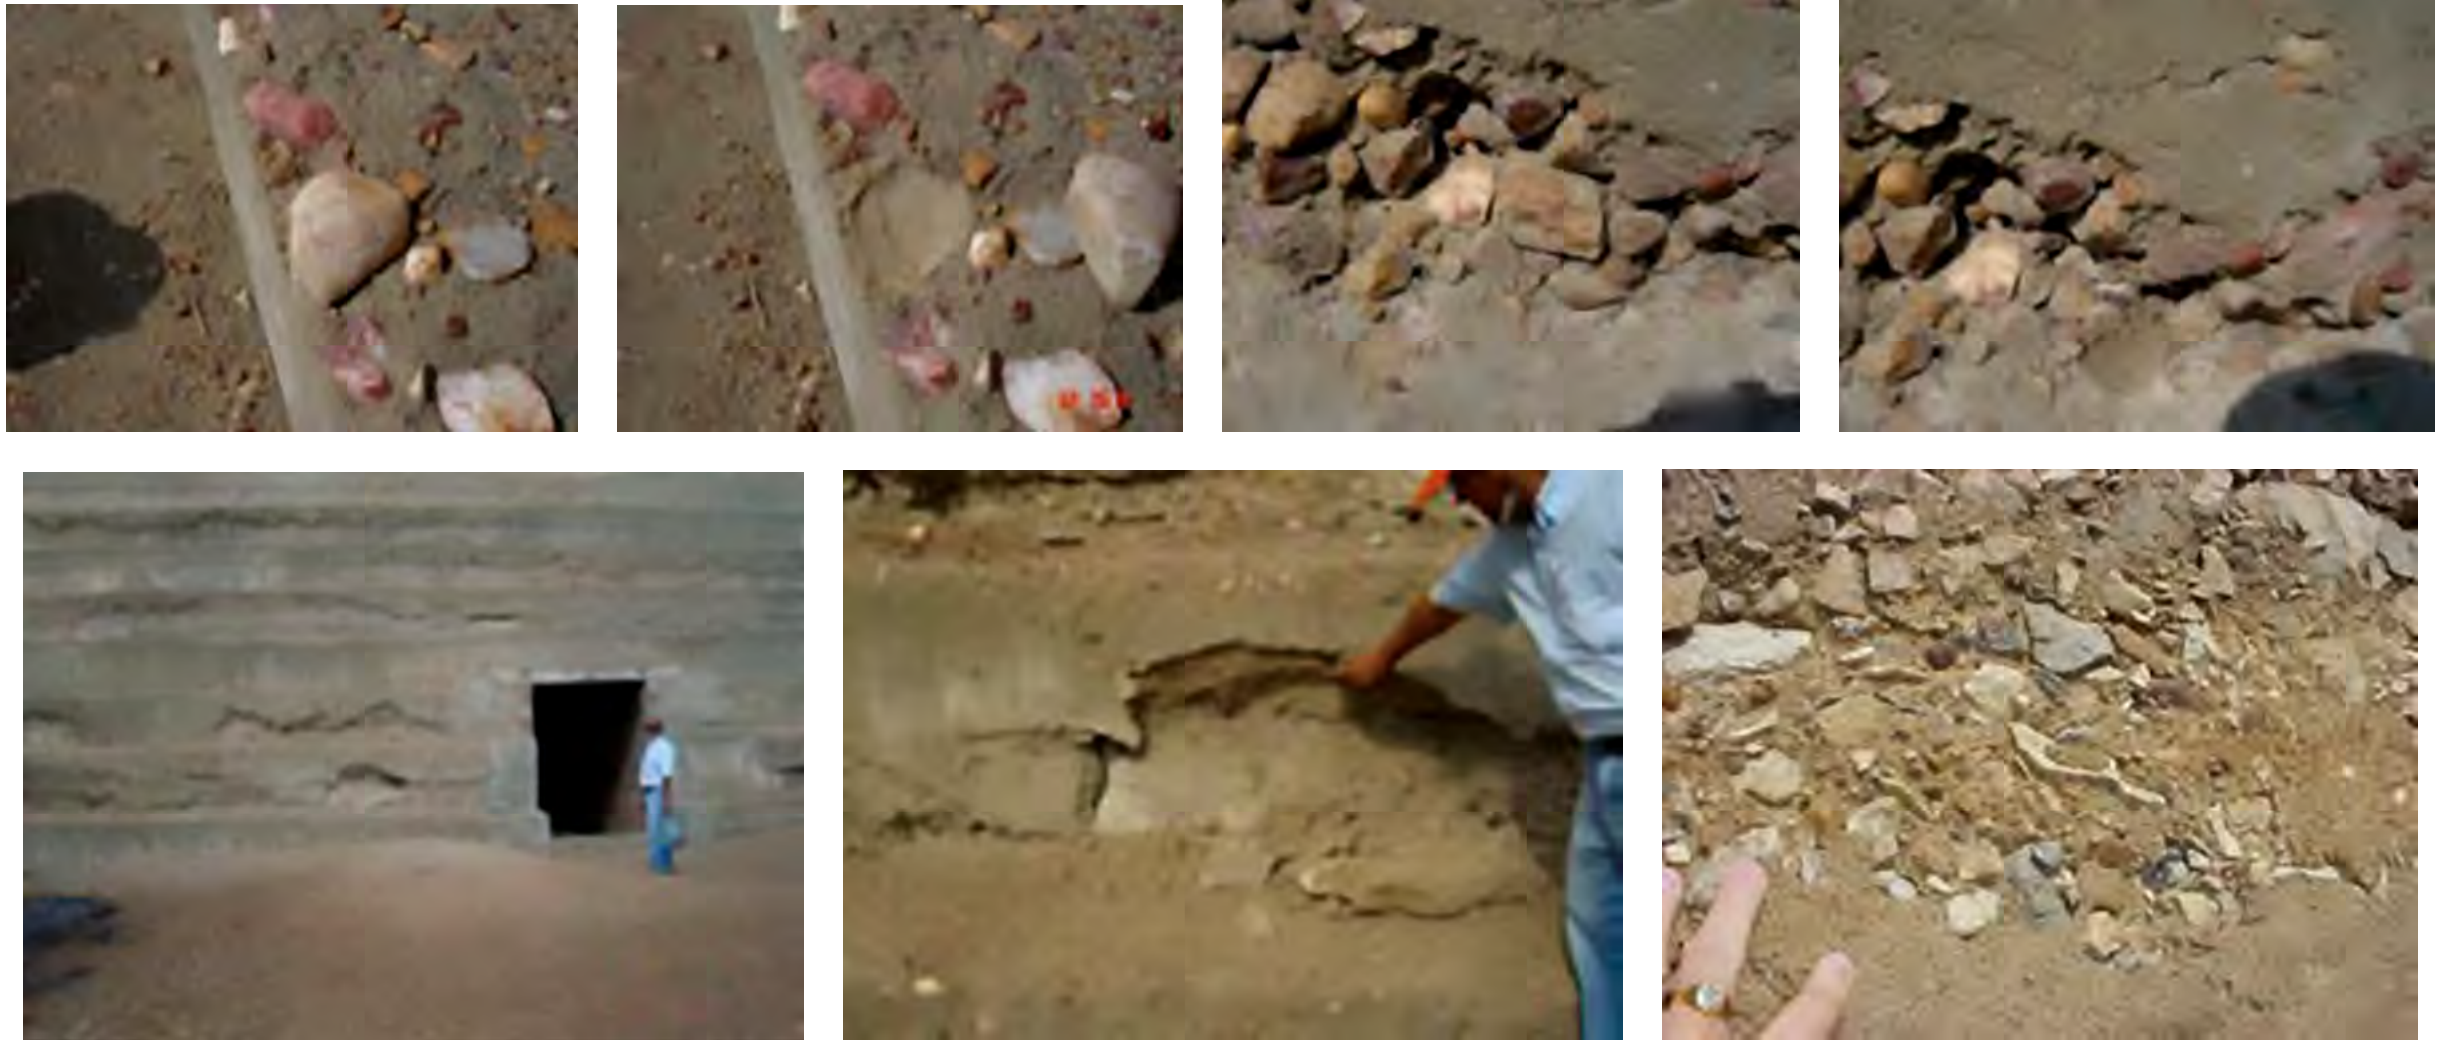
Poor quality of RCC in a dam (Pictures from Andriolo's archives)

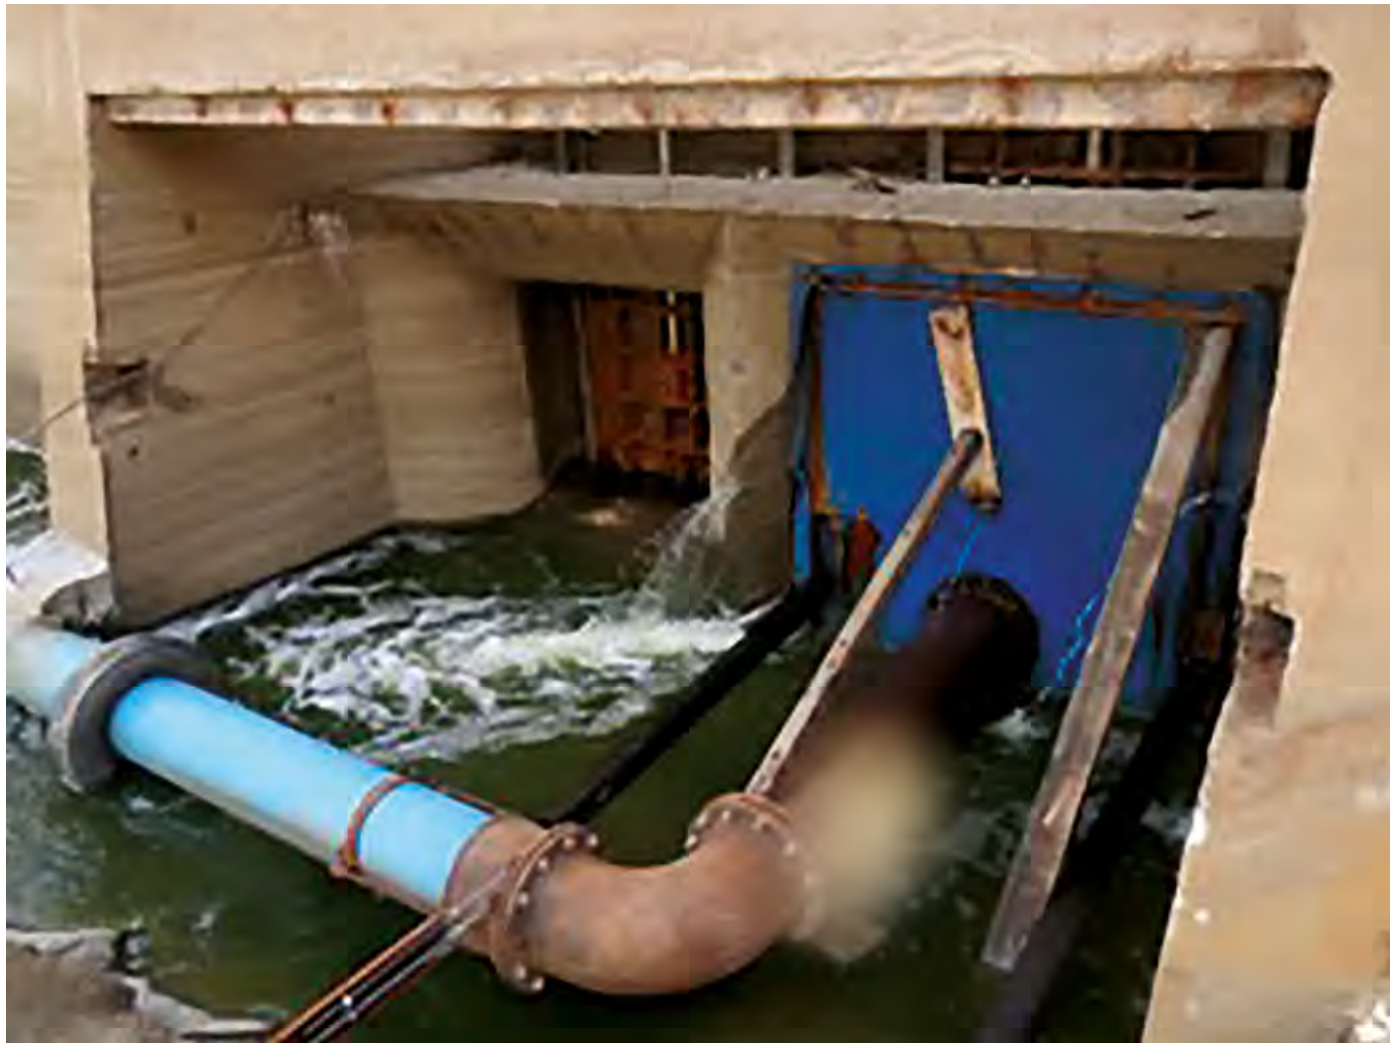
Inadequate support for pipes (Pictures from Andriolo’s archives)

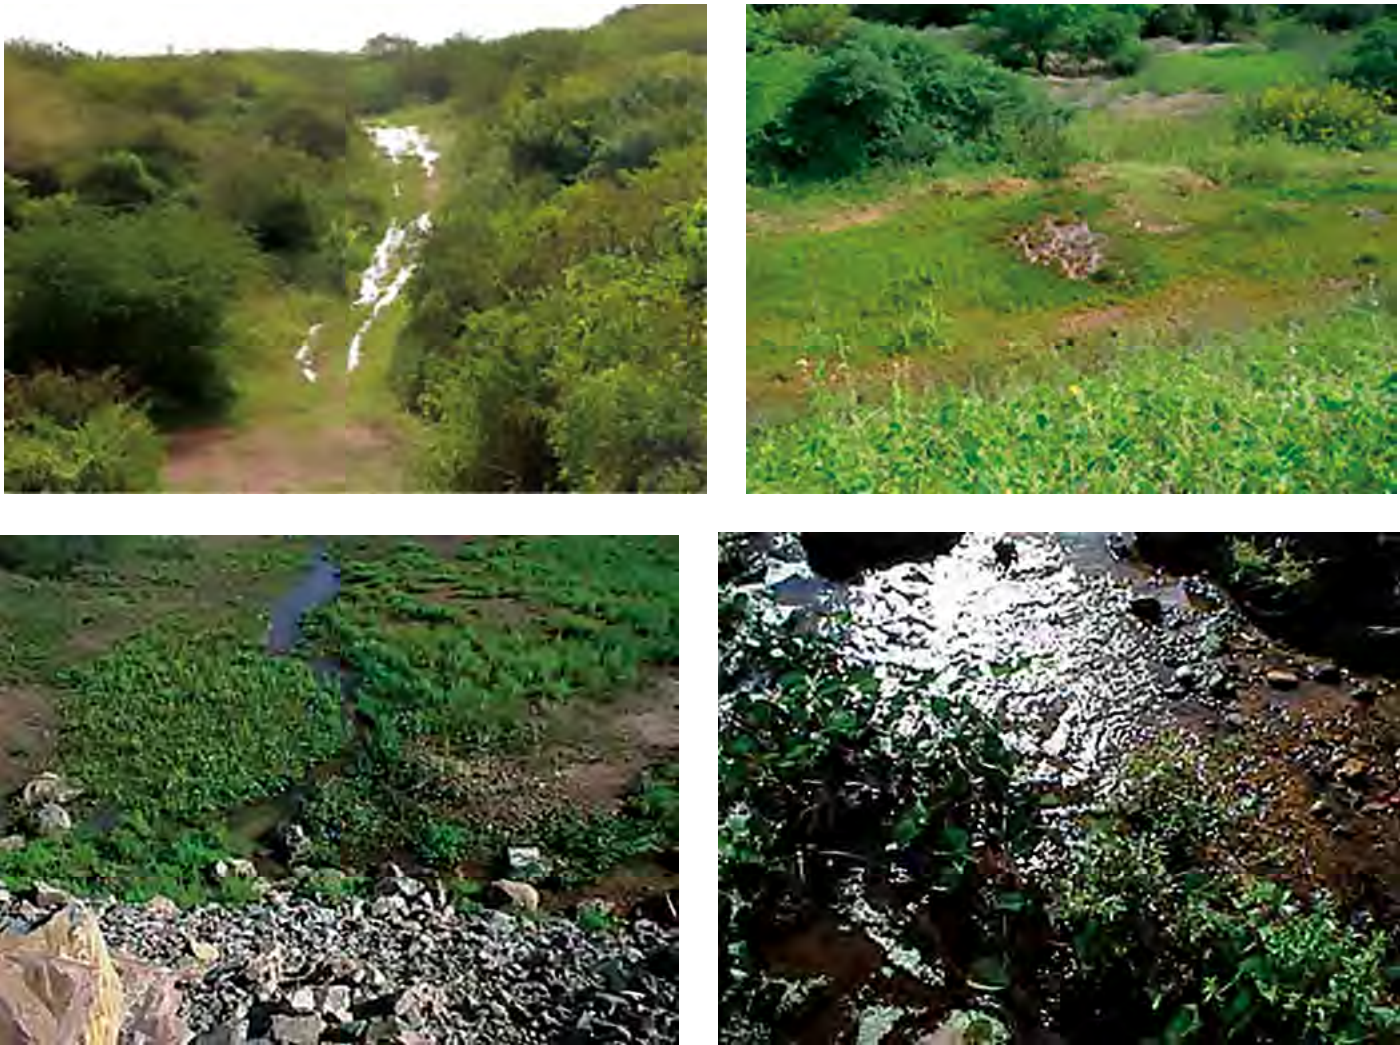
Water seeping through an embankment dam (Pictures from Andriolo's archives)

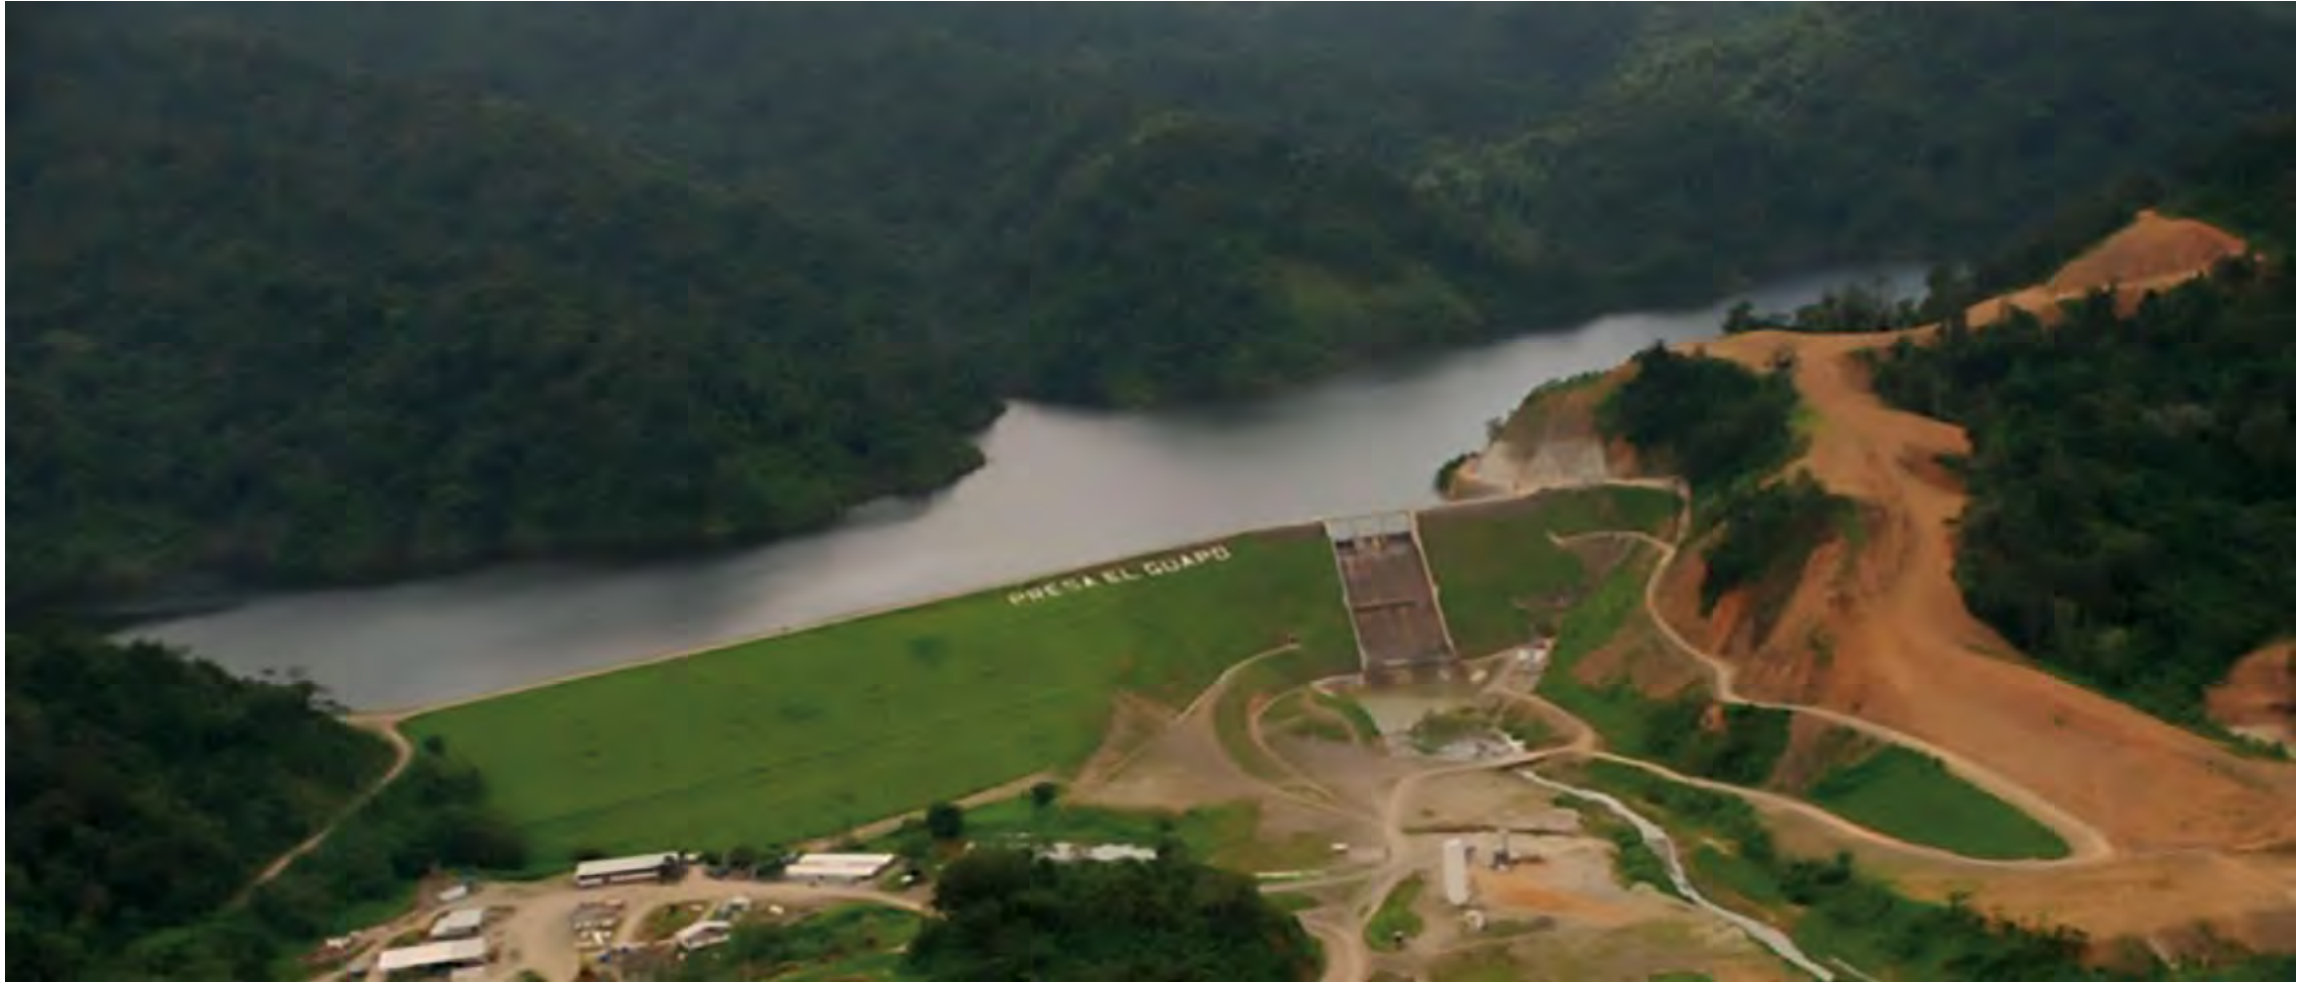
The El Guapo Dam spillway failed December 16 1999, as a result of spillway failure from chute wall overtopping and erosion. The Spillway was reconstructed with Roller Compacted Concrete^[11-09]
