Is Your Dam Safe?

An281	Andriolo, Francisco Rodrigues; Moreira, José Eduardo
	Is Your Dam Safe? – Vol. 1 / authors: Francisco Rodrigues Andriolo e José Eduardo Moreira. São Carlos, 2022.
	1394 p. il. color
	ISBN – 978-65-5668-011-8
	DOI – http://dx.doi.org/10.26626/9786556680118/2022B001
	1. Dams. 2. Training. 3. Quality. 4. Repairs. 5.Controls. 6. Cement. I. Orgs. II. Title.
	CDD 370

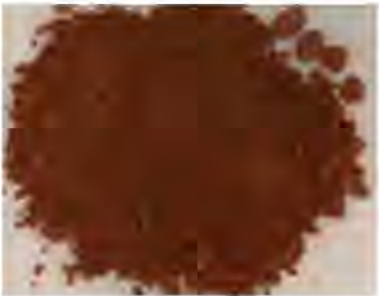
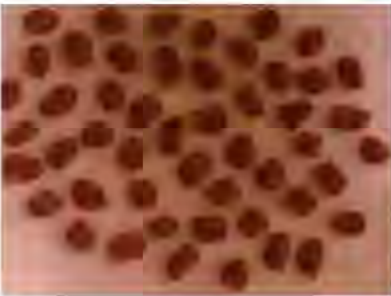
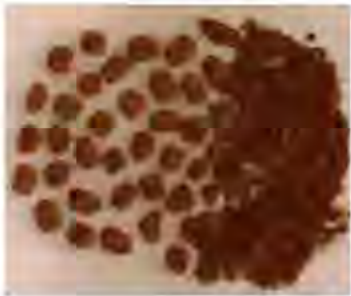
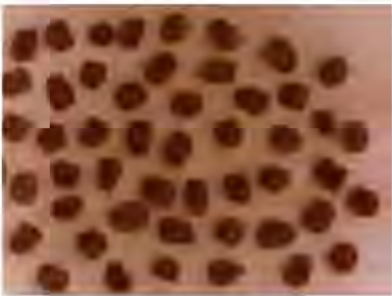
Cycles of Wetting and Oven-drying–LCEC – CESP- Laboratory – Ilha Solteira- 1974

Pieces of rocks showing fragmentation due to the expansive clay minerals^[03-03]

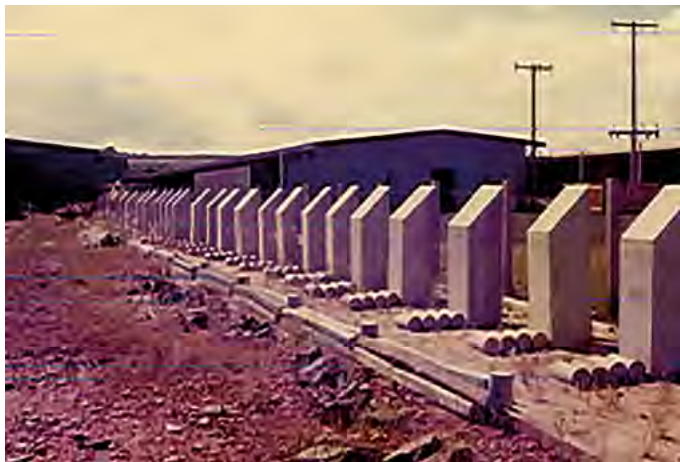
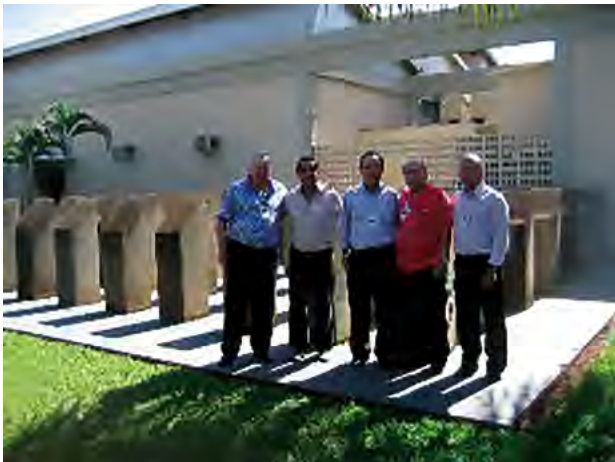
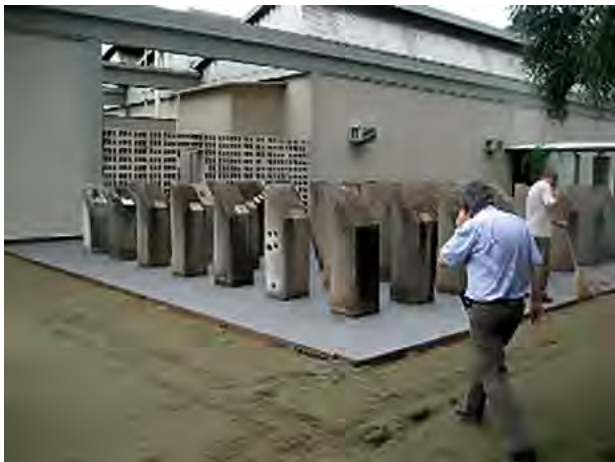
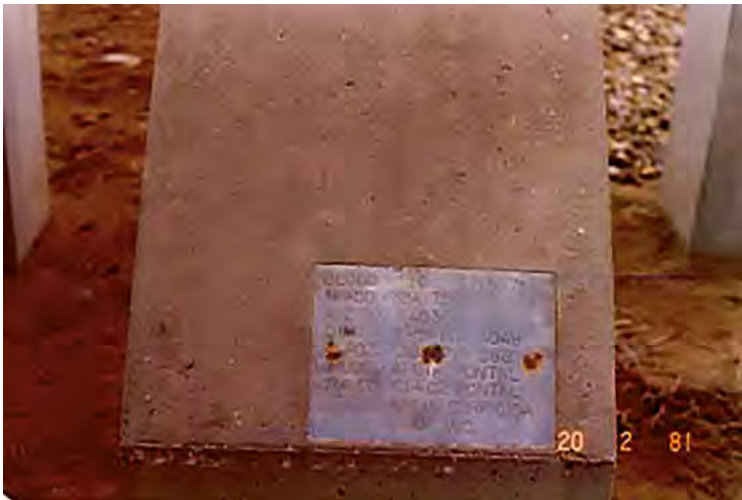
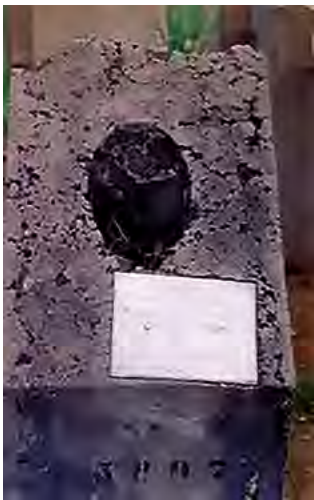
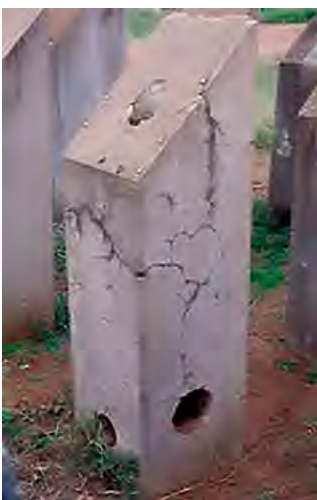
Concrete blocks that were cast (1972 – at CESP Laboratory-Ilha Solteira-SP-Brazil) to check the behavior due to the use of different cement-pozzolanic material and aggregates. The block-specimens were observed in between 1972-2012 (Andriolo’s Archive)

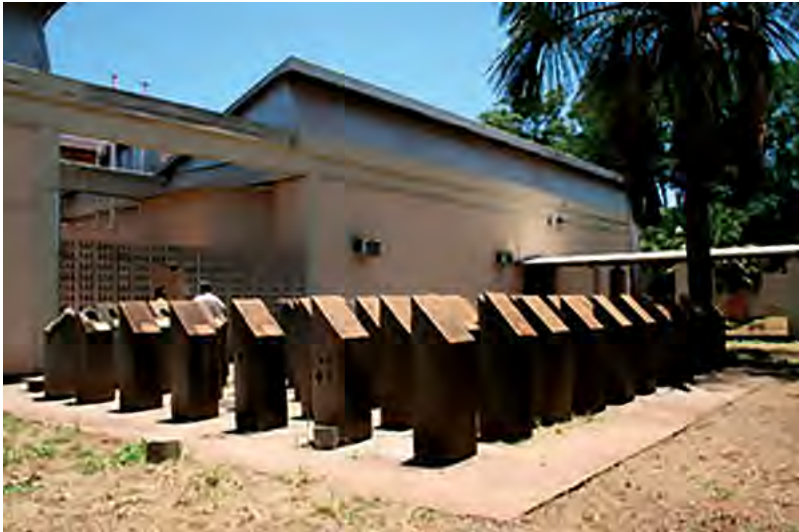
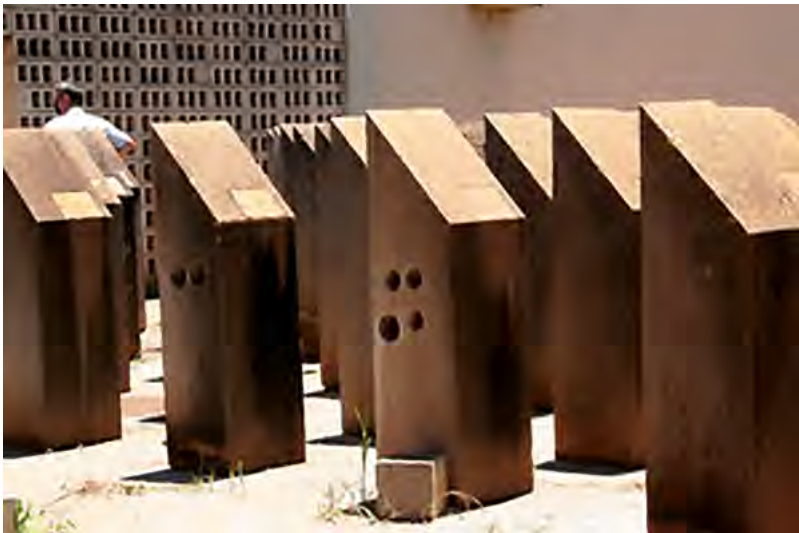
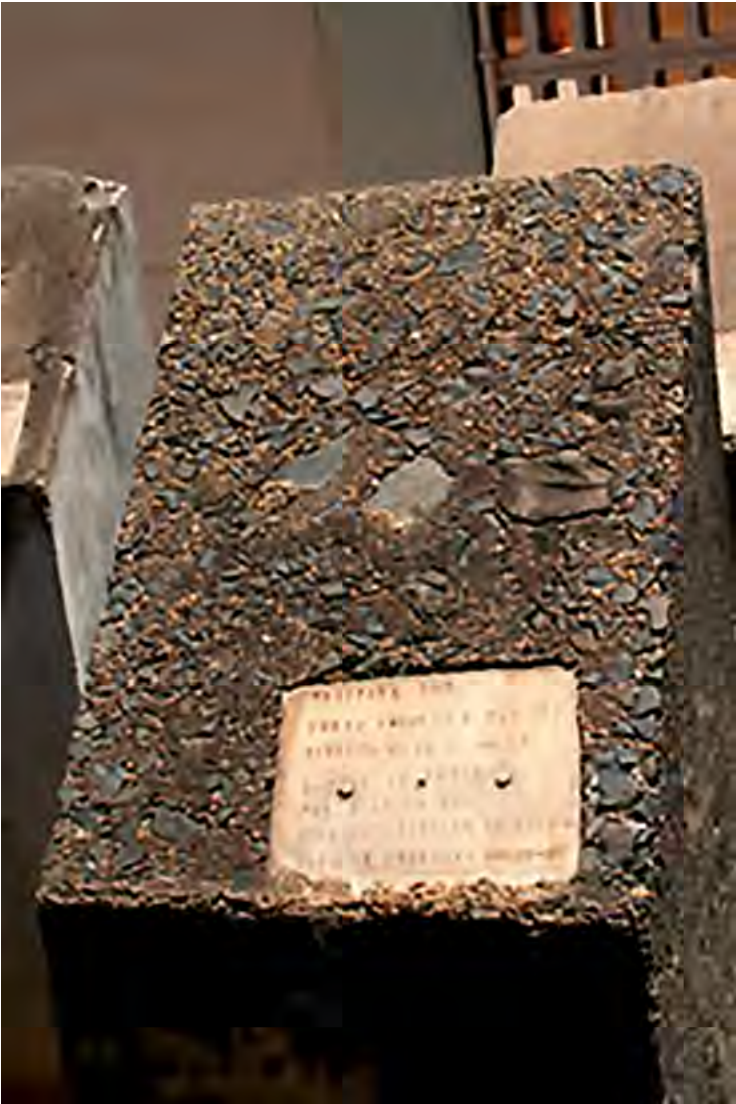
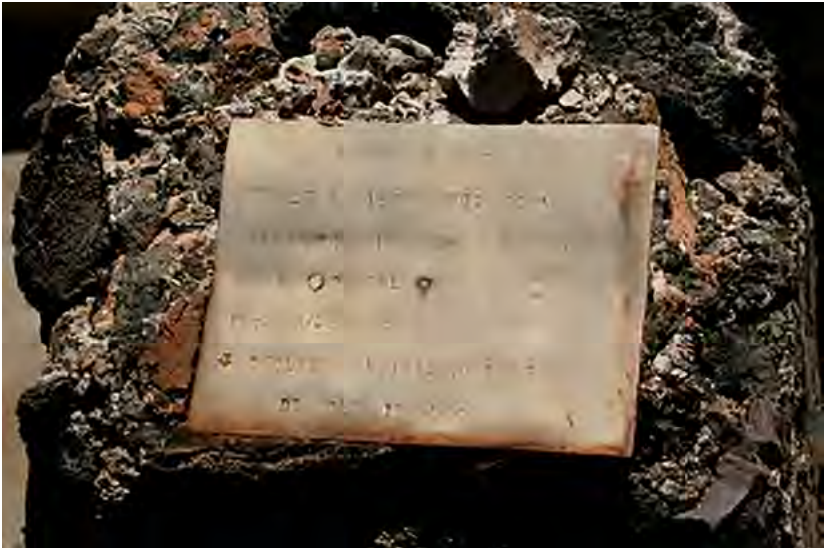
Concrete blocks that were cast (1972 – at CESP Laboratory – Ilha Solteira – SP, Brazil) to check the behavior due to the use of different cement-pozzolanic material and aggregates. Inspection during December, 2021 (Andriolo’s Archive)

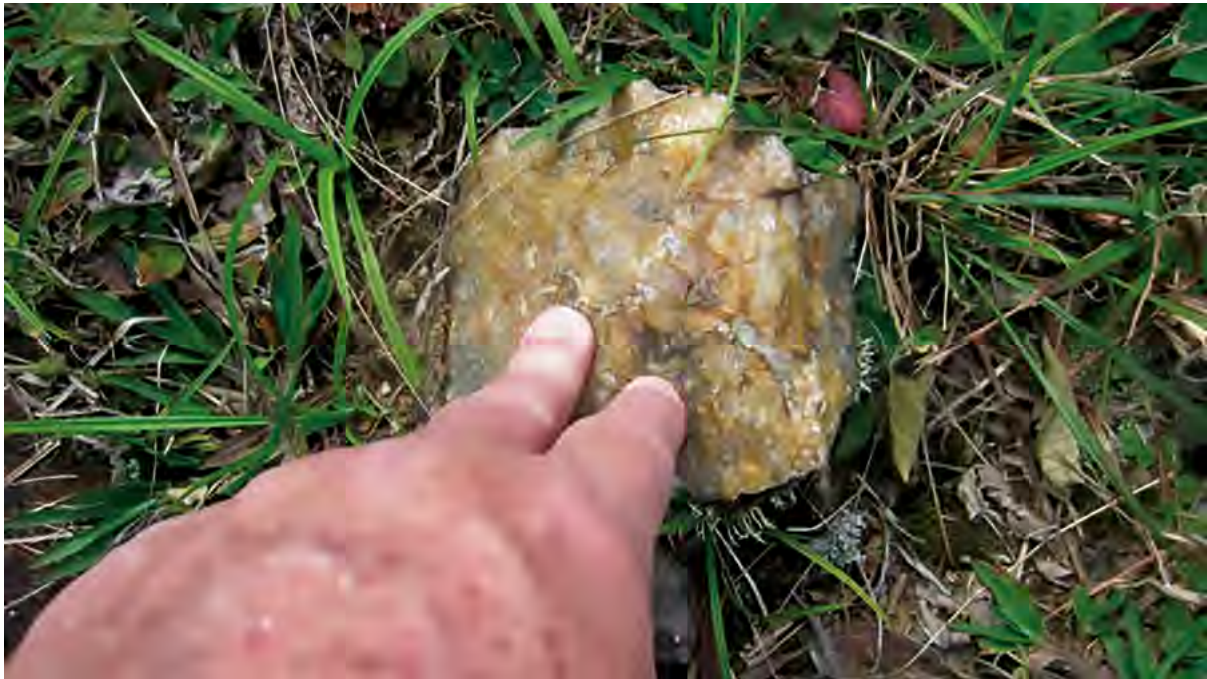
Rock piece around the dam, showing quartz

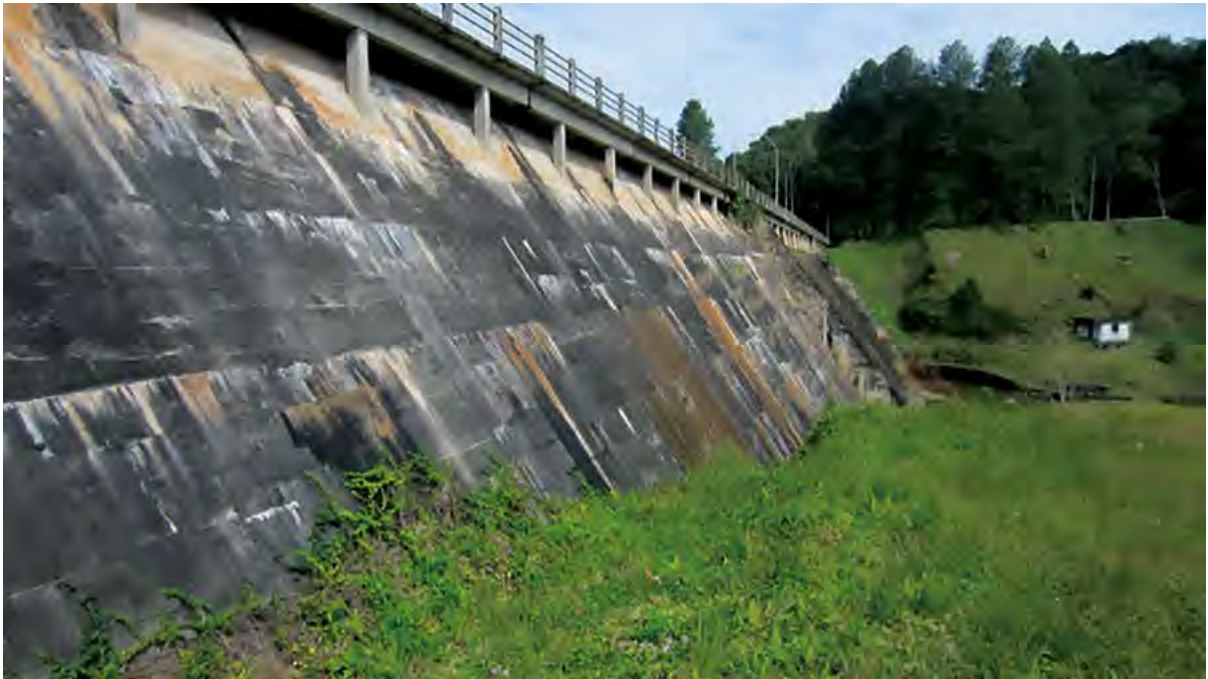
Aspect of the downstream face of the concrete dam

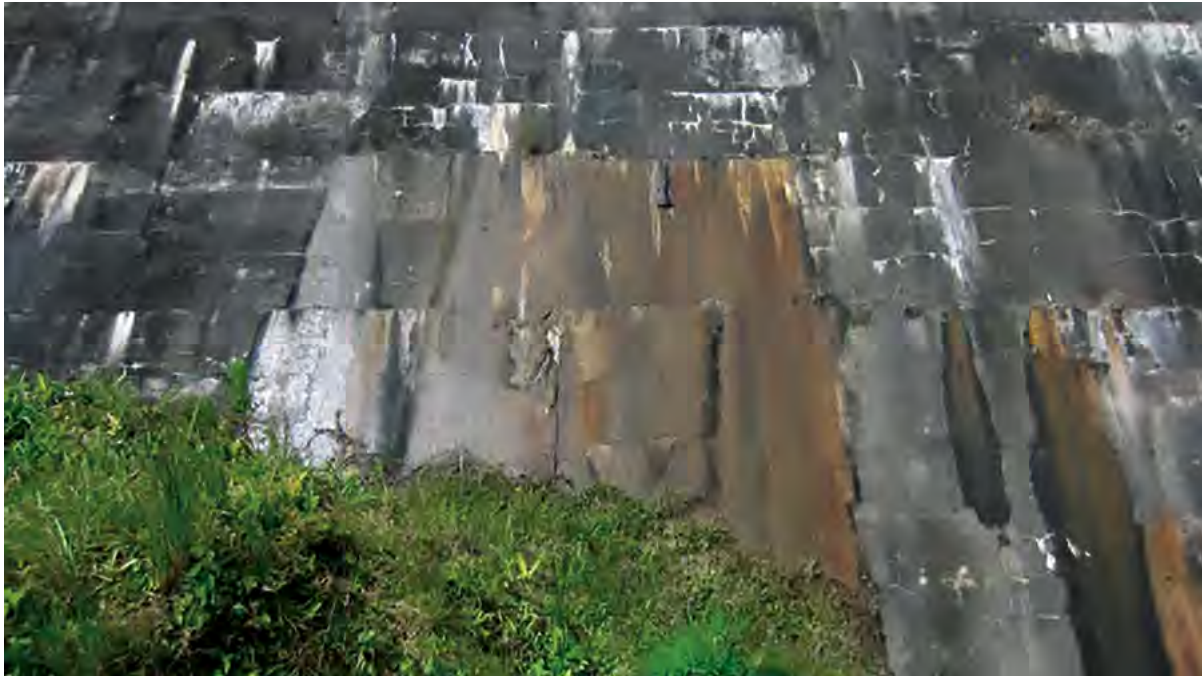
Aspect of the downstream face of the concrete dam

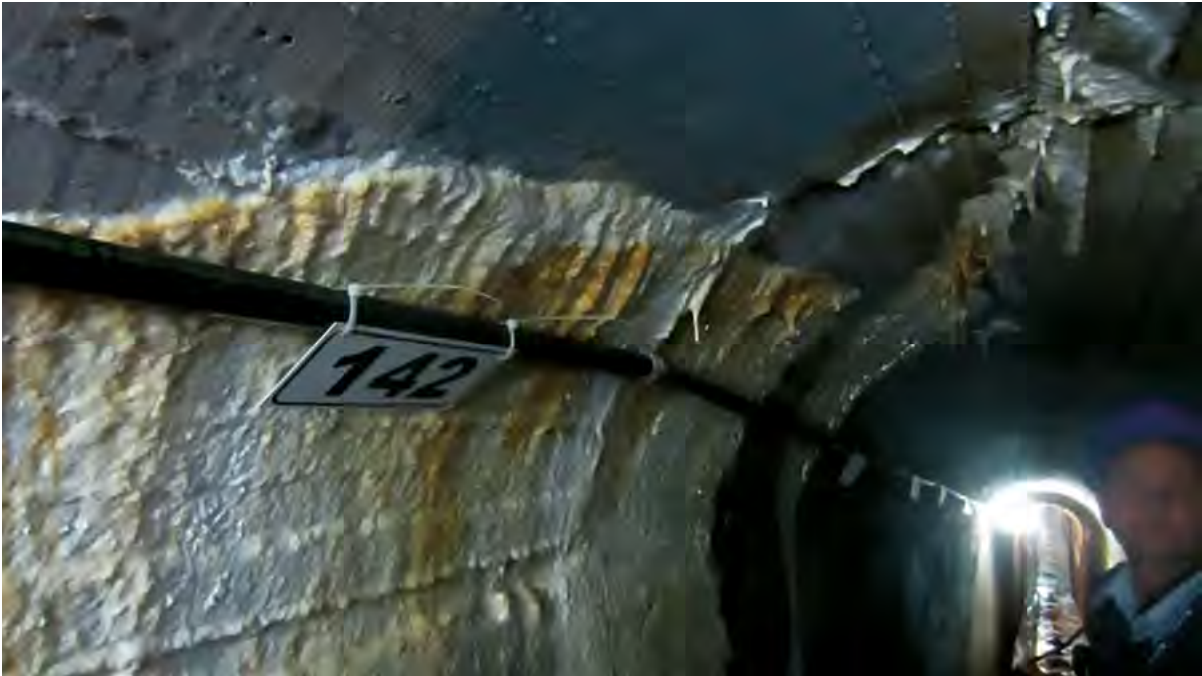
Aspect of the inner part of the dam gallery

Aspects of the inner part of the dam gallery. Evidence of Alkali Reaction Aggregated, observed inside the gallery of the Ribeirão do Campo Dam-SABESP-SP, Brazil-Built in 1962 (Andriolo’s Archive)

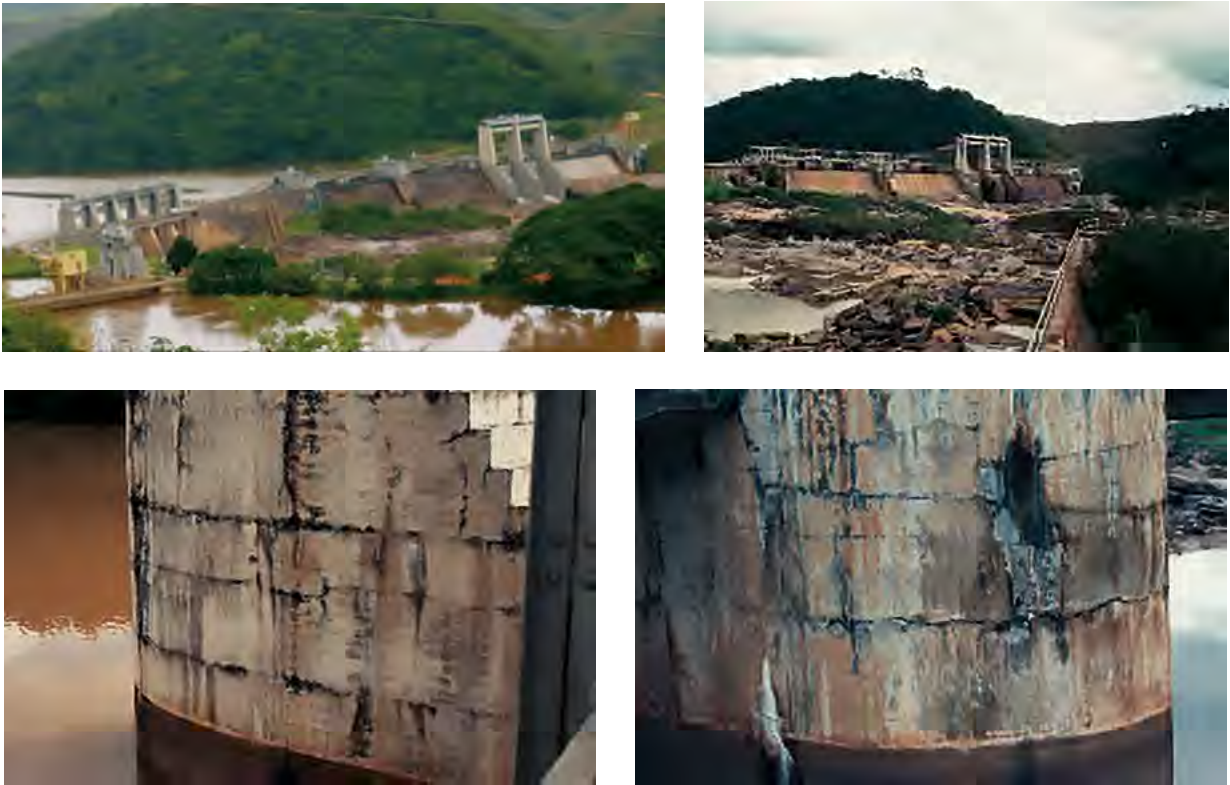
Ilha dos Pombos Dam that had been finished by 1924, (Brazil) and had shown RAA expansions (Andriolo’s Archive)

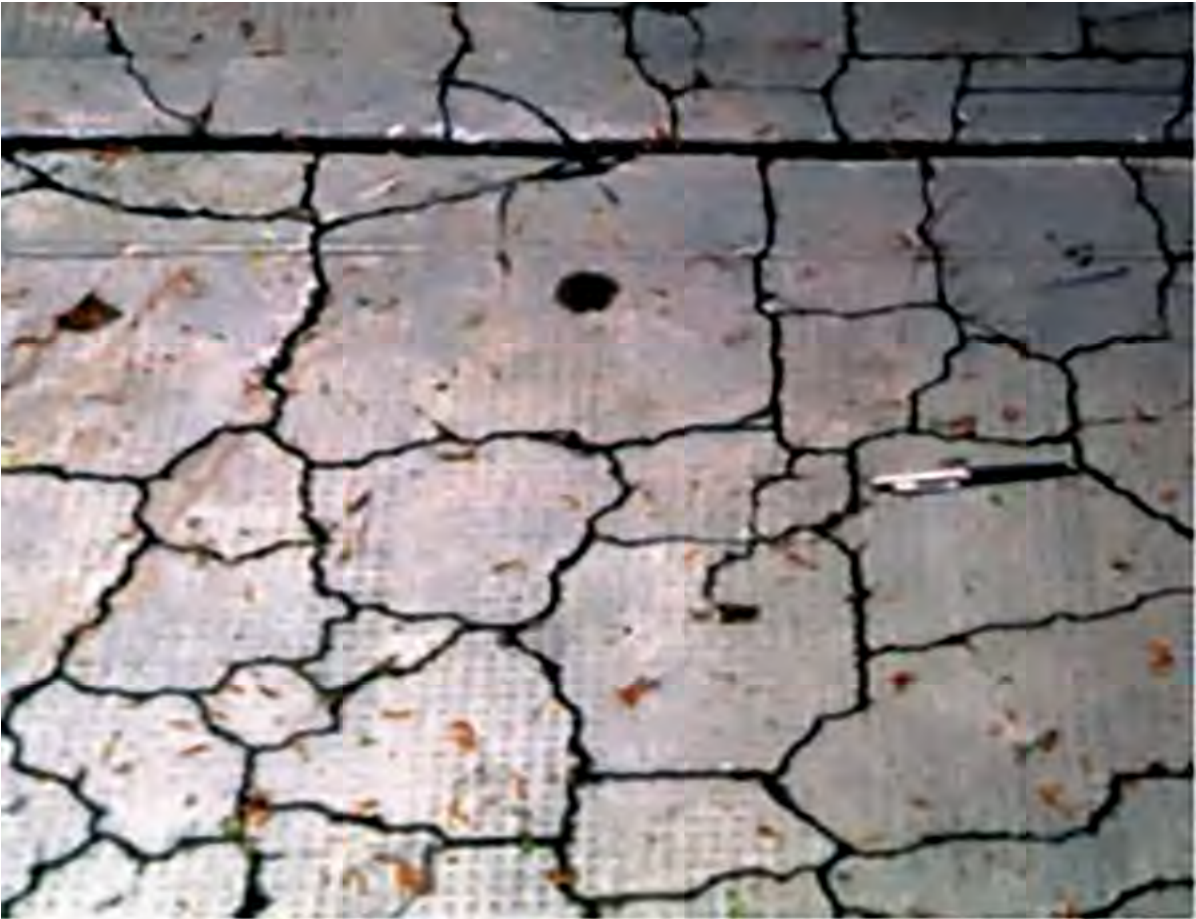
Map cracking pattern caused by ACR^[03-08]

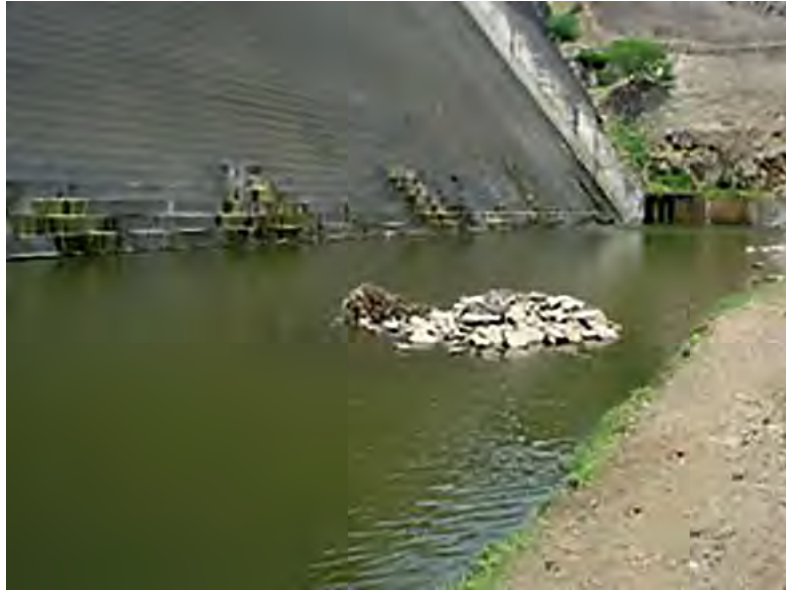
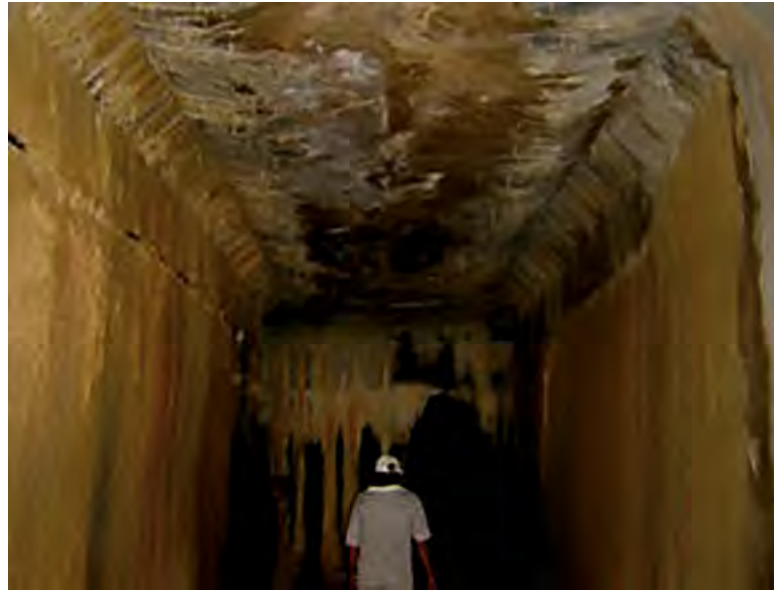
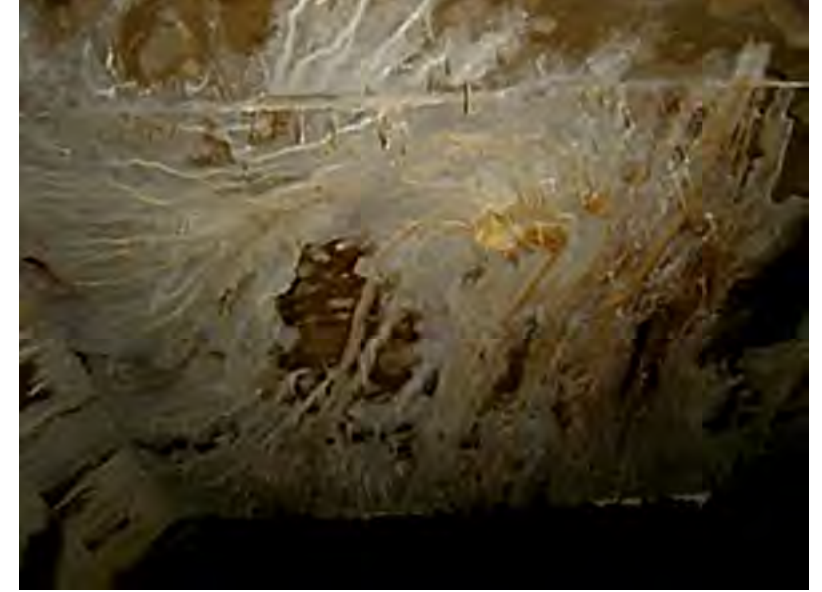
Leaching observed in the downstream face of a Dam and in the inner part of the dam gallery-(Andriolo's archive)

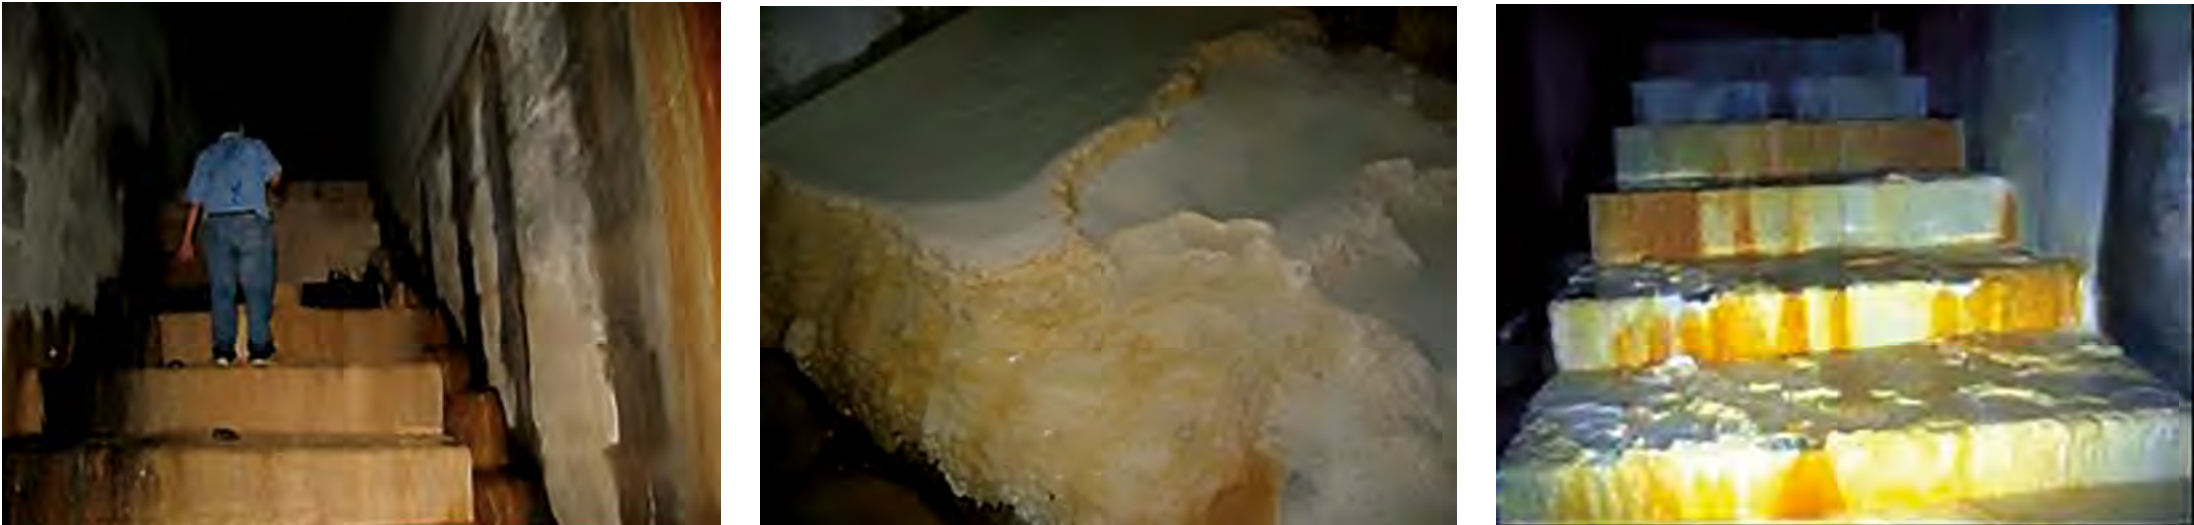
Leaching observed in the downstream face of a Dam and in the inner part of the dam gallery (Andriolo’s archive)

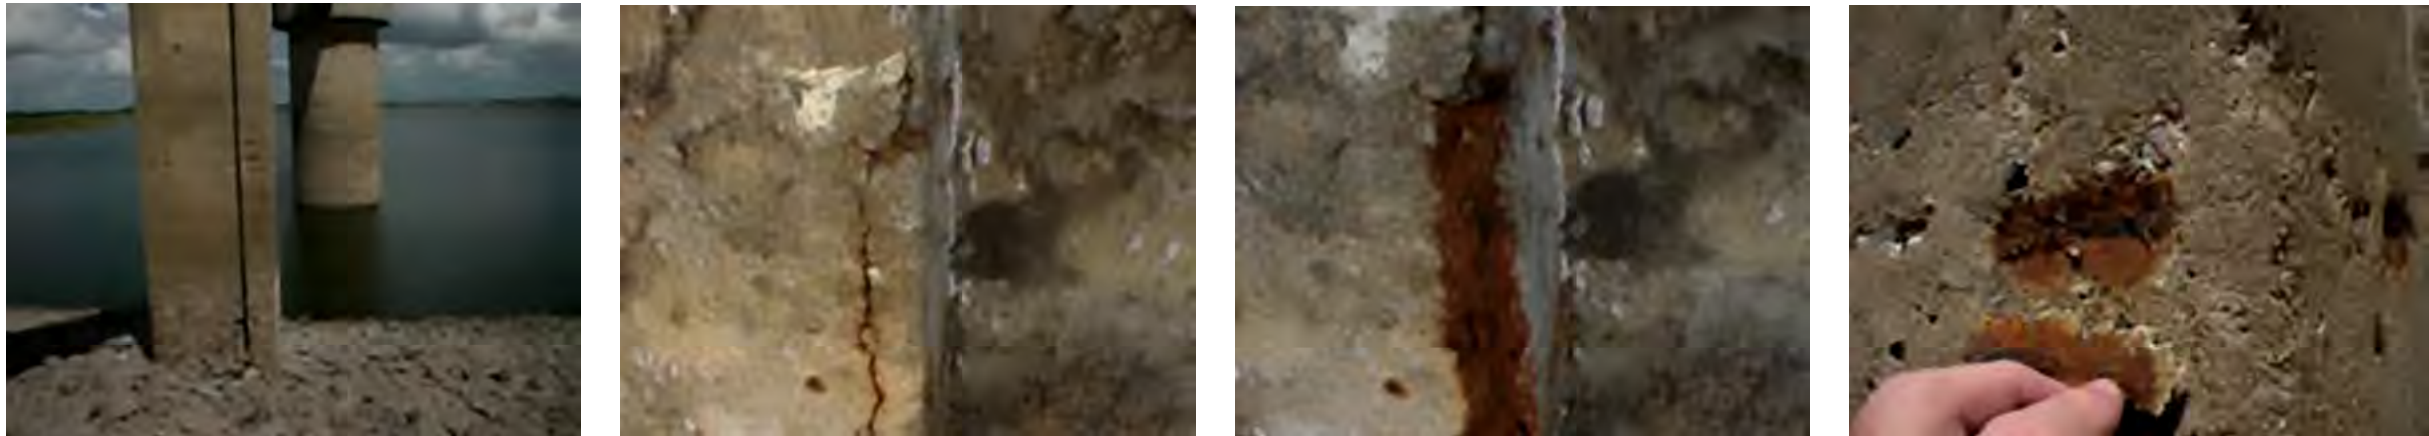
Pop-out due to corrosion of the reinforcement (Andriolo’s Archive)

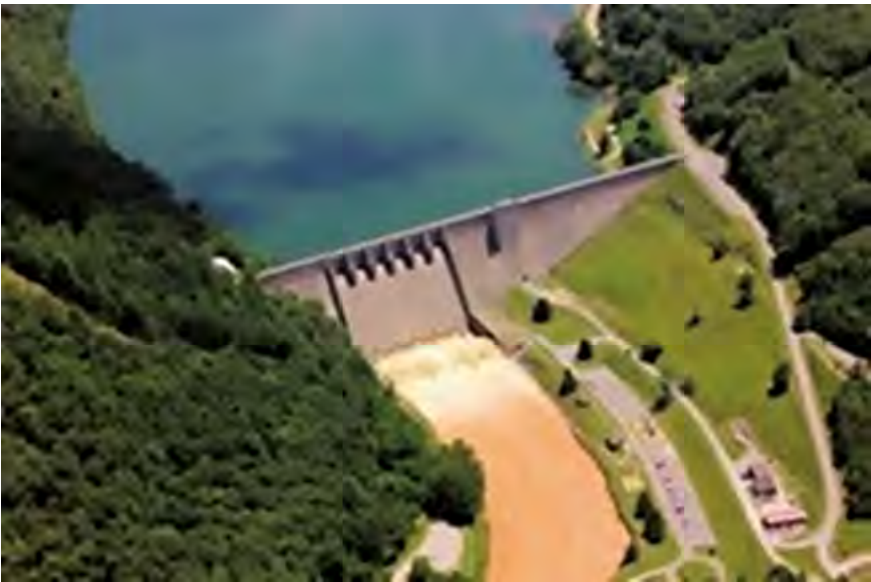
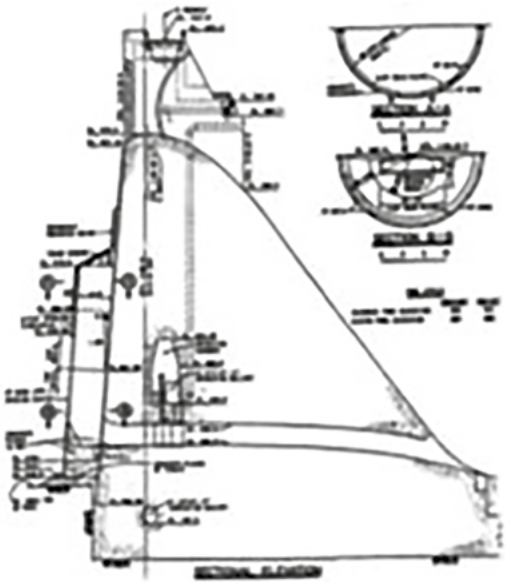
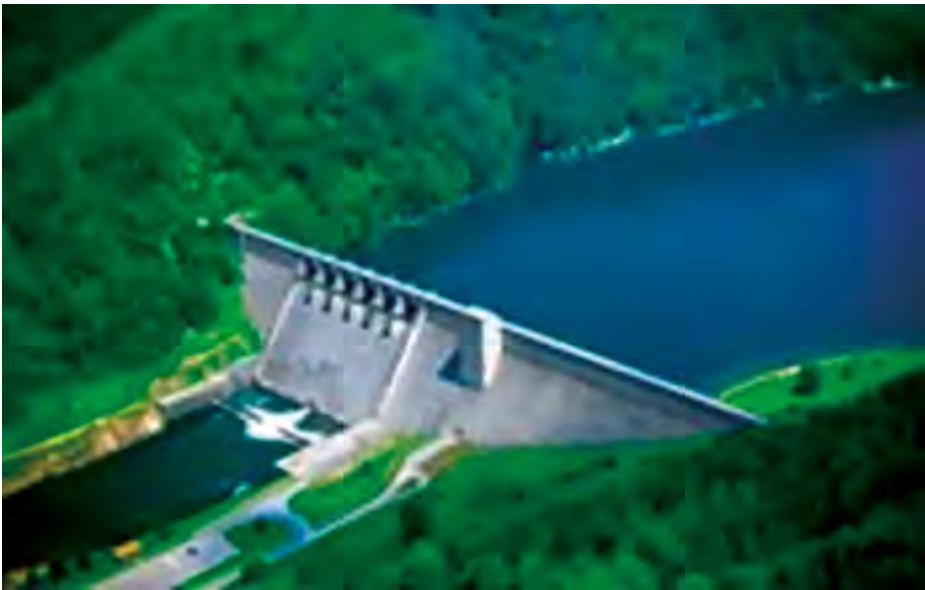
Case	Identification	Country	Finished	Materials and Studies -Rehabilitation	References
3.4.4-B	Sasanagare	Japan	1924	1984	[03-15]

Deterioration occurred at all parts of the dam, particularly the buttresses and slabs. A preliminary repair was made but this only revealed temporary improvement to the extent that in 1965, concrete began to fall off from the surface of the dam. In 1983-1984, after a careful aging survey, the buttresses were overlaid at both sides by 700 mm to 1100 mm thick concrete layers and the upstream slab by 300 mm to 700 mm thick concrete. The whole dam was overlaid by new concrete.

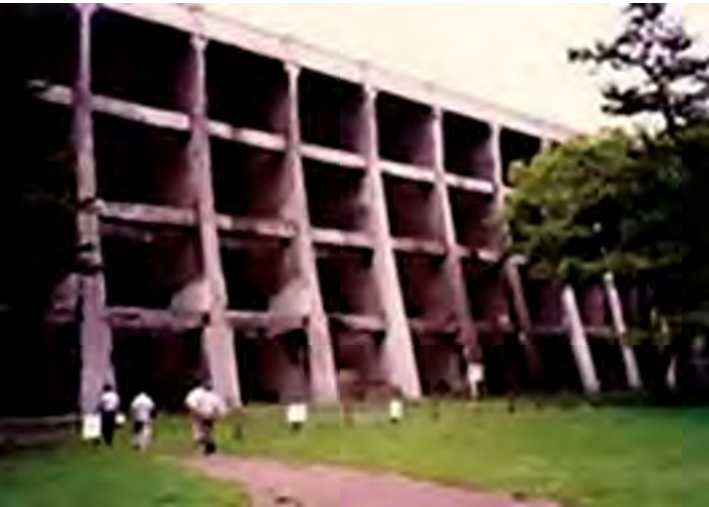
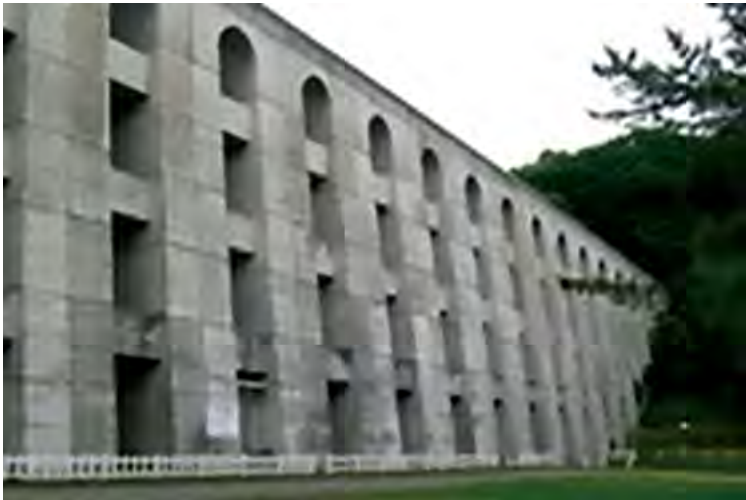
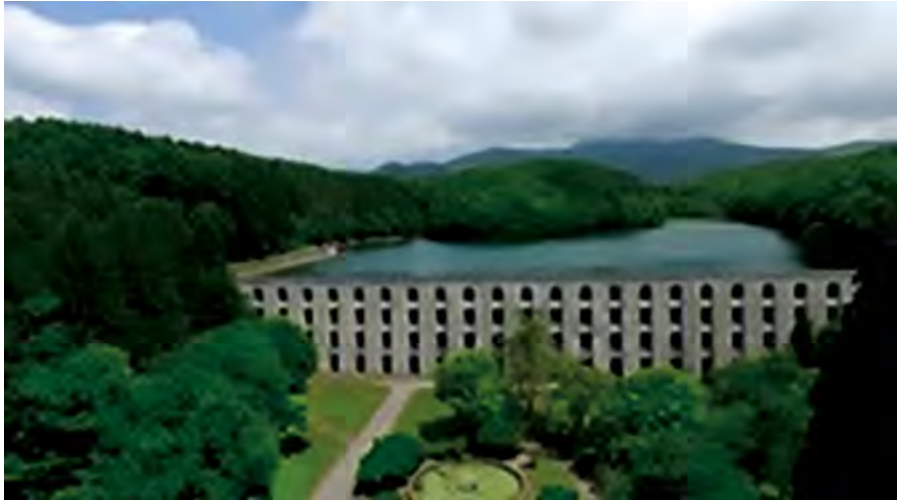
Case	Identification	Country	Finished	Materials and Studies -Rehabilitation	References
3.4.4-C	Wissota	USA	1918	1990	[03-16]

The sloping surface of the north and south hollow dams were affected by freeze-thaw actions. Deterioration of concrete was most severe at the buttress-slab, cold-joint junctions, where joint filler materials apparently failed, and near the edge of previous repairs. Rapid deterioration developed due to seepage through cracks and joints on the upstream slab, which saturated the downstream face. The dam was declared to be of high hazard and rehabilitation was carried out. The remedial measures included installing steel cofferdam sheeting along the downstream buttress faces down to bedrock; removal of soils between sheeting and slab face; cleaning of rock contact surfaces and concrete, and mass concrete pours for entire height.

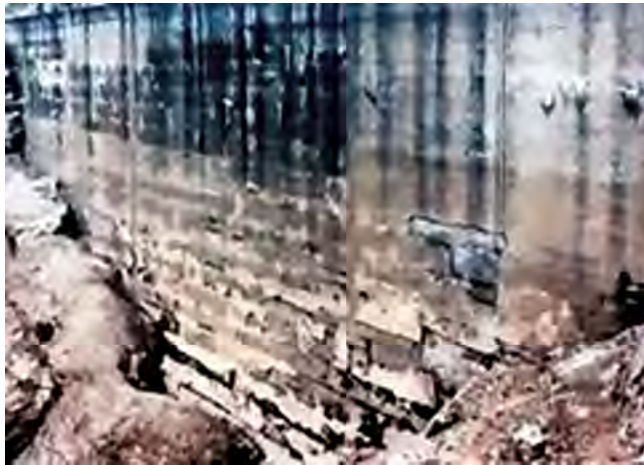
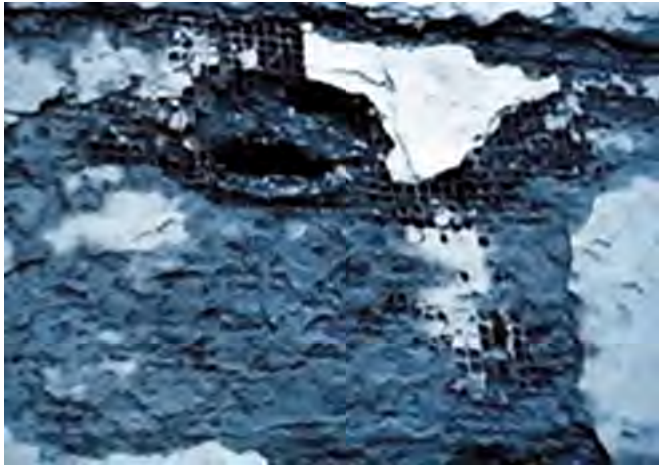
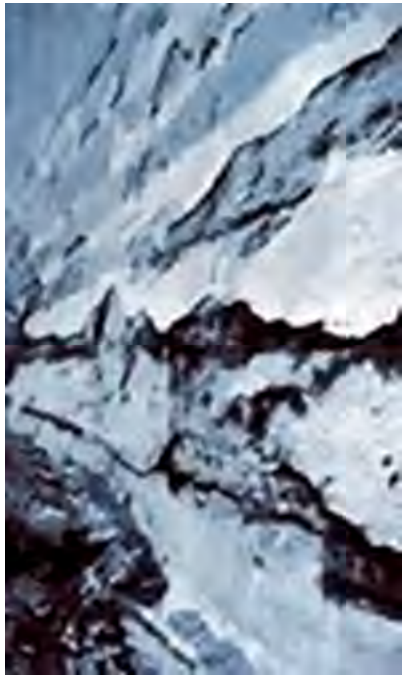
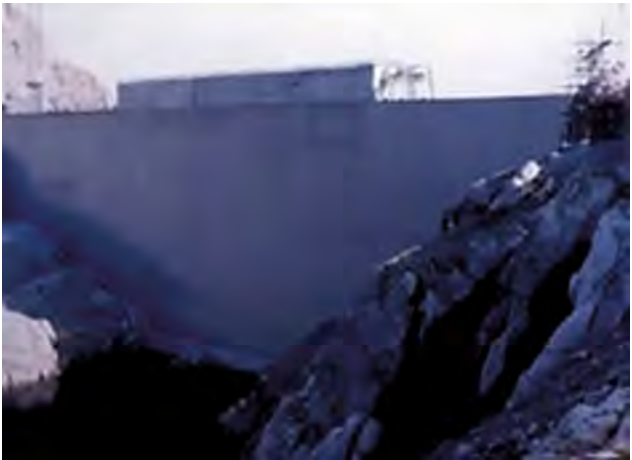
Case	Identification	Country	Finished	Materials and Studies -Rehabilitation	References
3.4.4-E	Wimbleball	UK	1977	2003	[03-20]

The concrete surface of the dam has suffered from spalling. Even towards the end of the construction of the dam, small pop-outs were observed on the inside concrete faces of the dam parapet walls. These were 10 mm in diameter with soft dark aggregate (pyrites-rich shale) exposed and a rust-colored stain below. Then the reinforced concrete valve tower and access bridge only need to be protected. The work involved breaking out all patches of soft or reactive aggregate near the surface and patching with a cementitious mortar, then coating the whole surface to reduce the quantity of oxygenated water penetrating the surface.

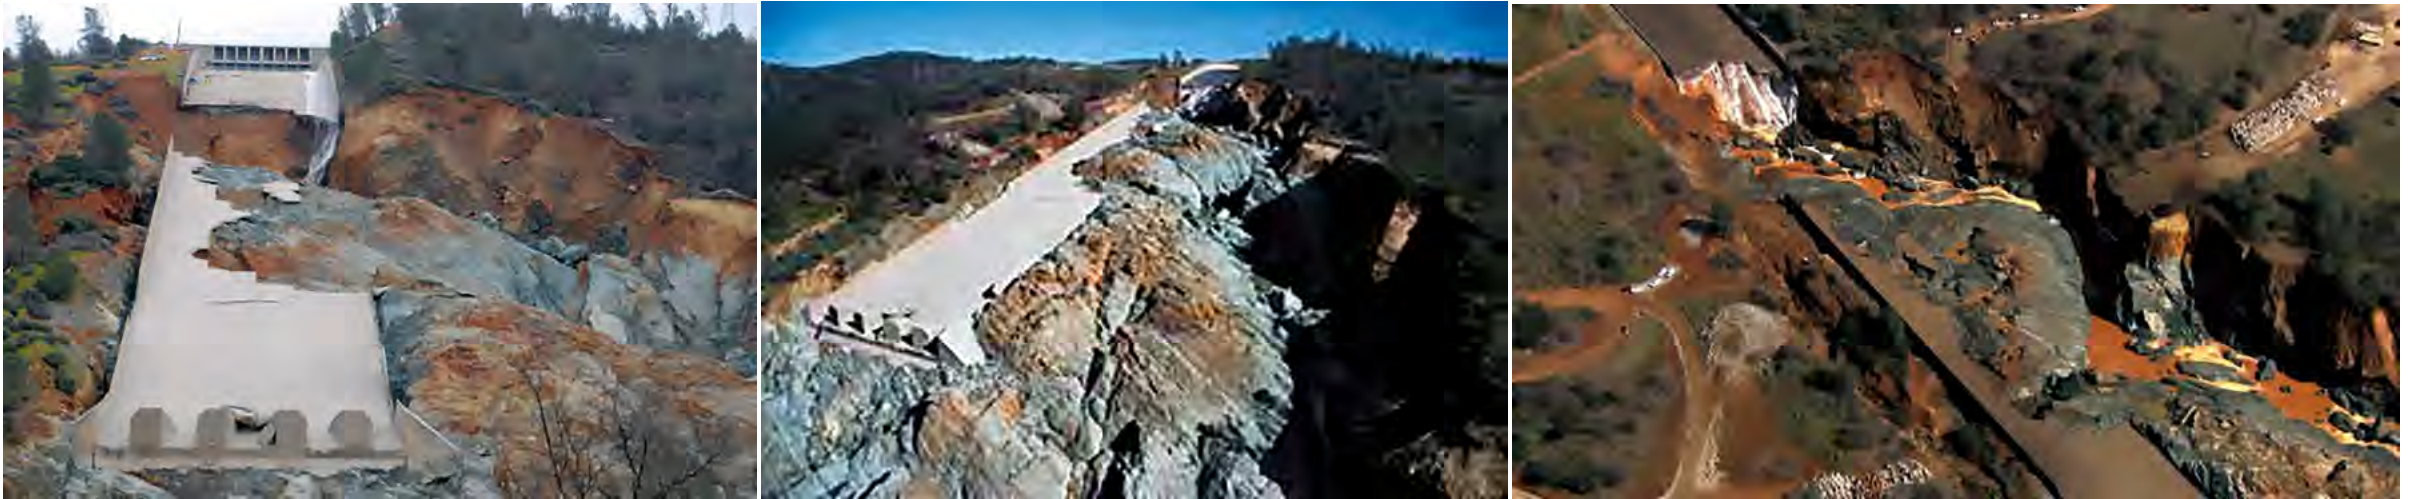
Oroville Spillway damage in 2017^[04-09]

There was no single root cause of the Oroville Dam^[04-09] spillway incident, nor was there a simple chain of events that led to the failure of the service spillway chute slab, the subsequent overtopping of the emergency spillway crest structure, and the necessity of the evacuation order. Rather, the incident was caused by a complex interaction of relatively common physical, human, organizational, and industry factors; starting with the design of the project and continuing until the incident. The physical factors can be placed into two general categories:

- ⇒ Inherent vulnerabilities in the spillway designs and as-constructed conditions, and subsequent chute slab deterioration;
- ⇒ Poor spillway foundation conditions in some locations.

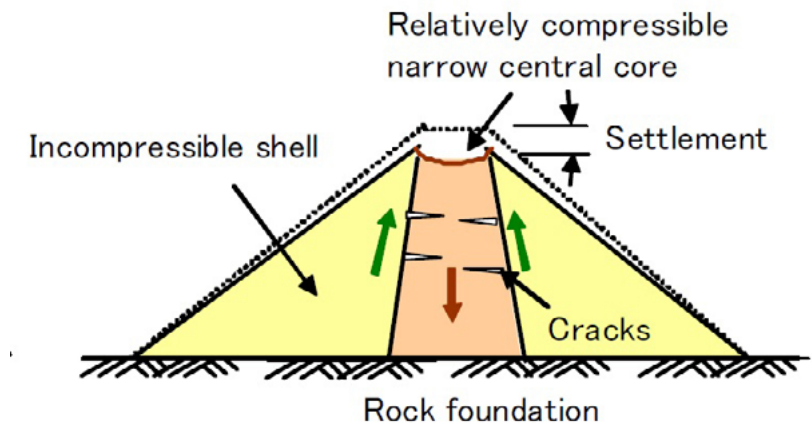
Core zone is exposed at the crest due to settlement and drug of surrounding shells, causing decrease in lateral constraint and opening of cracks

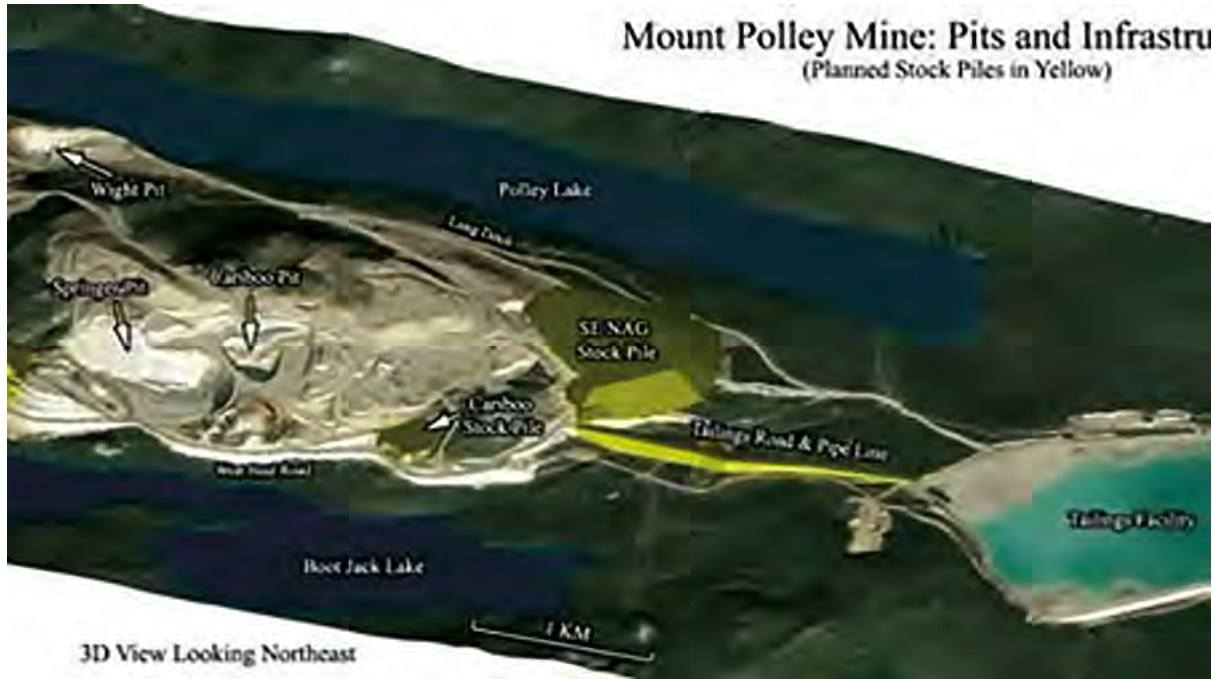
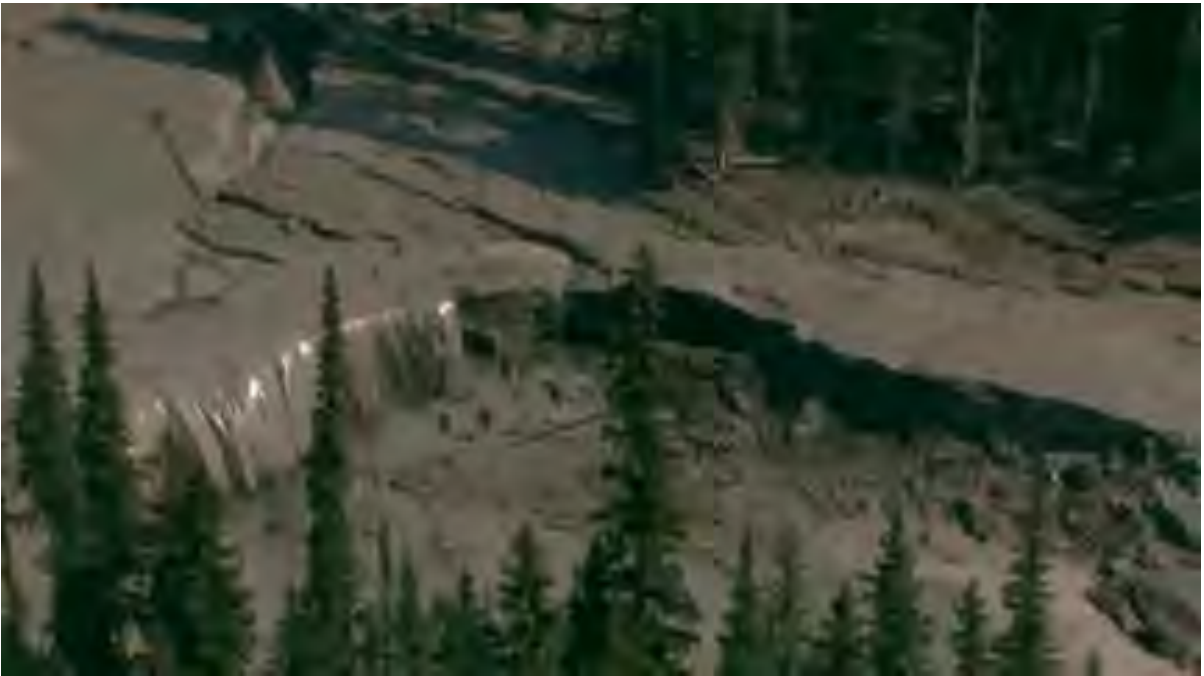
The Mount Polley open pit copper and gold mine disaster began in the early morning of August 4, 2014, with a partial breach of the tailings pond dam, releasing 10 million cubic meters of water and 4.5 million cubic meters of slurry into Polley Lake. By the end of the day the four square kilometers sized tailings pond was “virtually empty”. Mine safety experts and media articles have called this spill one of the biggest environmental disasters in modern Canadian history. The cause of the dam breakage was investigated with a final report published January, 31-2015 .

The investigation *of the cause of the spill revealed that mine engineers failed to account for glacial silt underneath the tailings containment pond*, leading to structural insufficiencies that caused the dam’s collapse.

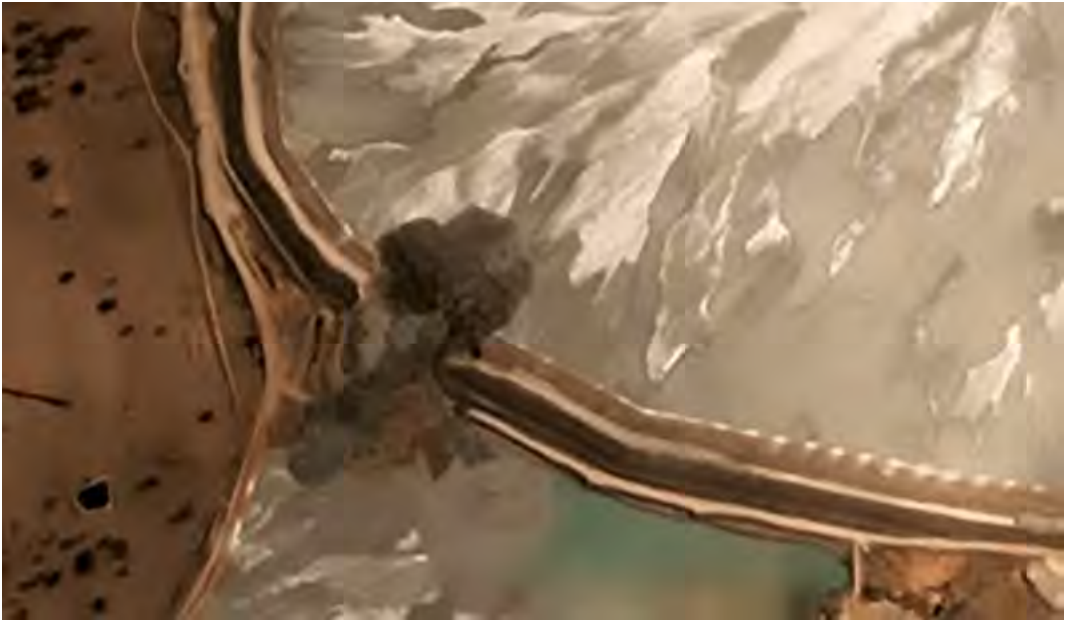
Case	Identification	Country	Since	Damage	References
4.5.1.3-B	Cadia's Northern Tailings	Australia	2017	2018	[04-14]

The slump occurred on March 9 in the southern wall of Cadia's Northern Tailings Storage Facility, causing it to lose containment of the section's tailings.

The Independent Report *concluded that the dominant factor determining the location of the Cadia tailings dam failure was the existence of a low-density foundation layer in the vicinity of the slump.* Other factors that contributed were the local height of the dam, the
