Is Your Dam Safe?

An281	Andriolo, Francisco Rodrigues; Moreira, José Eduardo
	Is Your Dam Safe? – Vol. 1 / authors: Francisco Rodrigues Andriolo e José Eduardo Moreira. São Carlos, 2022.
	1394 p. il. color
	ISBN – 978-65-5668-011-8
	DOI – http://dx.doi.org/10.26626/9786556680118/2022B001
	1. Dams. 2. Training. 3. Quality. 4. Repairs. 5.Controls. 6. Cement. I. Orgs. II. Title.
	CDD 370

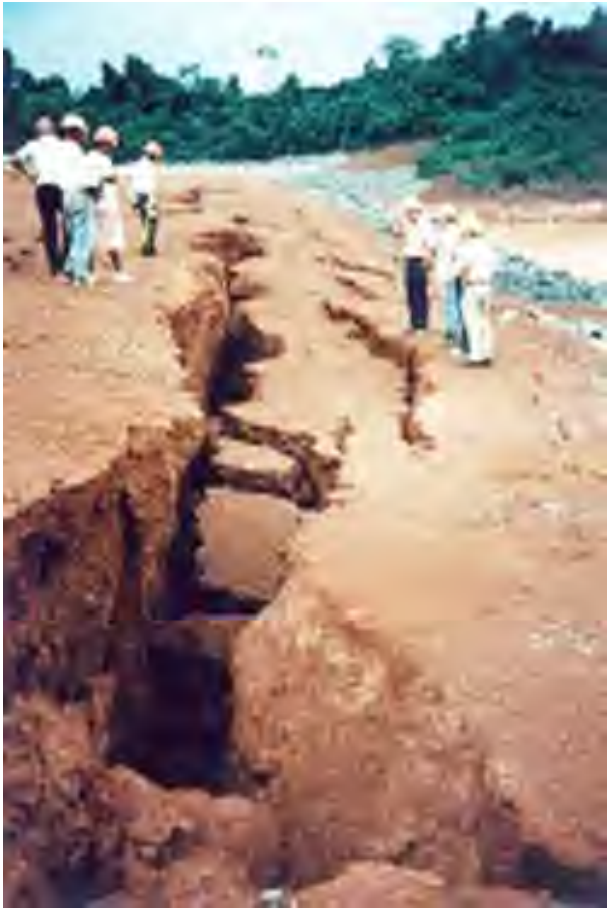
Case	Identification	Country	Since	Damage	References
4.5.1.3-C	Omai	Guyana	1992	1994	[04-15]

In 1994, the Omai tailings dam in Guyana broke down due to internal erosion which resulted in the release of sewage into nearby rivers. The dam contained an upstream sloping core and a downstream rockfill section, with foundation materials having the classic weathering profile of residual saprolite soils derived from parent andesite/diabase rocks. These clayey, low-permeability soils provided fill material for the dam core, and they also comprised a major component of the mine waste materials excavated as pit overburden. This saprolite mine waste was deposited in a wide zone adjacent to and contiguous with the downstream rockfill section of the dam, extending outward 400 m to the Omai River and confining the rockfill zone in all except the two limited areas near the abutments where the failure discharges emerged.

The Omai Tailings Dam case demonstrates yet again that no dam, tailings or otherwise, without adequate seepage protection around conduits or without adequate filters can be expected to survive for long. Even with the factors specific to the Omai situation, these failure mechanisms are by no means unique or new.

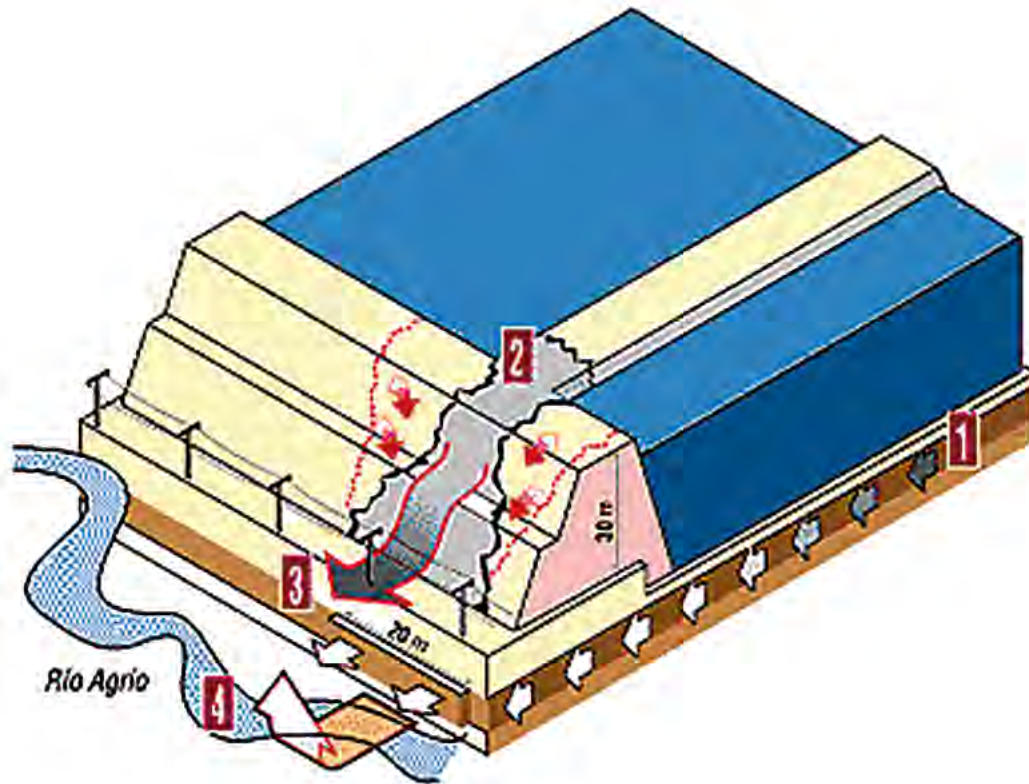
The embankment that failed at Los Frailes

1. Soil slab beneath the dam;
2. The dam cracked and broke;
3. Contaminated slurry spilled through the gap;
4. The river Agrio rose 3 meters.

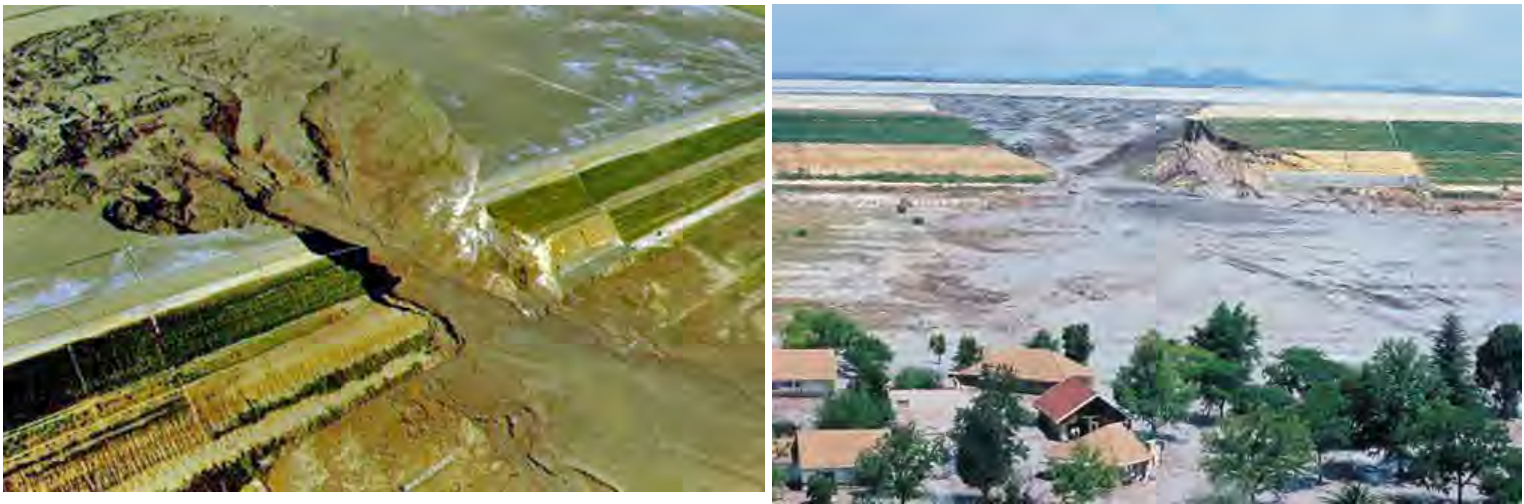
Aerial of the Merriespruit failure

In 1994, the Merriespruit tailings dam broke after a few hours of thundershowers. It is worth mentioning that this tailings pond is basically an upstream structure with less freeboard length and less reservoir area. When the flow rate of the overtopping water flow was greater than the starting flow rate of the tailings, the tailings dam continued to cause downward and bilateral erosion.

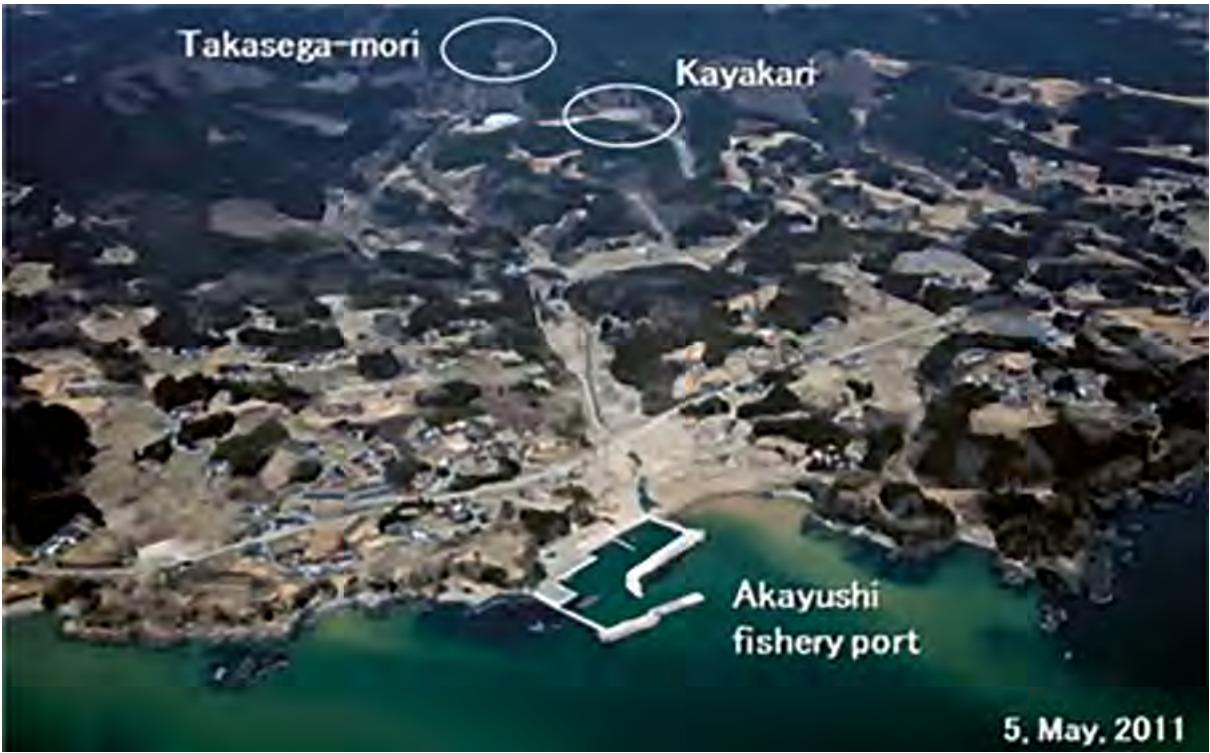
An earthquake occurred in eastern Japan in 2011, and the Kayakari dam at the Ohya mine liquefied because of the tailings material, releasing a large amount of clay and causing damage to the downstream environment. *Studies have shown that liquefaction leads to a significant reduction in the safety factors of tailings dams.* In addition, the construction method of the dam body, the particle size of the tailings, and the magnitude of the earthquake affects the stability of the tailings dam during an earthquake.

The Kayakari dam at the Ohya mine was close to Akayushi Port in Japan.

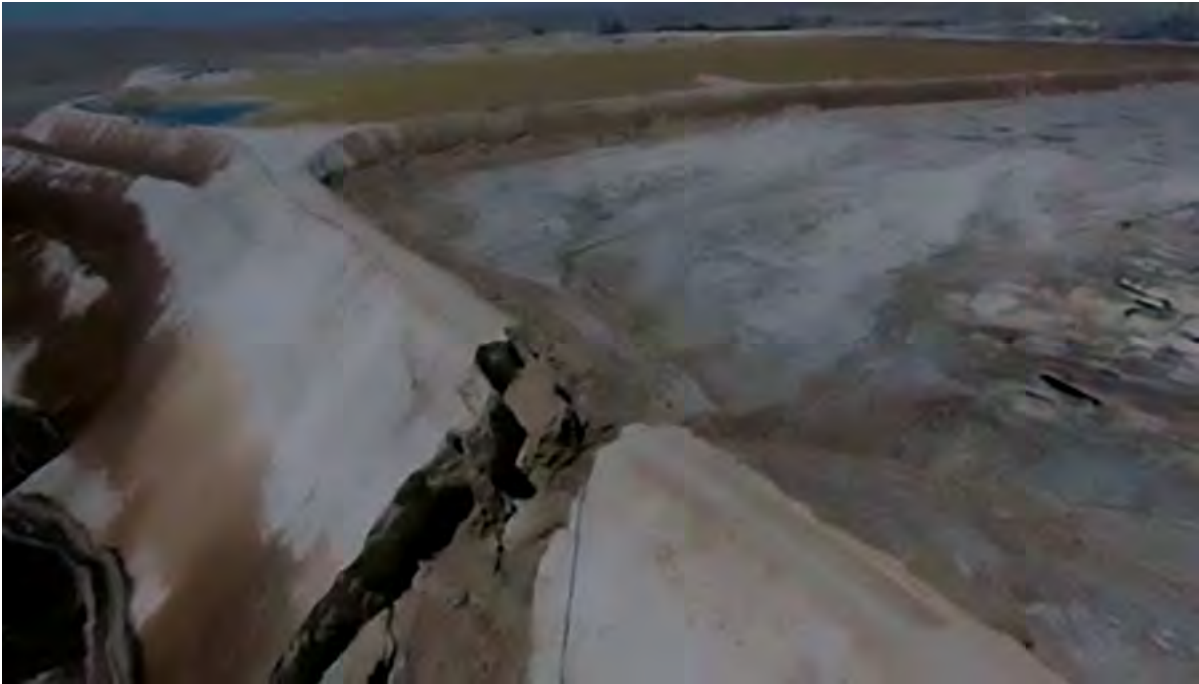
The flood began, by June 2017, when the 60 m high wall of a reservoir at a phosphate factory partially collapsed, letting loose 100,000 cubic meters of highly acidic wastewater in the Ashalim riverbed.

The Mishor Rotem tailings dam failure in Israel on 30th june, 2017

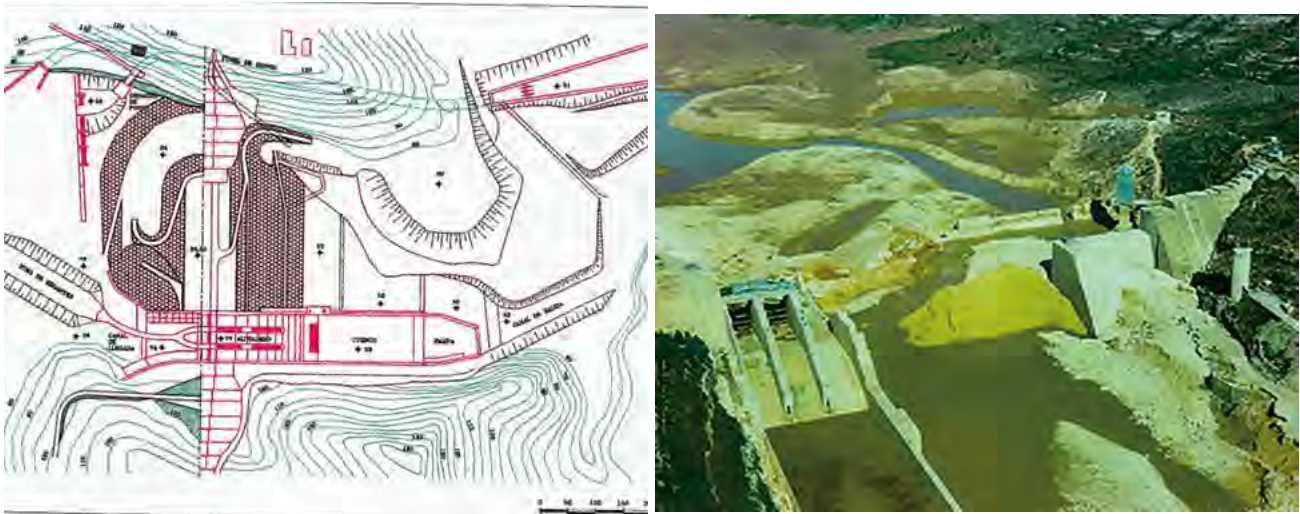
Tous dam was a 70-m-high rockfill dam with a central clay core located near Valencia, Spain, *failed due to overtopping. It was designed and built as a flood defense* structure being also used for regulation and irrigation. Its construction was started in 1958 following a project of a concrete 80-m-tall dam. During foundation works, geotechnical conditions revealed a problem, and the construction was stopped in 1964. It was continued in 1974 with a modified project, in which the central part had been changed to a loose material design with clay core and finally finished in 1978. It was an earth-gravity 70-m-tall dam with 400 m crest length. The dam was provided with radial gates to regulate the spillway whose capacity was 7000 m3/s; the bottom outlet had a capacity of 250m3/s. During October 19 and specially 20, 1982, a heavy rain took place in the Jucar basin close to Tous dam. The heaviest rain was recorded in the Cofrentes area, about 25 km north-west of Tous dam. The total rainfall in Cofrentes exceeded 550 mm with 285 mm of precipitation in only 3 hours. The estimated Inflow was 5000 m3/s and the gates of the spillway were to be opened. Unfortunately, the electric network was out of order due to the weather conditions; moreover, of the two emergency diesel generators, one was under repair and the other could not be started. Efforts to raise the gates manually were fruitless.

The overtopping started at 17.00 PM; the water overcame the dam reaching about 1.10 m above the crest at 19.15 PM. About 16 h after recognizing the impossibility of overtopping the flood gates, the dam was overtopped and washed out after 1 h by erosion of a greater part of the shoulders and of the central rockfill. After such an extraordinary flood, in the downstream basin, 8 people lost their lives and about 100,000 people had to be evacuated. The damages were estimated to reach \$400 million, even though some of that damage was likely caused by flooding before the breakers arrived. (fig. 2). A new Tous dam was built on the same site and part of the clayey core material, which had shown a relatively high resistance to water flow, was reused for constructing the new dam.

The Tous dam Design and after failure

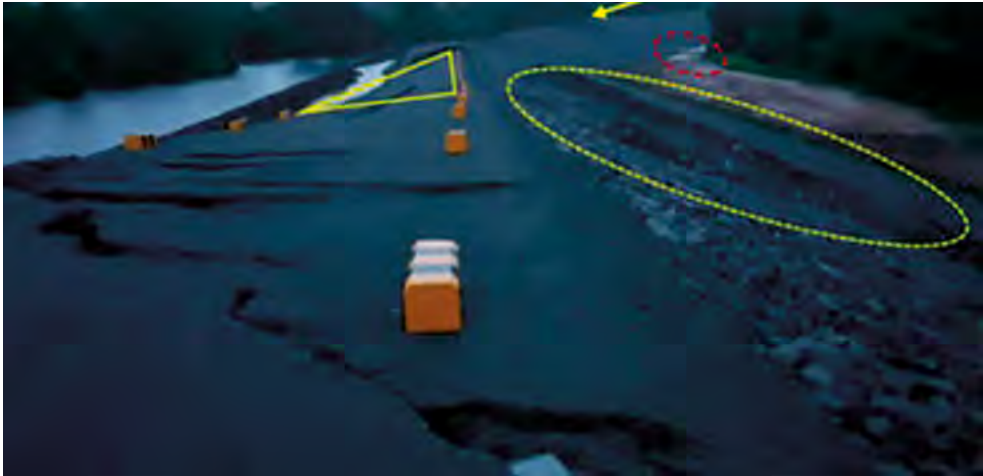
Initiation of the failure (23 july 04:30)

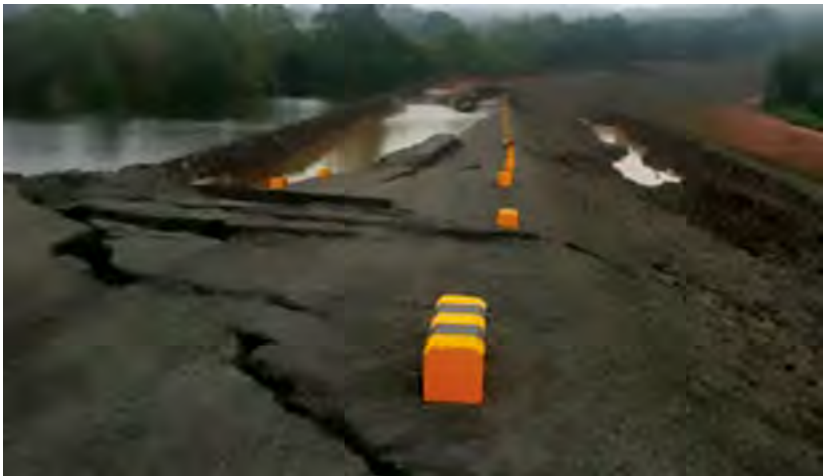
Beginning of water crossing the embankment (23 july 11:46)

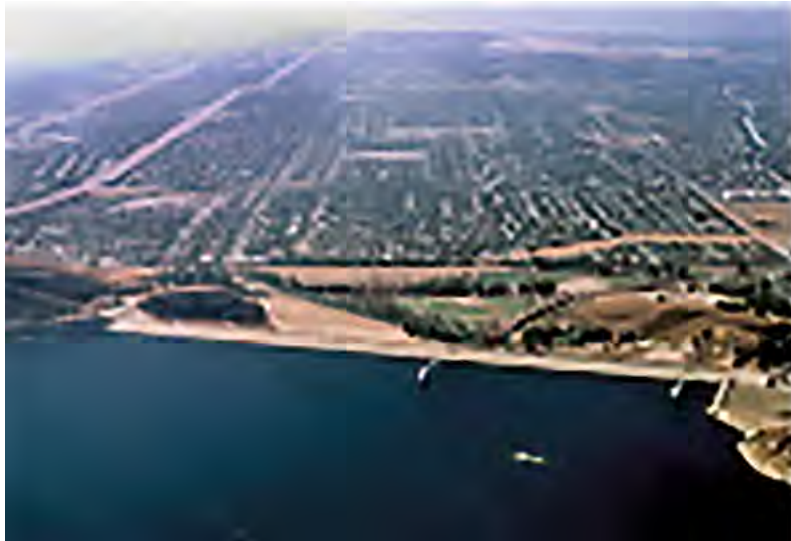
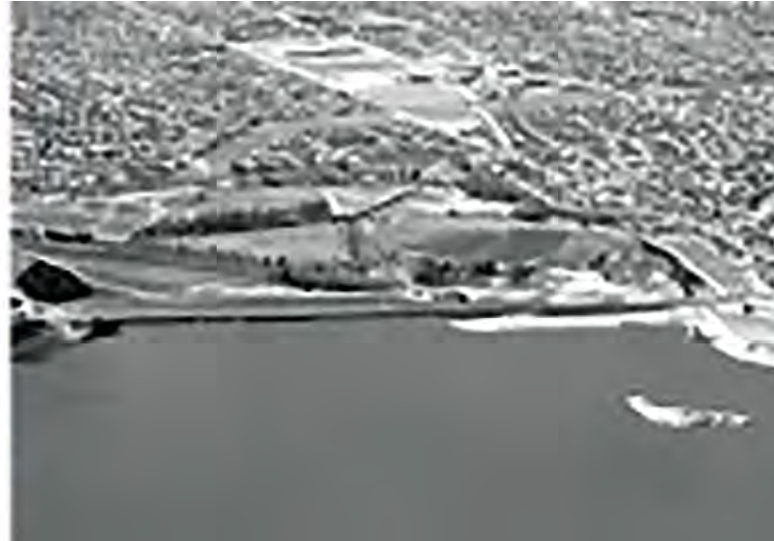
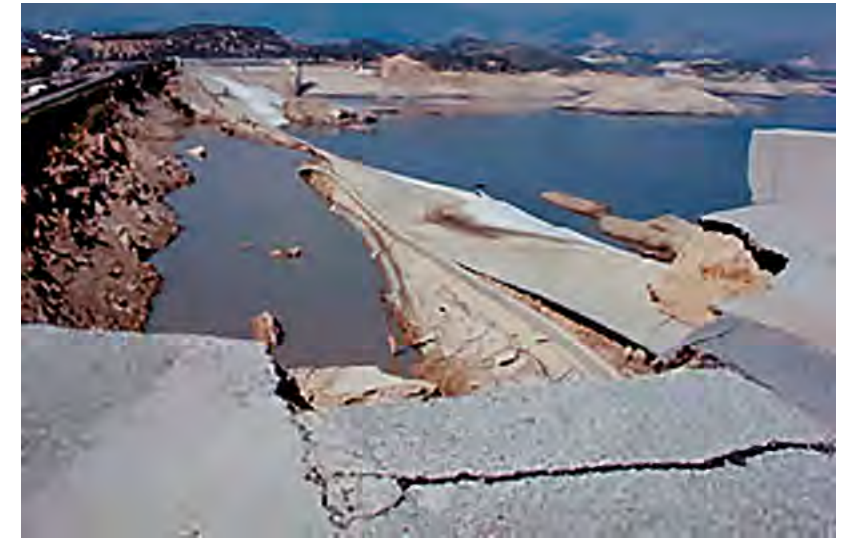
- ⇒ In 1971 a M=6.6 San Fernando earthquake (Feb 9, 6:00 a.m.) produced about 0.55 g peak acceleration at the dam crest.
- ⇒ The dam had 10,5 m of freeboard before the earthquake, and only 1 to 1,5 m afterward.
- ⇒ During the earthquake a major slide occurred on the upstream face, taking with it the crest and the upper 9.2 m of soil on the downstream slop.
- ⇒ About 80,000 people living in the downstream valley had to be hastily evacuated.

Before and after earthquake, Lower San Fernando dam, ASOD
Lower San Fernando Dam after 1971 earthquake, ASOD

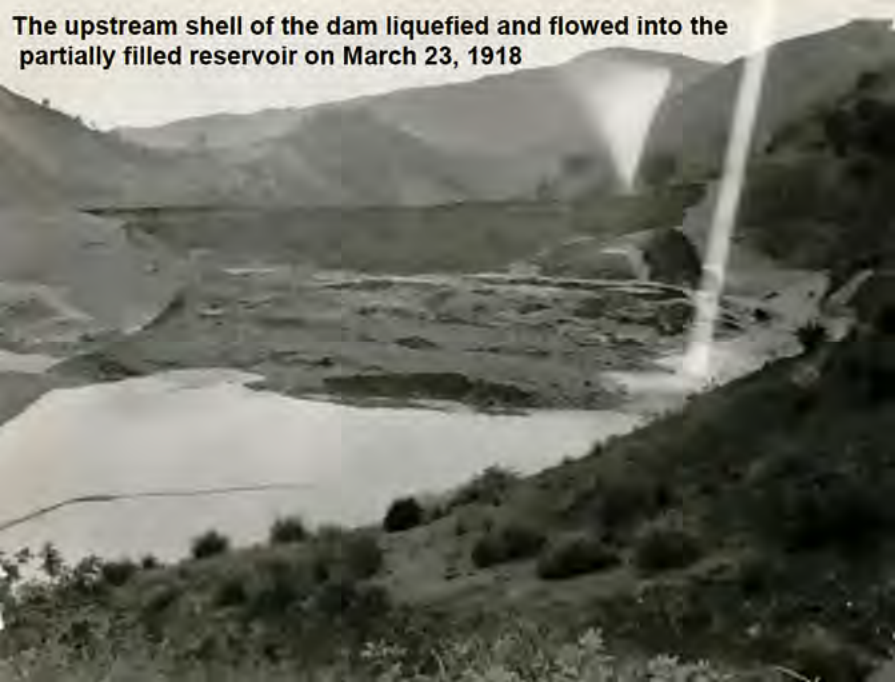
A slide occurred in the upstream shell of Calaveras Dam during its construction in 1918. The dam was constructed in part using hydraulic filling techniques, a technique that was common in that era but is seldom used today.

On March 23, 1918, the fill slid upstream in five minutes, destroying the intake tower

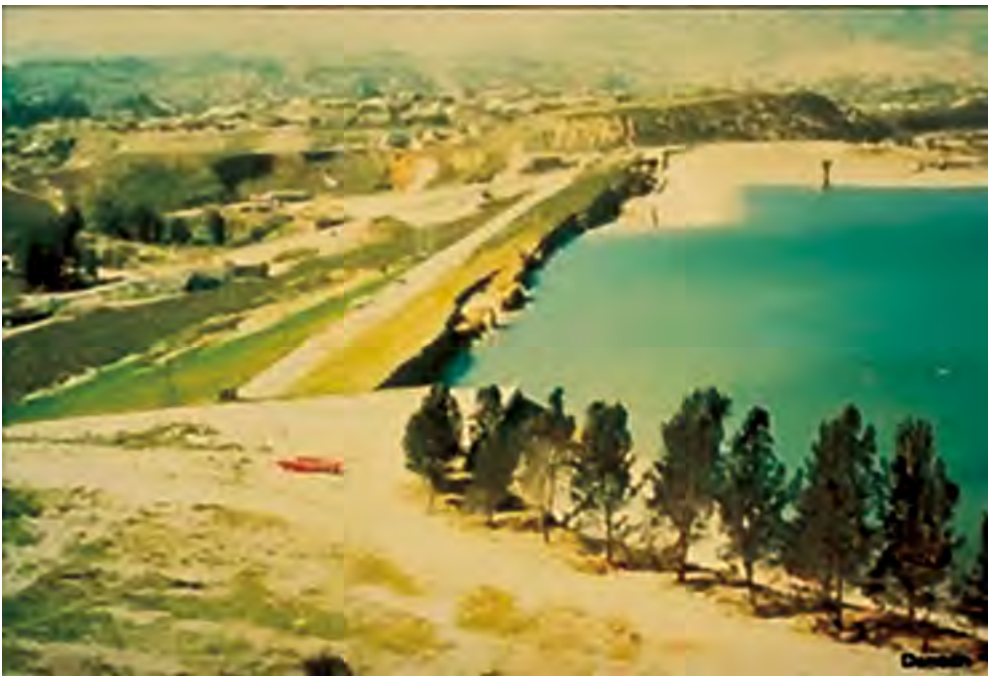
This aerial view shows how the crest of the dam disappeared under the reservoir as a result of the slide in the upstream shell. The slide occurred shortly after earthquake shaking ended and was attributed to loss of strength in the hydraulic fill due to liquefaction.

The earthquake ground shaking caused most of the upstream slope of LSFD, offset towards the left abutment, to fail, sliding into the reservoir and resulting in a substantial loss of freeboard. The embankment spread approximately 250 feet beyond the toe of the embankment. Further examination of the seismoscope on the crest indicated that the upstream slide developed after the earthquake had continued for some time and not during one of the peak motions.

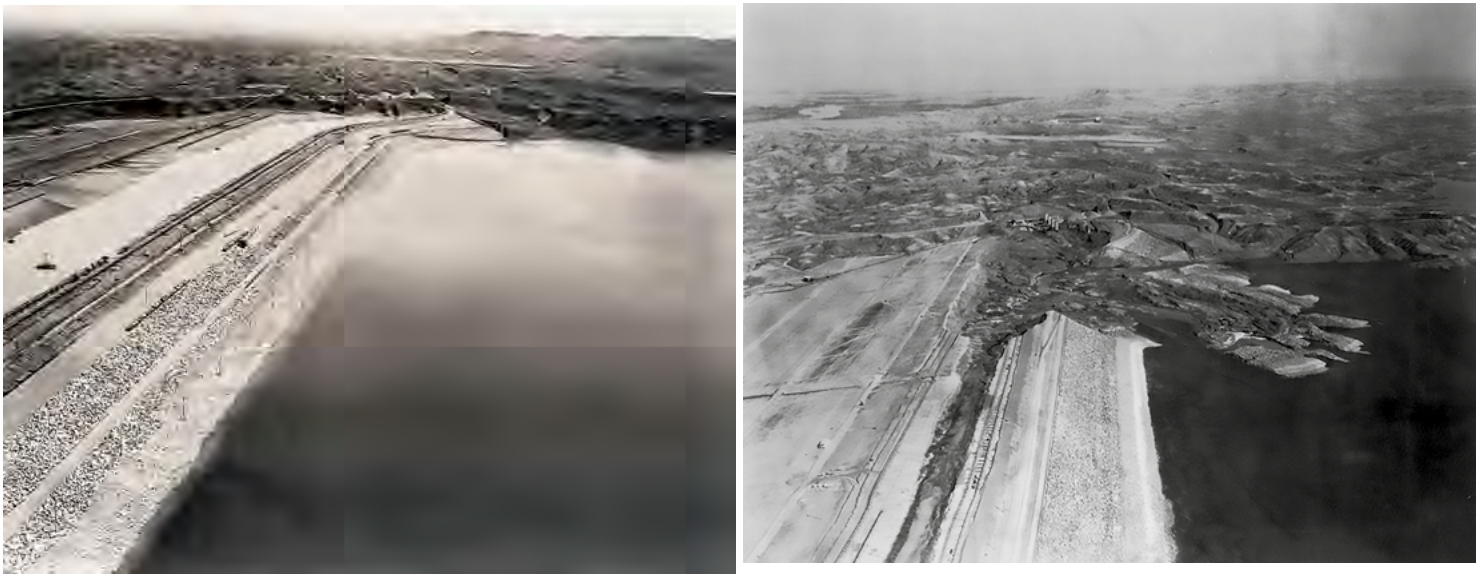
The slide took the lives of 8 men on September 22, 1938. Fort Peck Dam, Fort Peck, Montana. Courtesy, estate of Robert A. Midthun.

The major weak point in the dam seemed to be the bentonite seams in the Bear Paw shale. Very high water pressures were reported at some points in the shale during the construction. This was likely caused by consolidation due to the overburden of the fill being placed for the dam. The excess pore pressures could not be relieved due to the low permeability of the surrounding shale. This resulted in a low effective stress in the bentonite and a very low shear strength.

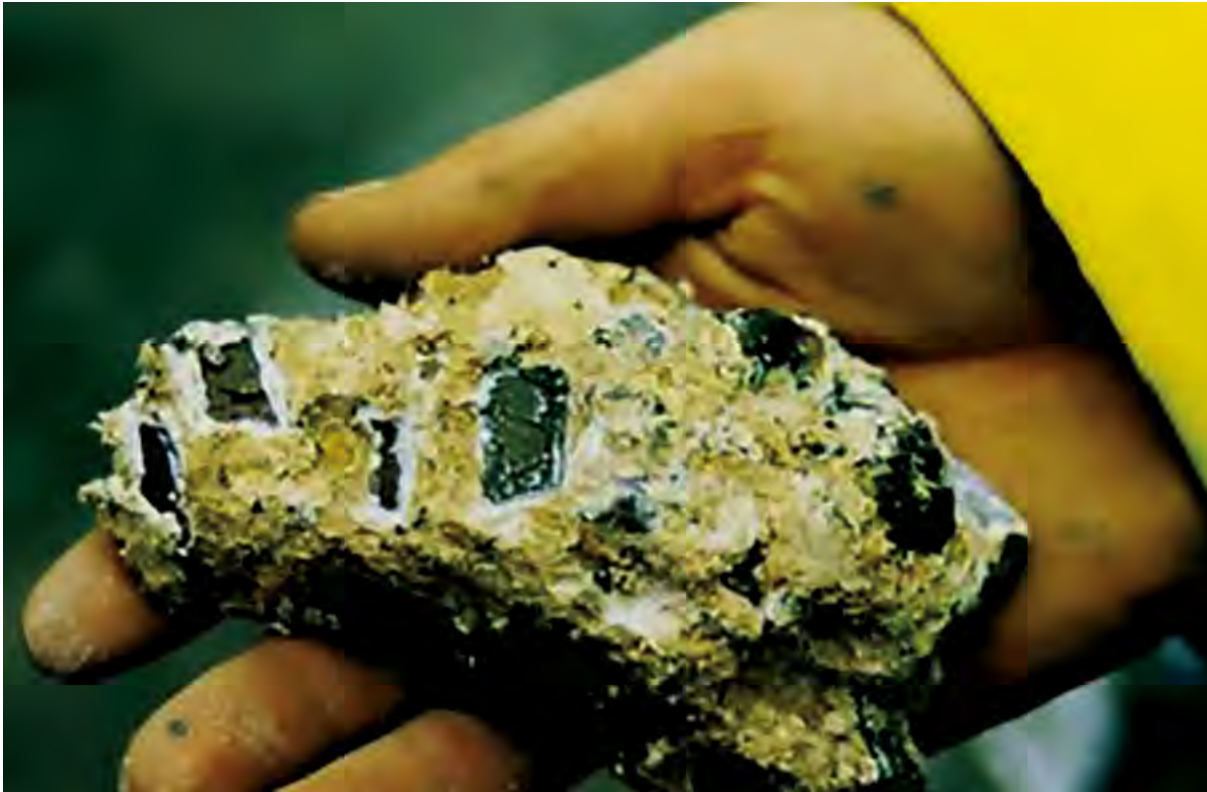
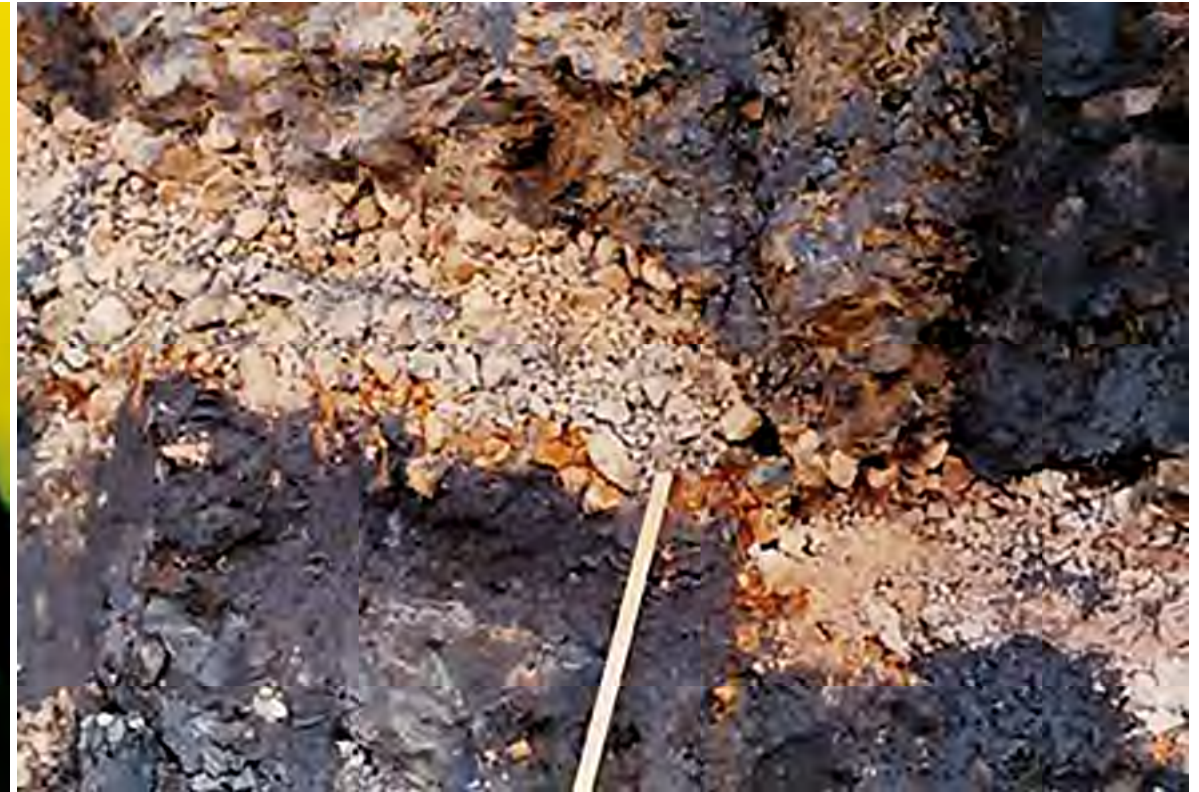
The scale of the failure was so great and the public concern so high, that an independent of any interested parties reported the actions being taken to investigate the failure. ***Sulphate attack on concrete was discovered when investigating the partial collapse of Carsington Dam in 1984.*** In this case, pyritic mudstone had been used to form the outer shoulders of the dam and, in order to prevent standing water, limestone

Degradation of concrete caused by sulphate (thaumasite) attack

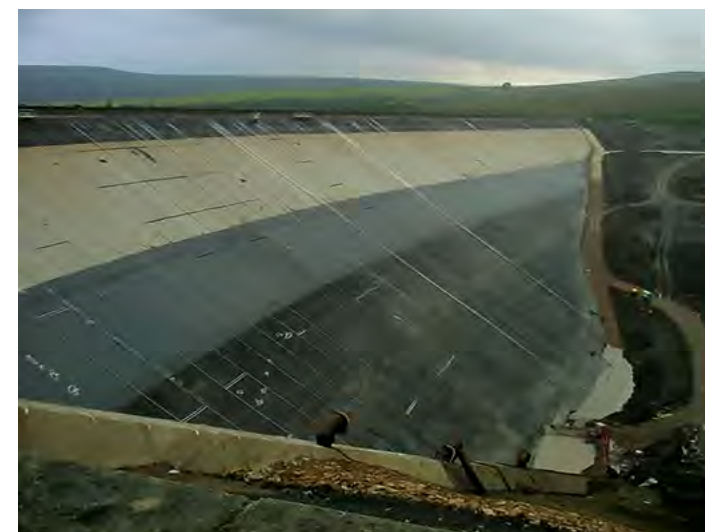
The defects detected during the 1996 inspection included 20 cracks within the upper layer of DAC varying in length up to about one meter, eight blisters which also had cracks, and debonding between the upper and lower layers of membrane. Inspection of the membrane in 2001 revealed 60 new defects, with several large cracks at the base of the dam, one of which had opened into a hole through the membrane. In December 2002, a Carpi composite PVC/fabric membrane liner was constructed over the DAC.

Back of Winscar Dam, Dunford Bridge.
This dam started to leak in 2000 and was emptied so that it could be repaired.

It was covered by an impermeable membrane to prevent water leaking through cracks in the concrete.

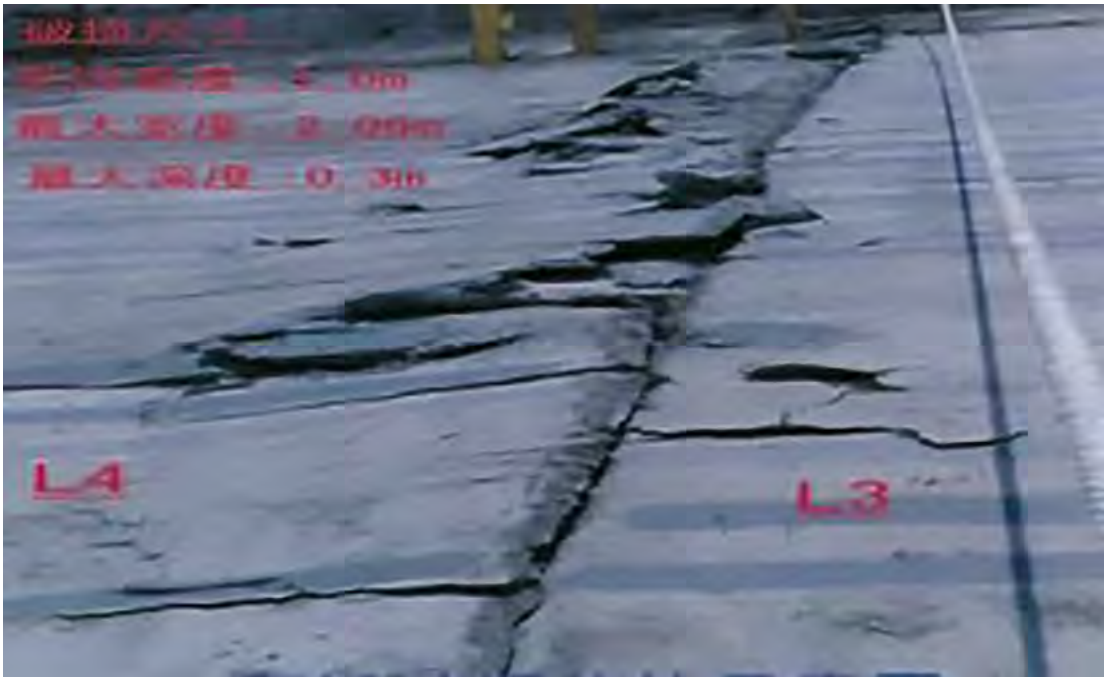
Finally, the leakage rate was large. It reached 80–140 l/s and fluctuated with changes in the reservoir water level.

The damages at Tianshengqiao no.1 Dam

Later, this damage zone was repaired and the joint was filled with embedded rubber plate, which showed good performance during the subsequent operation.

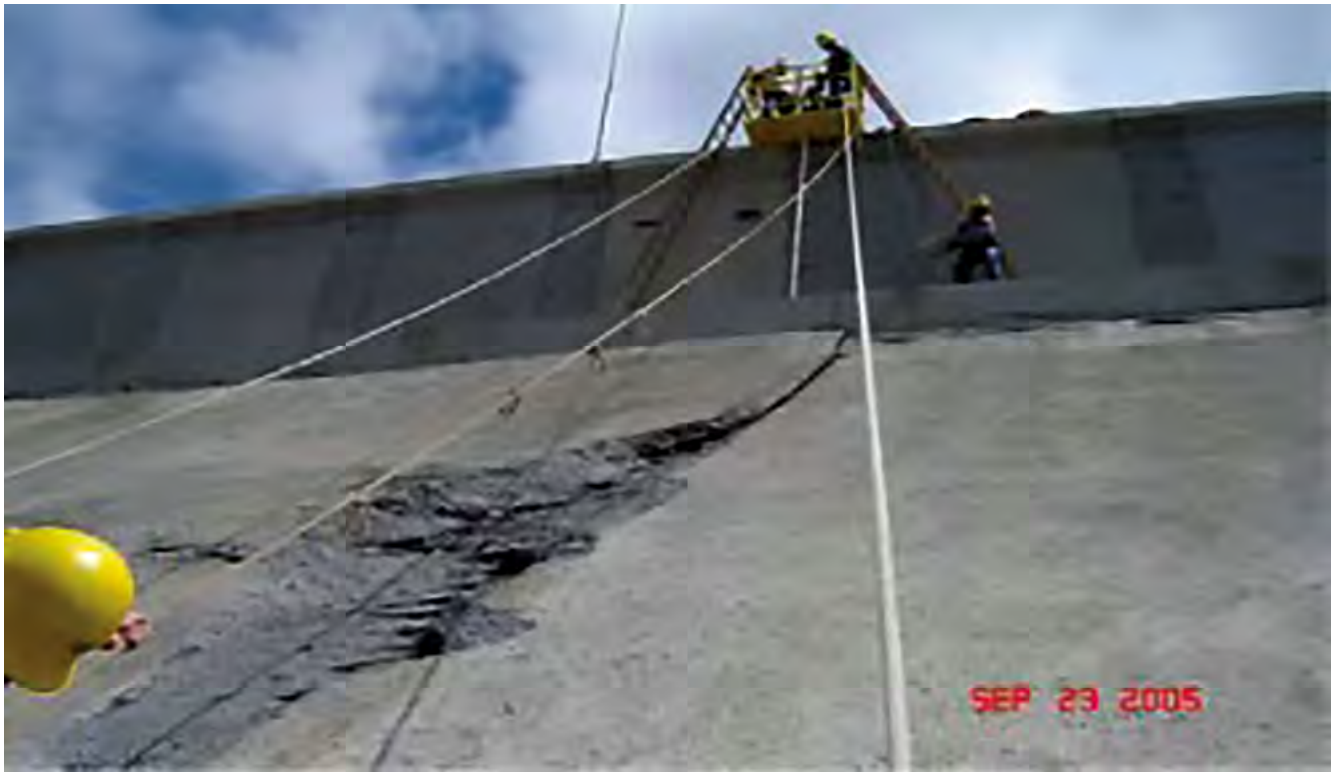
Some serious cracks, squeezed ruptures, and horizontal overlaps of concrete face slabs occurred at Barra Grande Dam (185 m high).

The damages at Barra Grande CFRD

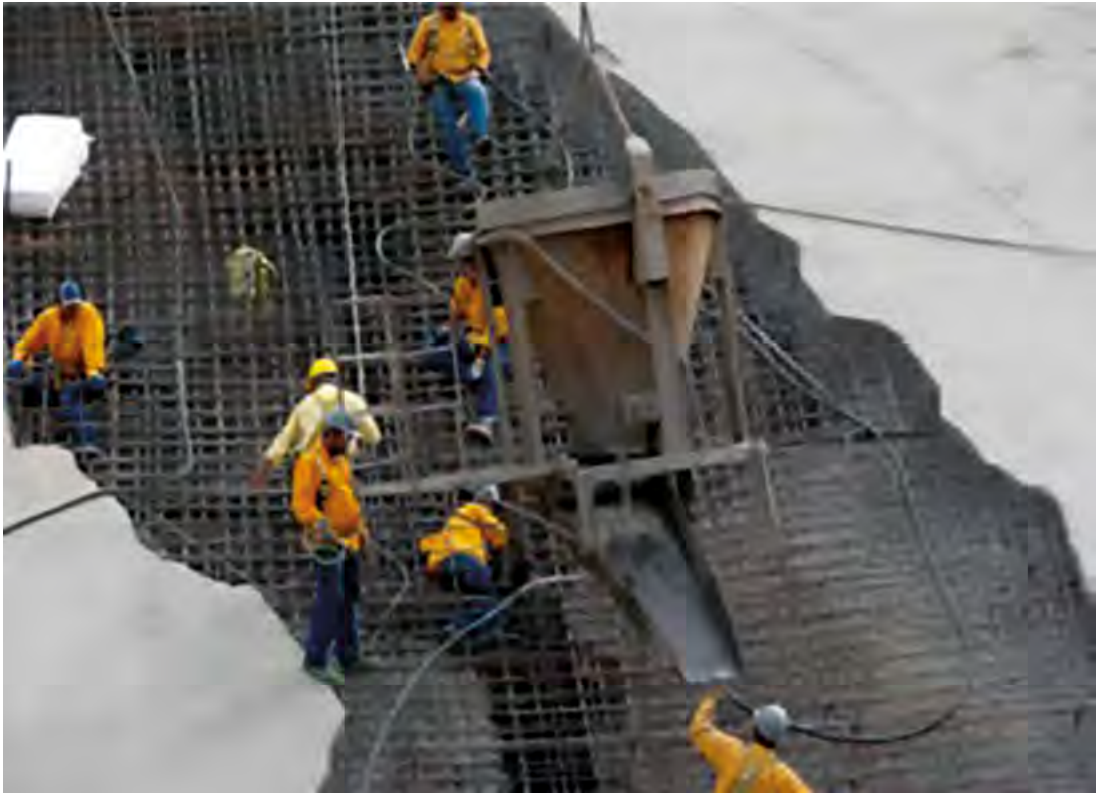
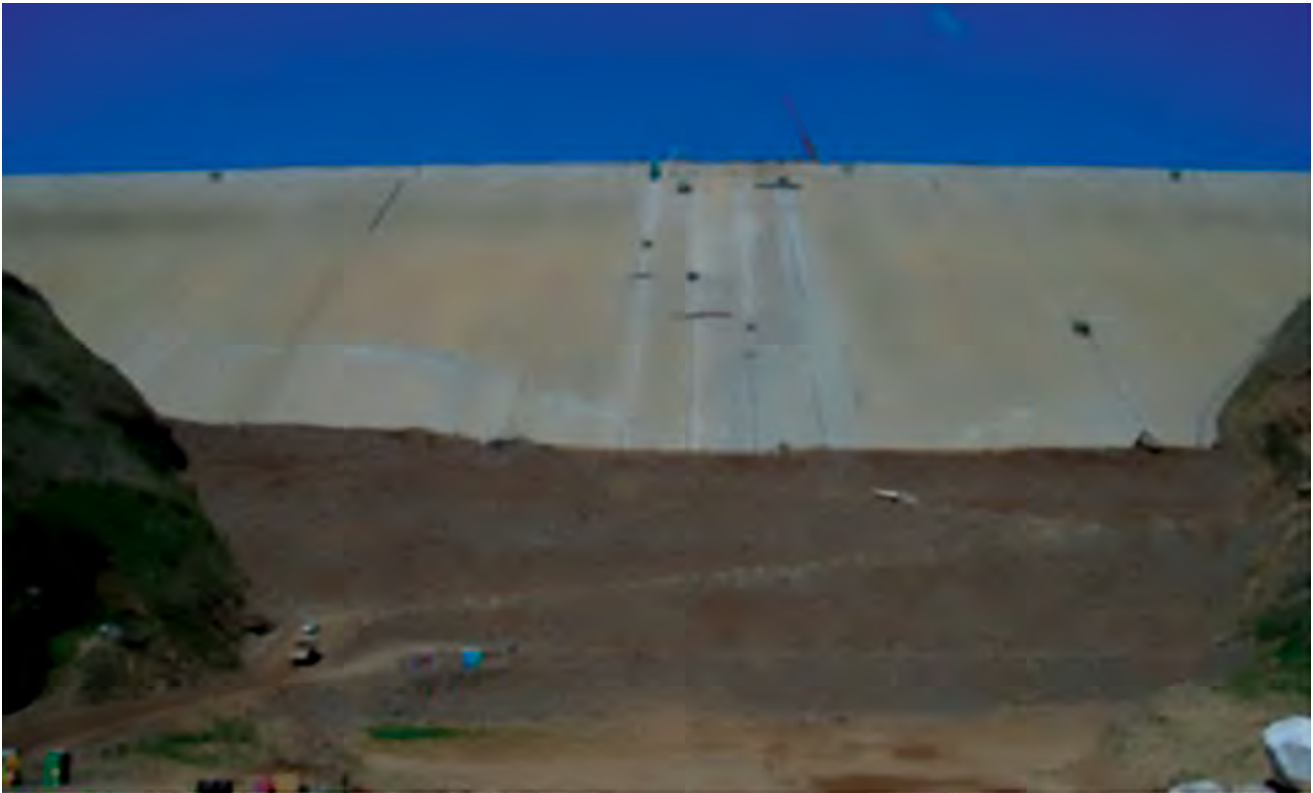
The damages at Campos Novos CFRD

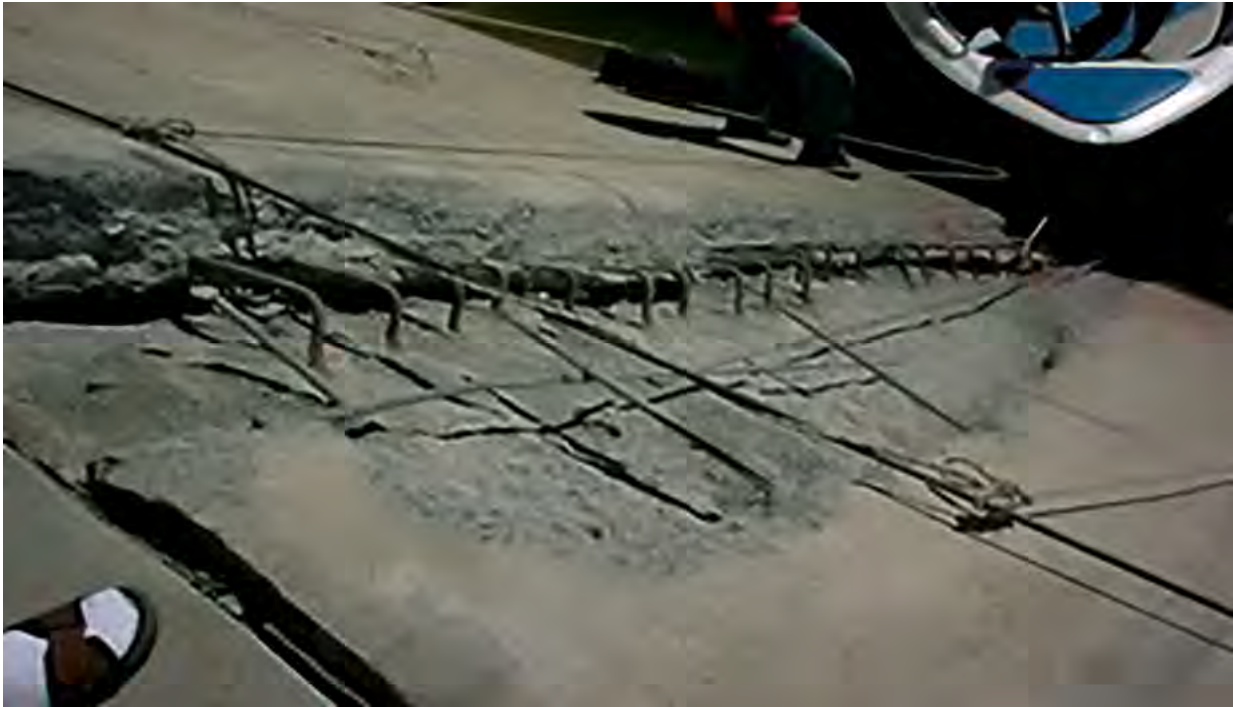
The cracks, squeezed ruptures, and horizontal overlaps of concrete face slabs occurred at Mohale Dam (145 m high), then the seepage discharge increased to twice.

The damages at Mohale CFRD

The dam was visited on February 13, 2006, with no anomalies detected. *In February 2006 heavy rains hit the Mohale region, resulting in a rapid rise of the reservoir to spilling conditions. This resulted in significant dam settlements downstream and cross valley movements of the crest, which in turn increased the already high compressive stresses within the center portion of the concrete slab, resulting in spalling failure of the slab.*

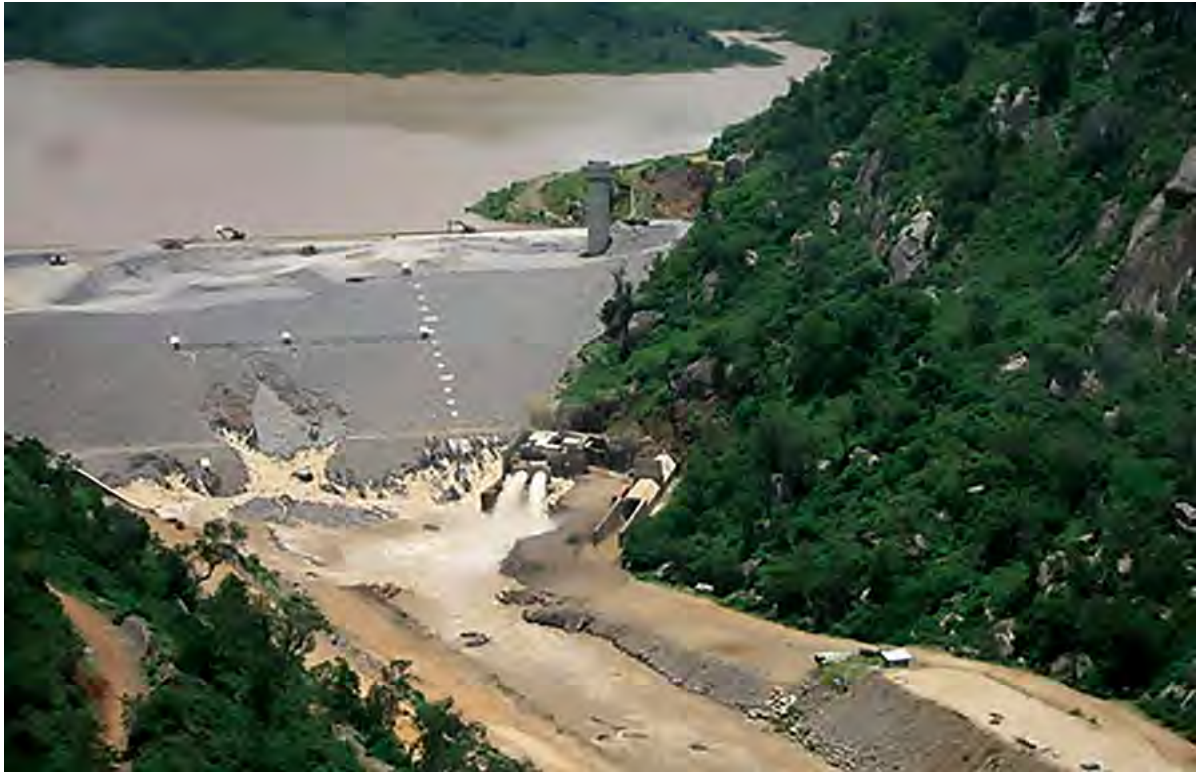
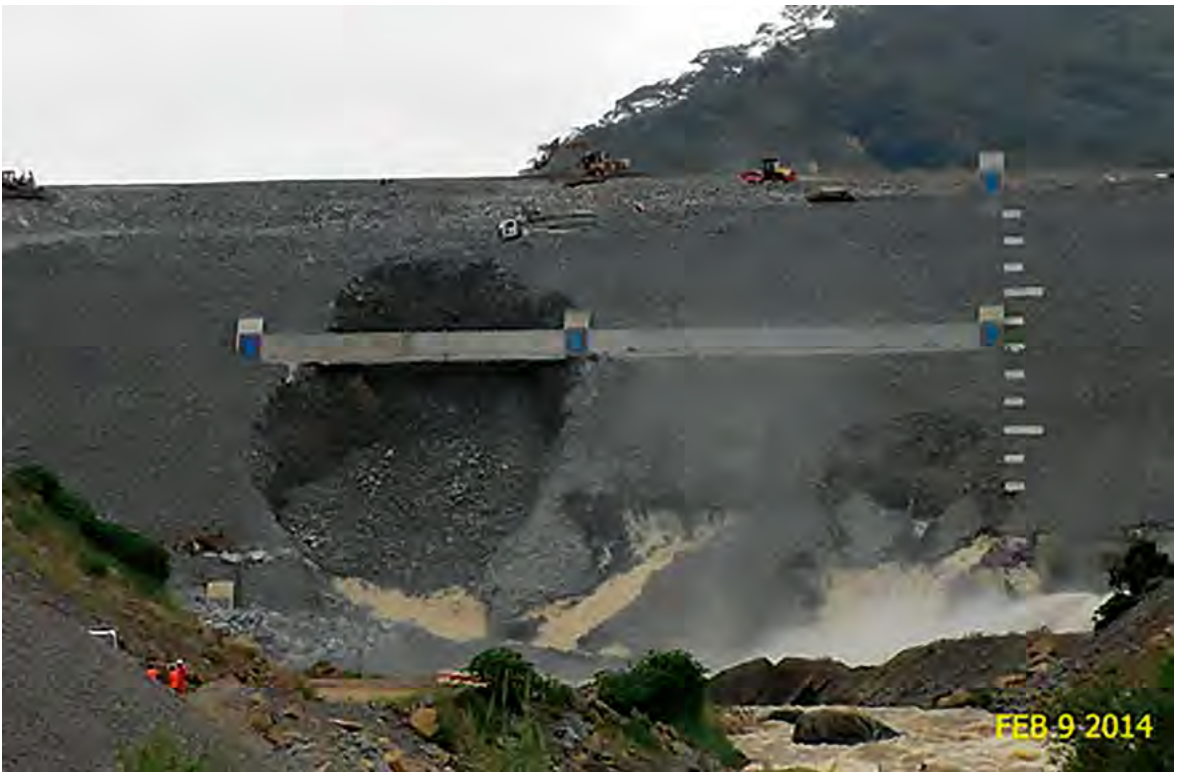
Heavy flooding in February 2014, caused a partial failure during construction, on February 4, on the downstream face of the dam. By late February the dam had not been fully breached but the unplanned rising reservoir behind the dam caused evacuations upstream. The Dam was eventually completed in December 2016, and commissioned in May 2017.

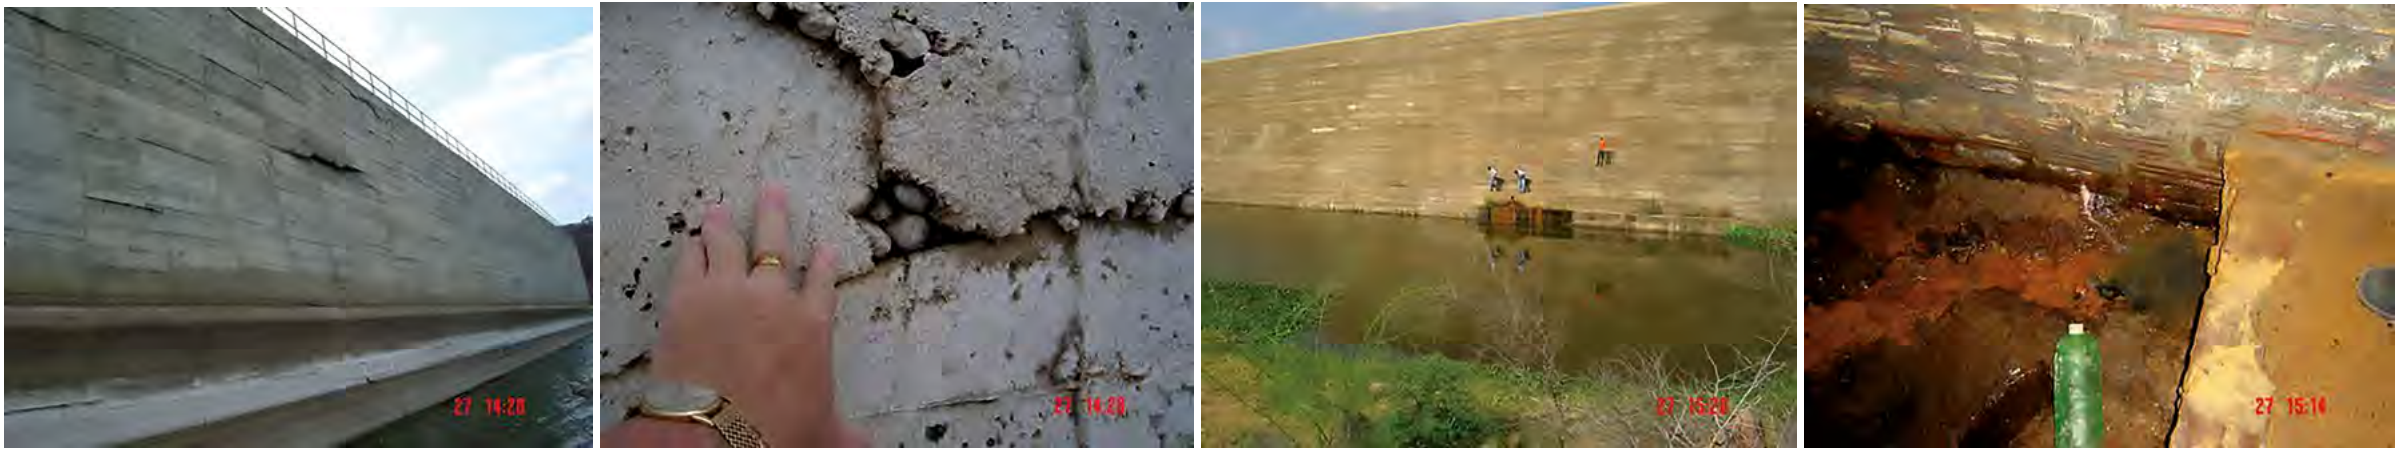
Case	Identification	Country	Finished	Damage		References
4.5.10-C	Umari	Brazil	2001	2005		Private Report from Andriolo

The same as 4.5.10-B, the inspections showed the face of the CCR dam executed simultaneously with CVC, with porosities, honeycombs and infiltrations to the downstream face, **resulting from methodology and execution of poor quality.**
