Is Your Dam Safe?

An281	Andriolo, Francisco Rodrigues; Moreira, José Eduardo
	Is Your Dam Safe? – Vol. 1 / authors: Francisco Rodrigues Andriolo e José Eduardo Moreira. São Carlos, 2022.
	1394 p. il. color
	ISBN – 978-65-5668-011-8
	DOI – http://dx.doi.org/10.26626/9786556680118/2022B001
	1. Dams. 2. Training. 3. Quality. 4. Repairs. 5.Controls. 6. Cement. I. Orgs. II. Title.
	CDD 370

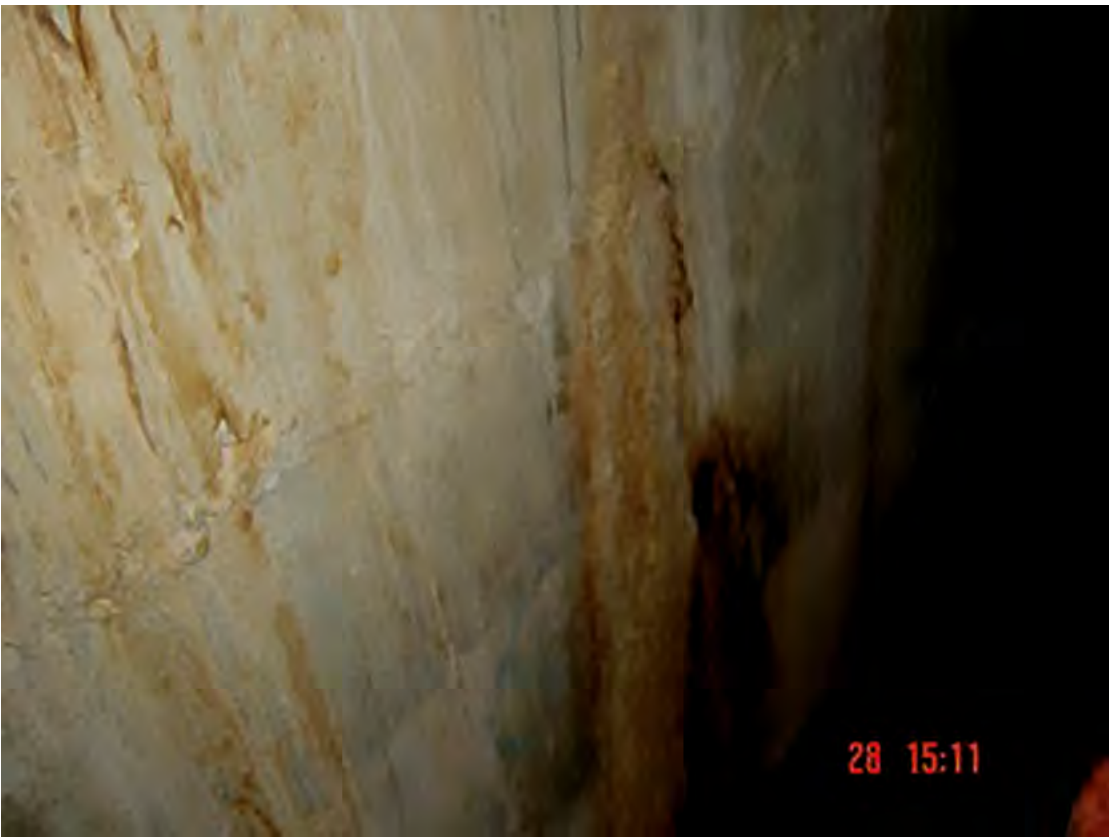
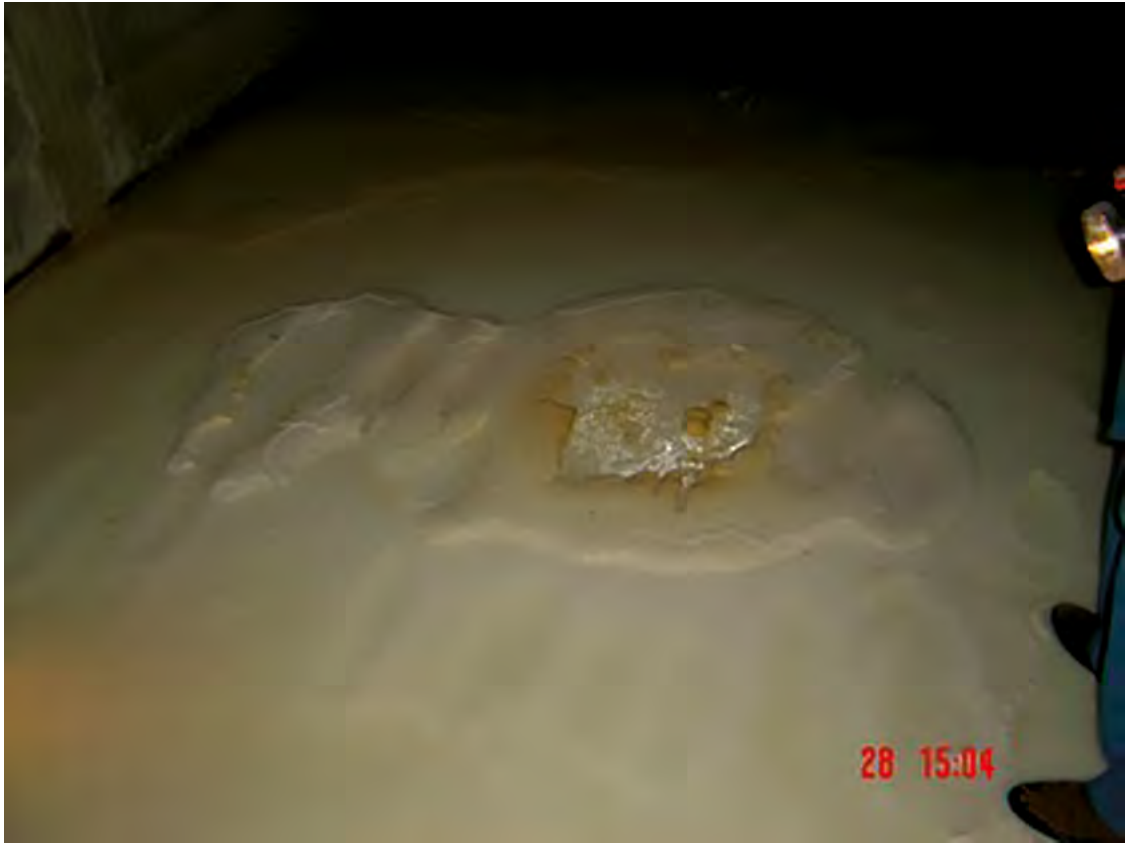
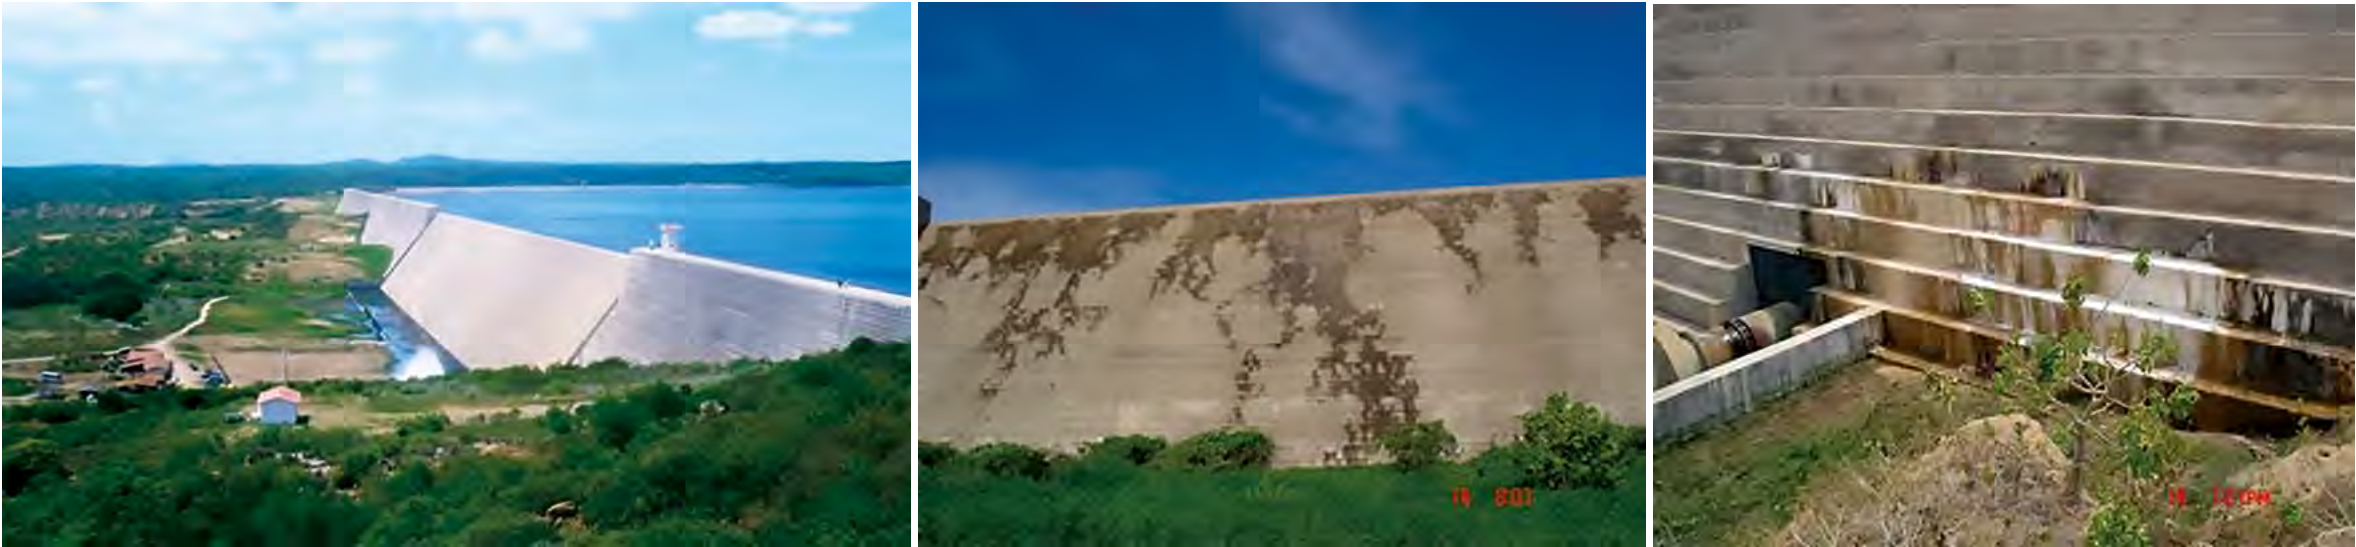
Case	Identification	Country	Finished	Damage	Actions	References
4.5.10-D	Santa Cruz do Apodi	Brazil	2002	2005	Repairs by 2006	Private Report from Andriolo

The same as 4.2.11-B and C, the inspections showed the face of the CCR dam executed simultaneously with CVC, with porosities, honeycombs and infiltrations to the downstream face, resulting from methodology and execution of poor quality.

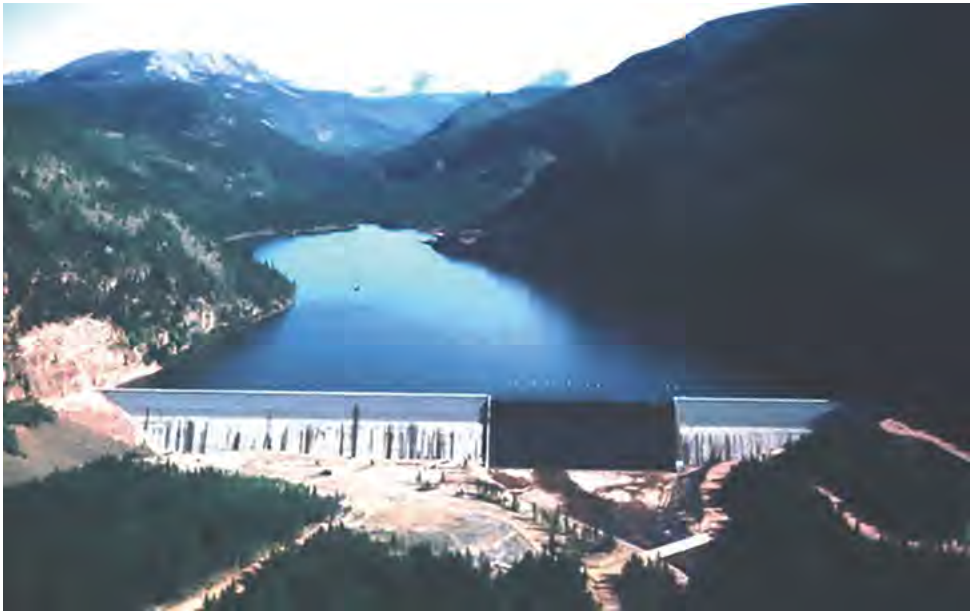
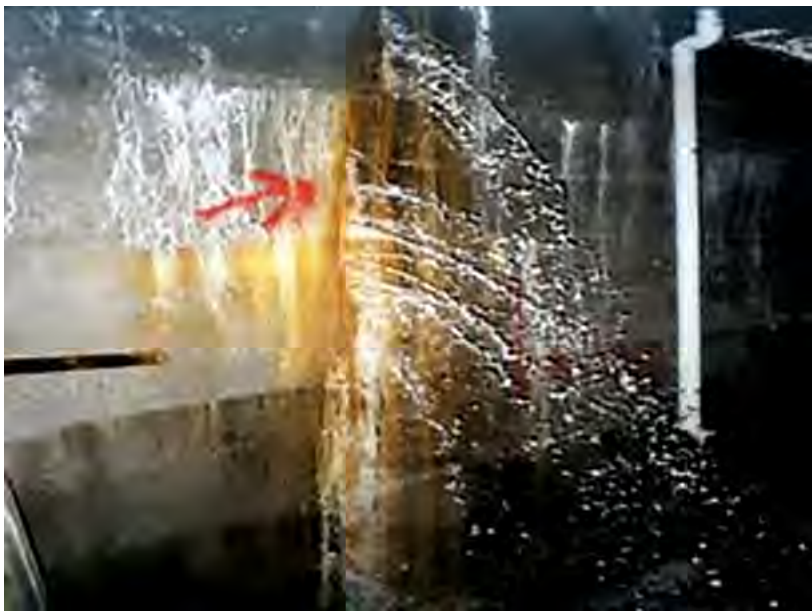
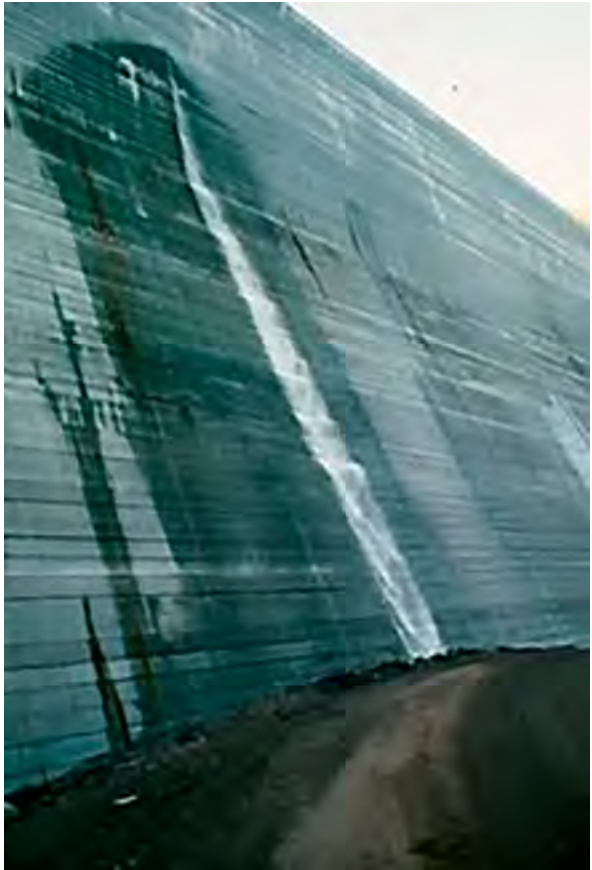
The dam was constructed continuously from abutment to abutment *without contraction joints or artificial cooling, which resulted in the development of thermally induced vertical cracks at several locations and leakage into the gallery and downstream face*. Both the upstream and downstream faces of the dam were constructed by extruding concrete using a conventional, horizontal, slipform paver and a side-hung mold.

Aerial view of the completed Upper Stillwater Dam, showing the downstream face and seepage from cracks following the first winter and first filling

Supplemental grouting was performed using both cement grout and polyurethane chemical grout, but it was only partially successful because significant leakage persisted at several cracks.

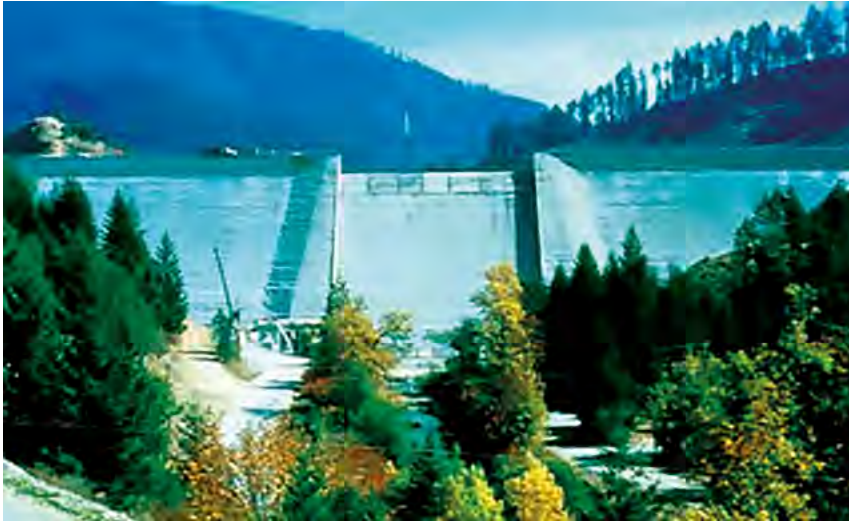
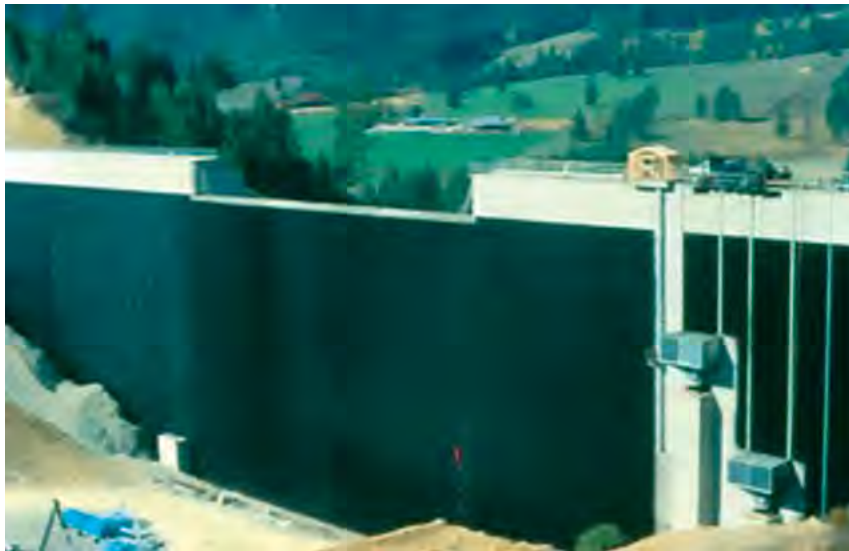
Case	Identification	Country	Finished	Damage	Actions	References
4.5.10-G	Galesville	USA	1985	1988	Groutings	[04-34]

For seepage control, two 20-mil thick layers of a coal-tar based elastomeric membrane was sprayed on the upstream face. A delay in the start of the RCC placement to warmer weather helped contribute to the initial formation of seven thermal related cracks that continued through the entire gravity structure. Following completion of the dam, unusually cold weather hit the site causing a reduction in volume and thus cracking. The sprayed-on membrane did not have sufficient elasticity to bridge the cracks.

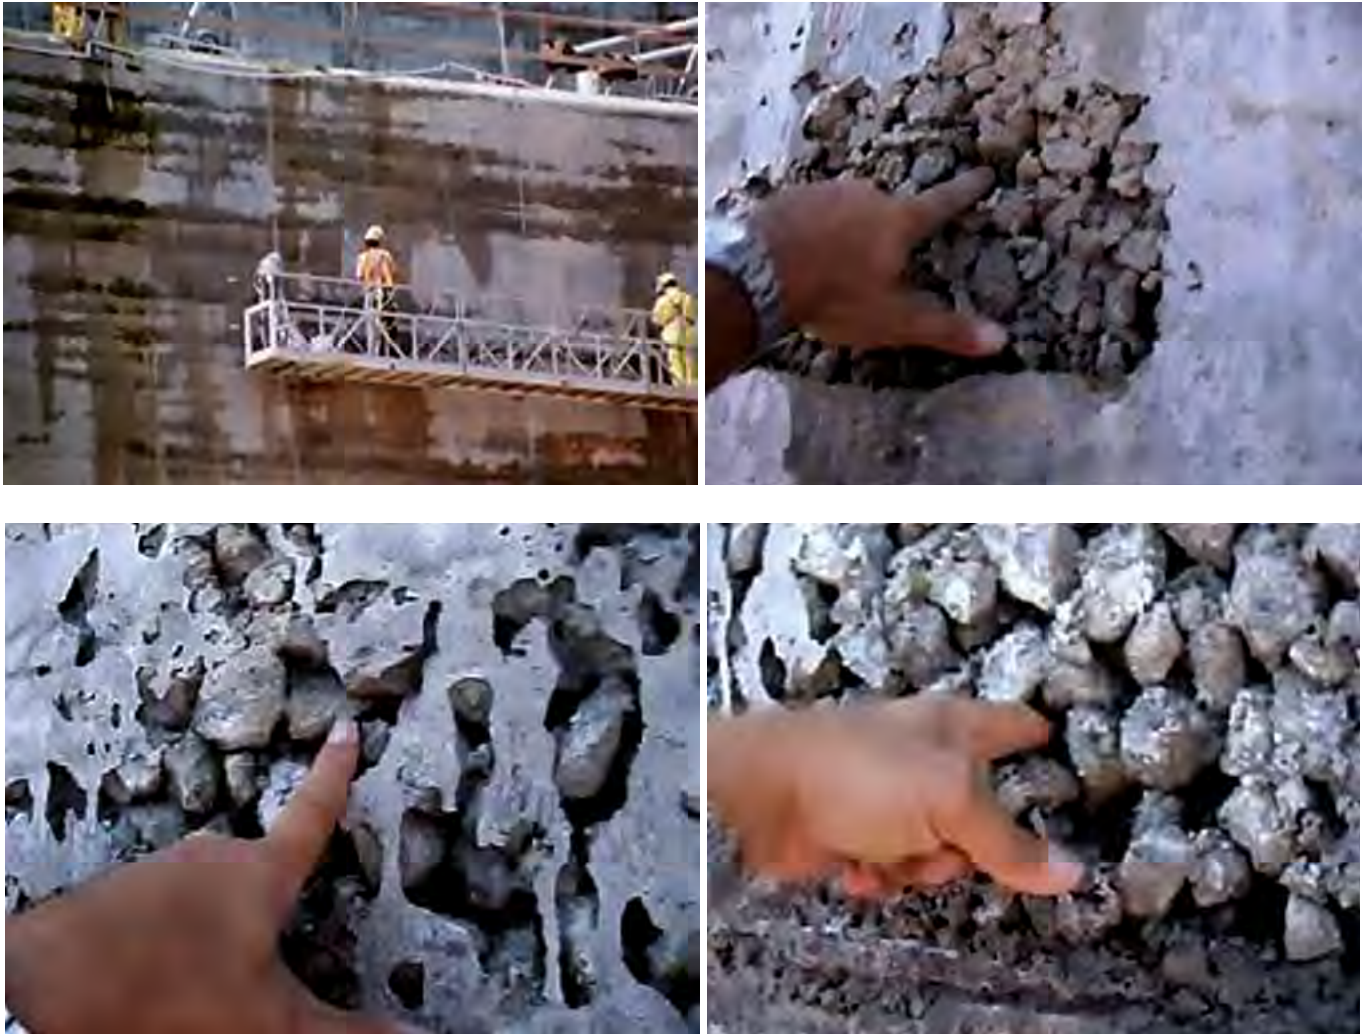
In this alternative, the vibration procedure must be controlled in order not to obtain a porous face as illustrated below.

Honeycombs in the Grout-Enriched RCC (GE-RCC) (Andriolo’s Archive)

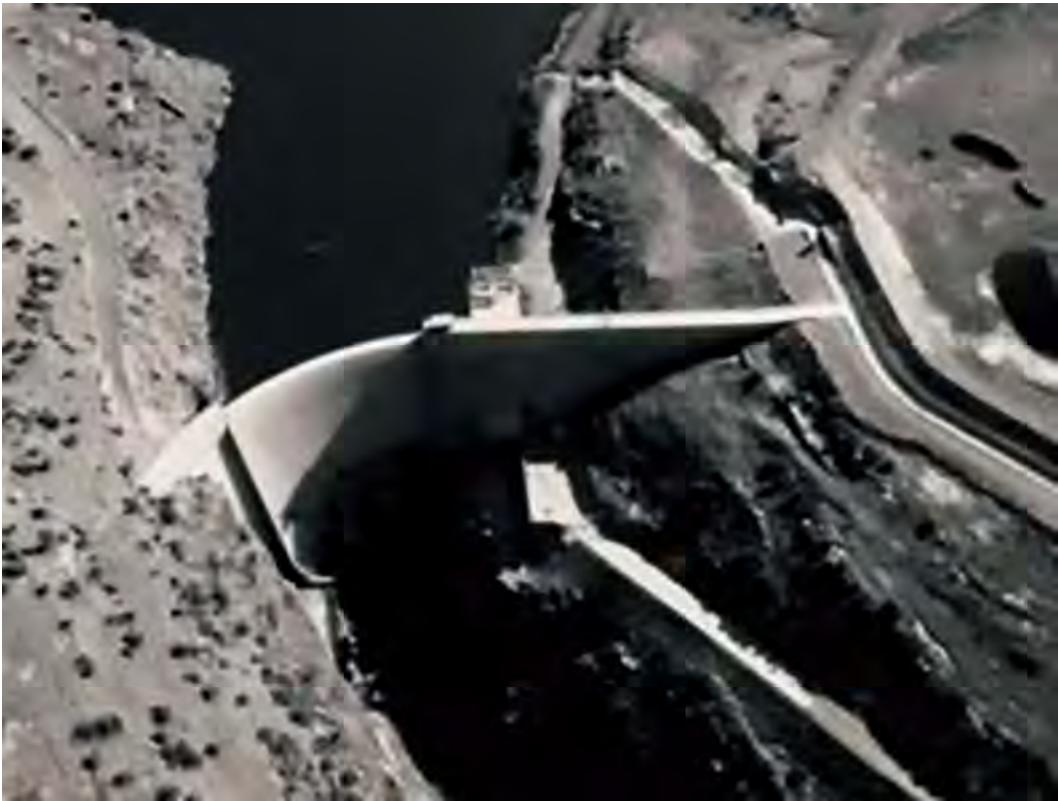
The 50-m-high dam is an asymmetric arch with a straight gravity left flank. The upstream faces is Vertical and the downstream face: 0.60:1 (H:V). *After the filling some cracks and seepage were observed from the downstream face.*

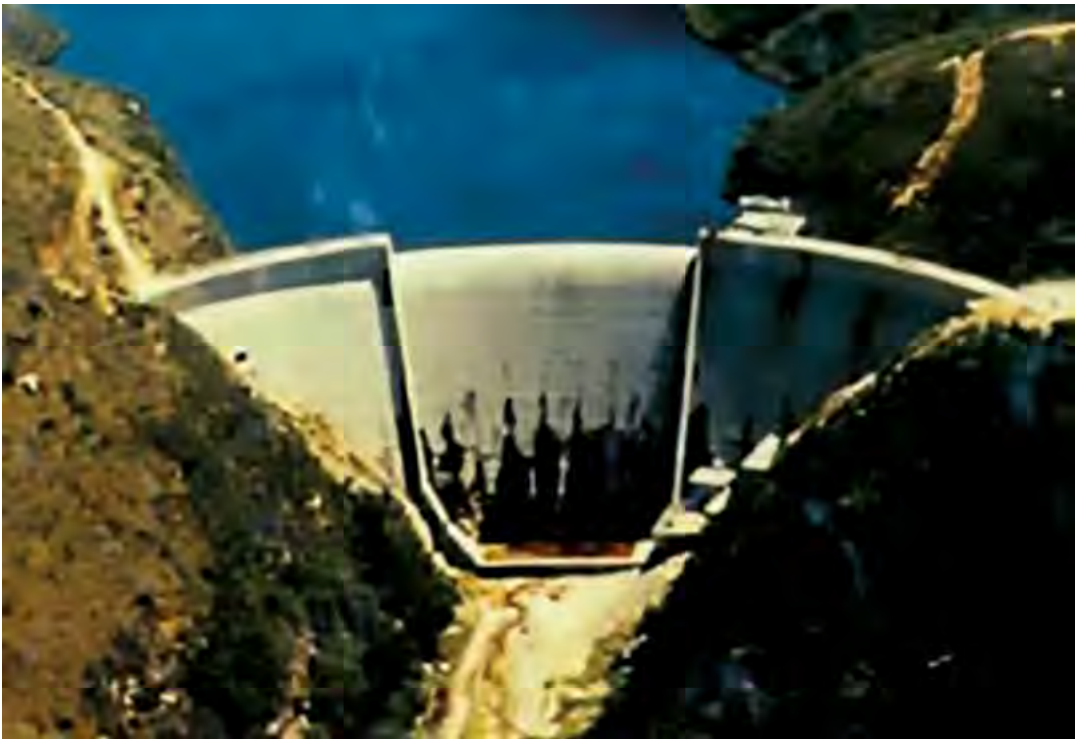
The Wolwedans Dam is situated on the Great Brak River near George in the Southern Cape Province of South Africa. The 70-m-high dam is a near symmetric arch with upstream face with CVC concrete: Vertical and downstream face: 0.50:1 (H:V). *As for a Knellpoort dam, after the filling some cracks and seepage were observed from the downstream face.*

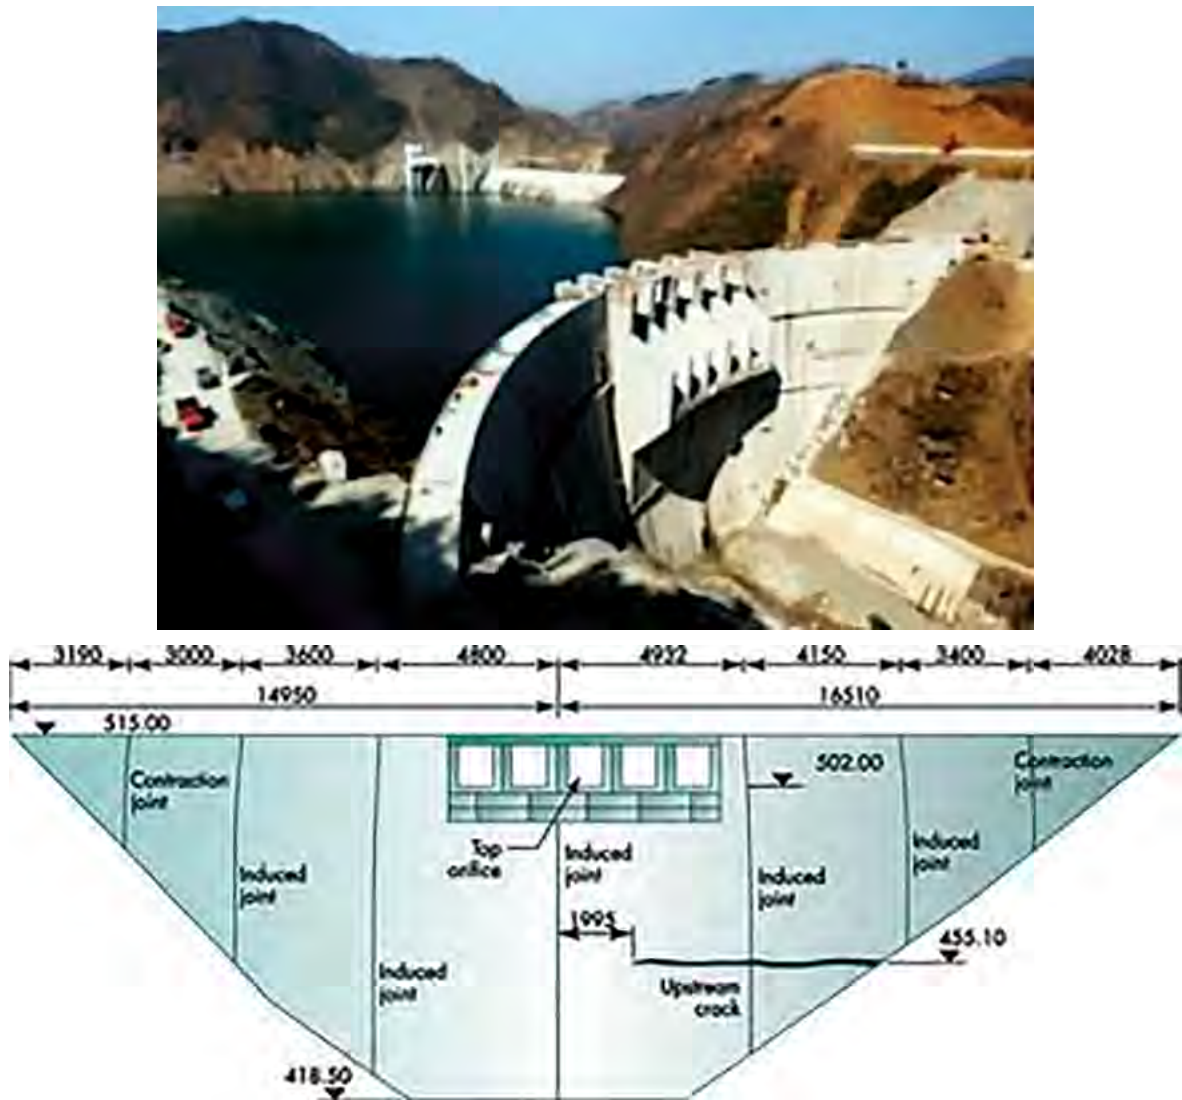
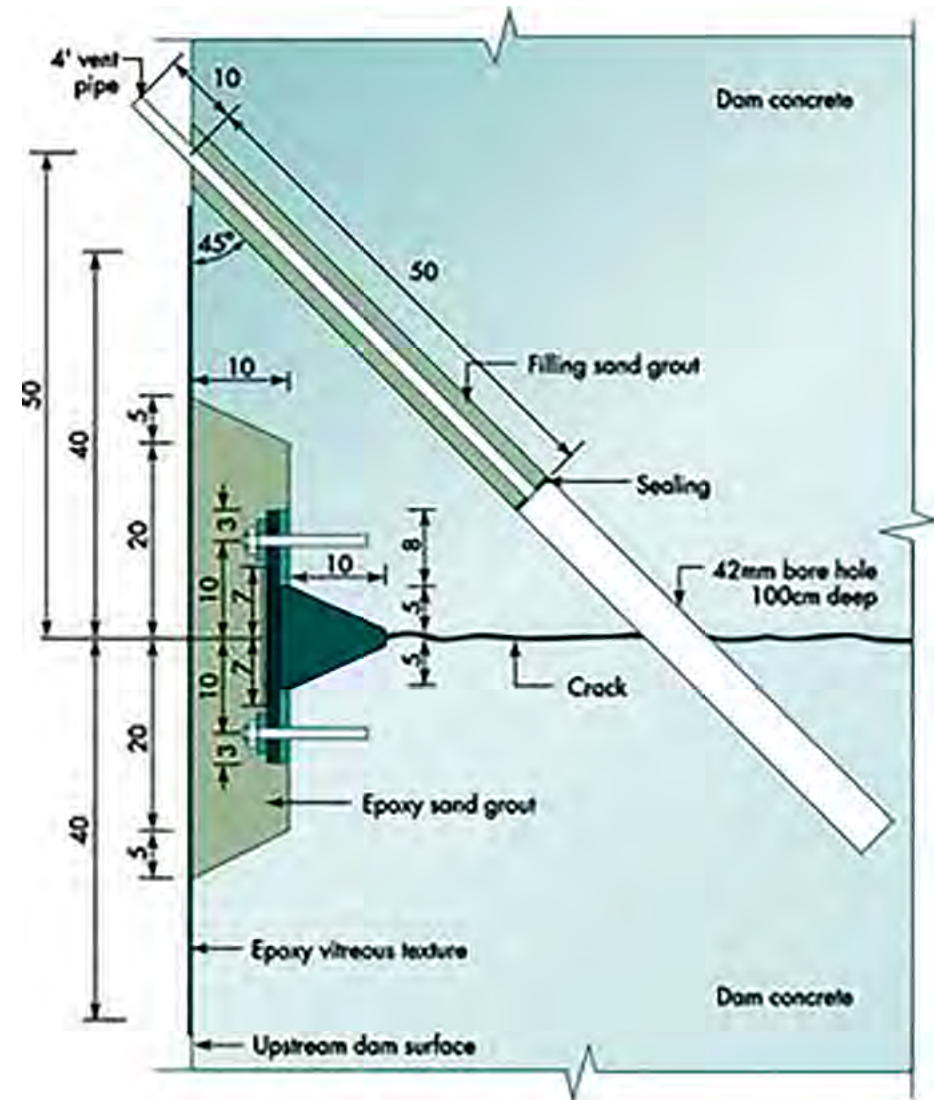
On August 8, 2002, a horizontal crack was found on the upstream face of the dam. Water pressure tests and bored dam concrete cores indicated that the crack was along the surface between placing lifts. The crack had developed from the dam upstream face to the downstream face, and had a total cracking area of nearly 1000 m², with a width less than 0.3 mm. After careful observation, indoor tests, and field experiments – measures including chemical grouting into the crack surface, sealing the crack boundary, and installing anchor steel piles through the crack – were carried out twice for the arch dam.

After the discovery of the crack, which may have appeared previously but remained unnoticed, another horizontal fracture was found at the same elevation on the dam's downstream face. A simple water pressure test was carried out on August 16, 2002, resulting in water leaking out of both the upstream and downstream cracks, and water splashed out from several other locations. Also, Ca(OH)_2 emitted from both cracks. After chemical grouting was undertaken for the first time on 21 October 2002, it was found that water still leaked out of the cracks, and the cracks were extending toward the crown cantilever. This clearly indicated that the first chemical grouting was not successful.

Crack treatment for the second time began on November 20, 2002. During the drilling of chemical grouting holes, especially when high-pressure winds drove water into the grouting pipe system and the crack surface, the cracks continued to further extend toward the crown cantilever, which was evident in the wet cracking trace. After surveying, it was found that the upstream crack extended from the right abutment to a location 19.95 m right from the reference plane, and the downstream crack extended from the right abutment to a location 28.6 m right from the reference plane. The crack ran through the upstream face to the downstream face and the total crack area was about 1000 m². This damage is an infrequent occurrence in RCC dams, and required a very difficult treatment process to fix the problem.

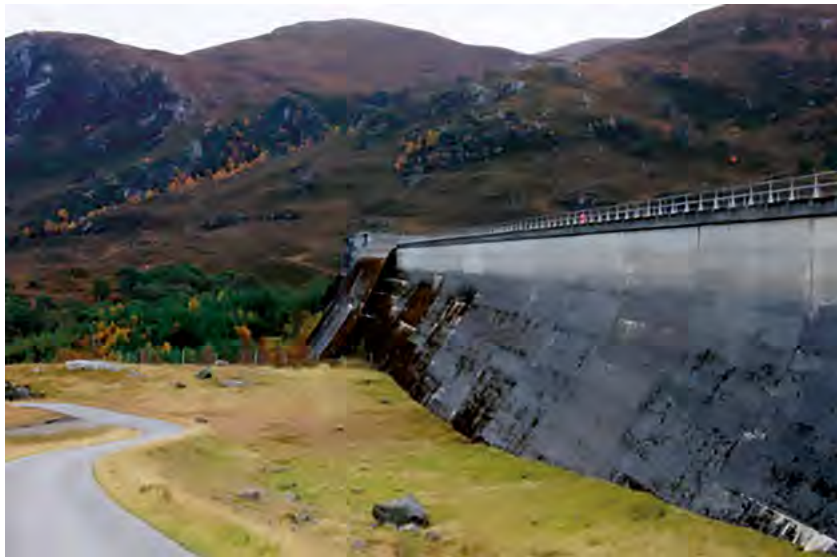
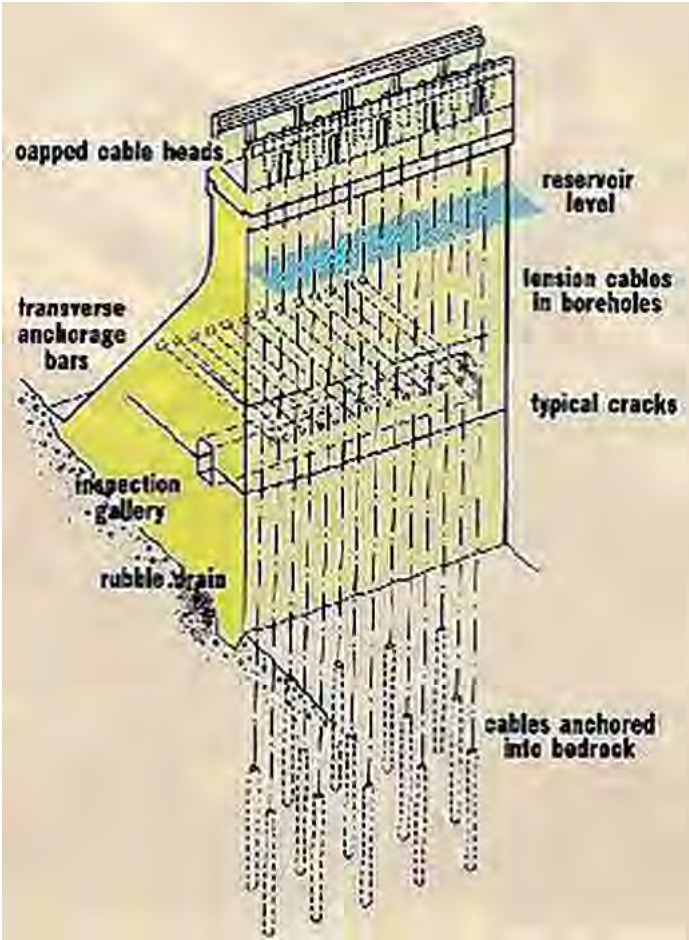
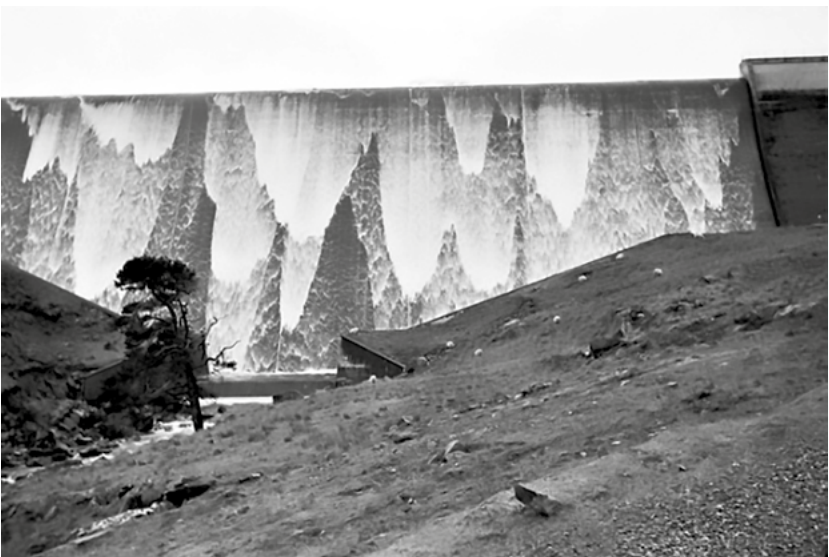
On July 4, 1986, it was reported that leakage into the longitudinal gallery had increased from 0.16 l/s to 5.2 l/s. Pre-existing nearly horizontal cracks in the gallery walls were found to have opened as much as 1.5 mm. This was mainly evident in the two blocks extending about

The reservoir level was lowered to seven meters below top water level. Existing instrumentation was monitored twice daily, and the results were assessed. Three-dimensional modelling showed the observed pattern of cracking to be consistent with a build-up of longitudinal compressive stress within the structure, leading to downstream tilting of the central buttress under high temperature loads. The build-up of compressive stress was thought to be the result of progressive deposition of calcium carbonate in the vertical construction joints resisting thermal expansion and closure of the valley sides.

After examining several options, it was decided to post-tension the four central blocks of the dam, to improve stability against overturning, and to hold the cracks closed under all foreseeable loading conditions. The most severe being that of high temperature and valley closure movements. Twenty-six vertical tendons were installed. The tendons were provided with double corrosion protection and were re-stressable and fully detensionable. Transverse tendons were also installed to counteract induced tension on the roof of the inspection gallery.

The layout of the post-tensioning is shown above

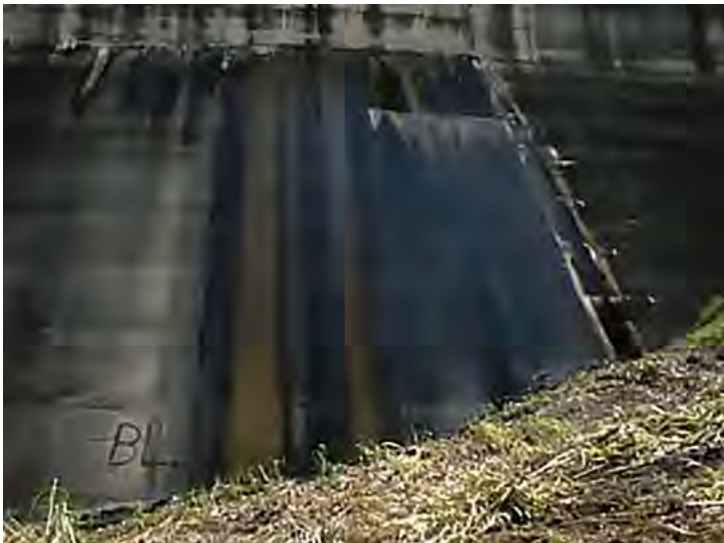
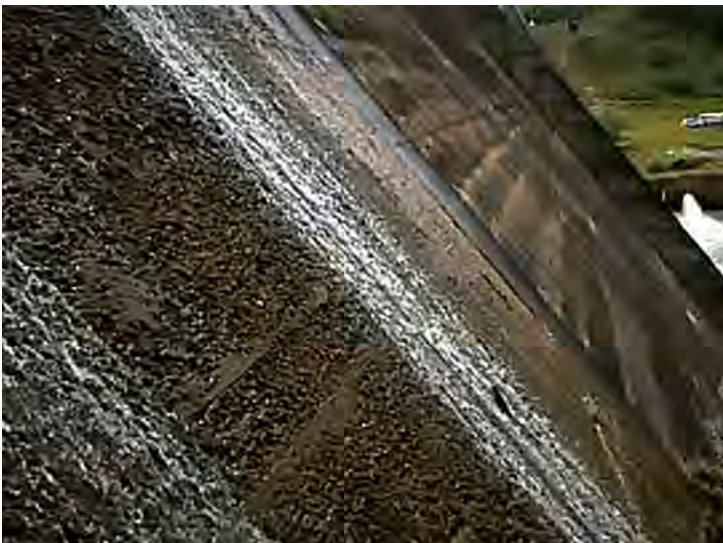
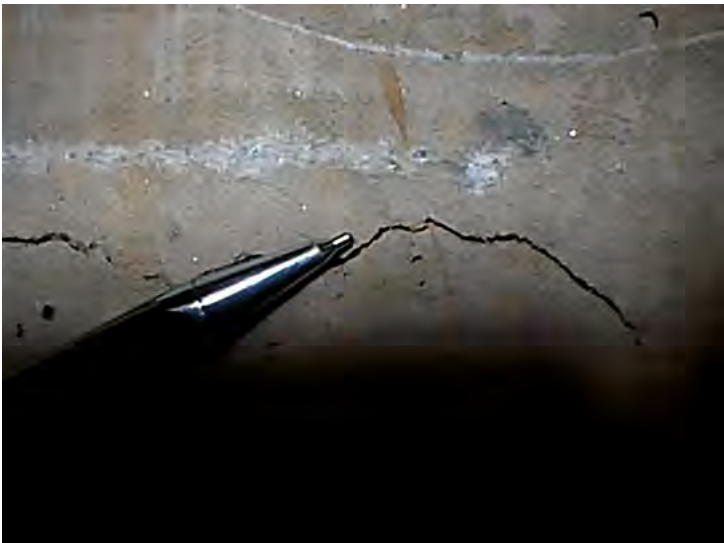
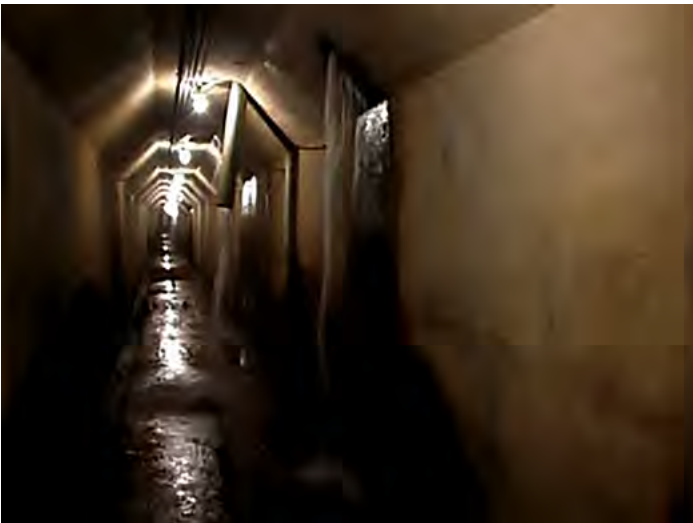
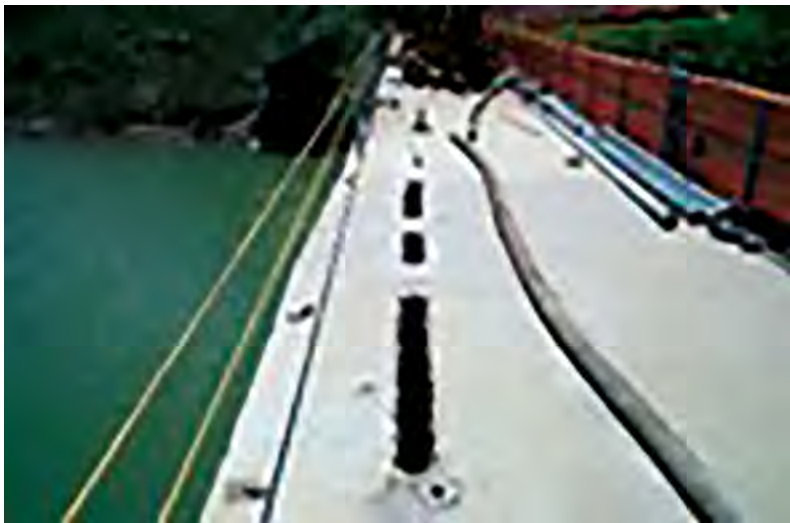
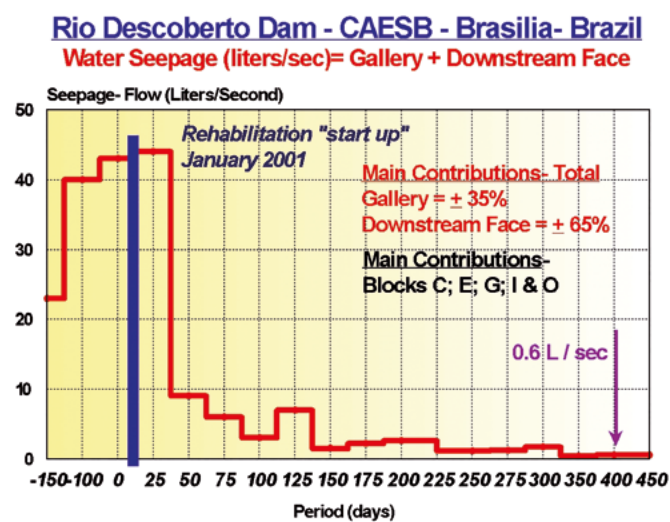
The consequences of pyrite composed concrete aggregate was known by the Descoberto Dam designers by the time of construction, but the pale local experience with that kind of problems allowed the use of a low-level pyrite concrete aggregate in this construction work. From that time, until the performance of this project in 2000, the water leakage increased strongly, becoming long horizontal leaching planes across the dam section.

At that time, it was constituted a Consultant Committee that ordered the collect of samples of inner inspection gallery drains sediment, dam’s concrete, and reservoir and drain water analyses. Those analyses indicated the presence of pyrite on the concrete aggregate and foundations. The combination of the presence of that mineral with the action of acidic (pure) water, was contributing to the degeneration of the concrete structure of the Descoberto Dam. The main pathologies observed were pyrite reactions. The best solution was to implant a waterproof barrier, avoiding the contact between the reservoir water and the body of the dam.

With the execution of the diaphragm the seepage was reduced. Currently (years 2019-2020) there are news that the small seepage has increased was observed again

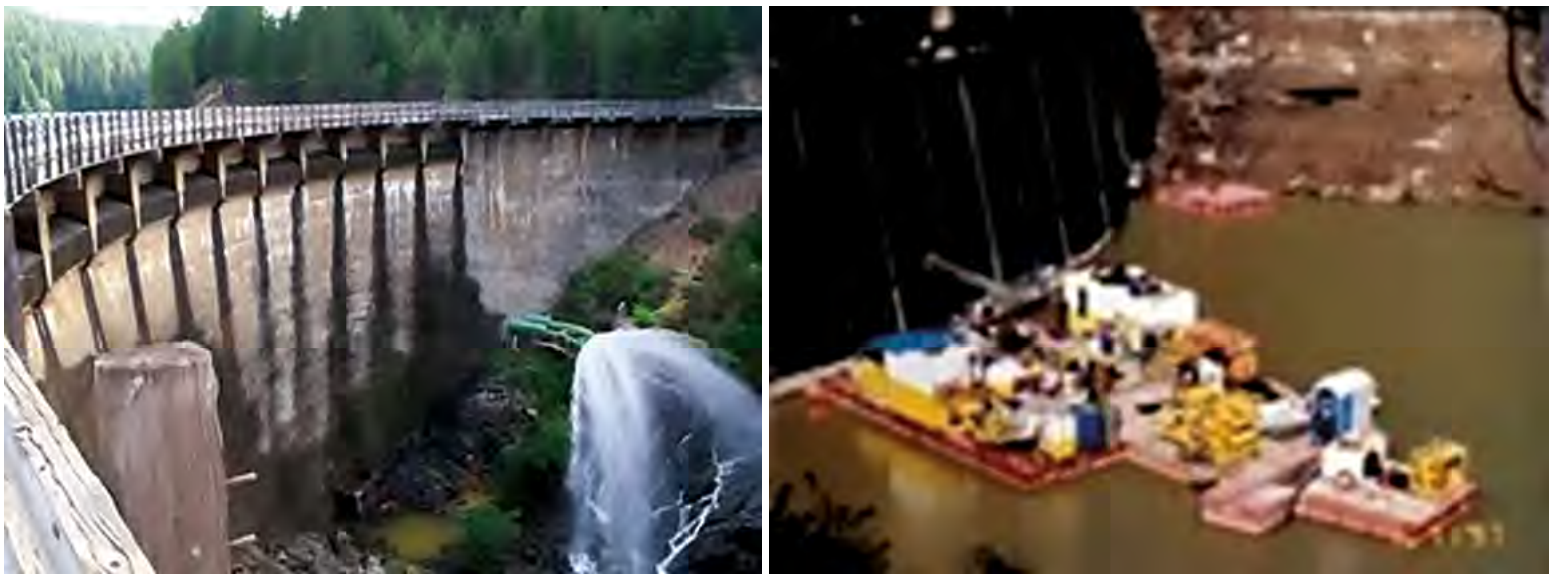
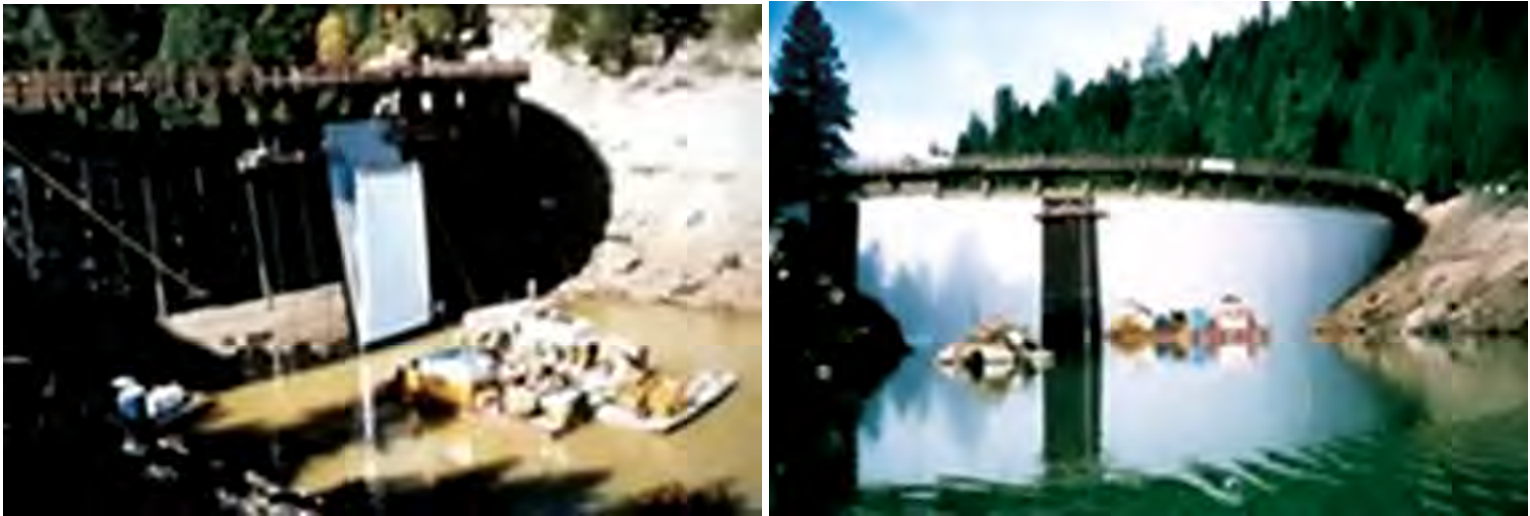
The Lost Creek Dam is an arch gravity dam whose reservoir cannot be emptied. The permeability of the concrete, and the consequent deterioration as a result of alternate freezing and thawing, resulted in progressive loss of concrete and decreasing strength of concrete at the downstream face. The stability of the dam was not an issue.

The installation underwater of an upstream PVC membrane system was the preferred option. To install internal profiles underwater, divers worked from swing platforms that were controlled from a materials barge. They used grid lines as guides to ensure the internal profiles were installed in a perfect vertical line. Gasket material was placed on the installed vertical profiles to provide a watertight seal at the membrane joints.

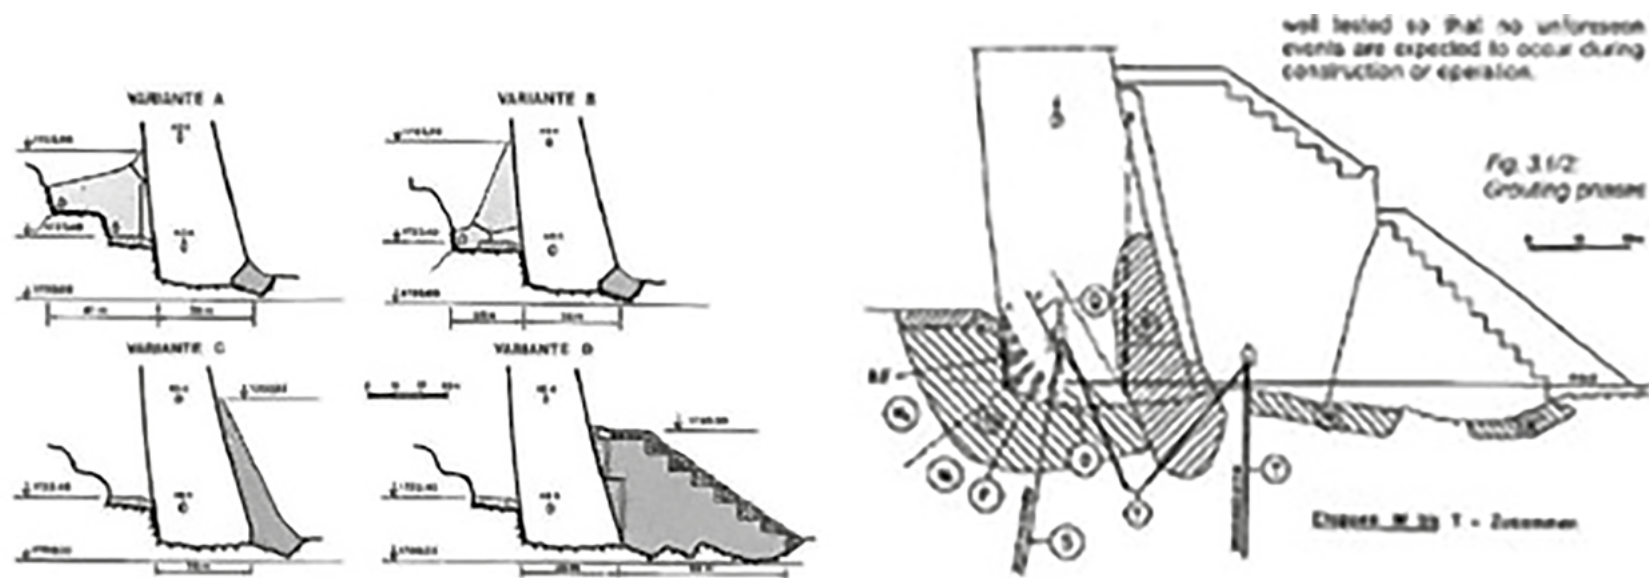
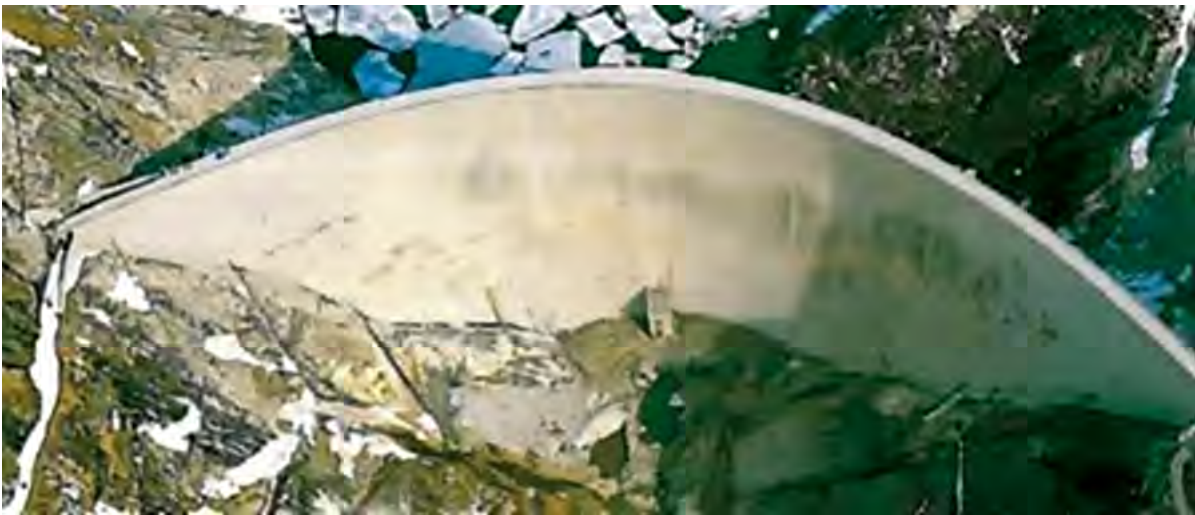
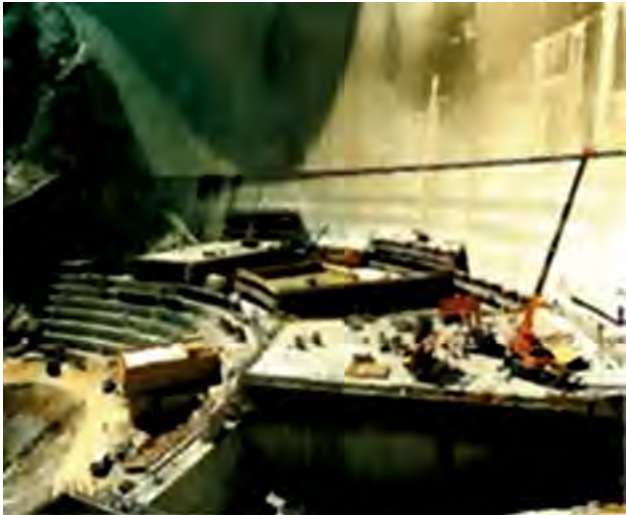
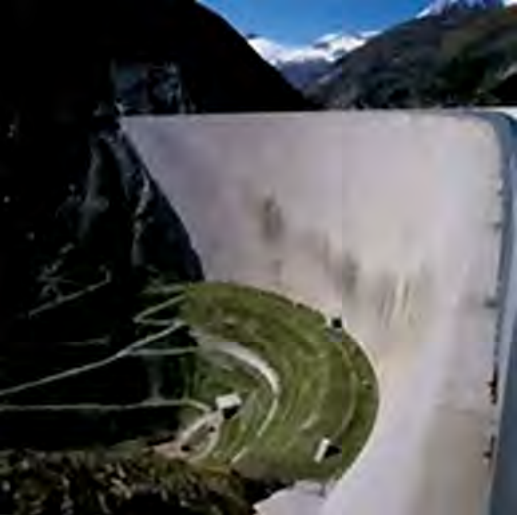
On first filling in 1978, when the reservoir level reached 1890 m, 42 m below the normal full storage level, the seepage into the drains just above the base of the dam increased suddenly. *The cause was considered to be a new set of inclined cracks in the foundation rock*

running from elevation 1750 m downstream between the control gallery and base of the dam. The cracks were assumed to be a consequence of high shear stresses in the base of the slender dam.

The rehabilitation work began in 1989 and was finished successfully in 1994. The adopted solution was to install a 70 m high supporting block of concrete downstream of the dam. Its function is to support the lower third of the dam, but only when the water in the reservoir exceeds a certain level. It was therefore necessary to bring the two elements together only after a certain water load had been applied. The problem was solved by installing reinforced neoprene cushions at nine levels at concrete consoles. Each cushion was connected to a double steel wedge construction that could be calibrated in height from adits below and above their horizon.
