Is Your Dam Safe?

An281	Andriolo, Francisco Rodrigues; Moreira, José Eduardo
	Is Your Dam Safe? – Vol. 1 / authors: Francisco Rodrigues Andriolo e José Eduardo Moreira. São Carlos, 2022.
	1394 p. il. color
	ISBN – 978-65-5668-011-8
	DOI – http://dx.doi.org/10.26626/9786556680118/2022B001
	1. Dams. 2. Training. 3. Quality. 4. Repairs. 5.Controls. 6. Cement. I. Orgs. II. Title.
	CDD 370

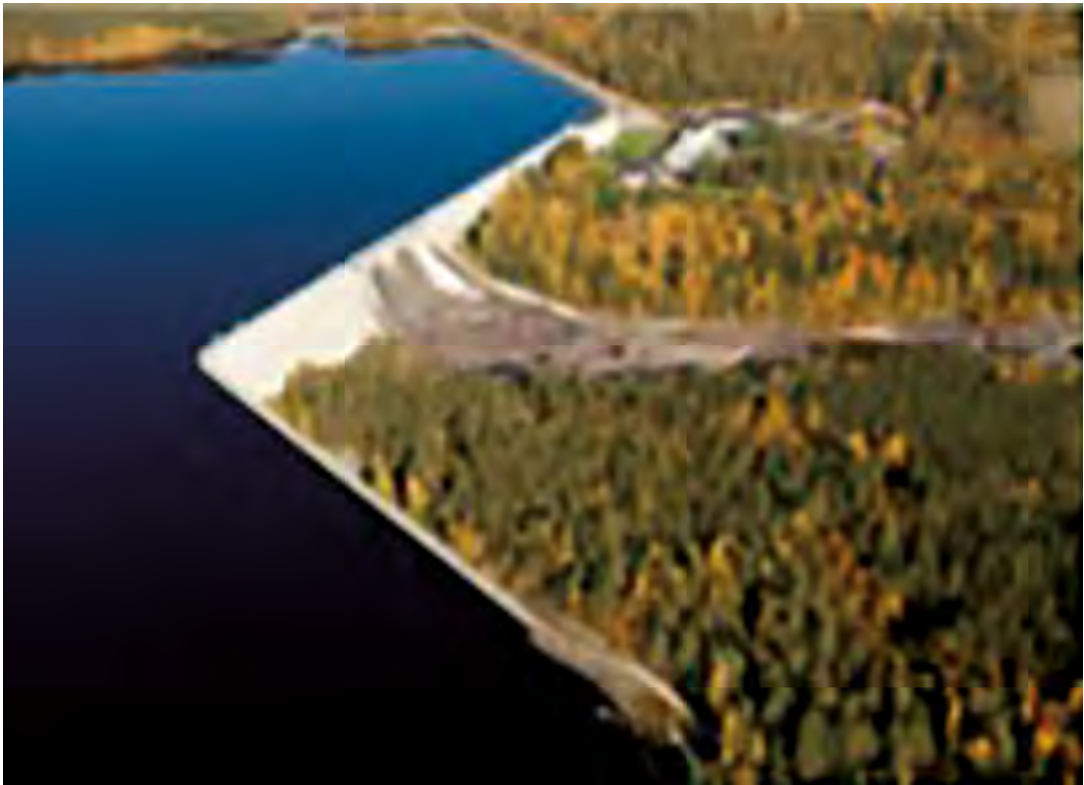
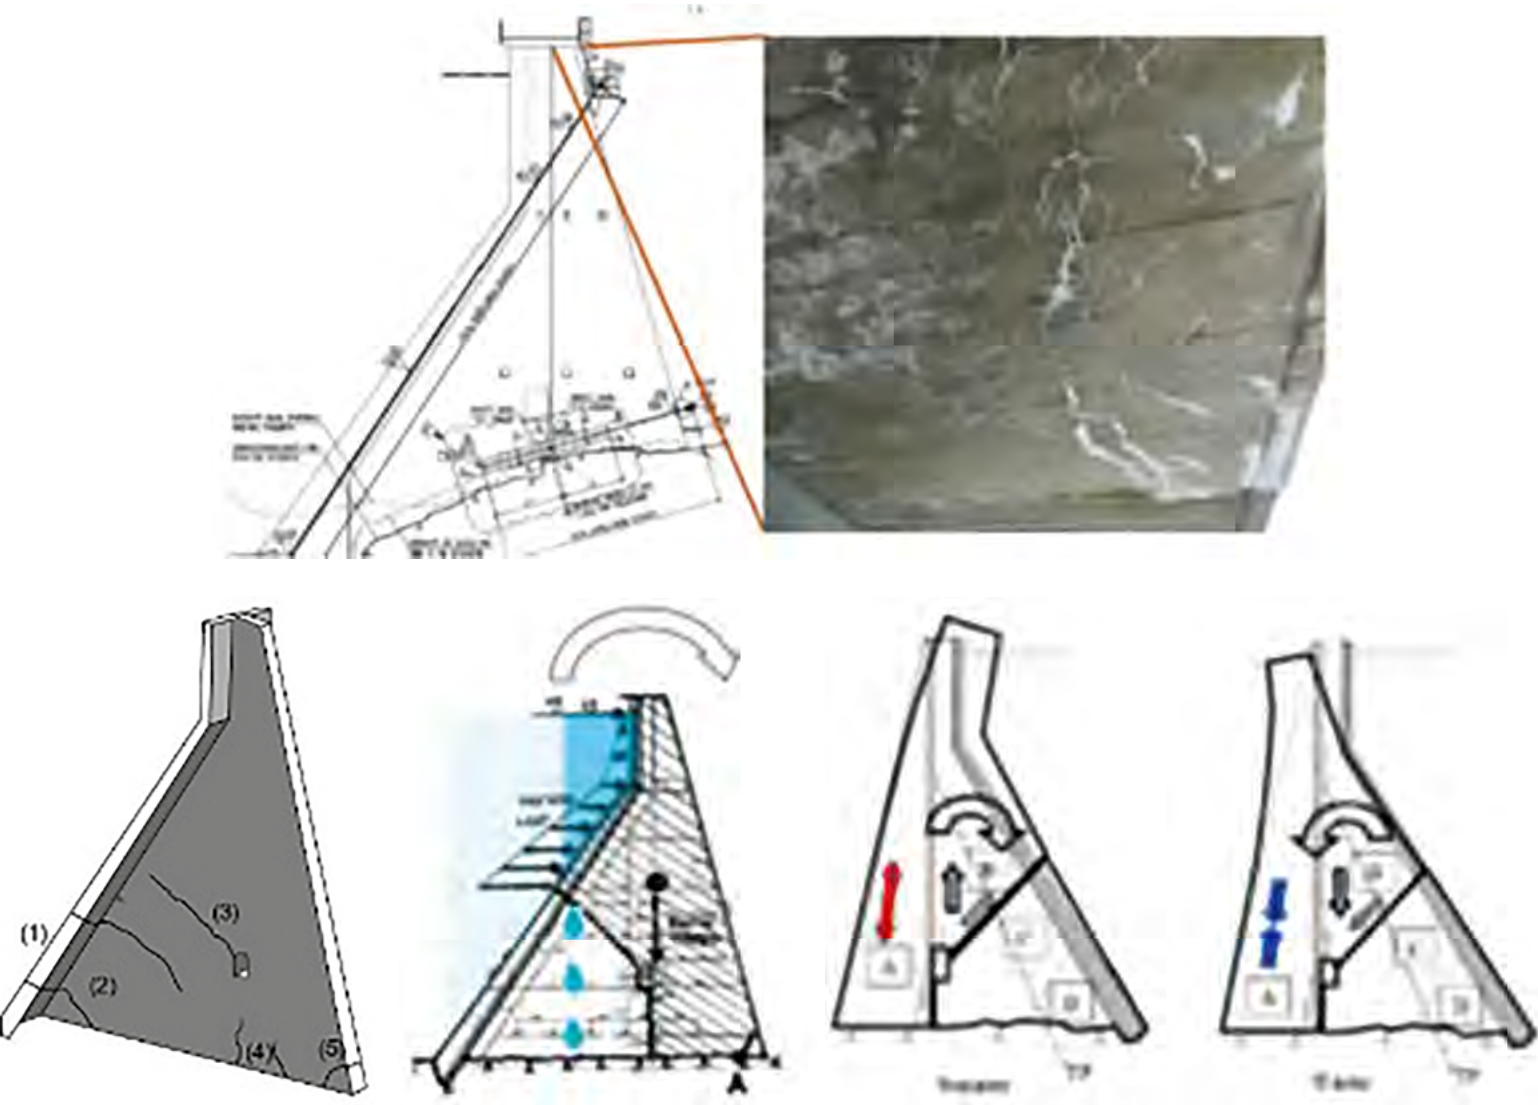
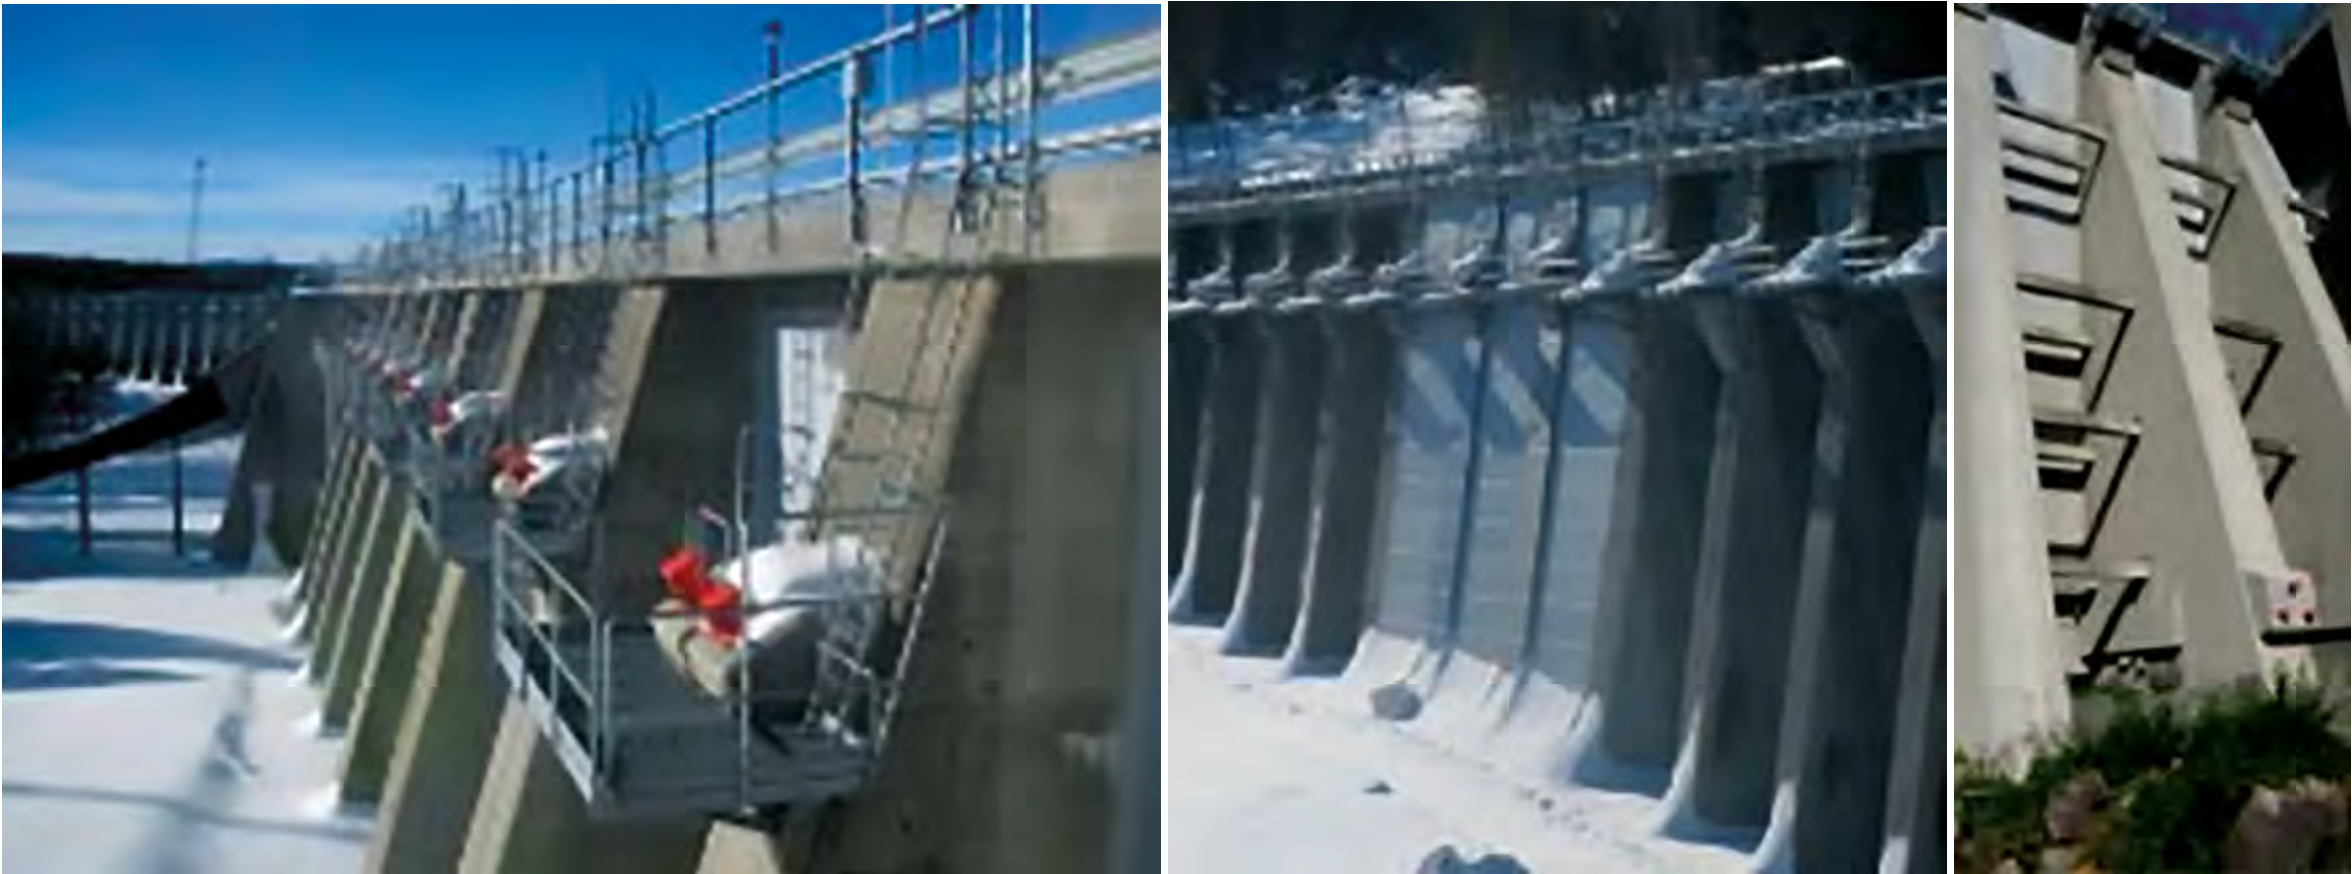
A few years after completion, *horizontal cracks were found in the lower parts of the front-plates and freeze-thaw damage was detected on the upstream side of the front-plates*. This resulted in a structural rehabilitation program where cracks were grouted and an insulating wall was installed to reduce the thermal gradient over the thickness of the front-plate. The program consisted of moving the insulating walls, improving the stability with ground anchorage tendons, strengthening the front-plates and, in addition, to widen the road on the dam crest to allow for heavy traffic.

Post-tensioned anchors were the practical and cost-effective method of strengthening the dam. They were used to stabilize the concrete and to combat the effects of alkaline and aggregate reaction. The post-tensioning technique requires minimum demolition, has only a minor impact on the dam, and was relatively inexpensive using a small number of anchors.

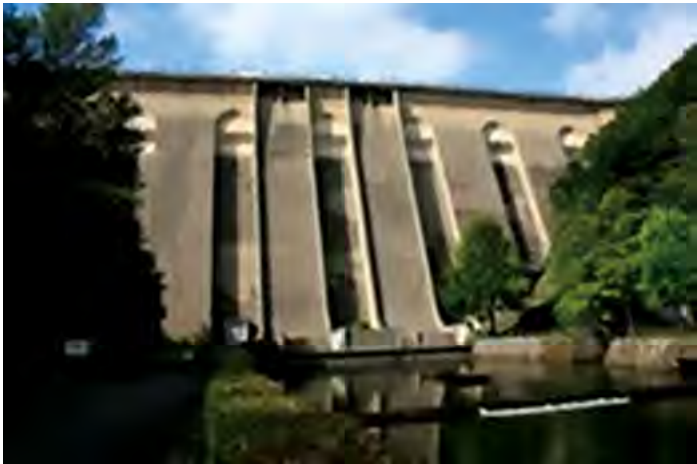
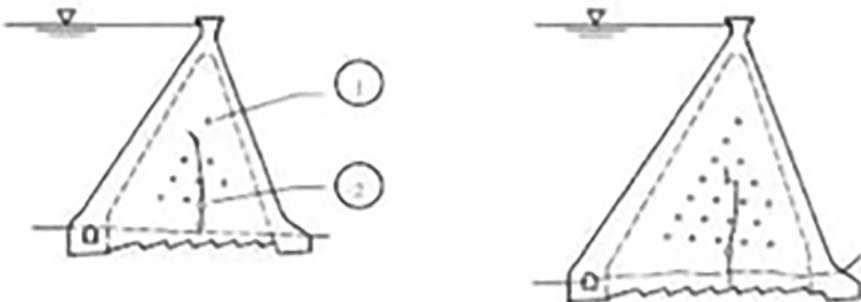
Fig. 3.3.4
Olef Dam. Typical crack pattern in the buttresses
1. Air circulation holes
2. Access hole

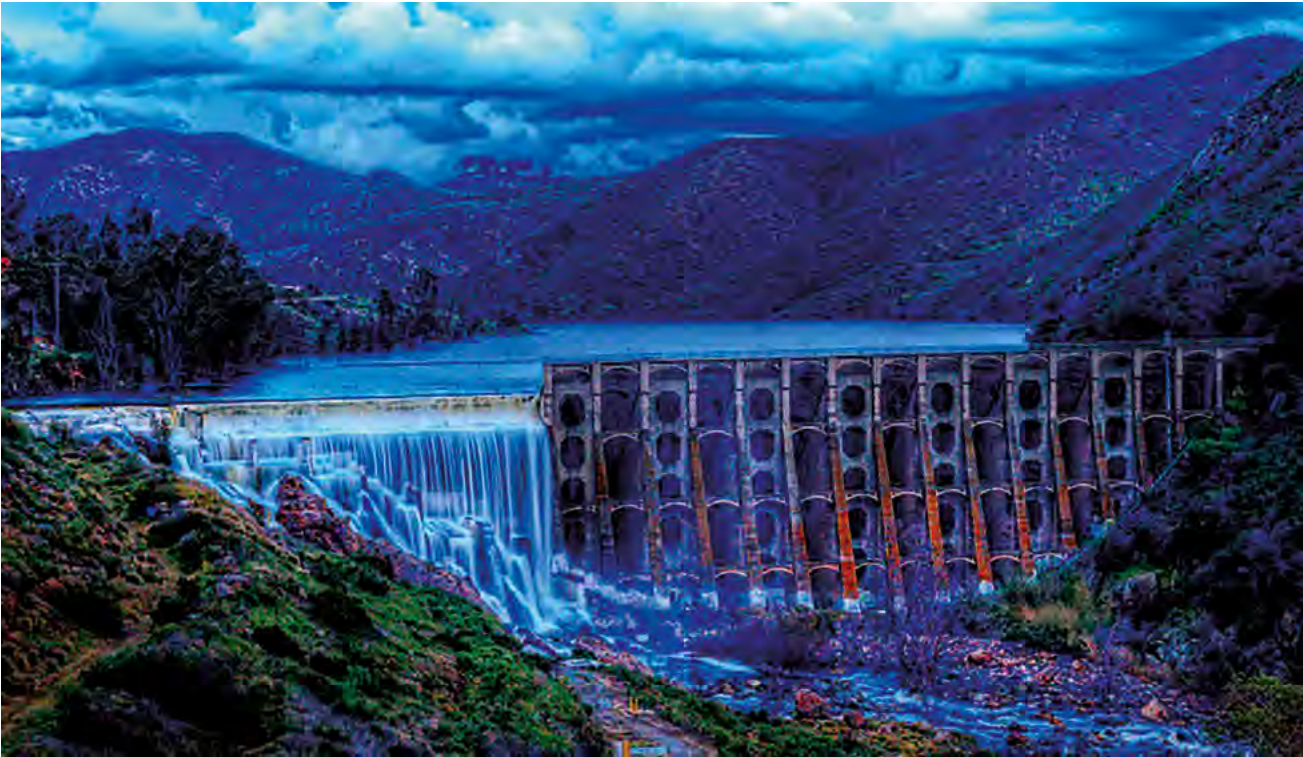
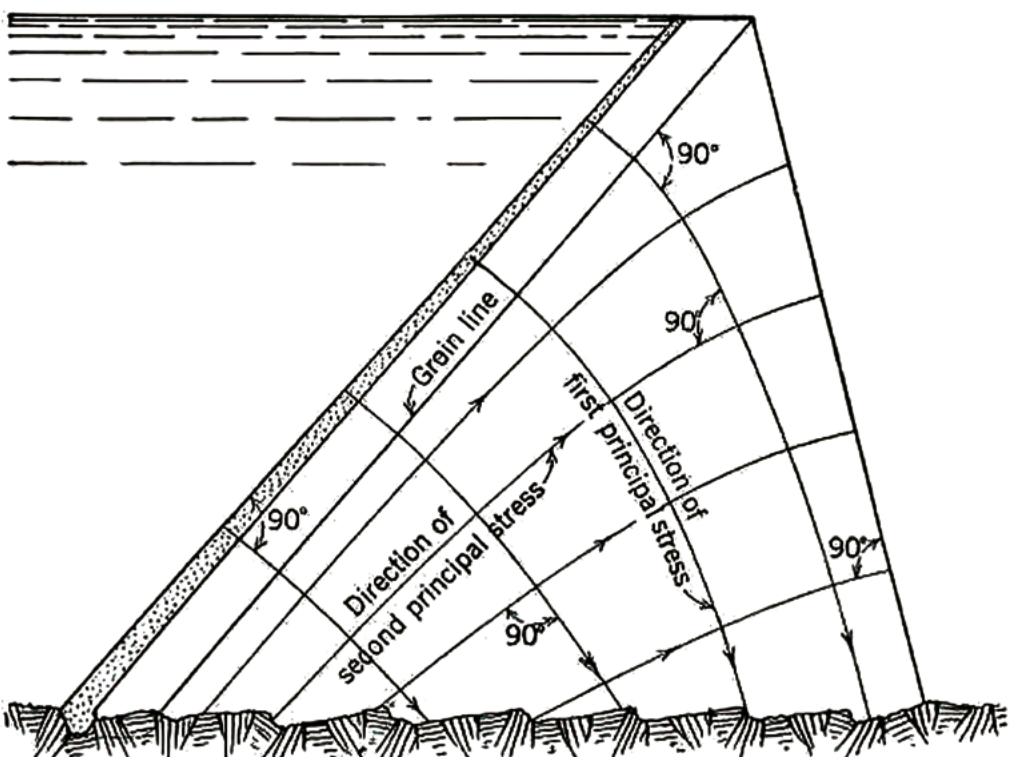
The buttress supports developed cracks parallel to the minimum stress trajectories. *A professional debate erupted as to the cause of these cracks, being induced tension, or caused by shrinkage of the concrete. This cracking problem was not explained until after instrumentation and study of similar cracks in Rodriguez Dam in 1929, by Fred Noetzli, Hubert Woods, and Roy Carlson.*

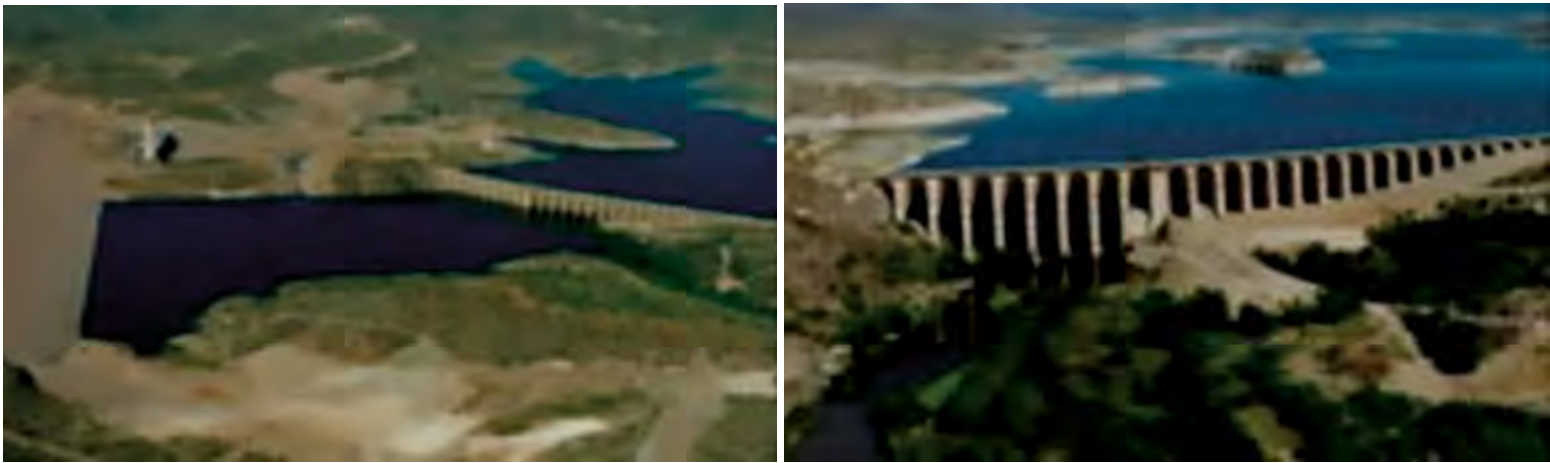
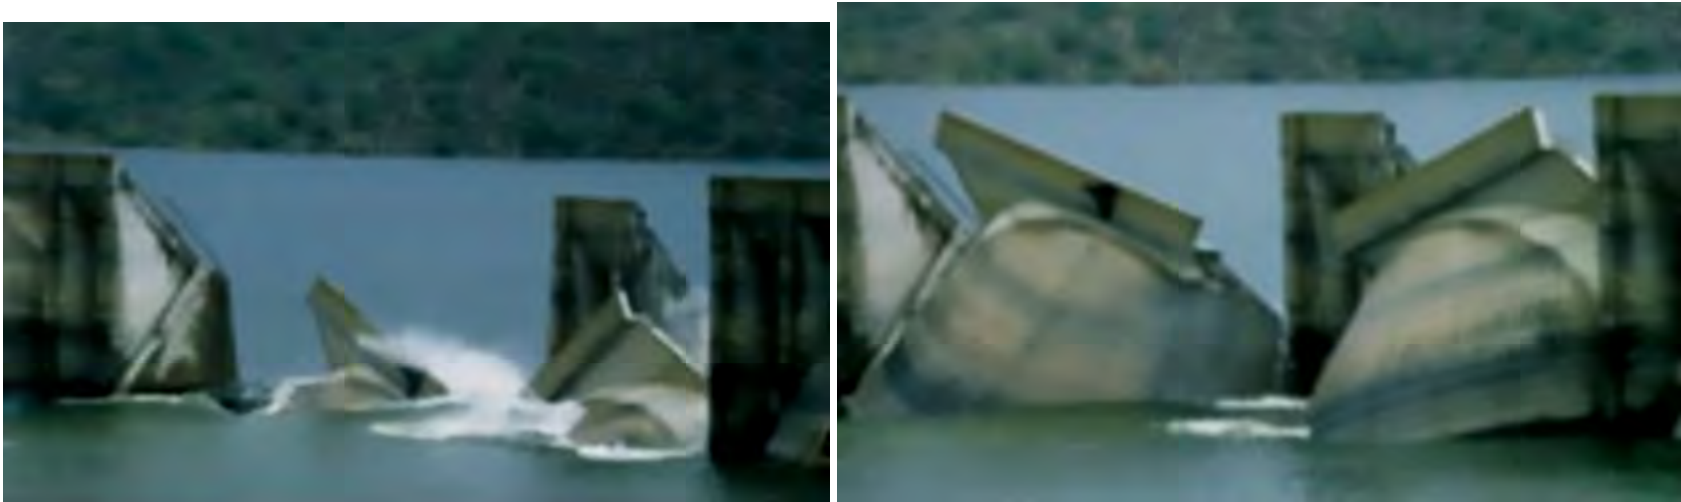
It was required that Waddell Dam be breached to ensure access to the full reservoir pool at New Waddell Dam and to provide access for boat traffic to a marina located between the two dams. It was decided to create a channel through the existing dam that would be large enough to pass flood flows with minimum restriction and would also be large enough and deep enough to allow for boat traffic at minimum reservoir level. The required breach through the dam was 68 m wide and 21 m deep.

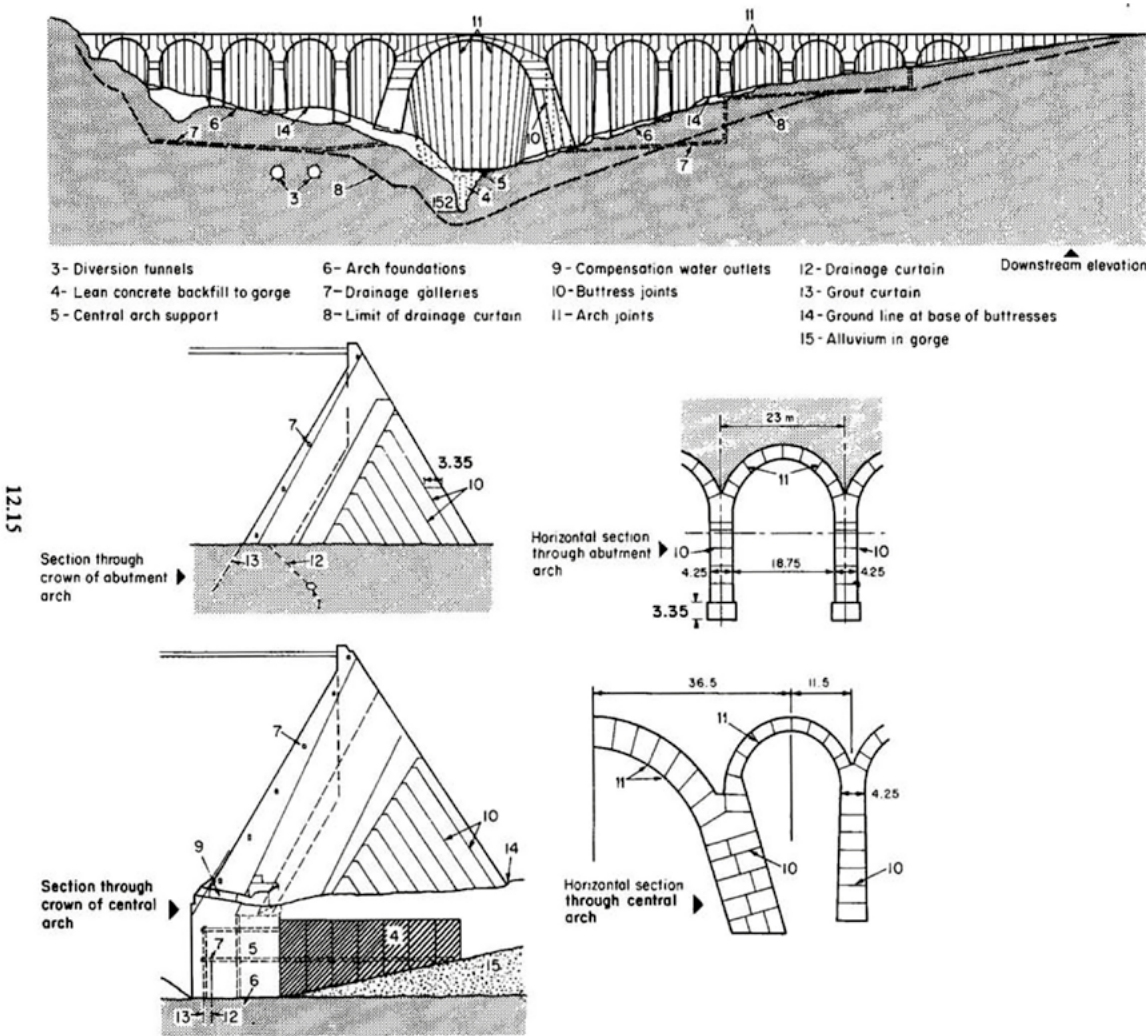
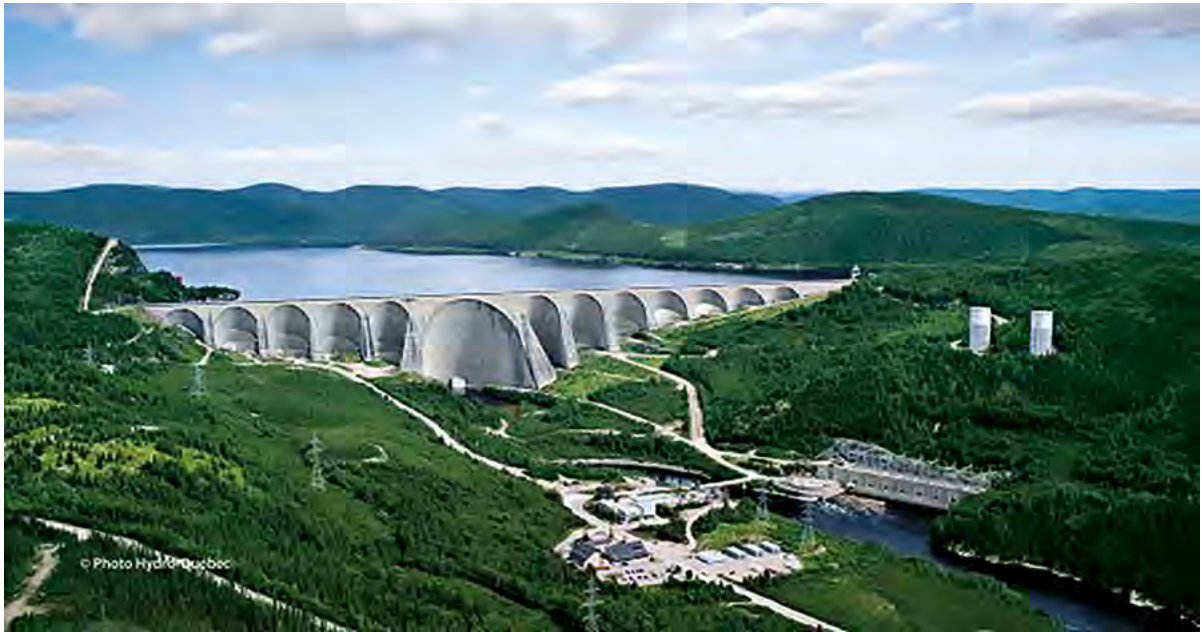
In 1997, as a result of the progress of the structural analysis studies and the injection research project, a decision was made to proceed with the injection of the dam. ***For twenty years, leakage marks have appeared on the downstream buttresses, and also some degradation of the concrete due to freeze-thaw cycles along the vertical joints were observed.*** This situation led to replace the joint sealing for enhancing the watertightness and appearance of the downstream face of the dam. So, a new and more effective solution was required to restore the watertightness and appearance of the joints.

The solution chosen in 2008, was to use a flexible waterproofing sheet geomembrane system to stop infiltration and freeze-thaw action affecting the buttresses. The solution developed to reduce freeze-thaw damage on the downstream buttresses of the dam consists of external waterstop over the vertical joints in the upper part of the downstream face. The waterproofing system used for the dam consists of:

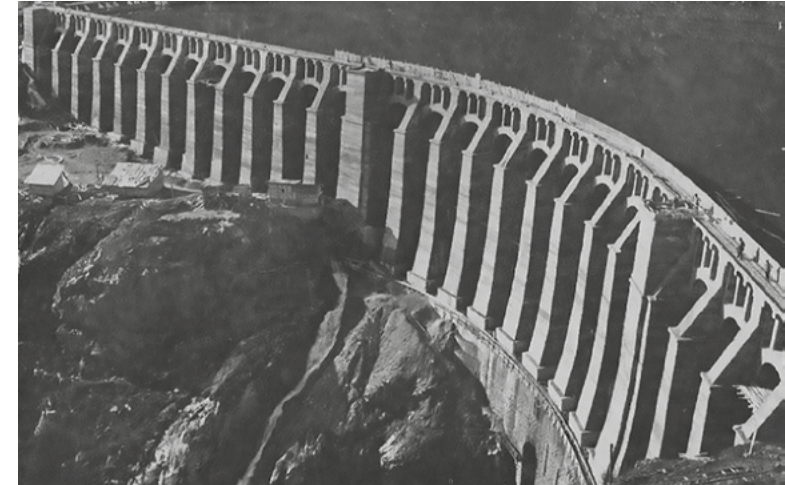
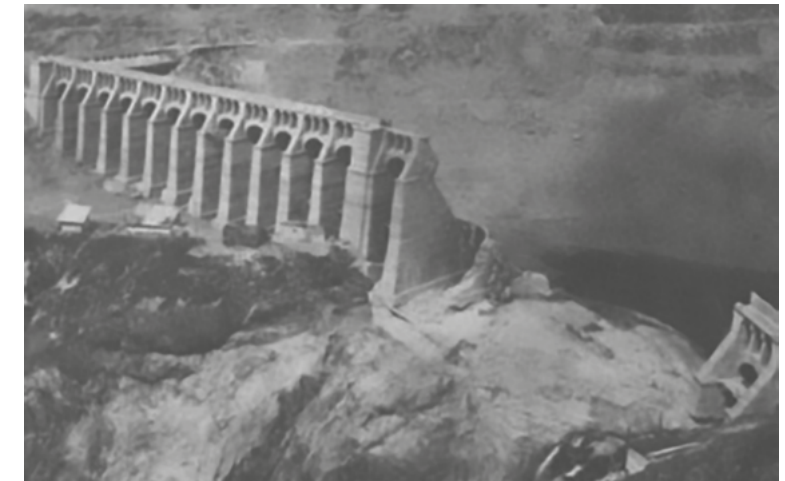
As reported, the cause of the failure was well defined by the engineers who first observed the Gleno structure: the work had been badly executed. The reinforced concrete part of the dam on the sides was placed directly on the rock surface, without being trenched into the rock. The masonry of the gravity base was made of lime mortar, whereas the specifications required cement mortar. The lime was burned near the site by the builders and transported to the dam by cableway. The gravel aggregate used in the concrete was

Gleno dam immediately before the filling and Gleno dam immediately after the failure

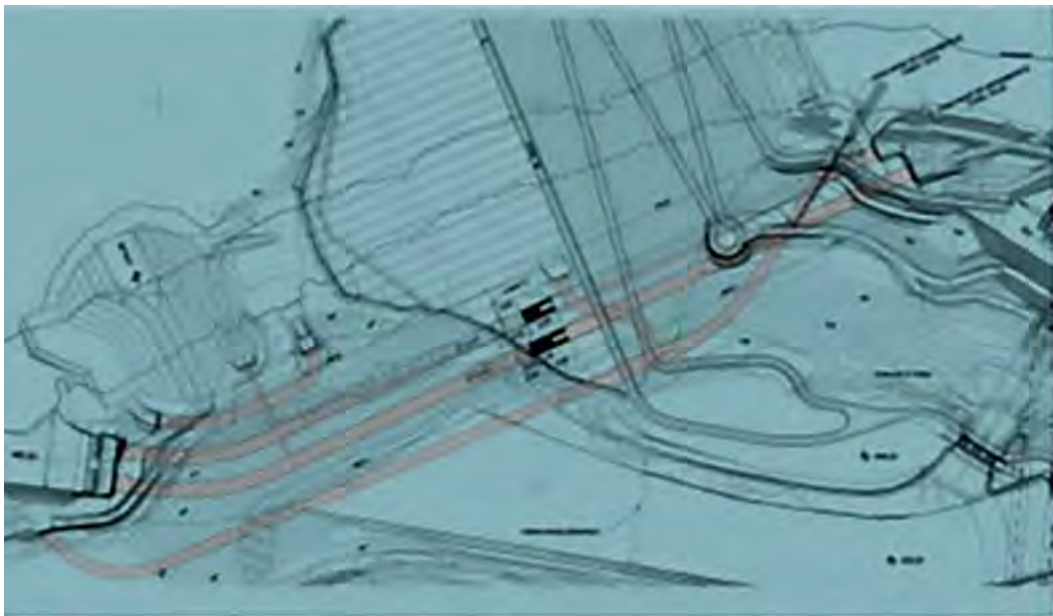
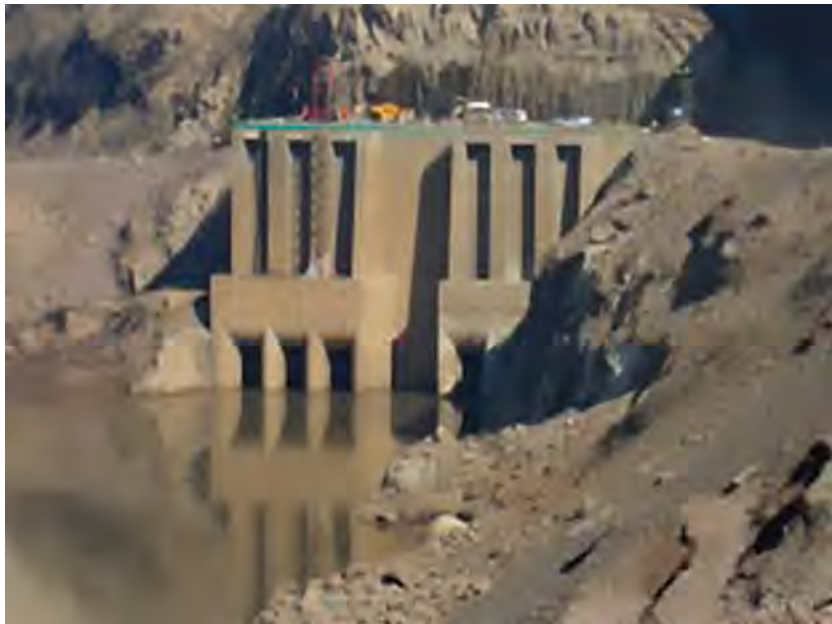
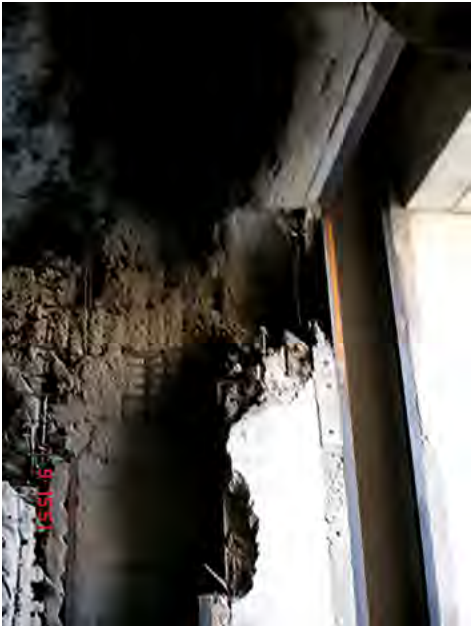
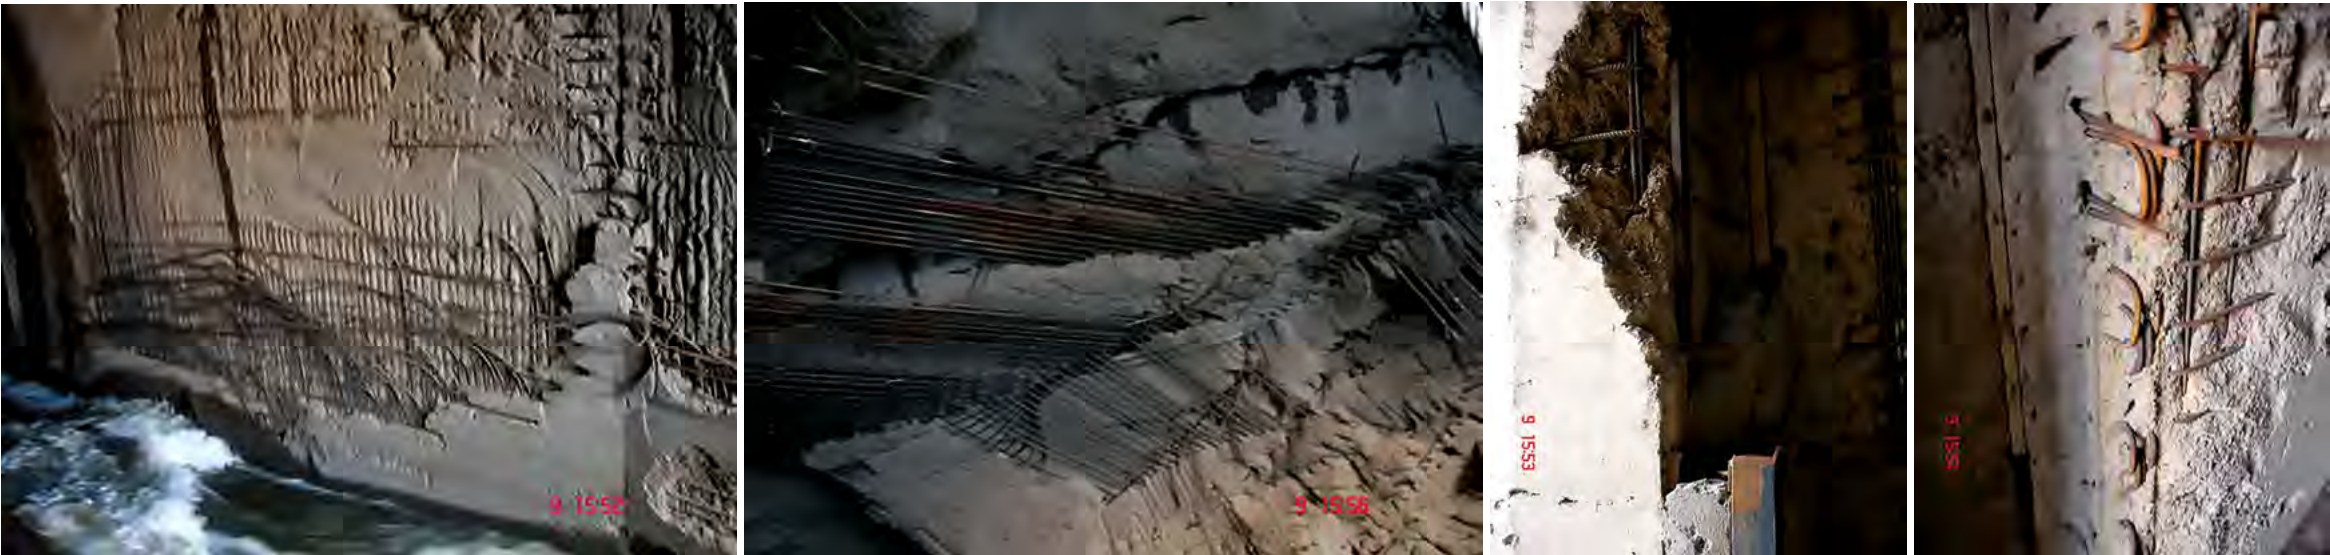
stage concrete members) in TD-01, which corresponds to the initial damage area in TD-02, manifests consistent crack patterns. ***They indicate incipient structural failure and provide the most significant and reliable evidence for the investigation.***

The concrete defects in the first stage concrete, second stage concrete, and the construction joints had significant contributions to the failure and final collapse of the TD-02. The evidence shows that the construction joints in the edge members were poorly constructed and

numerous voids and honeycombs existed in the concrete. The concrete defects facilitated penetration of water into the concrete and probably contributed to a significant size of damage.

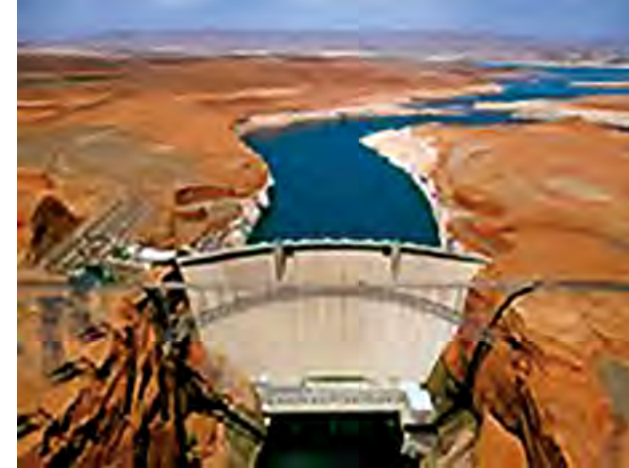
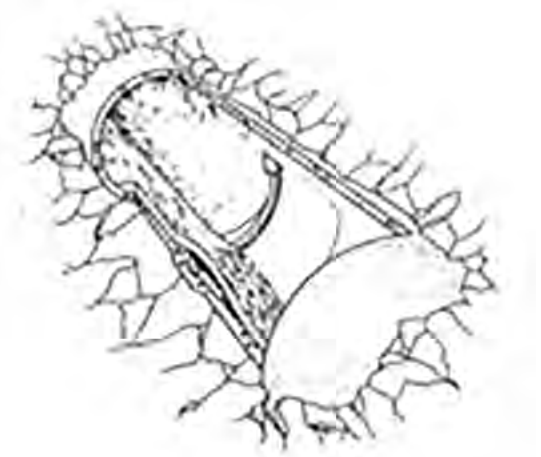
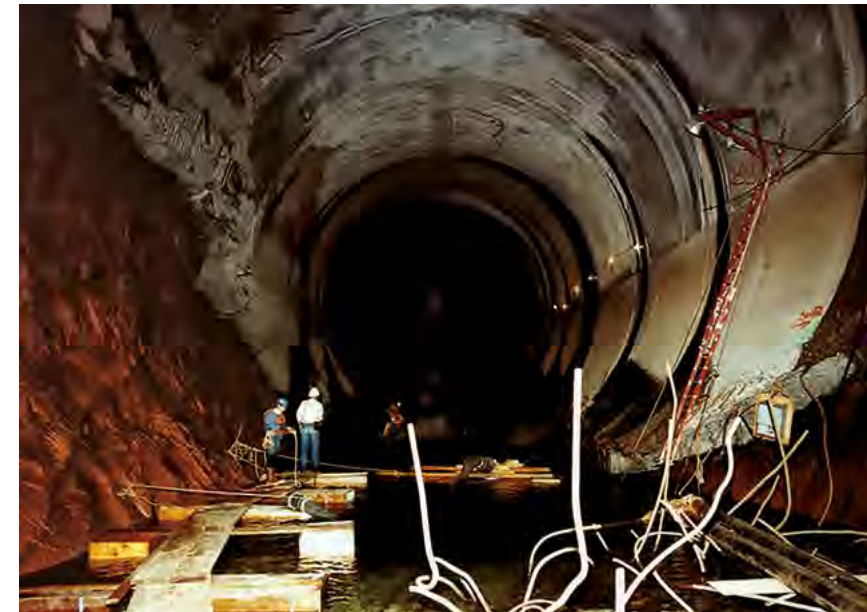
Bureau of Reclamation (BuRec) responded by reducing releases by half, however, the rumblings continued. The engineers soon closed the spillways for inspection crews who were lowered down the spillway tunnels and ***found that cavitation had severely damaged and eroded***

Repair work began with the removal of the entire tunnel lining, including sections that were not damaged, to improve safety, speed construction, and produce satisfactory, long-lasting results. Damaged and missing reinforcement was replaced. New reinforcement was manually welded to existing reinforcement in most cases. In areas where drainage water prevented welding, steel dowels were epoxied into drill holes in the liner and then wired to the existing reinforcing in a splicing technique.

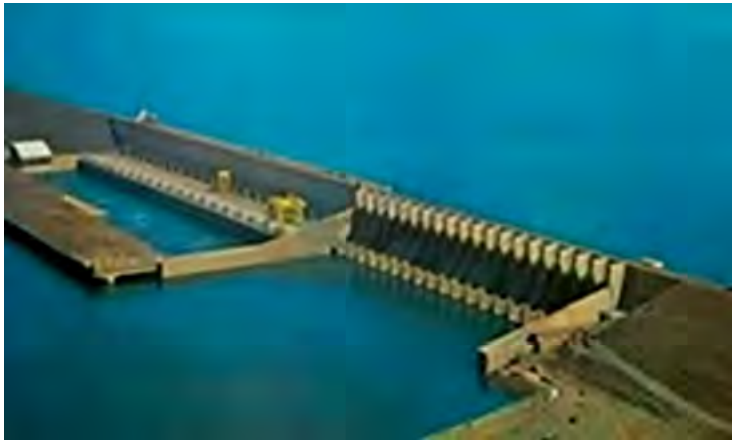
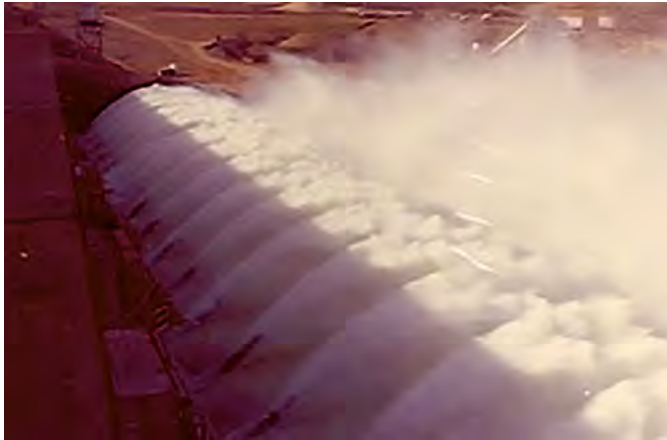
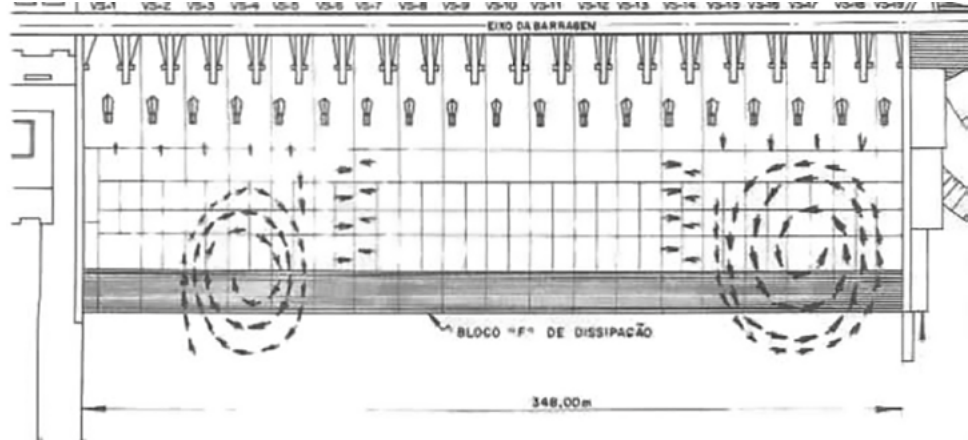
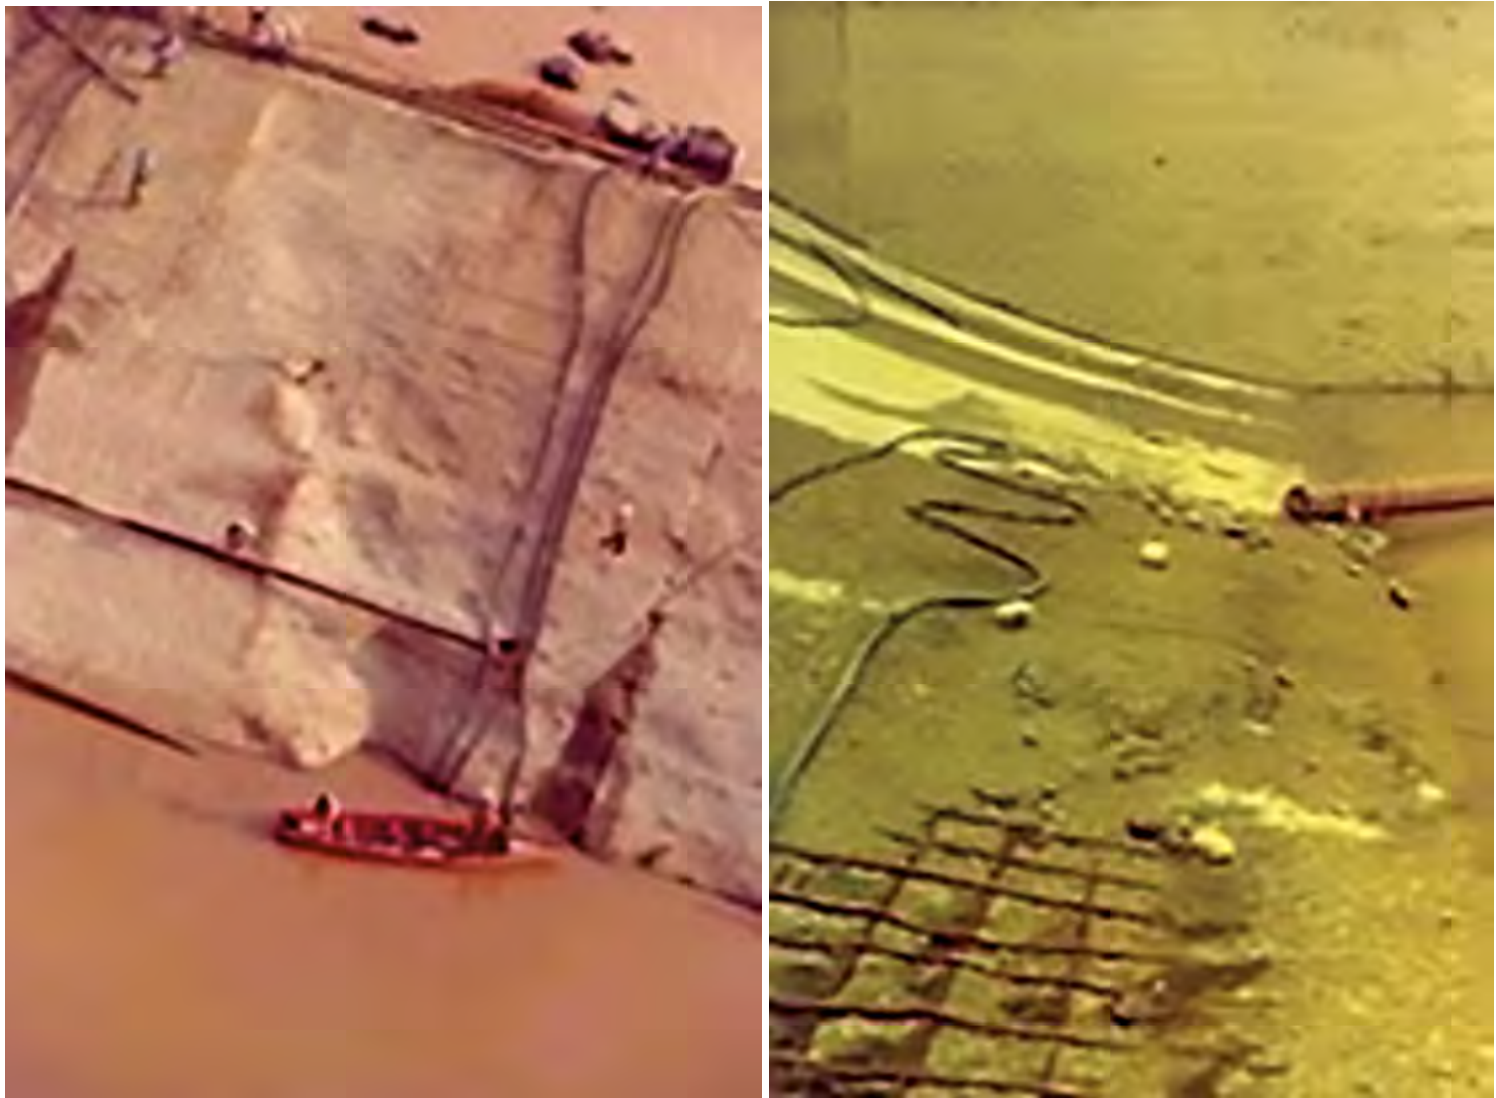
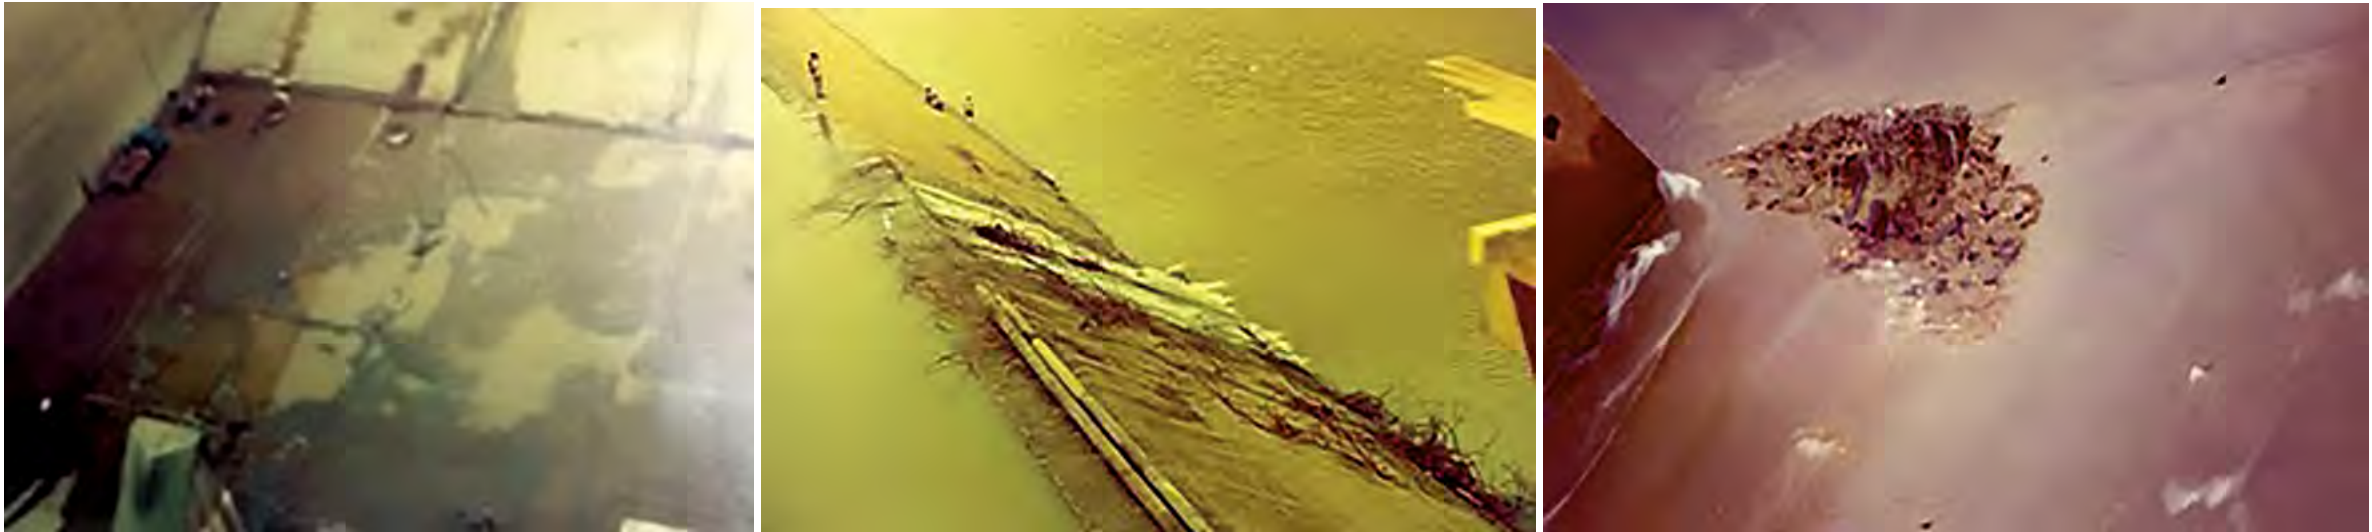
There was abrasion observed in the stilling basin because of the erosive action of the rock blocks carried from downstream into the basin next to the deflector teeth erosion due to cavitation. The following measures were taken: underwater concrete in the critical areas of the basin before a partial reducing of the reservoir level; study on hydraulic model; and repair of the eroded area with epoxy mortar and concrete.

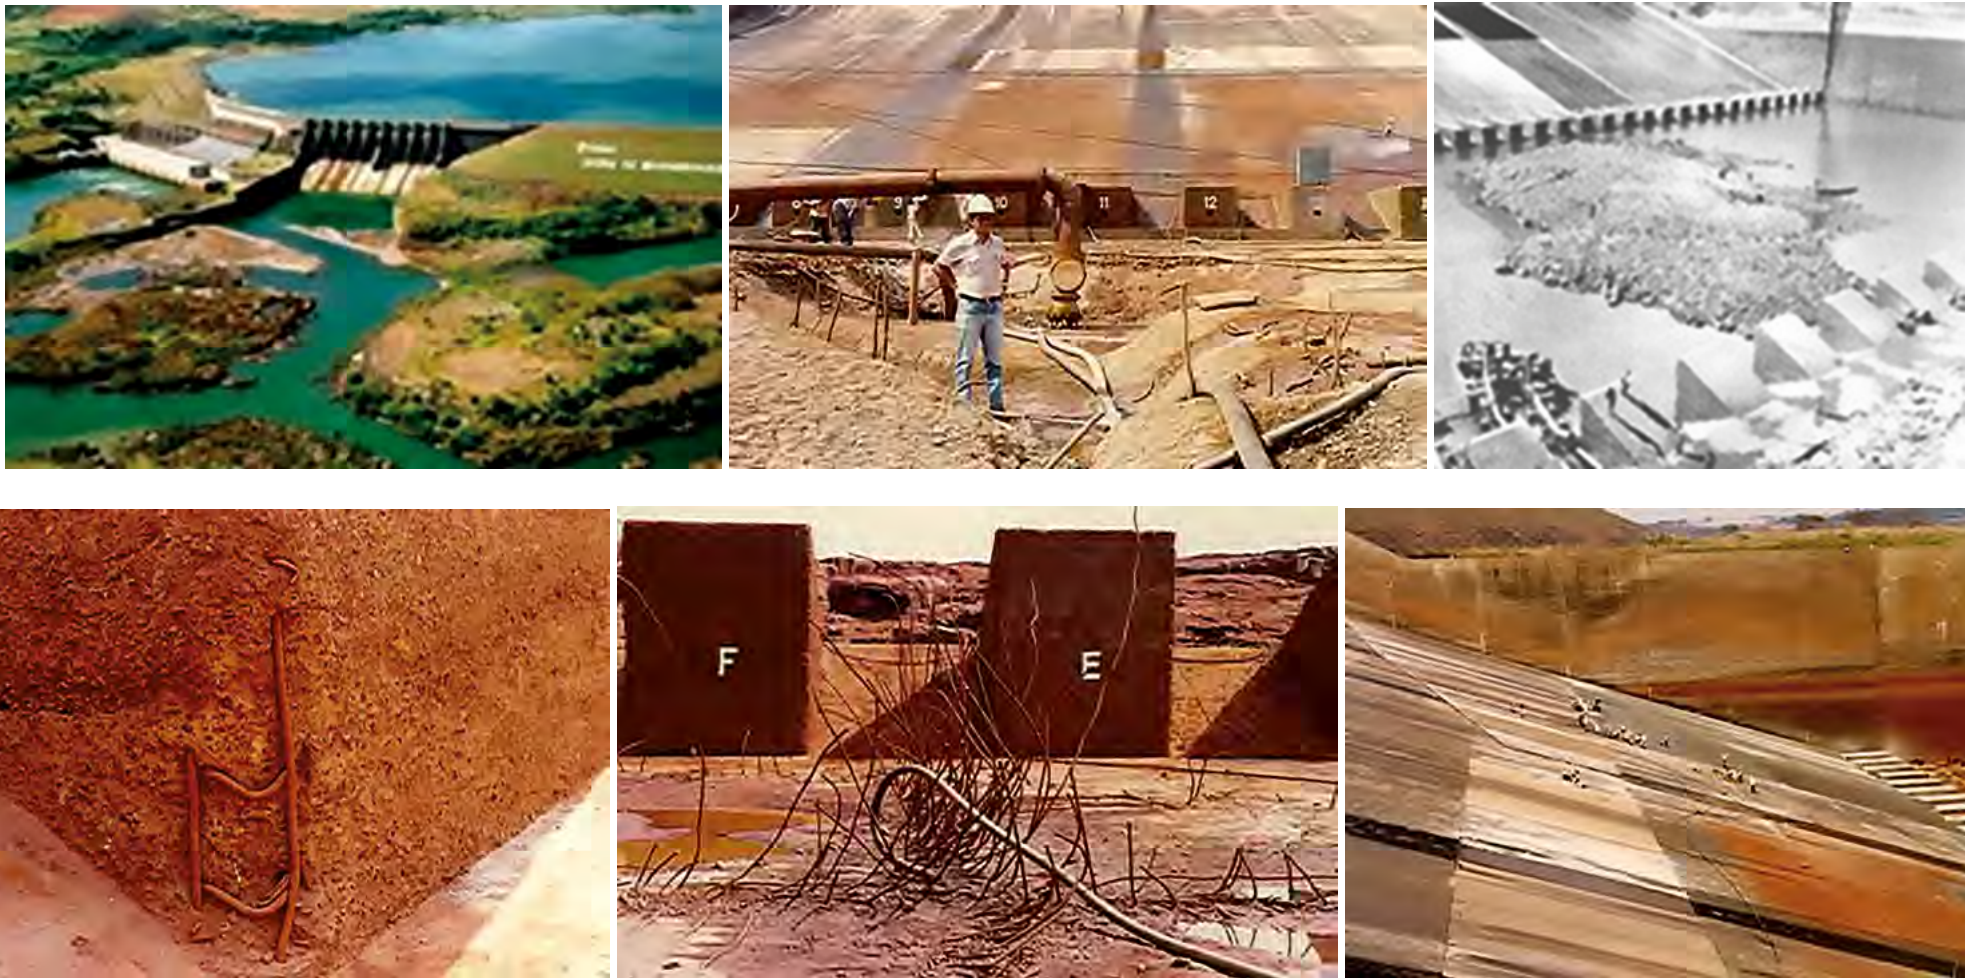
The stilling basin was dewatered in 1980, for the recovery of the eroded concrete. The horizontal bottom slab was with widespread erosion observing surface damage, reinforcement, and erosions. Spillway chute presented with gradual abrasion with no major wear compared to those seen in 1975 and 1978.
