Is Your Dam Safe?

An281	Andriolo, Francisco Rodrigues; Moreira, José Eduardo
	Is Your Dam Safe? – Vol. 1 / authors: Francisco Rodrigues Andriolo e José Eduardo Moreira. São Carlos, 2022.
	1394 p. il. color
	ISBN – 978-65-5668-011-8
	DOI – http://dx.doi.org/10.26626/9786556680118/2022B001
	1. Dams. 2. Training. 3. Quality. 4. Repairs. 5.Controls. 6. Cement. I. Orgs. II. Title.
	CDD 370

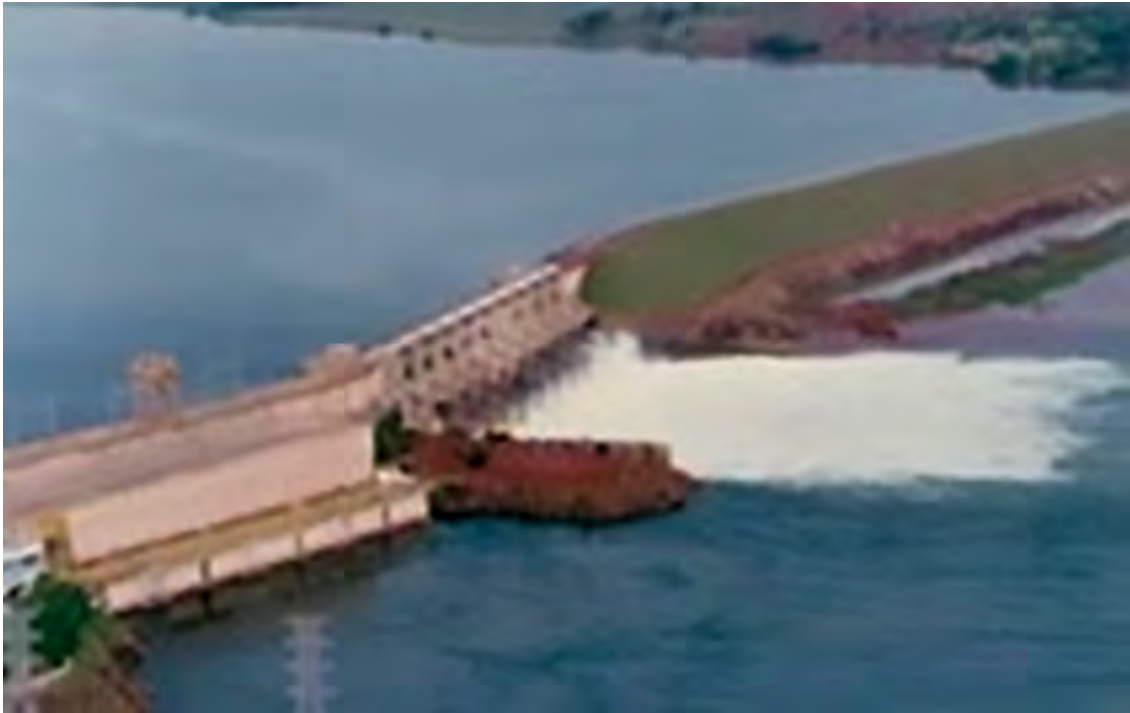
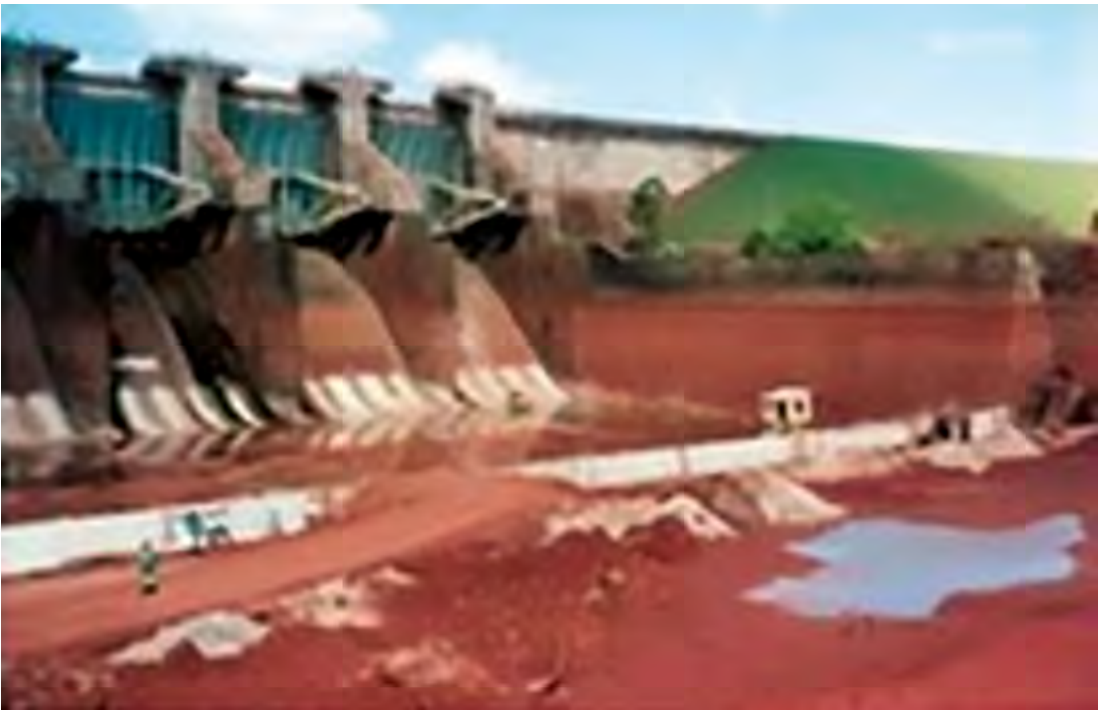
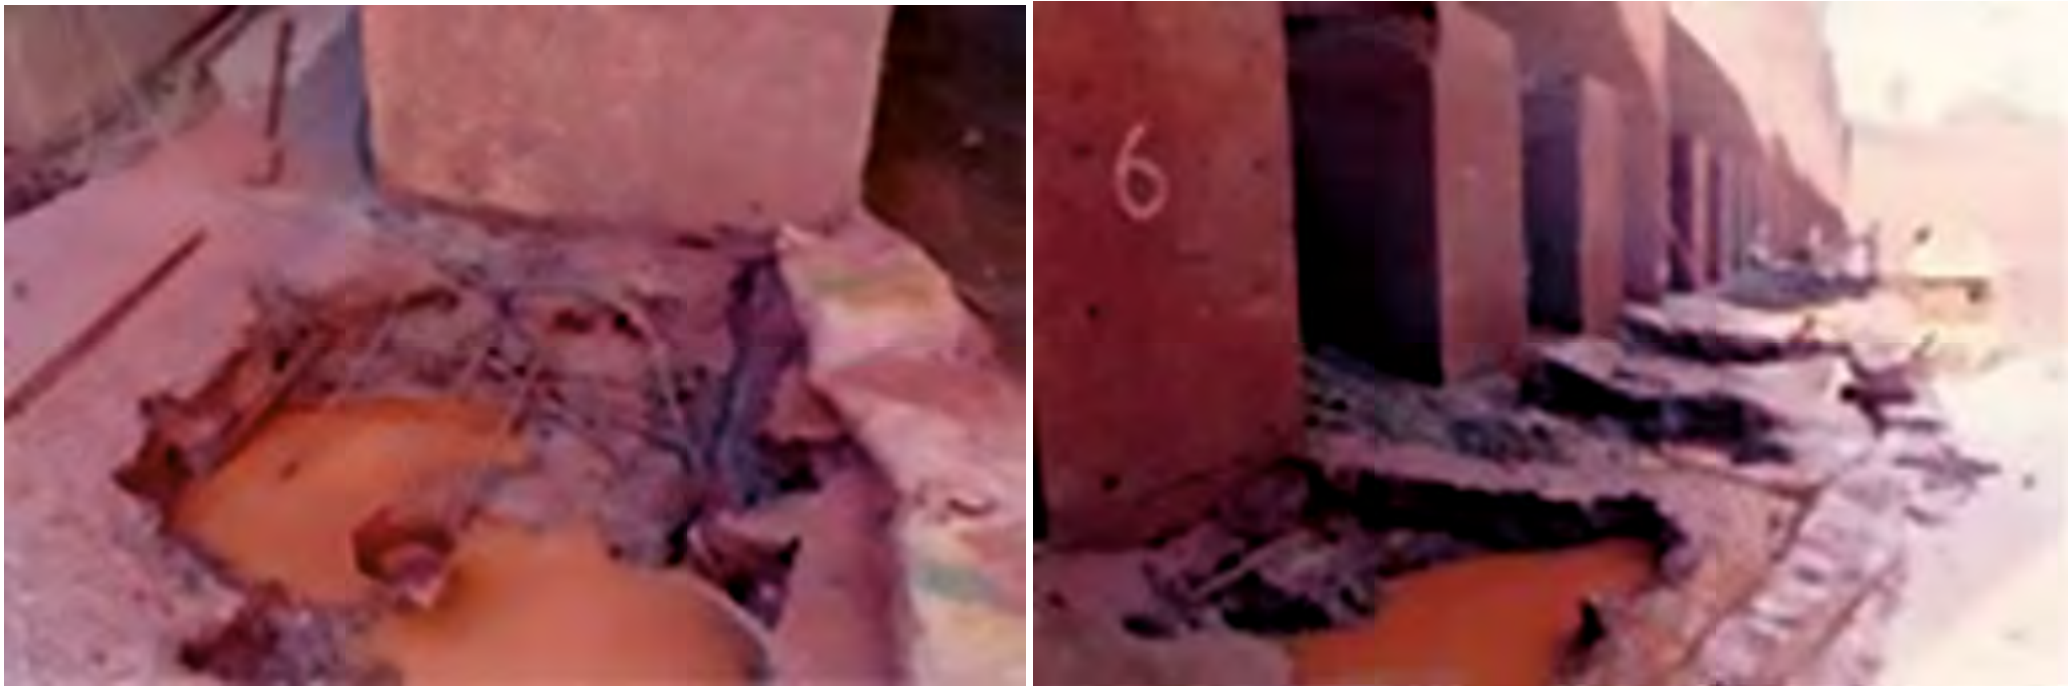
Erosion on surface of the blocks and slab of the spillway with the reinforcement exposed. The repair was performed with concrete and epoxy mortar.

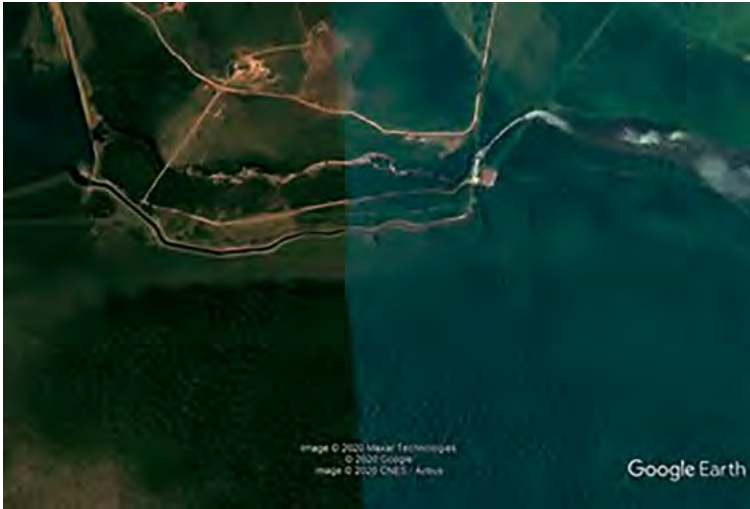
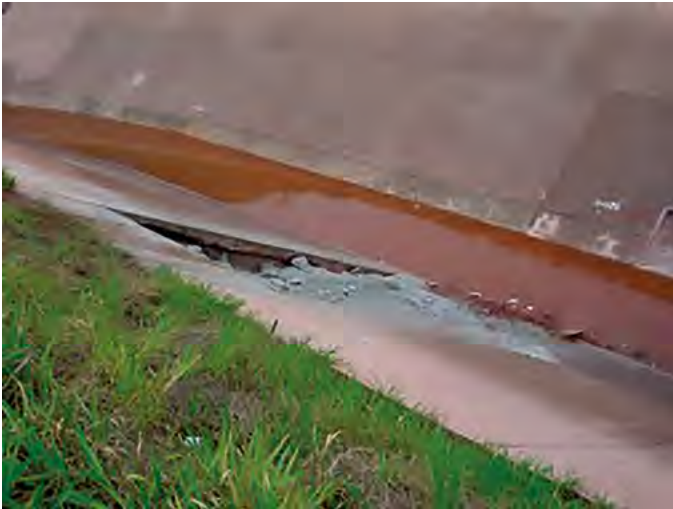
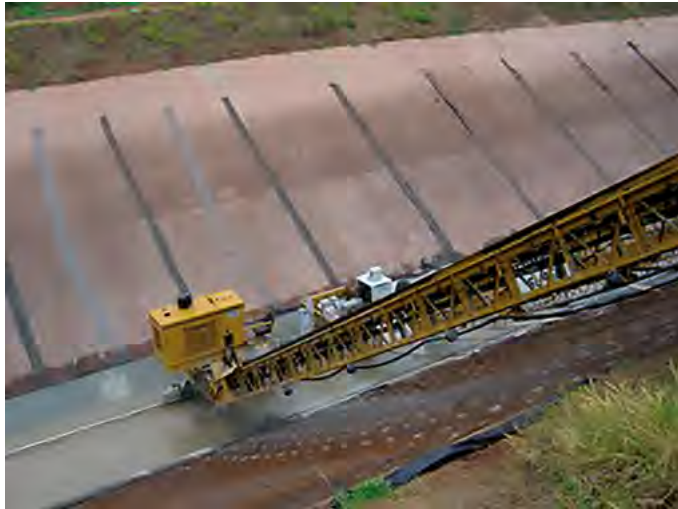
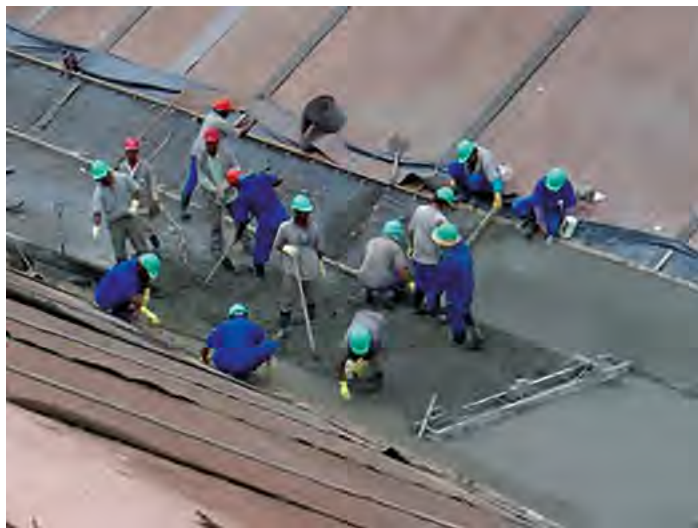
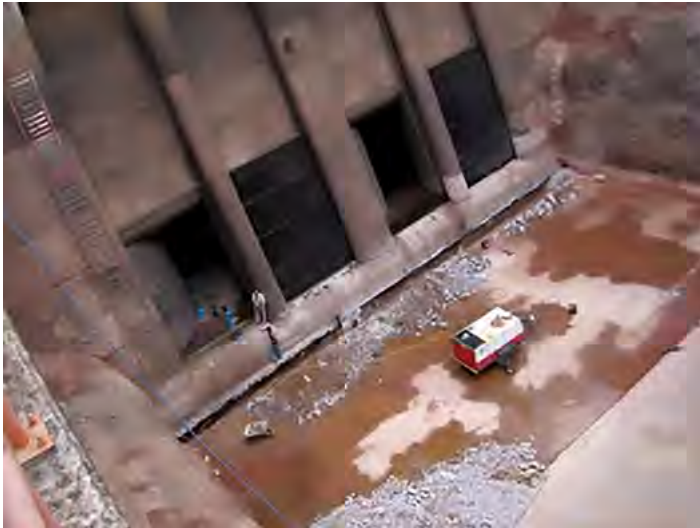
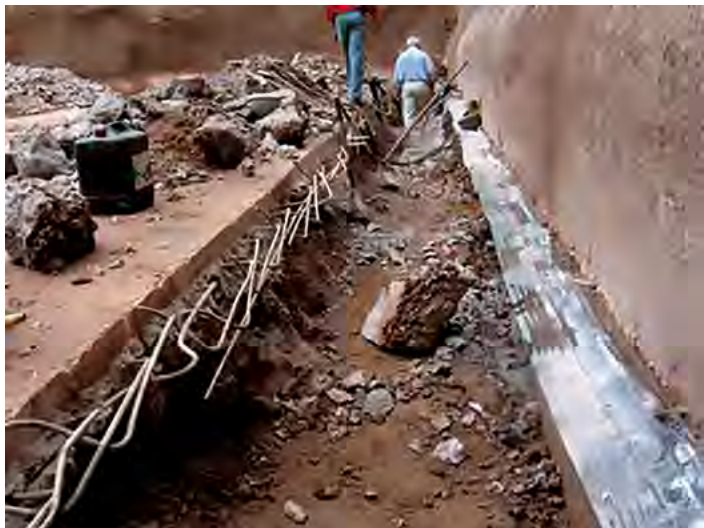
The Jubas Hydroelectric Complex, in Mato Grosso-Brazil, has intakes and power plants that are supplied by channels. In an inspection carried out in 2005, it was seen the need to repair the Channel that feeds the Juba I HPP, *due to leaks and deteriorations*.

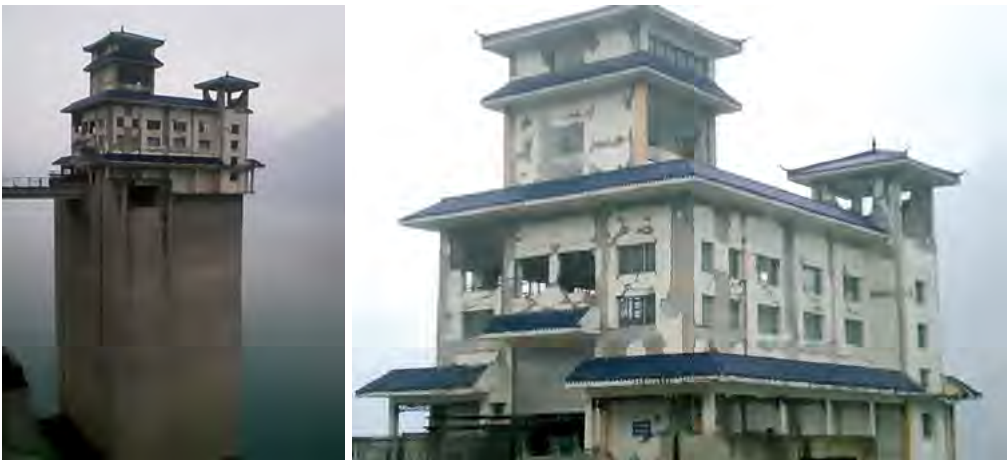
Damage of reinforced concrete building on top of the intake towers of the Zipingpu reservoir, after the May 12, 2008, Wenchuan earthquake^[04-66]

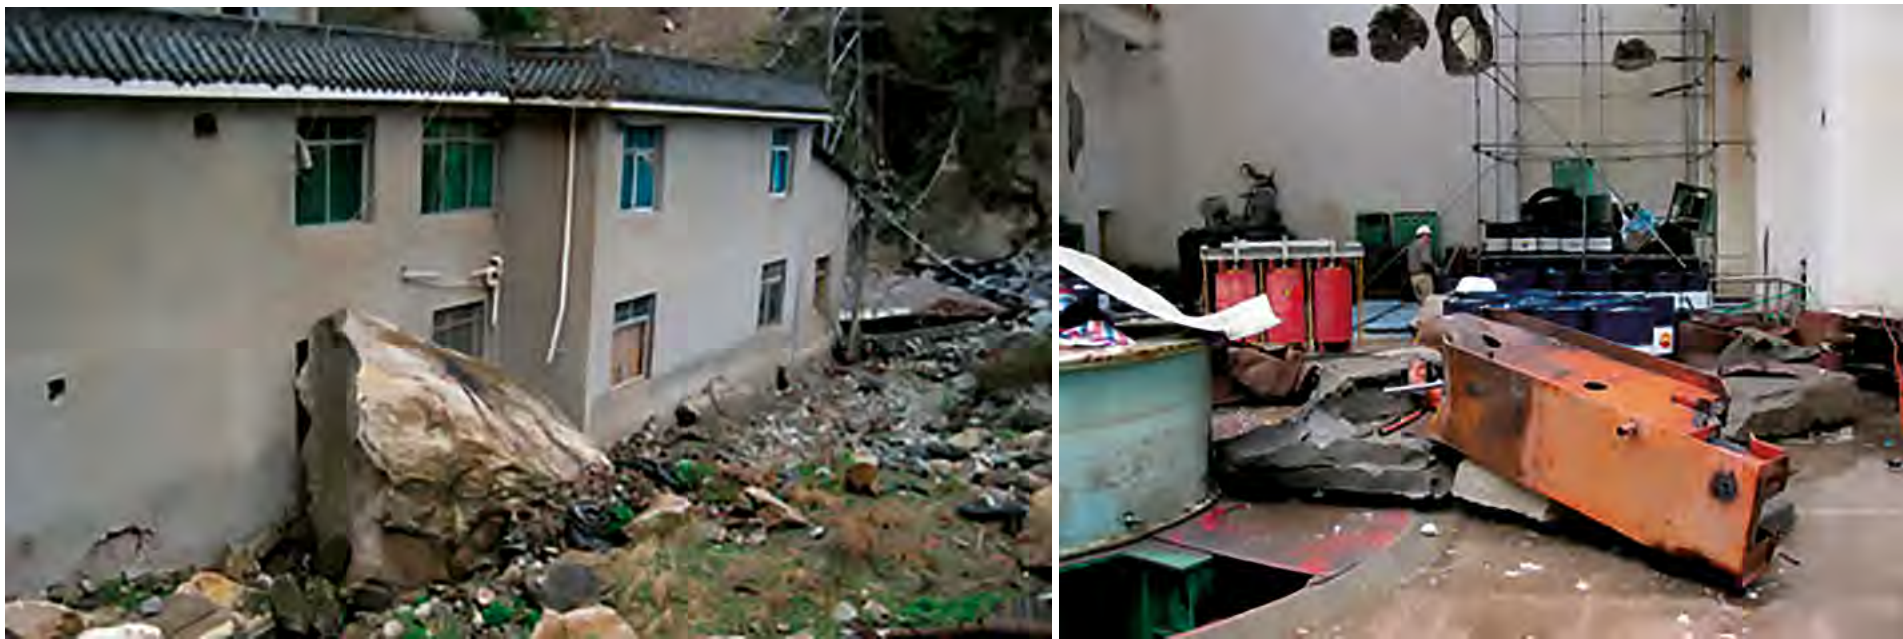
The Shapai Dam powerhouse located several kilometers downstream was severely damaged by high velocity rock falls and the movement joint of the penstock failed, causing flooding of the powerhouse. In the case of Shapai Dam the powerhouse was damaged as bellow.

Damages in Shapai Powerhouse after the May 12, 2008 Wenchuan earthquake^[04-66]

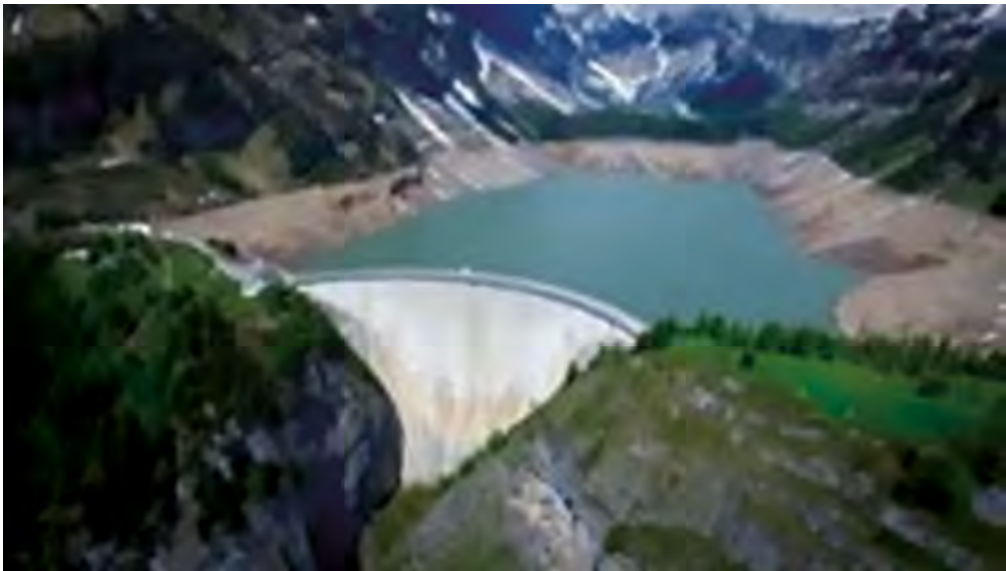
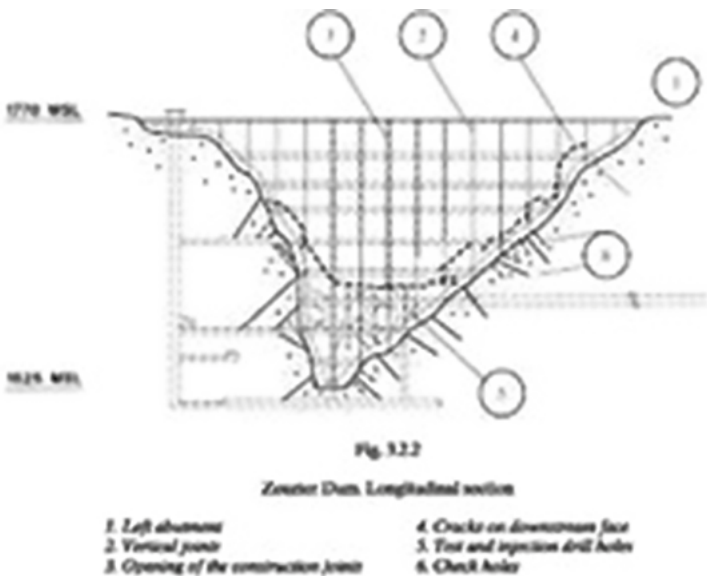
Owing to these deformations, some of the vertical contraction joints in the upper part of the upstream face opened and cracks developed along the downstream toe. The major cracks are located mainly in the lower third of the dam and along the foundation. Other cracks also appeared in the inspection galleries and shafts.

A program was established for examination of the condition of the dam and its foundations and for evaluation of methods suitable for repairing the damage to it. Three zones were defined: grout curtain, abutment, and dam body.

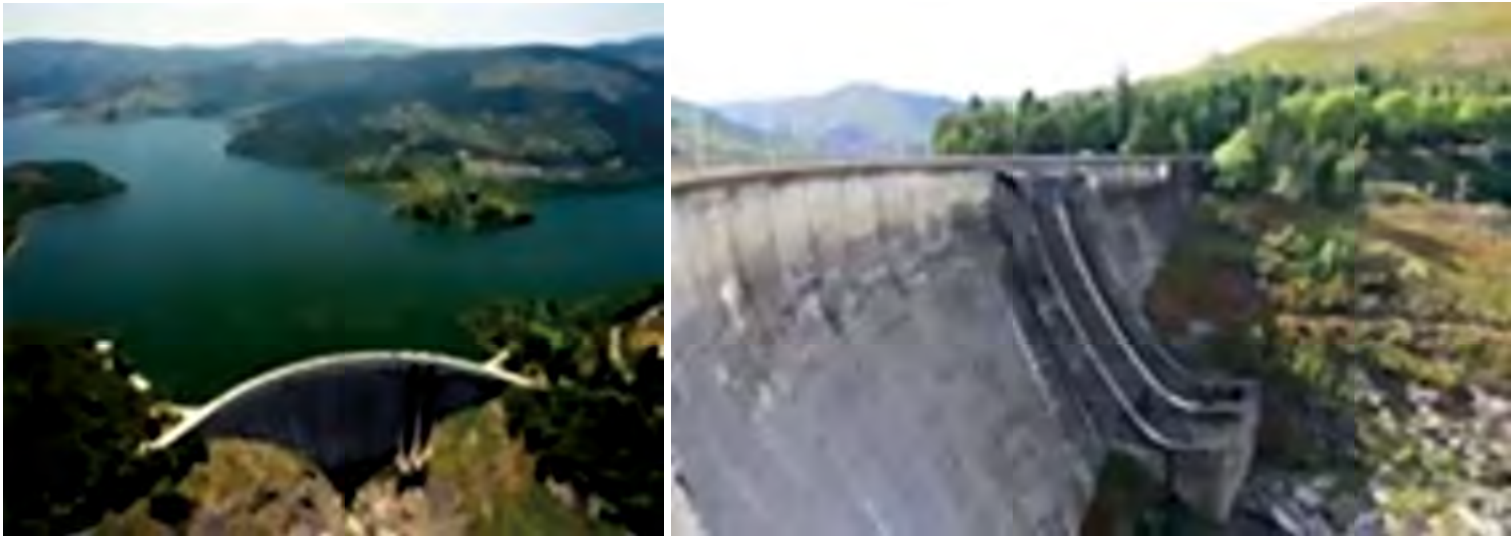
Case	Identification	Country	Finished	Damage	Actions	References
4.7-C	Venda Nova	Portugal	1951	1984	Improving the Foundation	[04-70]

A monitoring system installed in the dam showed the seepage remaining and the uplift pressure increasing. ***This was due to the opening of faults and sub-horizontal joints at the left bank and valley bottom.*** It was accompanied by washing out and the dissolution of filling materials. Repair work was carried out to improve the hydraulic behavior of the foundation. This aimed at improving the strength and watertightness at the lower zone of the foundation rock mass.

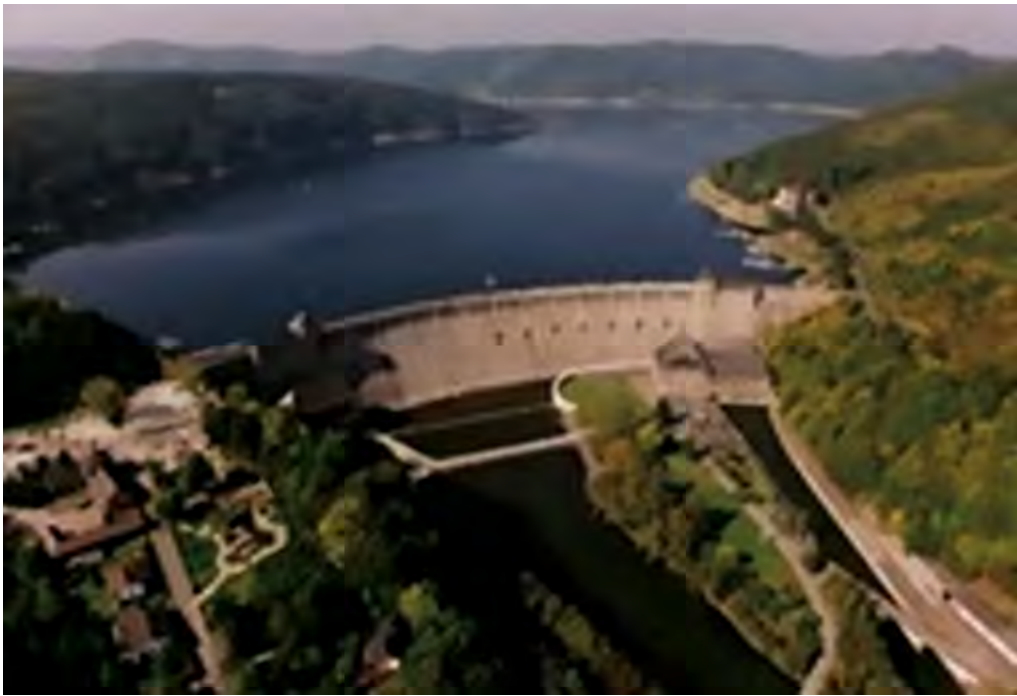
Case	Identification	Country	Finished	Damage	Actions	References
4.7-D	Lister	Germany	1911	1965	Adoption of a Gallery	[04-71]

To *improve the stability of the dam, a drainage gallery was excavated at the bottom of the dam, to reduce the uplift pressure*. After some years it was observed that joint filling material was transported to the gallery, increasing the permeability of the rock below the dam. Additional calculations proved the dam to be stable with the gallery flooded from the downstream side and the gallery was allowed to fill up, preventing further erosion.

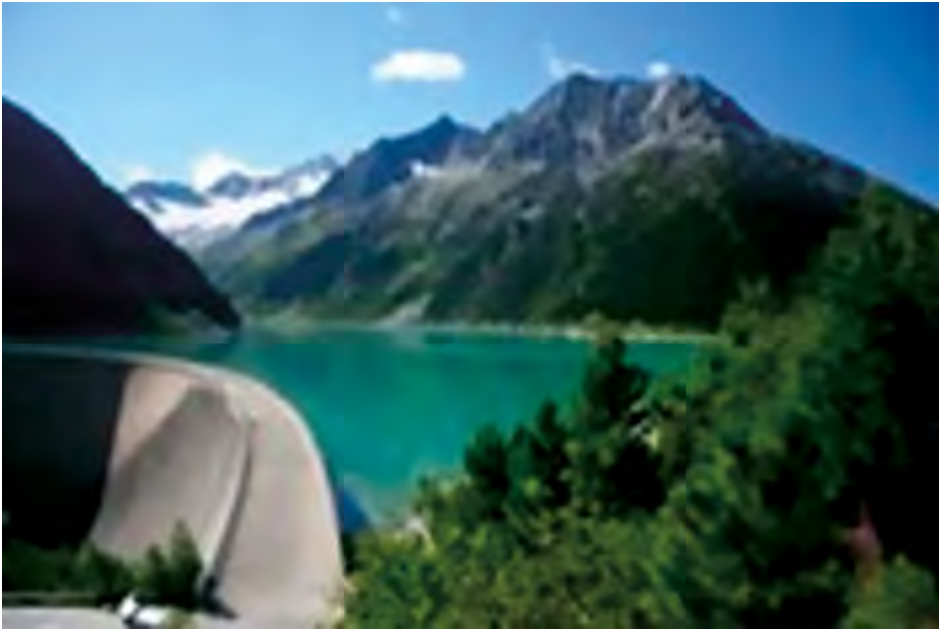
Case	Identification	Country	Finished	Damage	Actions	References
4.7-E	Schelegeis	Austria	1973	1983	Adding a cut off wall	[04-71]

The volume of seepage water emerging in the inspection gallery at the dam base increased markedly during the final stage of reservoir filling. Ninety percent of the seepage was concentrated over a 150 m length of the foundation. Investigations showed that the grout curtain, situated between the upstream toe and the inspection gallery, was cracked due to tension. Cracked grout curtain repaired with a new 5 m deep cutoff wall.

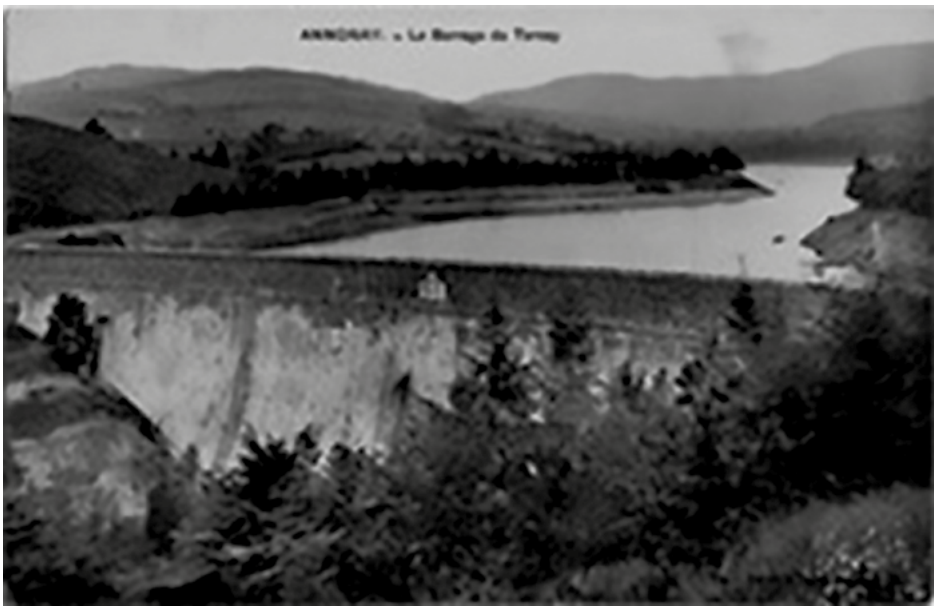
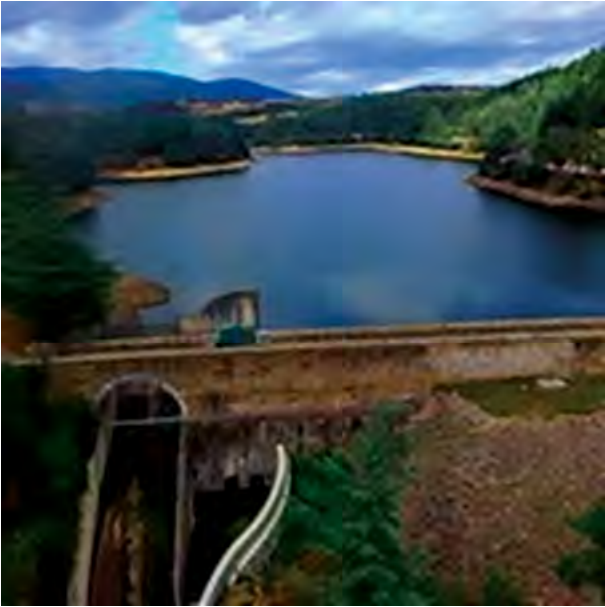
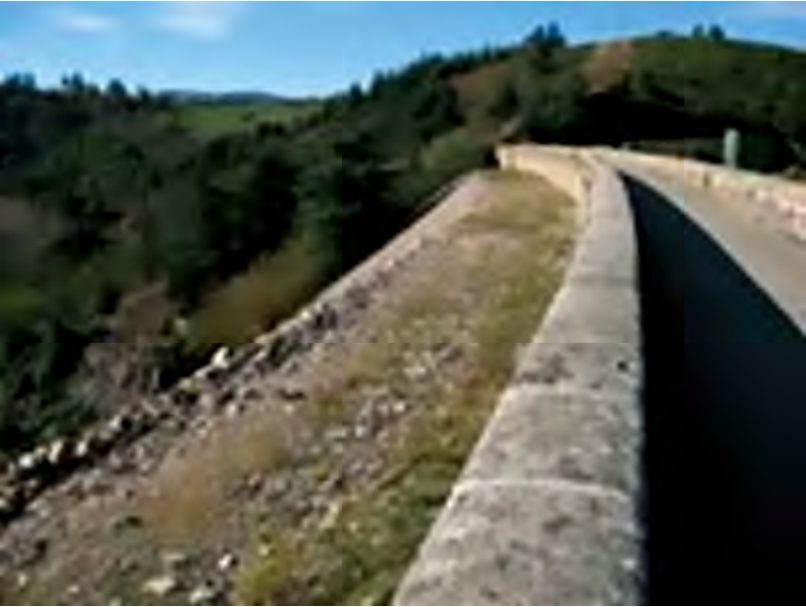
Case	Identification	Country	Finished	Damage	Actions	References
4.7-F	Ternay	France	1867	1990	Adding a rockfill	[04-71]

Stability problems and cracks were repaired by strengthening and by shape correction. An earth and rockfill embankment was placed downstream.

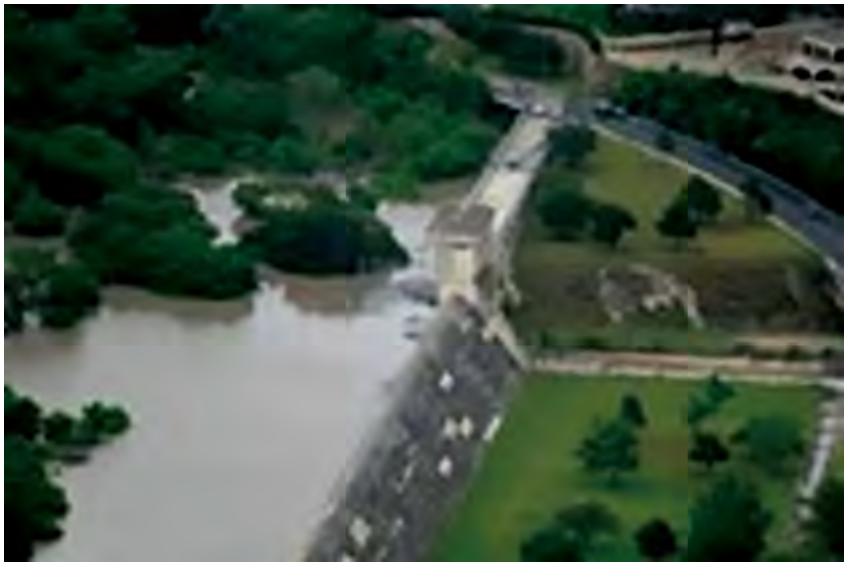
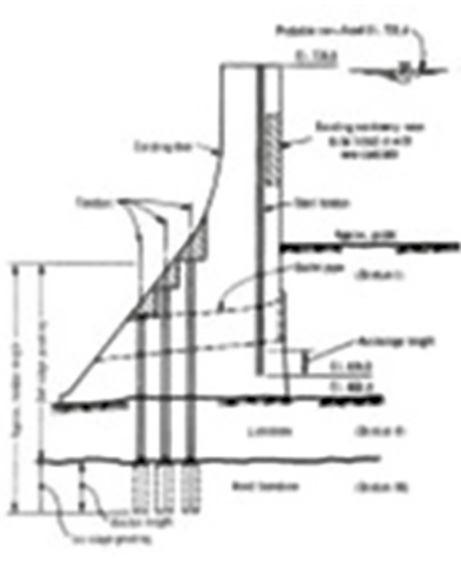
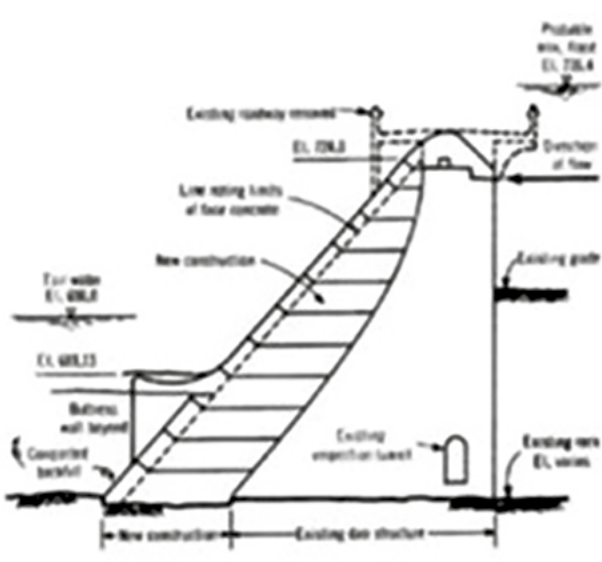
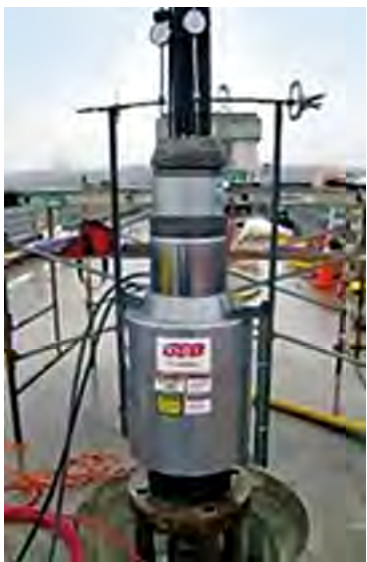
Case	Identification	Country	Finished	Damage	Actions	References
4.7-G	Olmos	USA	1975	1979	Prestressed Anchors	[04-71]

A major dam rehabilitation program had to be implemented in order to prevent damage during maximum overflow.

The alternative selected was to strengthen the two non-overflow sections with prestressed anchors installed in 2 – to 3-m thick, hard limestone 15 m below the base of the dam and to increase the stability of the spillway with mass concrete. For construction of the 39-m-long ogee spillway crest, the topmost portion of the dam had to be removed.

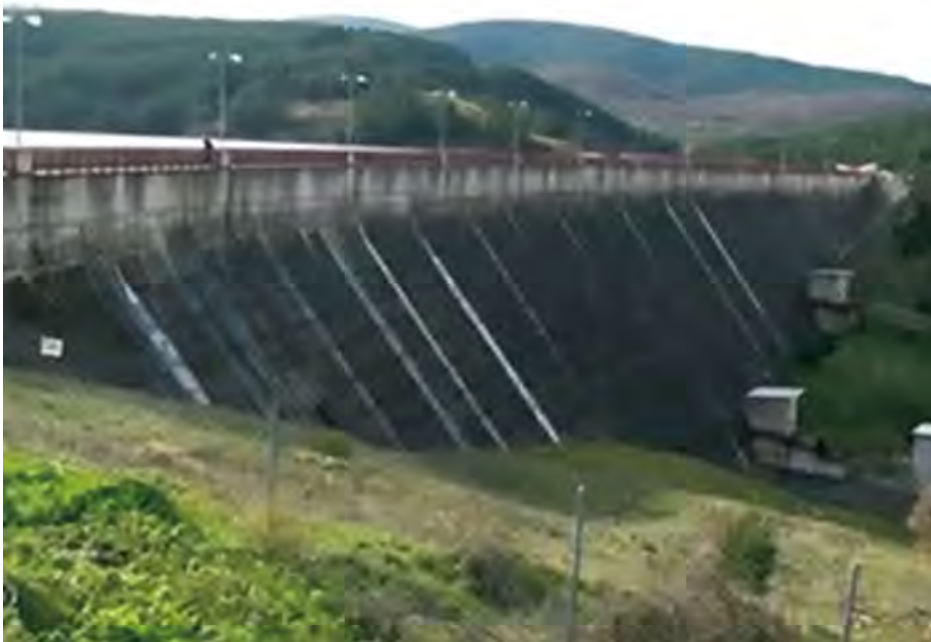
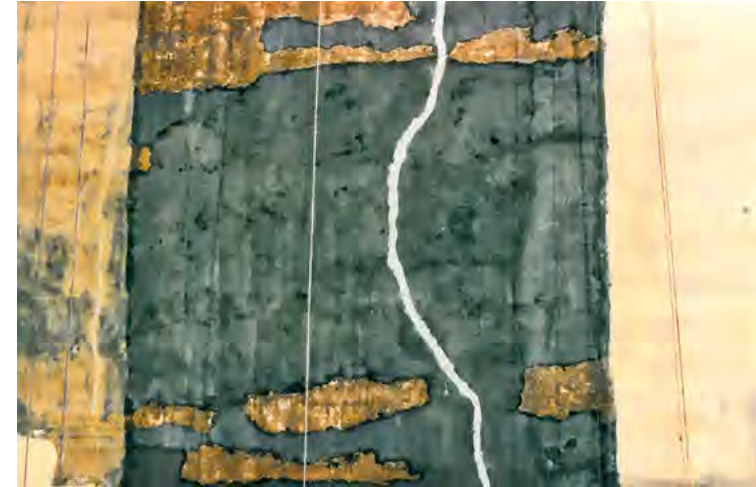
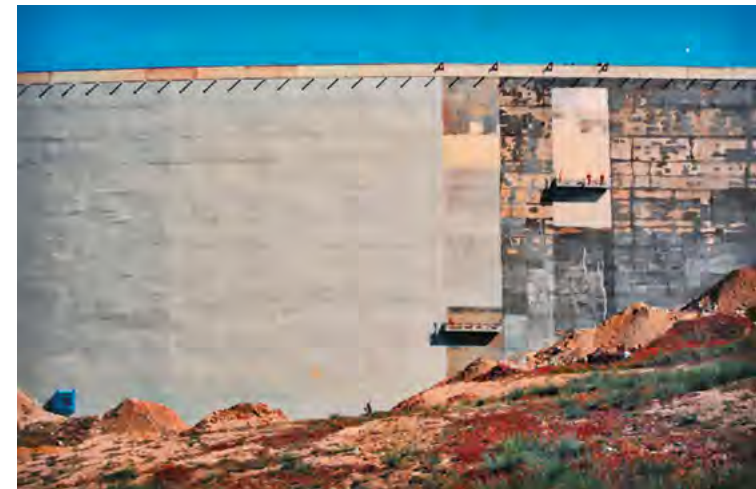
Arlanzon concrete dam was constructed without contraction joints. Fifteen large vertical cracks developed, from the upstream to the downstream faces, causing leakage that damaged the dam, particularly at the downstream face, owing to frost.

Repairs on the Arlanzón dam upstream face (courtesy from Group Teimper)

The rehabilitation works included the treatment of the cracks, by grouting with an epoxy resin, as well as the treatment of the dam faces and the consolidation and drainage of the dam body.

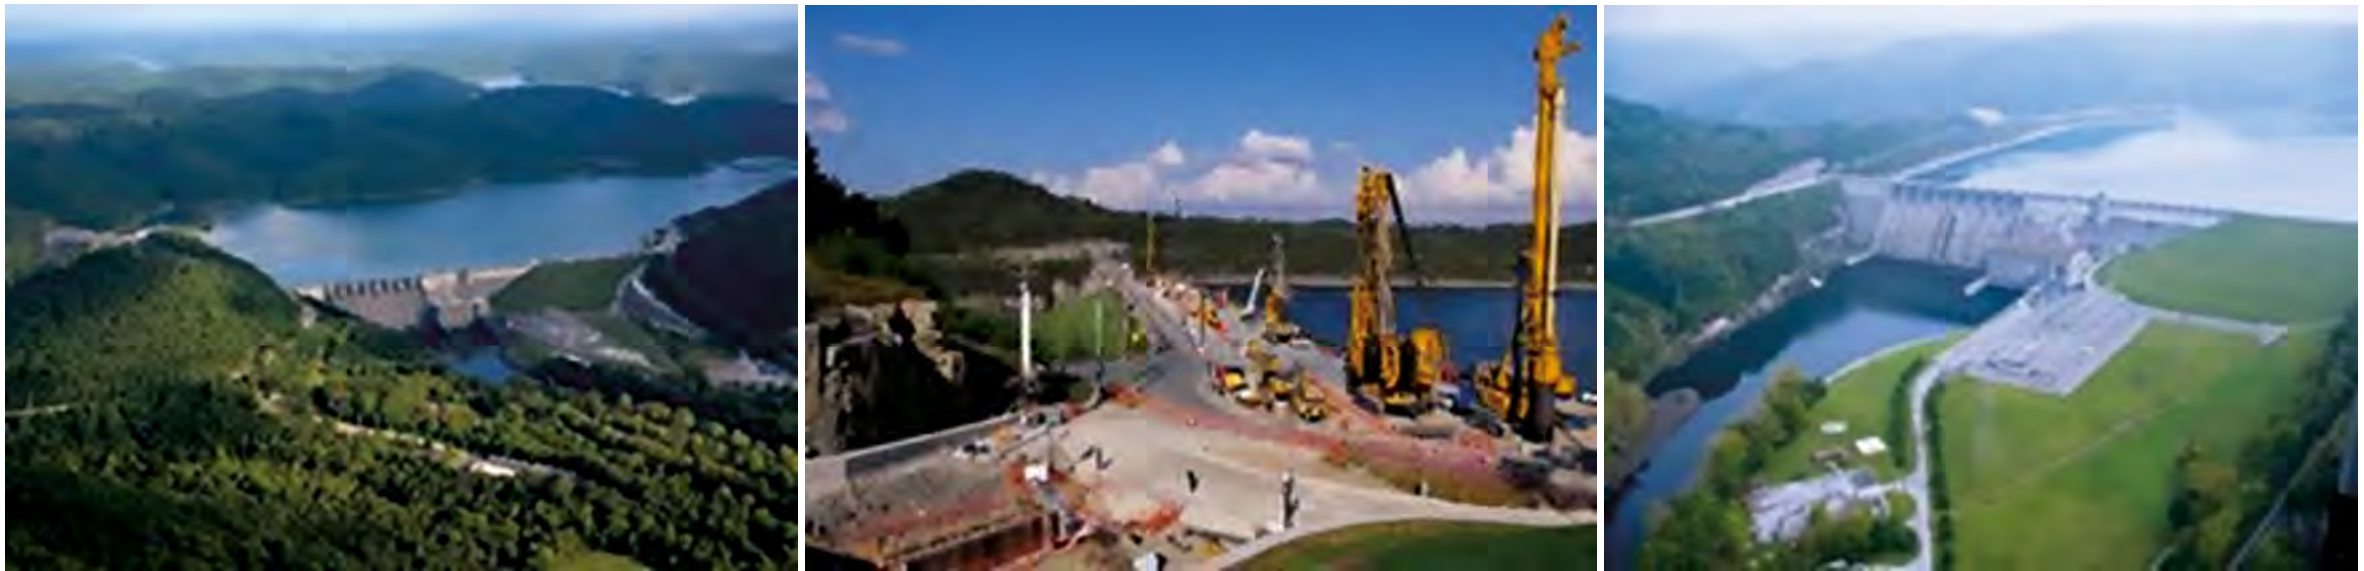
Case	Identification	Country	Finished	Damage	Actions	References
4.7-J	Center Hill	USA	1948	2008-2012	Adoption of a cut off	[04-74] & [04-75]

A detailed engineering inspection in August 1967 found several horizontal lift joints to be leaking excessively. Two of these joints were located near the center of the spillway near crest elevation. The conclusion reached by this investigation was that the cause of the leakage was

Some of the rock types were identified as potentially reactive. The concrete cores contained many aggregate particles with reaction rims left in relief when the more soluble carbonate particles were acid etched. The tests on the concrete cores and petrographic examinations led to the conclusion that some potentially reactive aggregates were used in the concrete. There was no proof that shortening the bridge spans and spillway gates was more than a short-term solution to operational deficiencies and that the structure might not continue to grow.

An approved 2006 Major Rehabilitation study recommended foundation concrete cutoff walls along the entire length of the main and the saddle dam and grouting of the rims. Initial construction work elements began in 2008, preliminary grouting was completed in late 2010 and main dam barrier wall construction began in 2012. During construction, additional information was obtained, and a formal risk assessment completed, which altered the recommendation.

Less grouting along the rims and a roller compacted concrete (RCC) reinforcing berm downstream of the saddle dam (in lieu of a barrier wall) is recommended in a Supplement to the original Major Rehabilitation study. Aggregate used for the concrete was taken from an onsite quarry in the Ordovician Cannon Formation, but no limitation was placed on the alkali content of the cement. Until 1947, all concrete used in the structure was non-air entrained.

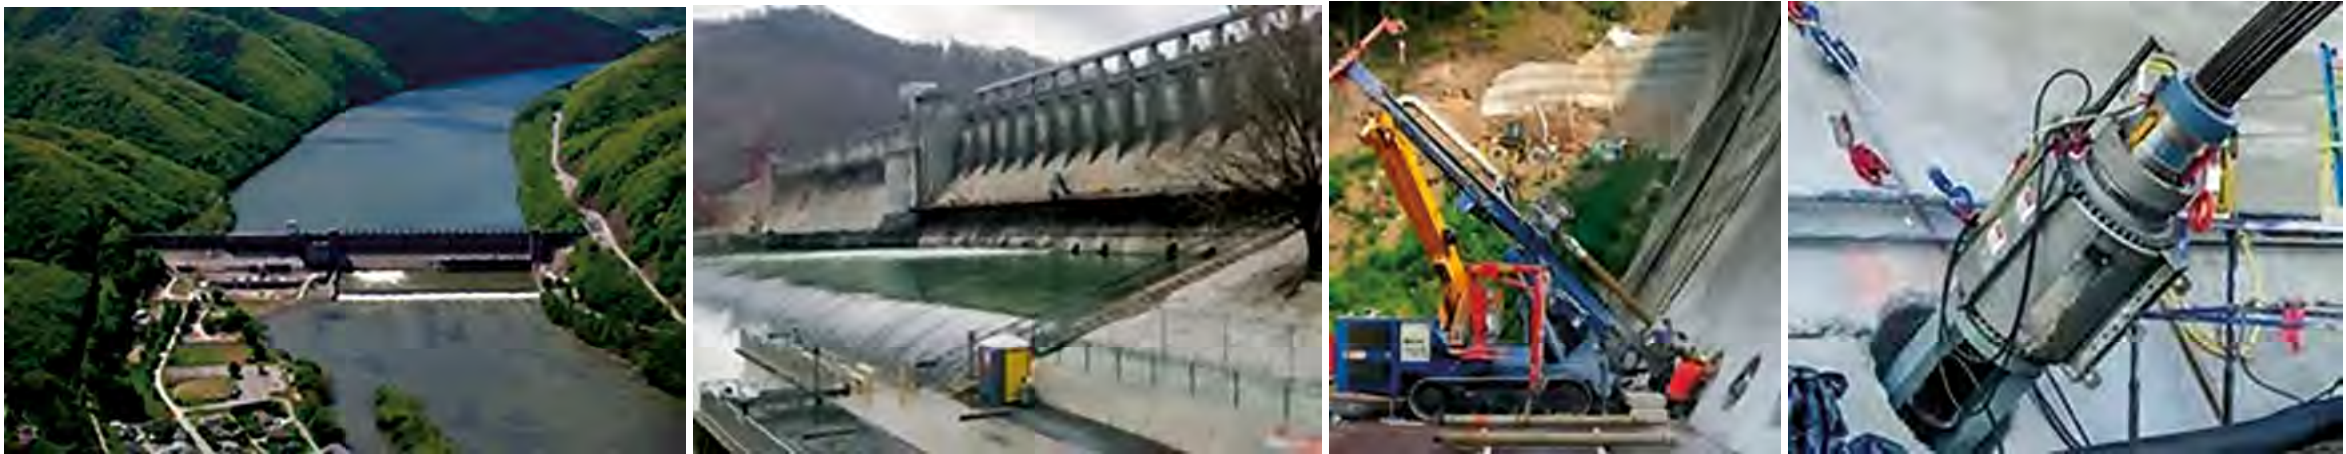
Case	Identification	Country	Finished	Damage	Actions	References
4.7-K	Bluestone	USA	1949	2011	Installation of Anchors	[04-76]

New calculations identified the possibility for dam failure due to the monoliths sliding on the bedrock. As a result, a total of 216 high-strength anchors, comprising high strength multi strands, were installed at critical monoliths to stabilize the dam.

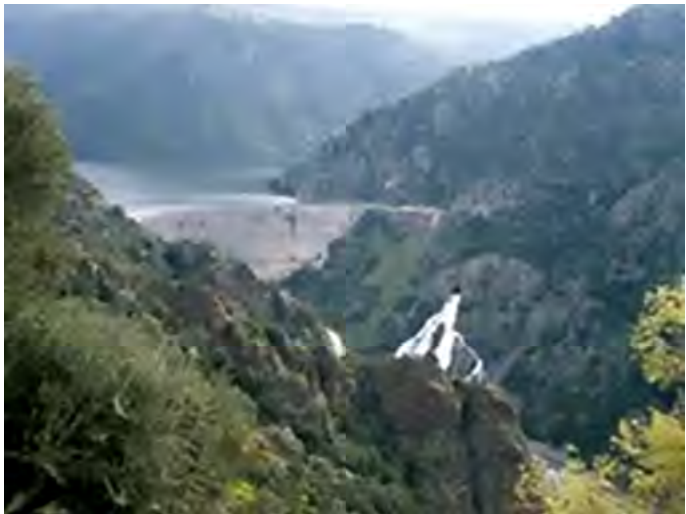
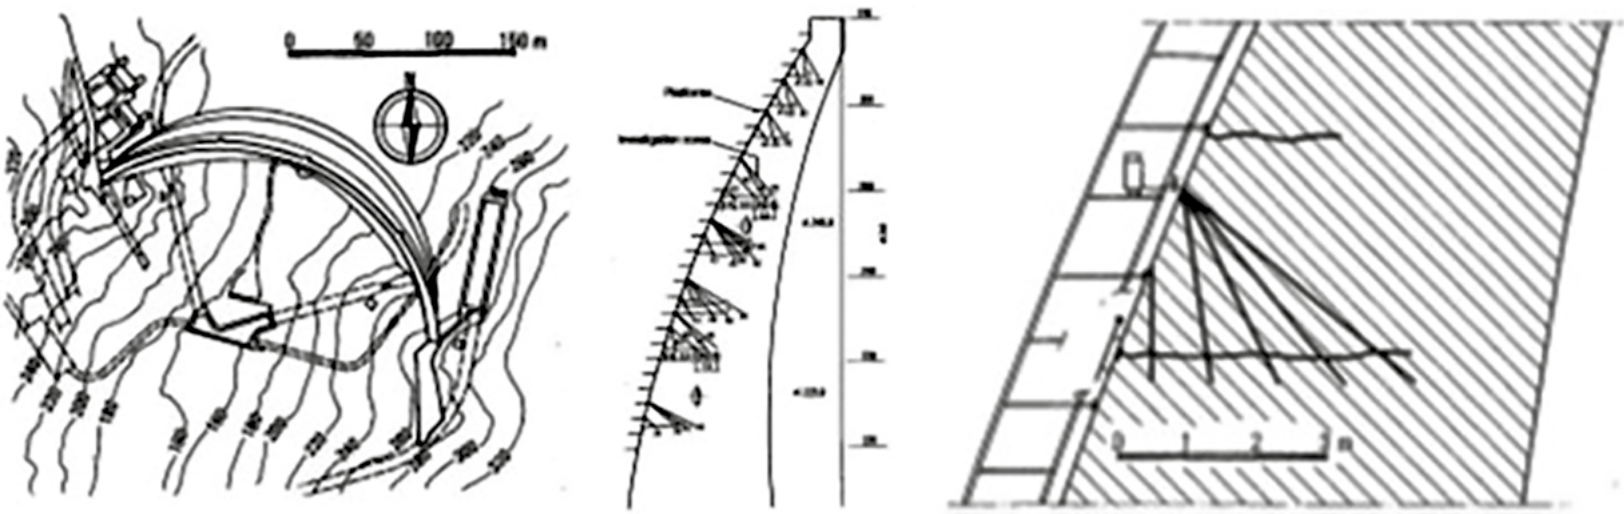
Case	Identification	Country	Finished	Damage	Actions	References
4.7-L	Flumendosa	Italy	1957	1995	Epoxi Resin Grout	[04-77]

In the Flumendosa Dam, *cracks developed along the construction lift joints*, at the highest elevations of the upstream face. These were grouted with epoxy resin.

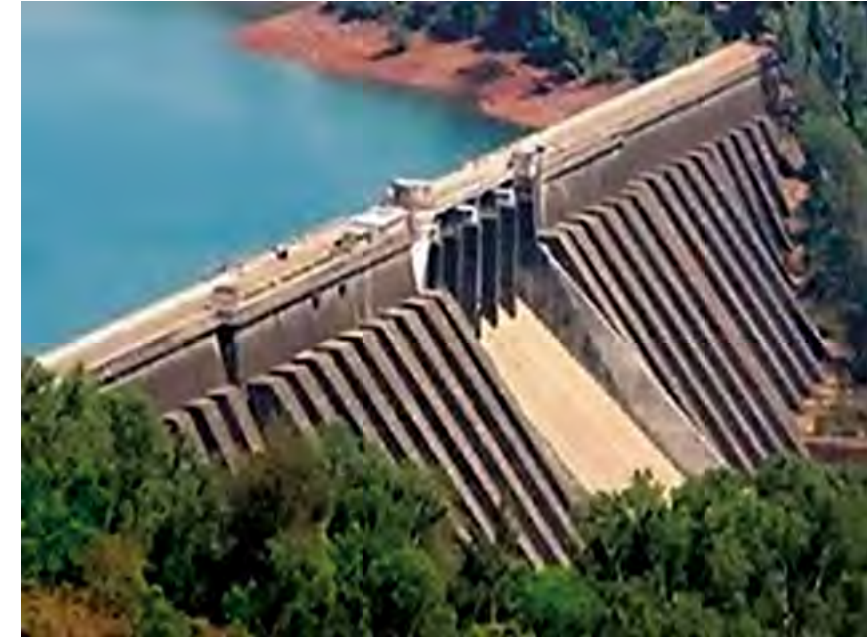
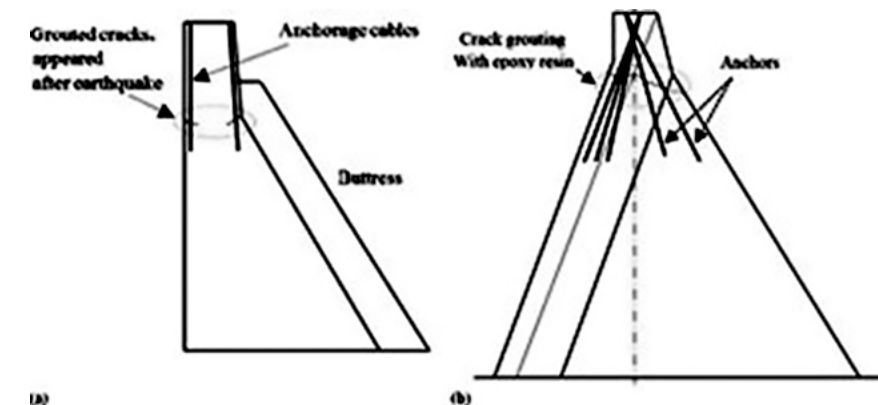
Case	Identification	Country	Finished	Damage	Actions	References
4.7-M	Koyna	India	1962	1990	Epoxi Resin Grout	[04-78] to [04-81]

The dam **was designed with a seismic coefficient of 0.05**, constant over the entire height corresponding to maximum water level in the lake. The dam constructed in 1962 across river **Koyna has experienced an earthquake of magnitude 6.5** in the Richter scale on December 11, 1967. Through measurements in the gallery located in the dam, the leakage through the dam body and foundation was monitored. This showed an increasing trend after the earthquake. *The Koyna dam developed some surface cracks.*

- ⇒ Grouting the cracks with epoxy resin, polyester grouting, and sealing of crack upstream with grouting and guniting, thus reestablishing the monolithicity of the dam to the extent that the epoxy grout can penetrate through the face and at the same time prevent the water ingress into the dam body;
- ⇒ Strengthening of 7 high monoliths by pre-stressed cables was carried out because it was not possible to assert that:
 - the crack did not extend beyond the grouted face;
 - the crack did not continue from upstream to downstream face;
 - the resin grout has bonded the whole width of the dam.

It was therefore decided that cracked and deep monoliths should be stitched across the crack by pre-stressed cables, so that the bodies above and below the crack act together in unison under dynamic forces.

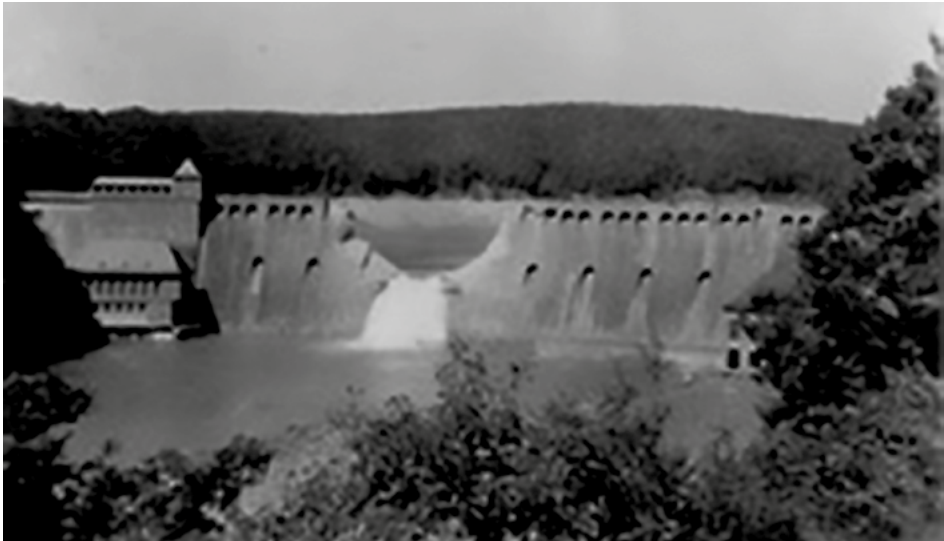
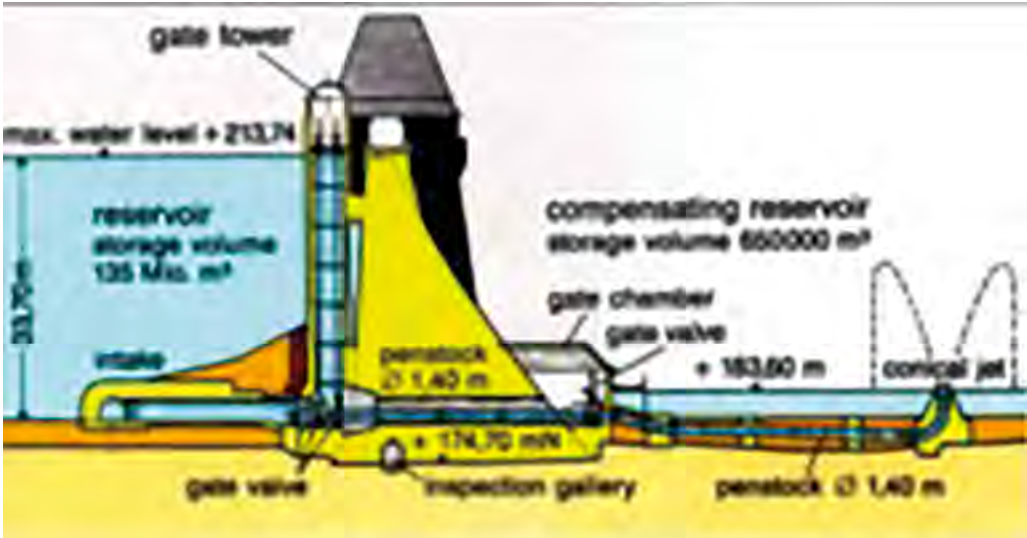
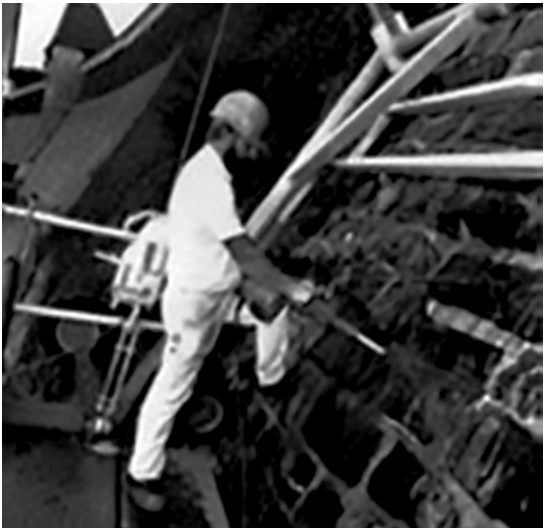
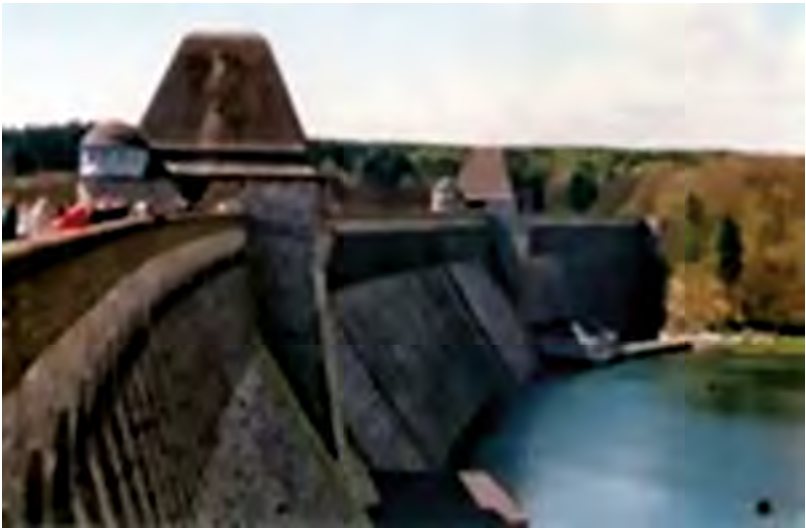
Case	Identification	Country	Finished	Damage	Actions	References
4.7-N	Möhne	Germany	1913	1943-1990	Repaired	[04-82]

The dam was damaged by bombing in 1943 and repaired rapidly in the same year. The downstream face of the dam had not been investigated since the reconstruction in 1943. *In the early nineties, a detailed inspection was made on the downstream face using specialized access platforms.*

It revealed that extended rehabilitation work was necessary. The masonry was repaired by replacing face stones and by renewing the mortar in joints. Afterwards the faces of the two towers of the dam were rehabilitated in the same way and this was followed by rehabilitation of the pillars between the flood escape openings at the crest. *At the Möhne Dam in Germany, the low-level outlet gates were found by inspection to have suffered corrosion and to be unacceptably leaking.*

The rehabilitation of the Möhne Dam provides a valuable case history describing the replacement of the low-level outlet valves underwater. Inspections by divers showed that the culverts were in poor condition. It was decided therefore to rehabilitate the masonry culverts and to provide a support for the emergency gates by installing steel liners within the culverts.
