Is Your Dam Safe?

An281	Andriolo, Francisco Rodrigues; Moreira, José Eduardo
	Is Your Dam Safe? – Vol. 1 / authors: Francisco Rodrigues Andriolo e José Eduardo Moreira. São Carlos, 2022.
	1394 p. il. color
	ISBN – 978-65-5668-011-8
	DOI – http://dx.doi.org/10.26626/9786556680118/2022B001
	1. Dams. 2. Training. 3. Quality. 4. Repairs. 5.Controls. 6. Cement. I. Orgs. II. Title.
	CDD 370

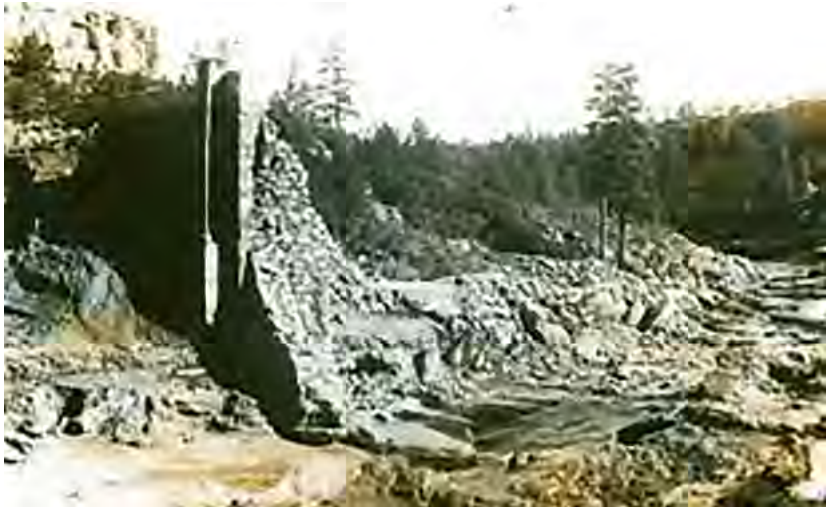
The dam was controversial from the beginning. Just after construction, Castlewood Dam showed *signs of settlement, with cracks and seepage* visible on the face of the dam. Safety was questioned by downstream citizens and a committee of engineers determined that improvements to the dam were necessary. Meanwhile, Denver Water Storage Company, owner of the dam, and the dam’s designers argued that the dam was safe. In 1897, a section of the dam washed out prompting multiple repairs. Following the repairs, leakage remained visible, but to a lesser degree.

During the 1933 thunderstorm the reservoir rapidly filled until water flowed over the central spillway and eventually overtopped the remainder of the dam by a little over a foot. Prior to the build-up of tailwater, erosion likely initiated at the toe of the central spillway section. The masonry apron in this location was washed away and deep erosion of the underlying mudstone quickly ensued. *At the same time, scour may have started along the groins due to overtopping flow.*

Castlewood Canyon Dam after the rupture
(from internet)

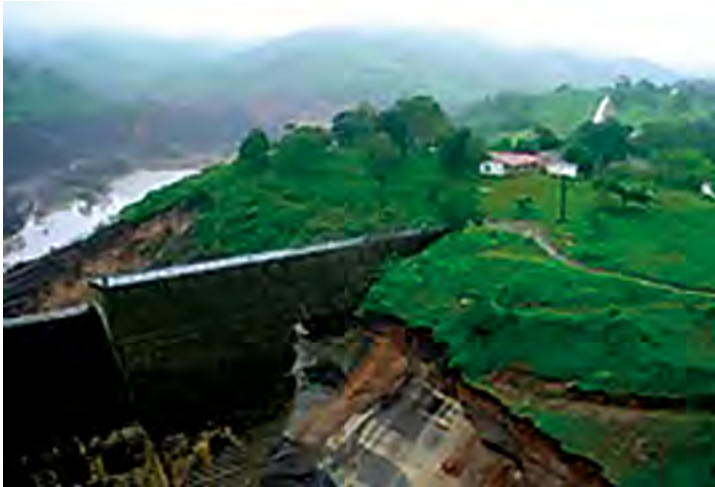
On the night of June 17, 2004, the dam broke after a **foundation failure**, reaching part of the territories and inhabitants of the municipalities of Alagoa Nova, and the urban sites of two other cities, where the disaster gained greater dimension. The dam was rebuilt by 2017.

Camará Dam after failure (*)

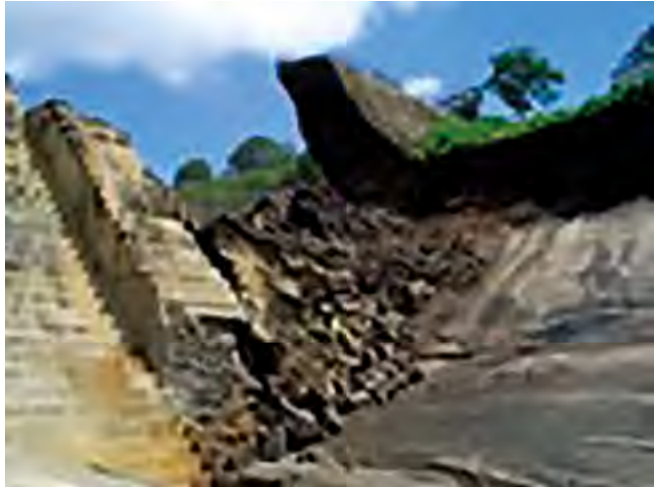
Additional rupture (*)

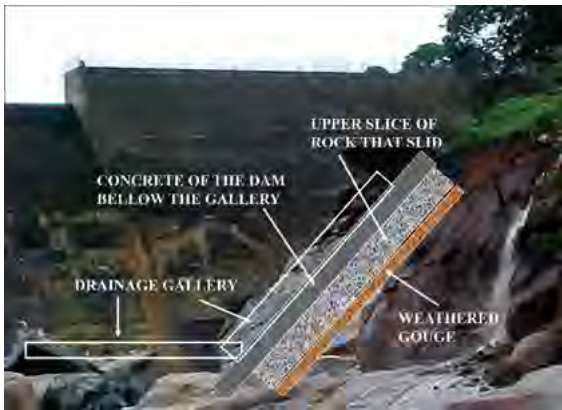
Rupture aspect [04-84]

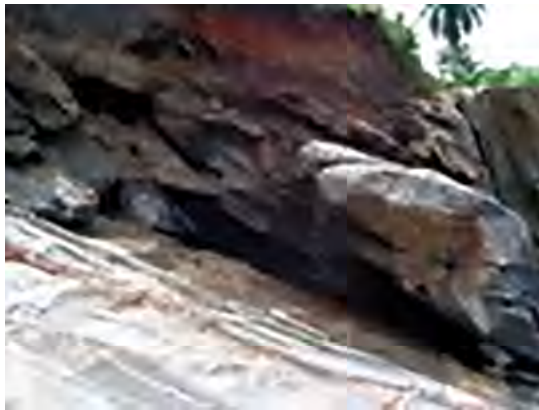
Local of the foundation Rupture (*)

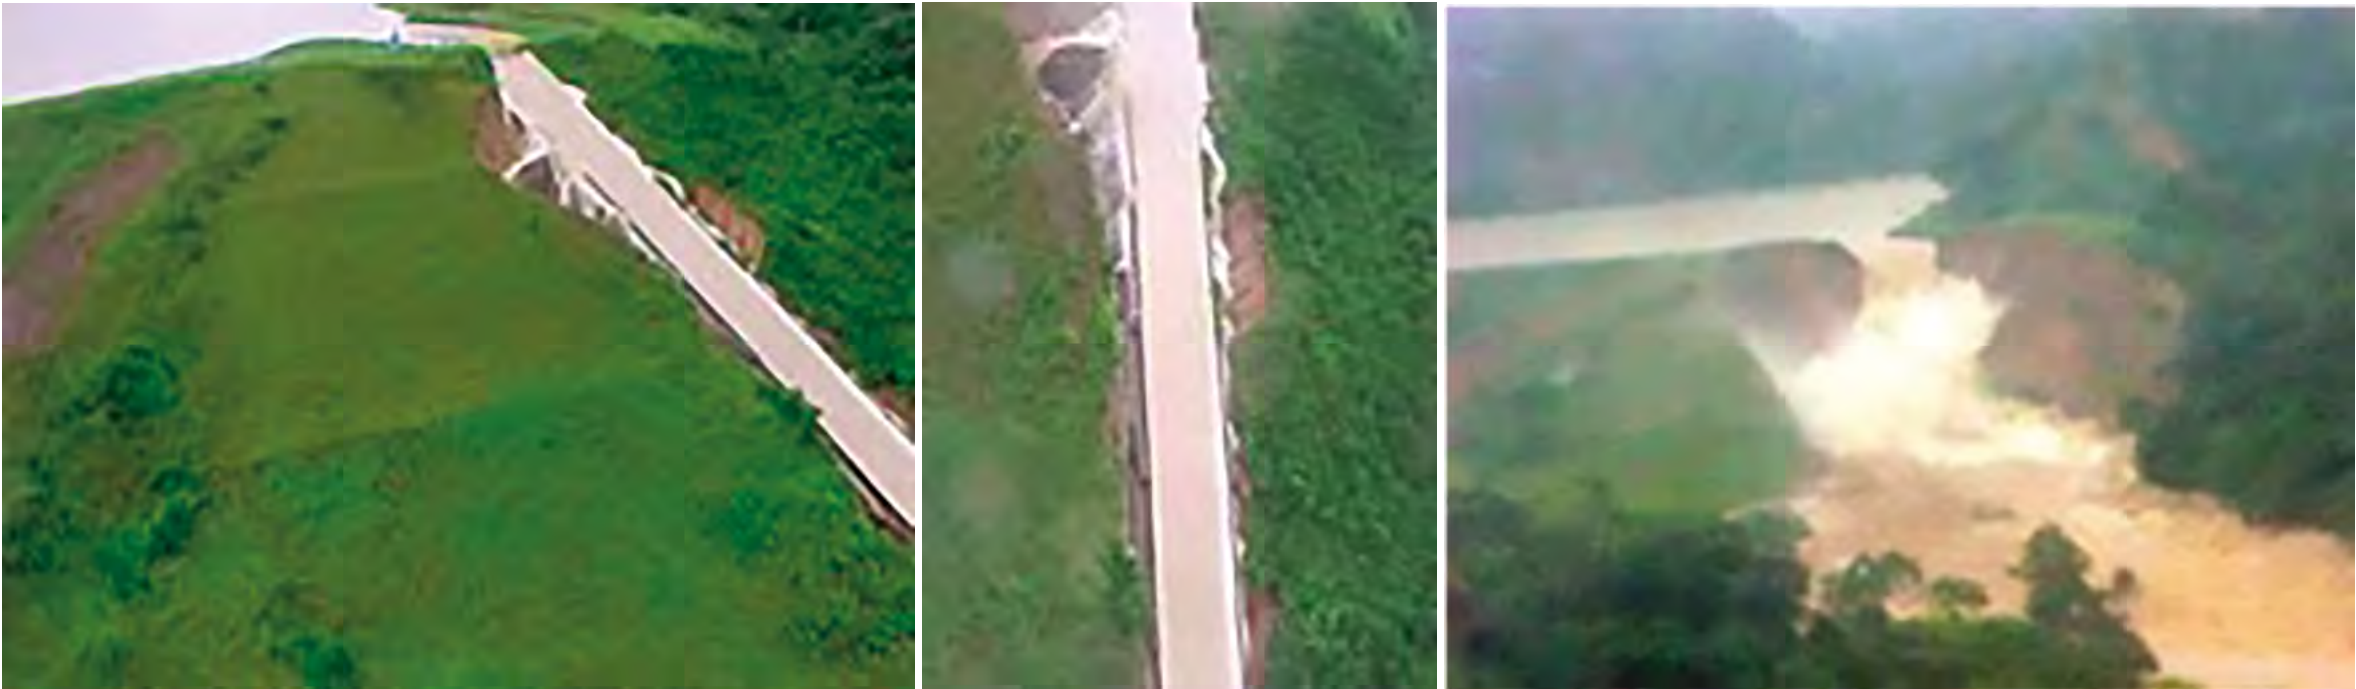
El Guapo dam reservoir was at its peak **when it was unable to contain the floods due to the great magnitude and thus a rupture occurred.** A new RCC concrete spillway was constructed, and the embankment was repaired.

Sequency of the failure

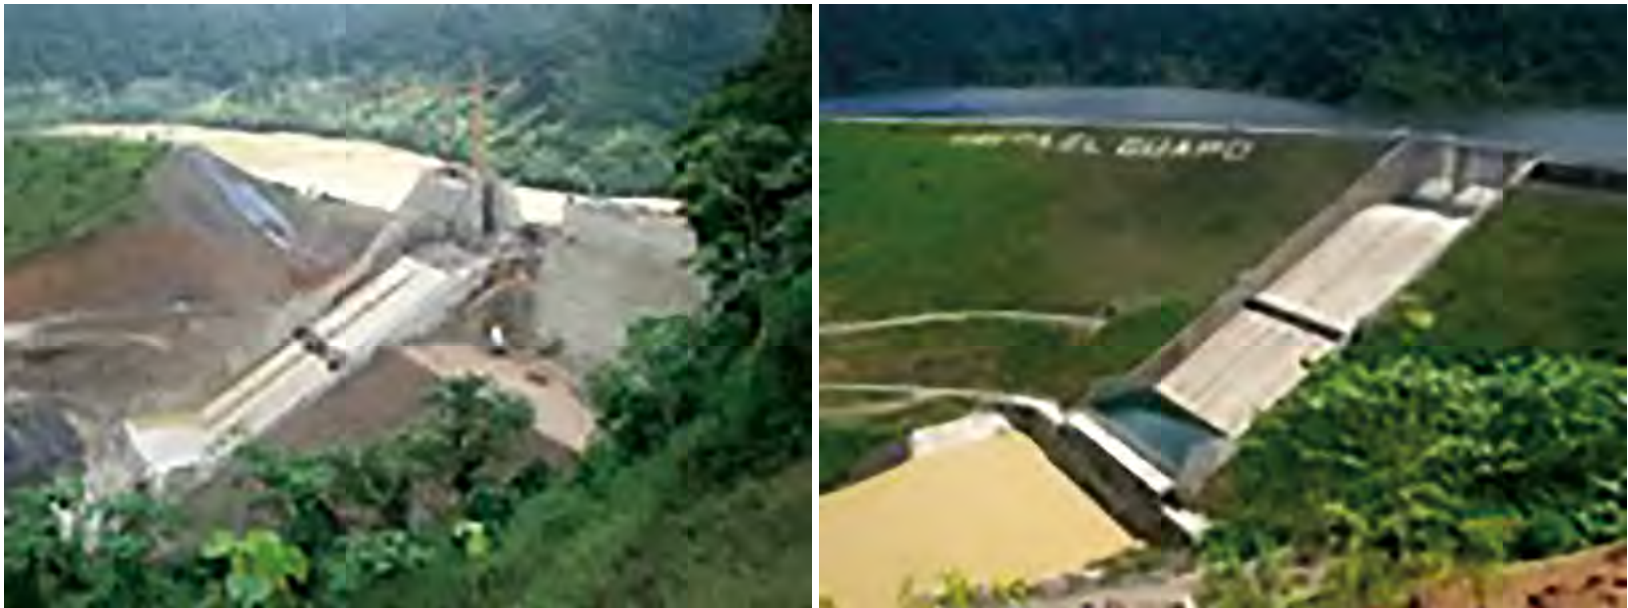
Spillway as rebuilt (courtesy from the Contractor)

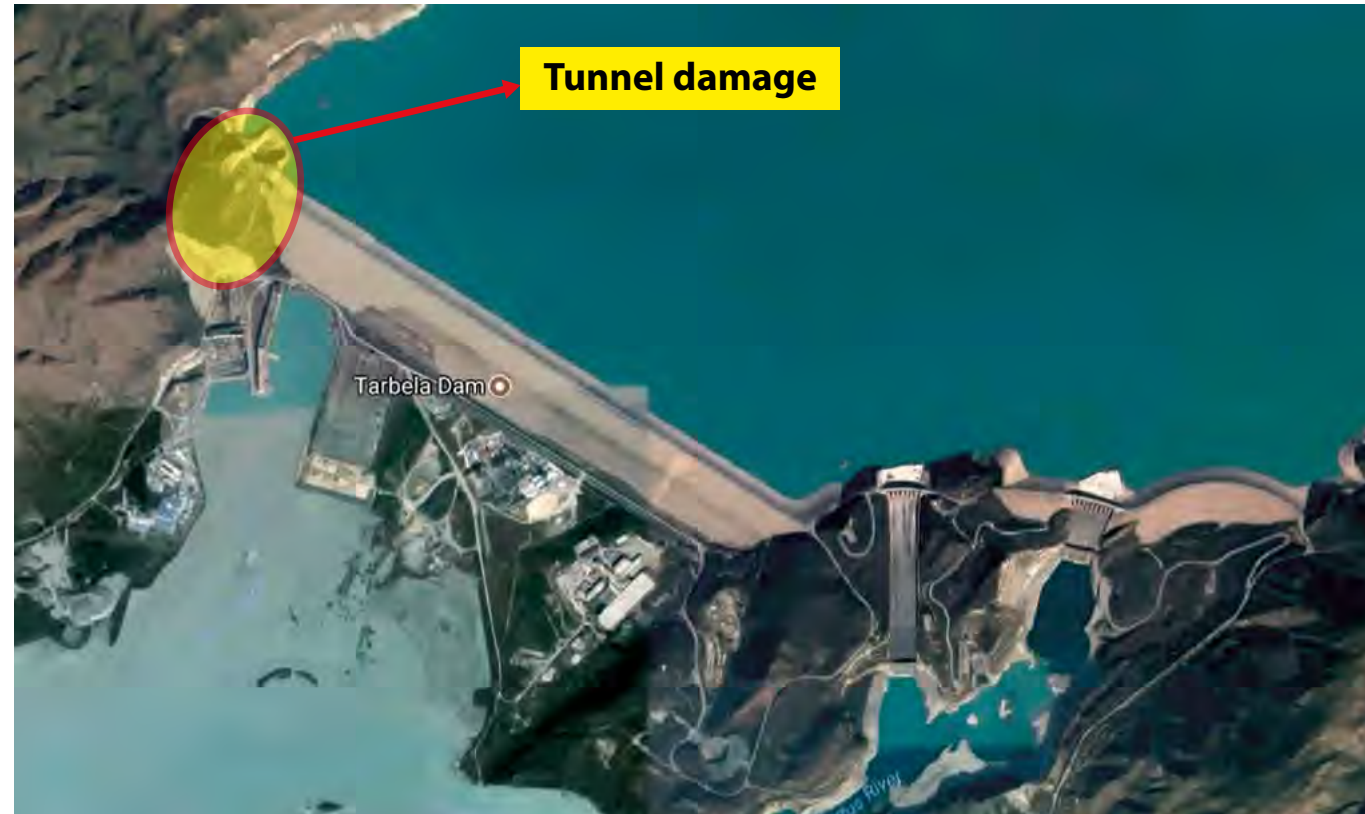
Illustration where the tunnel that collapsed (picture from Internet)

The water conveyance structures for the Tarbela Dam Project consist of two spillways (Service and Auxiliary), five large diameter tunnels, and one small tunnel for irrigation. Tunnel 1 was 13,3 m in diameter and served as river diversion tunnel prior and during the initial filling of Tarbela reservoir in 1974. On the August 21, 1974, while discharging flows under high heads from Tarbela reservoir, tunnel 2 suddenly collapsed.

Cavitation was a factor that led to the collapse of tunnel 2 in August 1974. The flow situation that led to the cavitation in tunnel 2 was caused by the operation of the central gate (one of three), which stuck at part-gate-opening at heads that steadily increased up to a maximum of 109m. In tunnel 1, damage occurred when each of the three gates could be opened only partly during emergency drawdown of the reservoir.

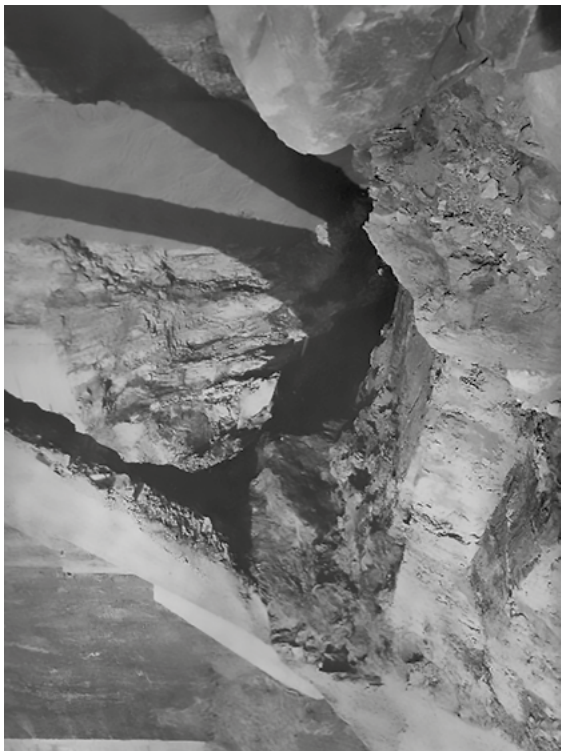
Tunnel 2 collapse/
suspended air vent to gates
(courtesy R. Allione)

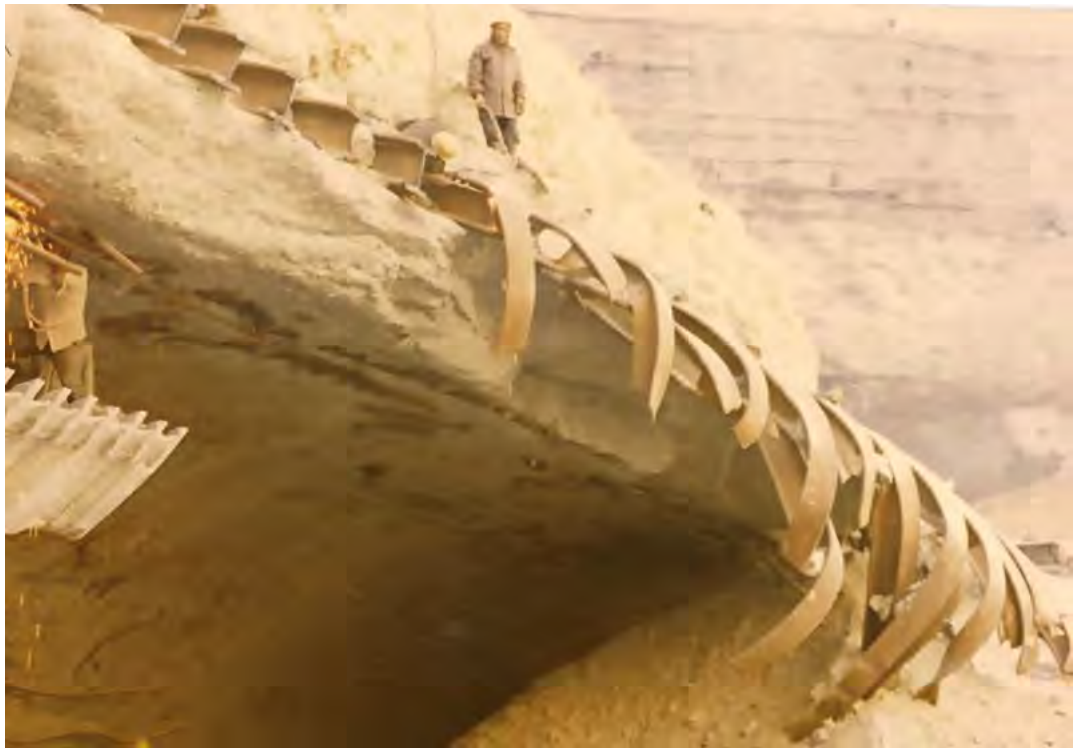
Tunnel 2 collapse, diameter 13,3 m and
6 inches steel ribs HEM 360 (courtesy R. Allione)

The part-gate operation was the result of accidental jamming of the gates due solely to structural failures in the gate track systems and was forced by circumstances that could not be foreseen. The original design basis for the intakes, tunnels and gates was that the gates should only be used to shut off the flow completely when the time came to discontinue diversion through the tunnels. **Later, after additional studies, design review and some modifications were made.**

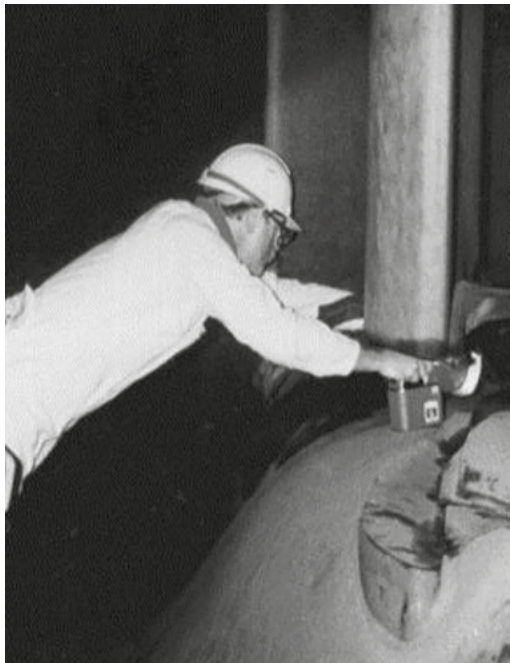
On 2 May 1990, the 180MW Francis turbine-generator running at full speed was instantaneously stopped by a foreign body left in the penstock following maintenance. The turbine casing and concrete machine block surrounding the power station **were destroyed in May 1990 when two steel beams entered the turbine**. The resulting force ruined the power station and the dam’s control systems, making it impossible to gradually release water from the near-capacity dam by conventional means.

One of the twelve stay vanes fractured at the base.

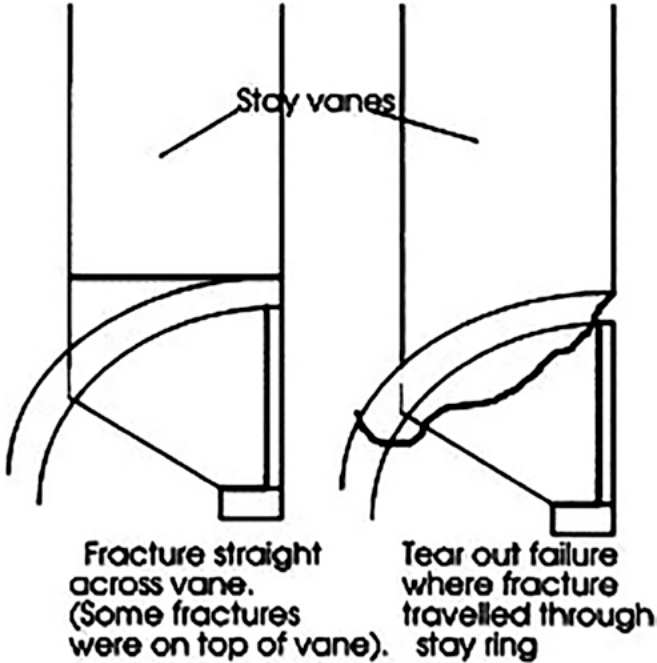
Illustration of fracture locations

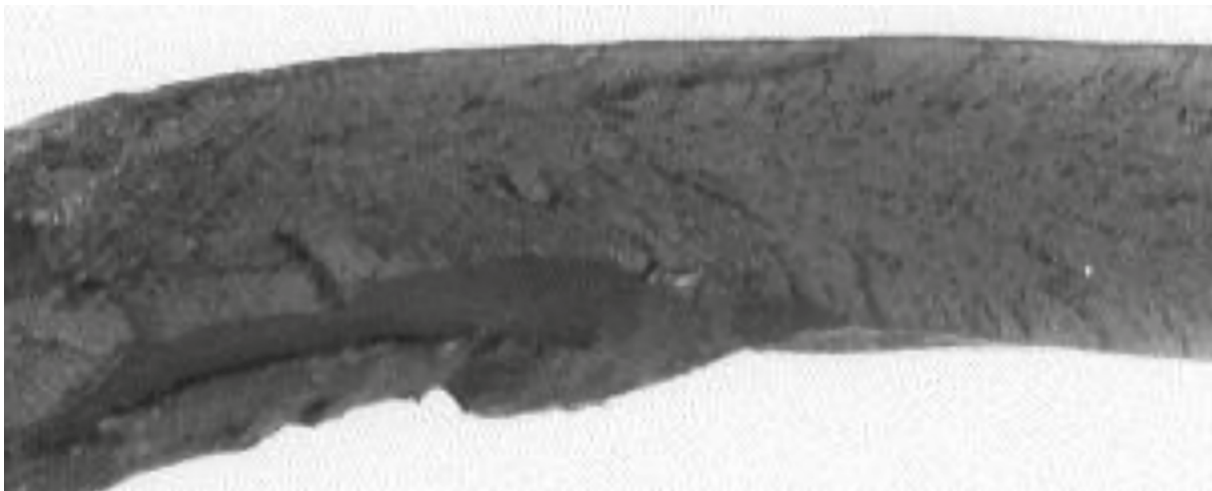
Fracture surface

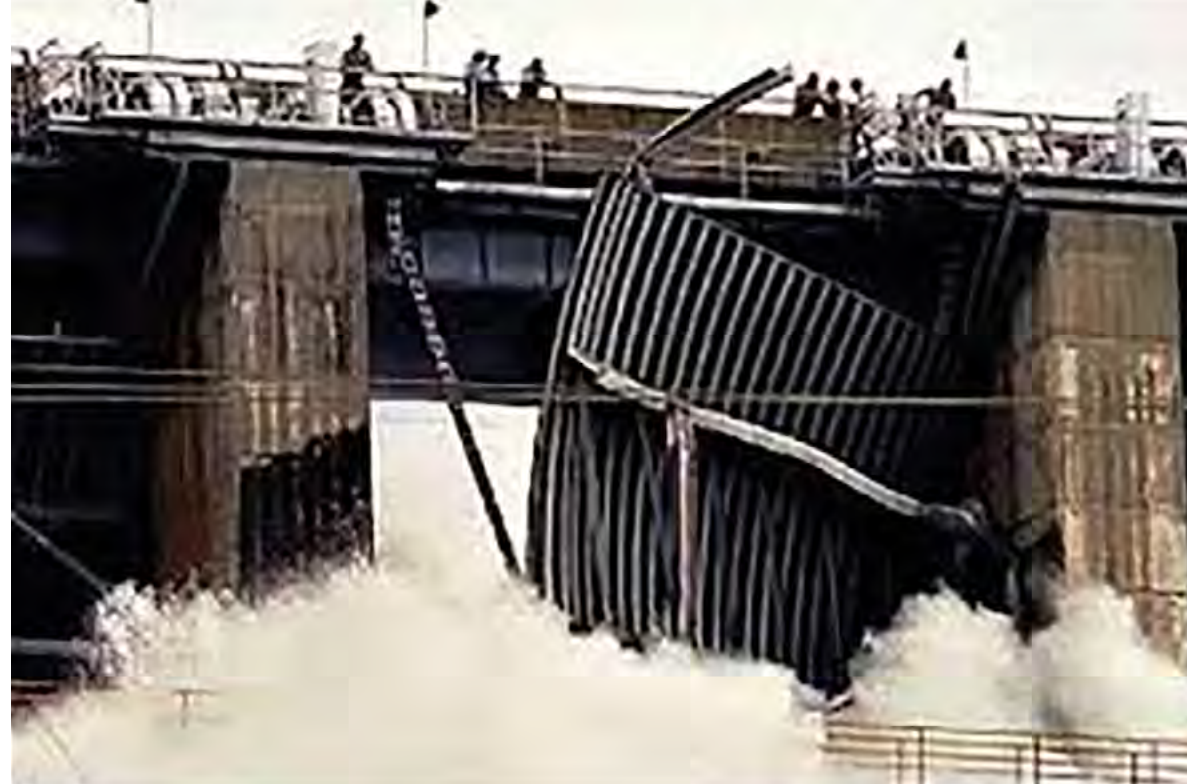
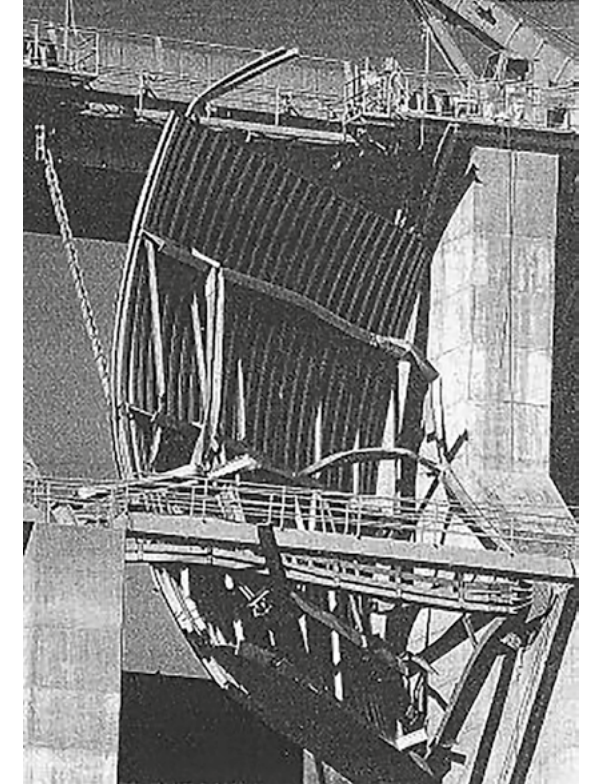
Radial gate at Folsom dam during and after the failure

- ⇒ All radial spillway gates that could involve loss of human life in the event of failure should be inspected thoroughly and design calculations reviewed to ensure the gates meet current design standards;
- ⇒ Trunnion moments were not considered in many gate designs prior to the mid- 1960s and therefore reinforcement may have to be added where a trunnion moment was overlooked;

- ⇒ To prevent possible self-excited vibrations which can cause fatigue damage and damage to the hoisting system, gates should be made adequately stiff;
- ⇒ Monitoring of a gate's condition over time should be undertaken every five years and could include loading on the hoist, changing geometry of the arms and strain gauge data to check changes in the trunnion moment caused by corrosion.

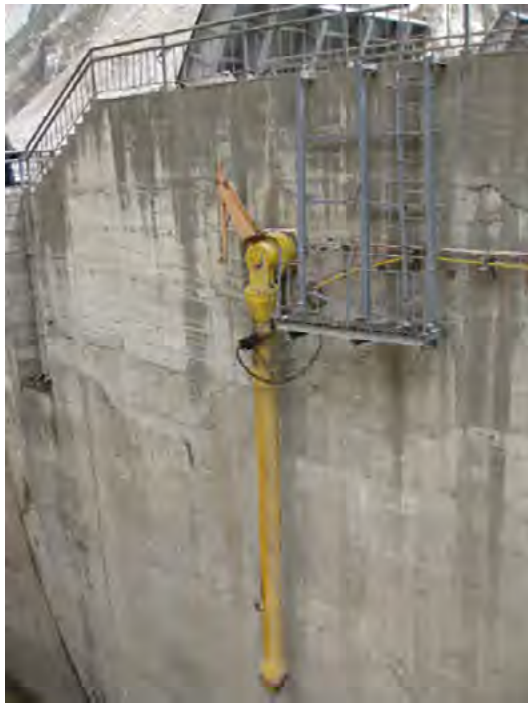
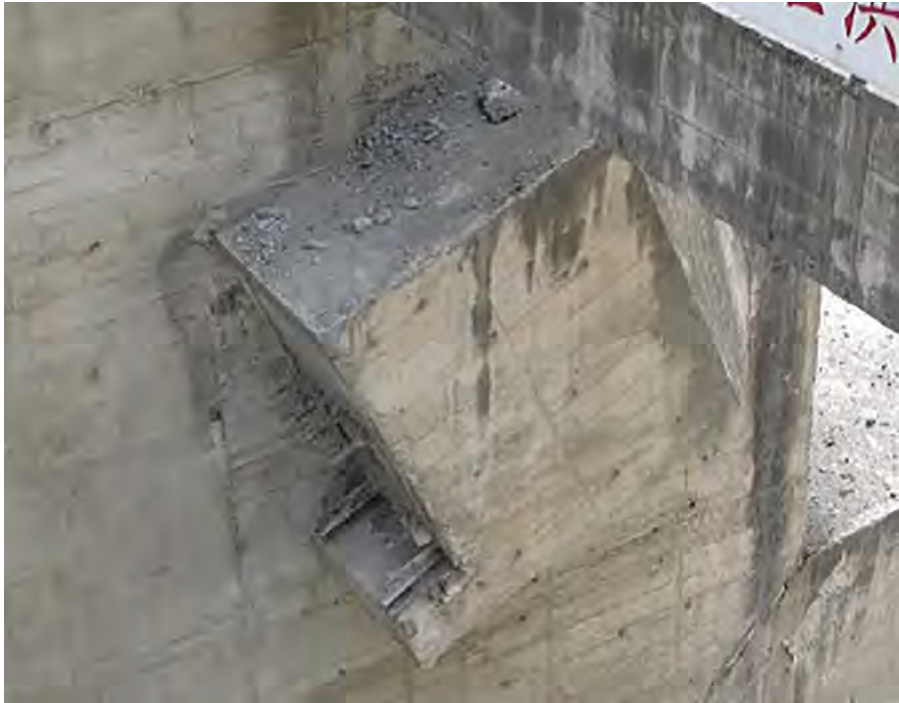
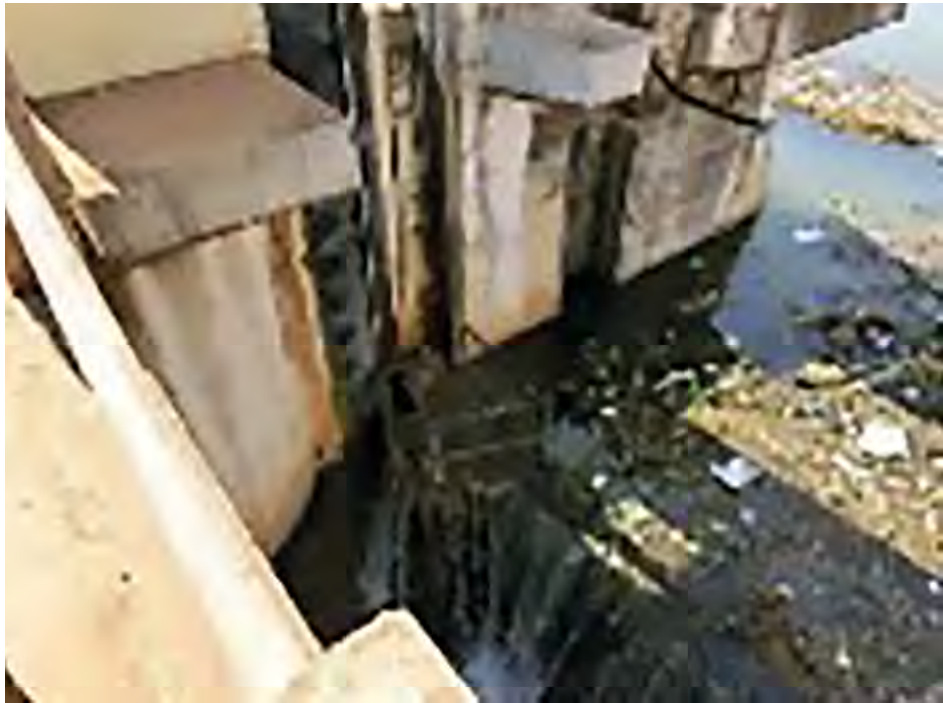
In the case of Taiping Dam Spillway, the Radial gate was damaged as below.

Failure of radial gate of run-of-river power plant due to rock falling on arm whose support has not been designed for transverse loads (May 12, 2008, Wenchuan earthquake)

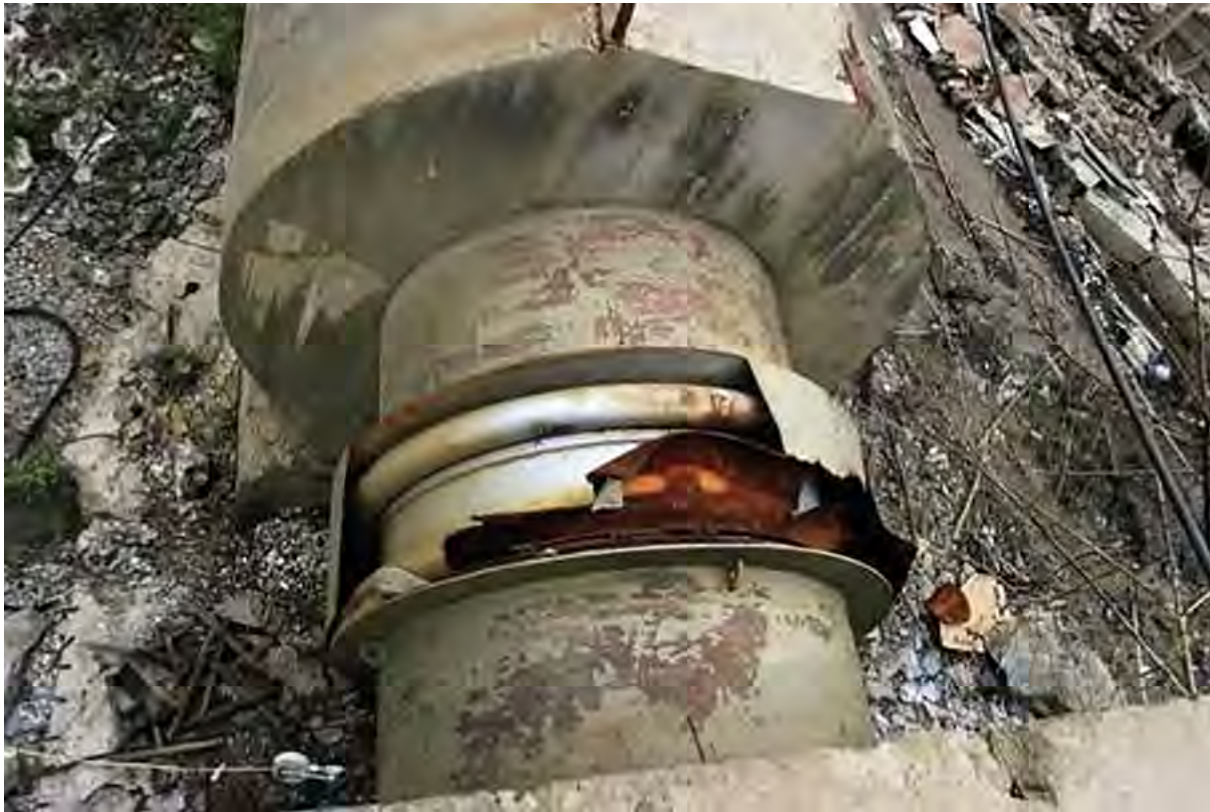
In the case of Shapai Dam, the penstock was damaged as bellow due to the Earthquake

Failure of penstock near Shapai powerhouse: detail of damaged expansion joint (Wenchuan Earthquake)

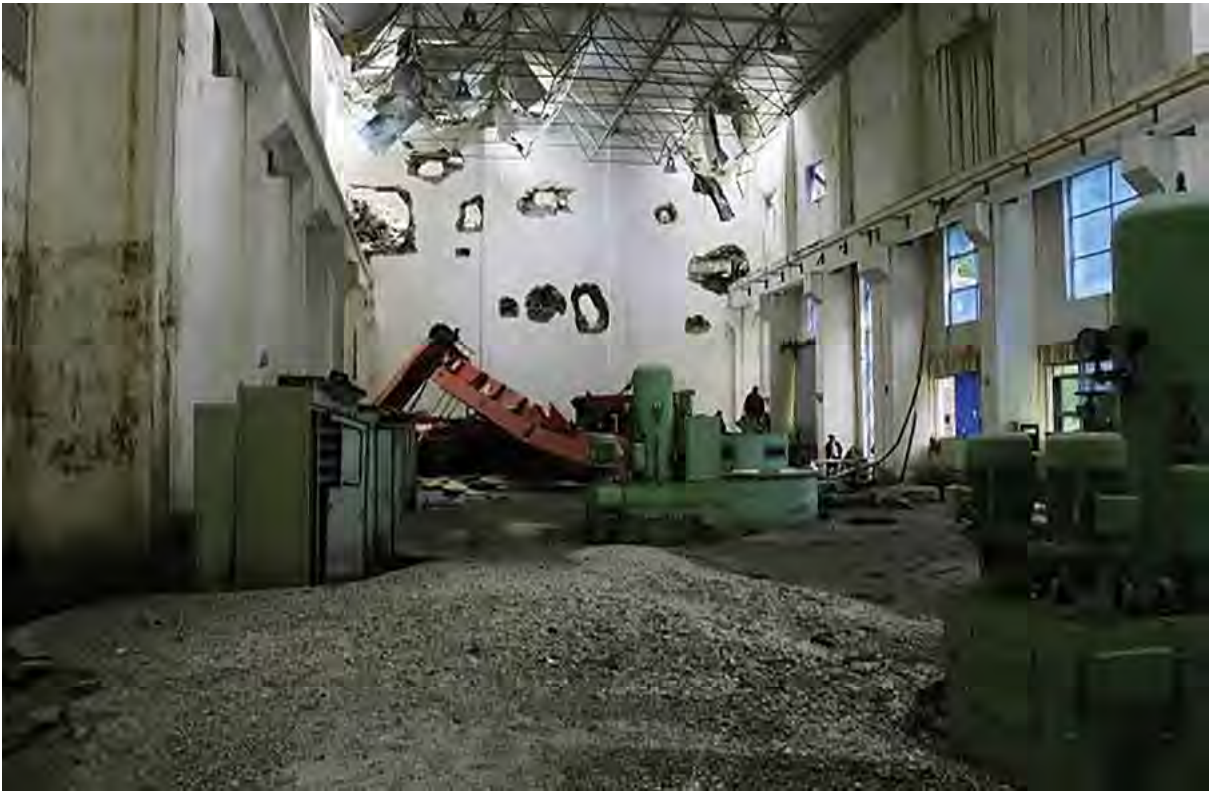
Damaged crane, end wall and roof of powerhouse of Shapai arch-gravity dam project caused by rockfall; sediments were deposited due to penstock failure and powerhouse earthquake, China)

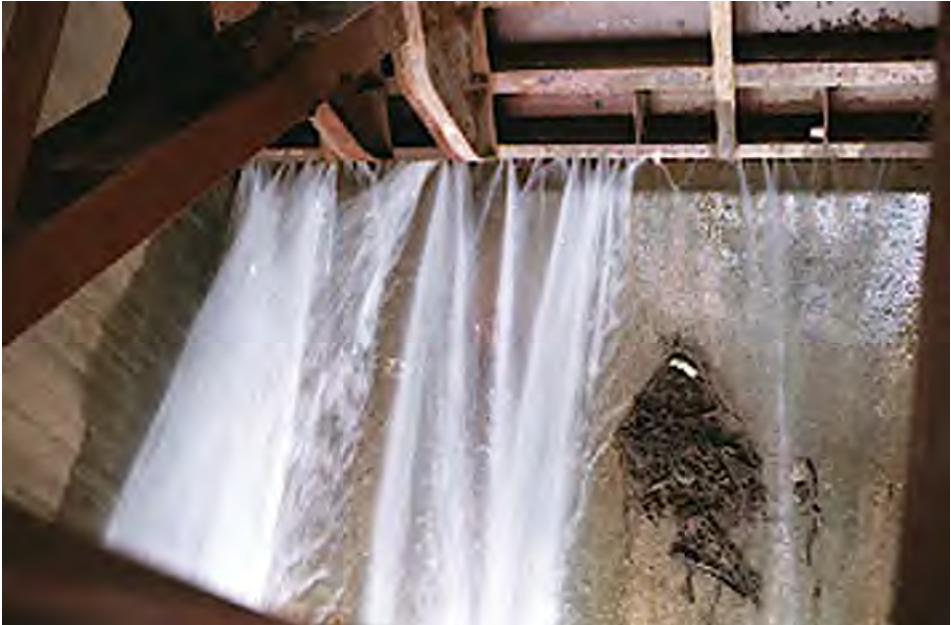
At Sefidrud dam, the radial gate of the intermediate level spillway shown was damaged during the 1990 Manjil earthquake

Damage of the radial gate of intermediate level spillway of Sefidrud dam caused by June 21, 1990, Manjil earthquake, large hydrodynamic pressures caused inelastic buckling of gate arms, gate distortions and leakage

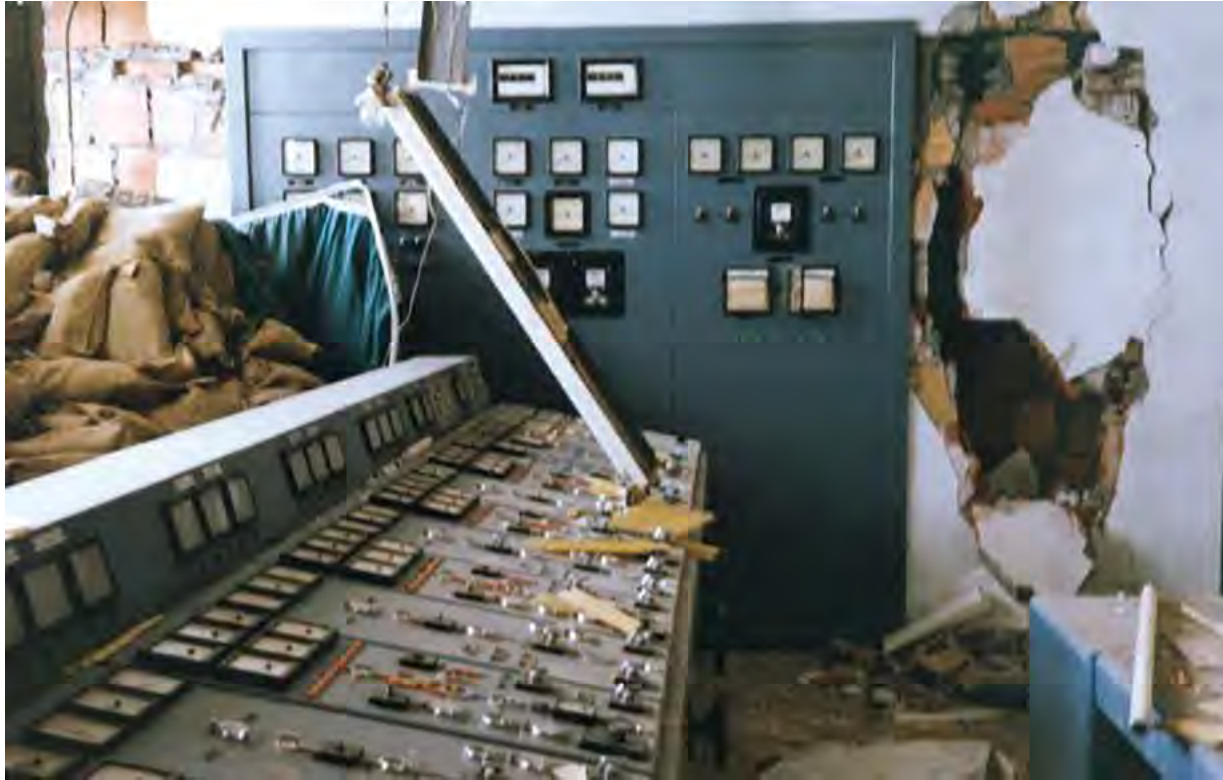
Non-structural elements falling on panel in control room of powerhouse of Sefidrud dam project and electrical cabinet attached to infill wall (June 21, 1990, Manjil earthquake)

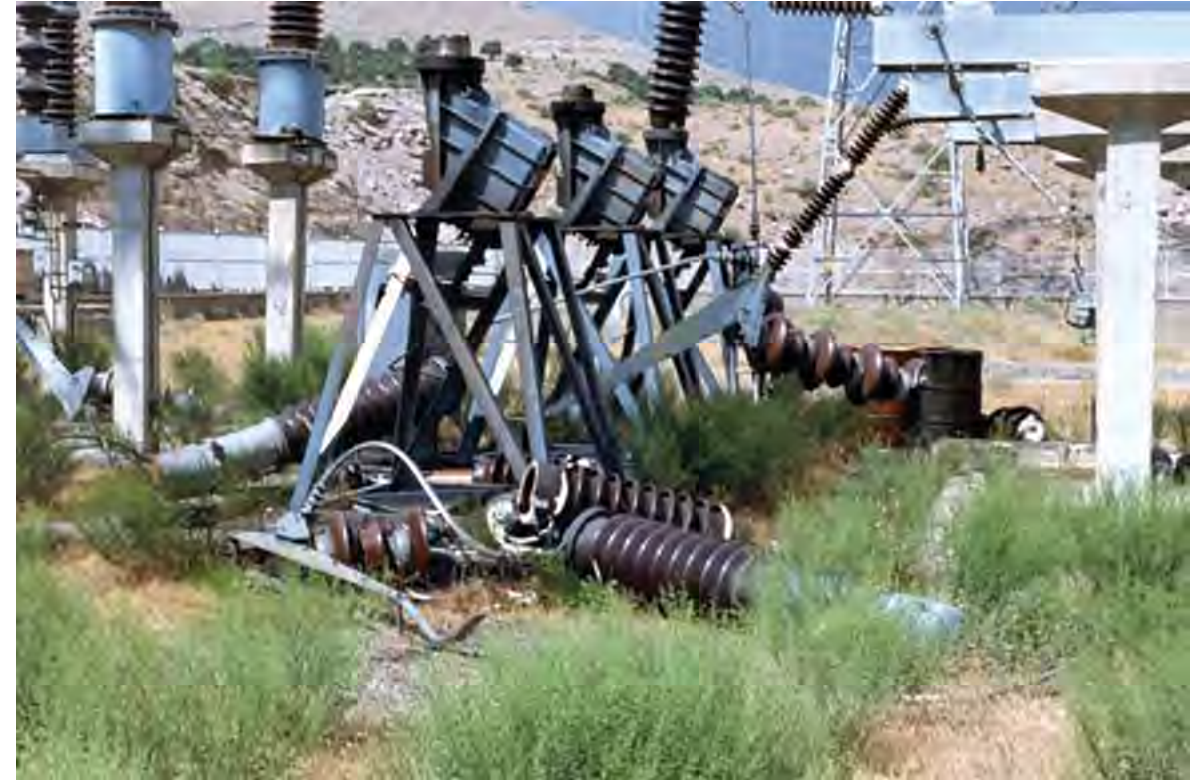
Overturned switchyard equipment with high center of mass caused by amplified ground shaking on fill, and ground movements (Sefid Rud dam, June 21, 1990, Manjil earthquake)

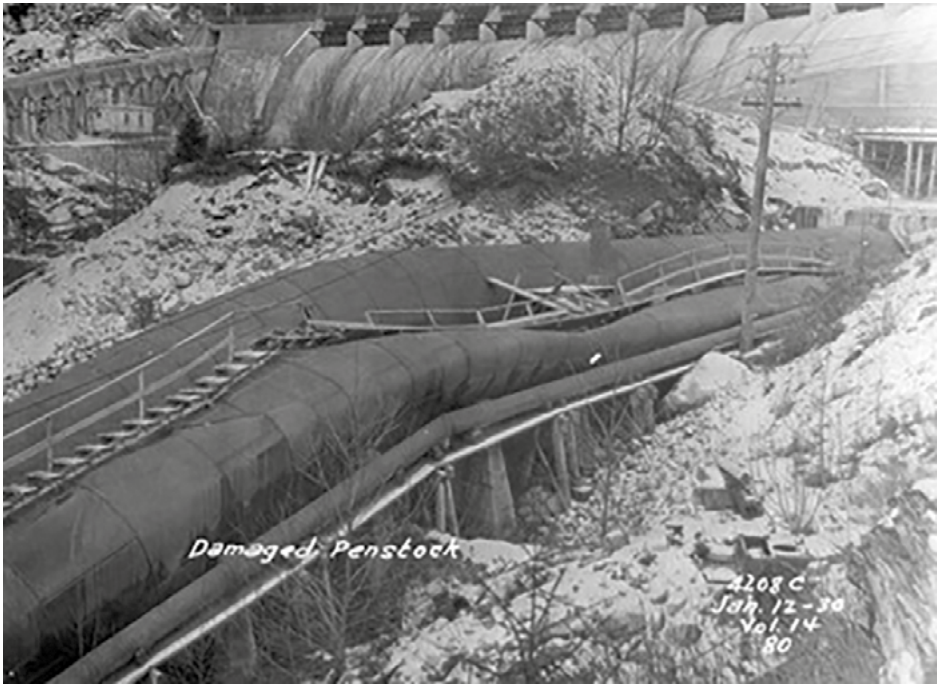
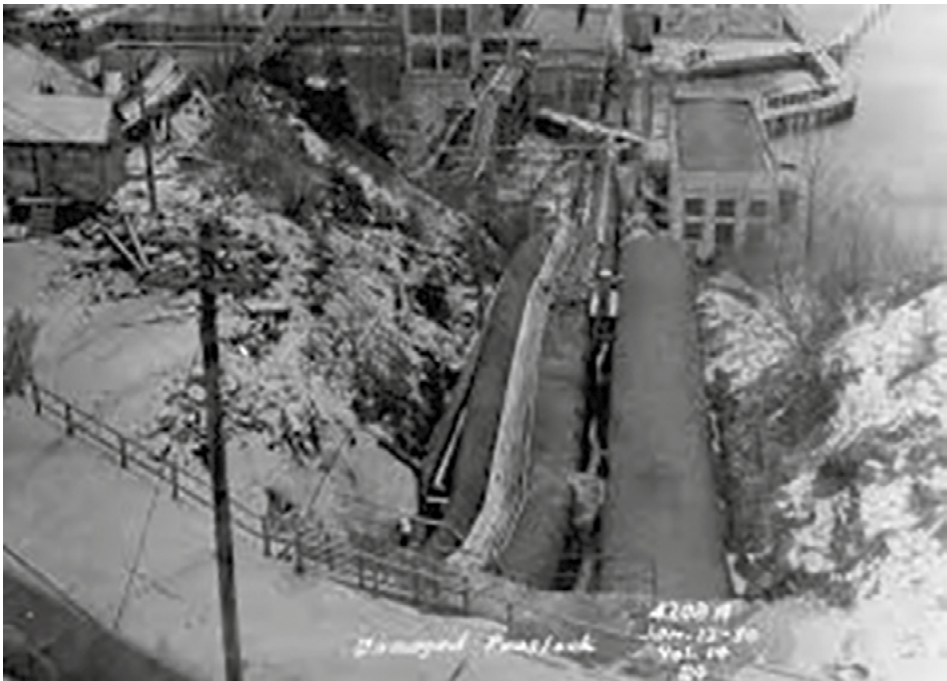
Buntzen Hydro Dam - Damaged Penstock - City of Vancouver Archives

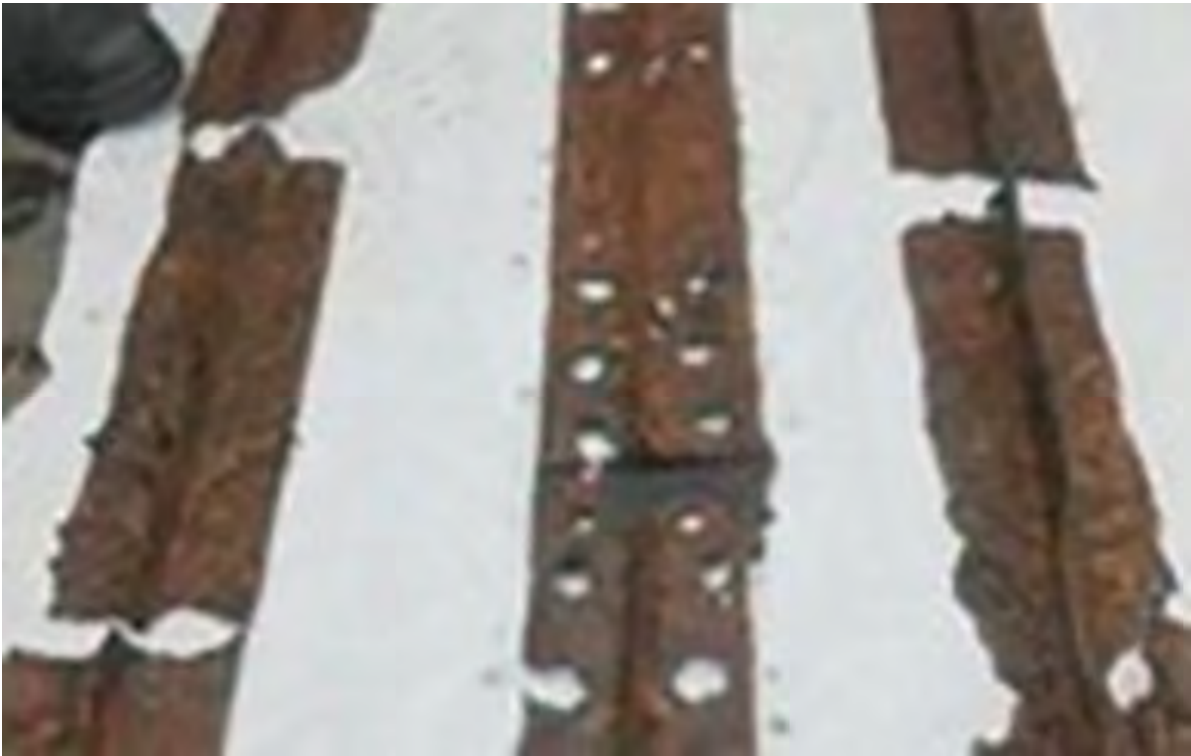
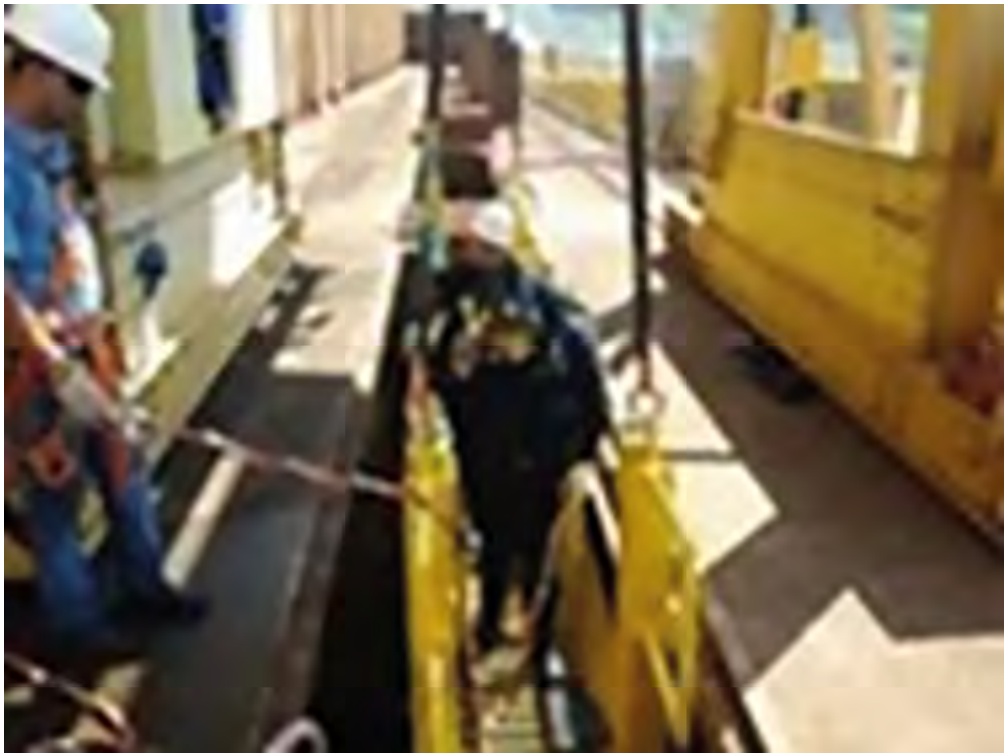
Part of the tailrace guide wall on the right bank was damaged. In several other locations were observed cracks and the structure was not in contact with the foundation. The gates had to be repaired, also. Recently, the equipment for the supervision and control of the power house and locks have been updated.

Damages in the guides of the tailrace - Barra Bonita Dam

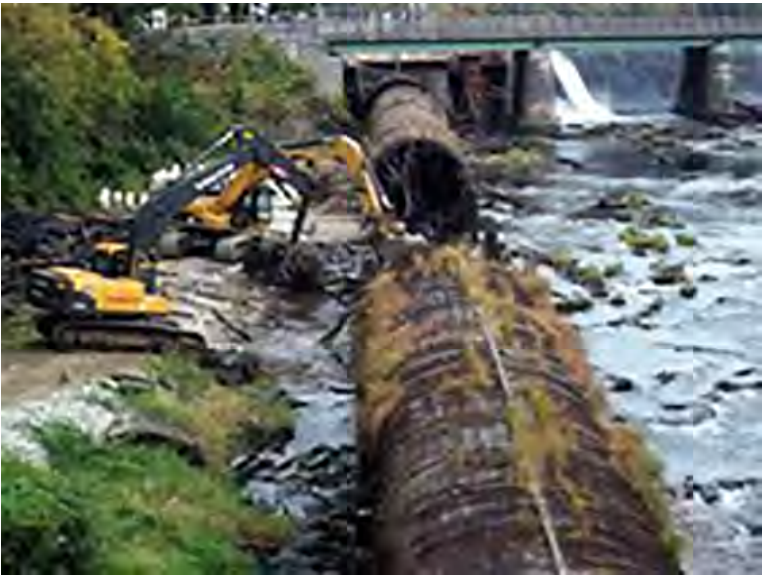
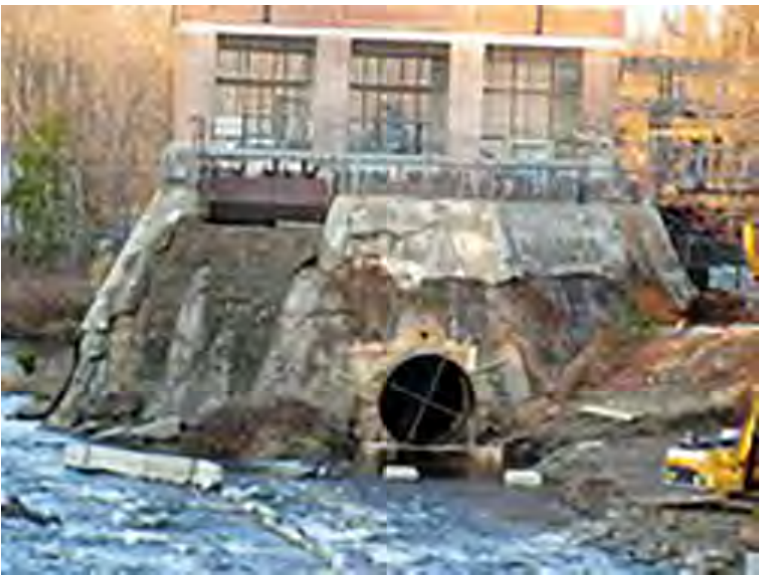
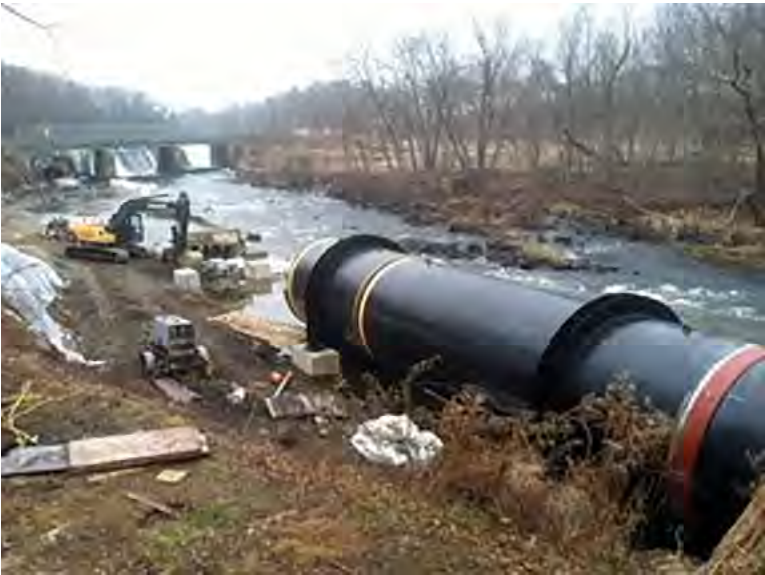
The Pepperell dam was constructed in 1918 when the Pepperell Paper Company was formed to purchase the Nashua River Paper Company and constructed a new powerhouse on the opposite side of the river using a dedicated wood stave penstock to deliver all the flow to three new turbines located in a new powerhouse whose power output was delivered to the new paper mill. The 1918 concrete dam has an ogee shaped spillway, which was starting to crack and was repaired during the summer of 2012 *when the penstock was replaced a second time since 1918.*

Penstock being replaced in Pepperell Dam

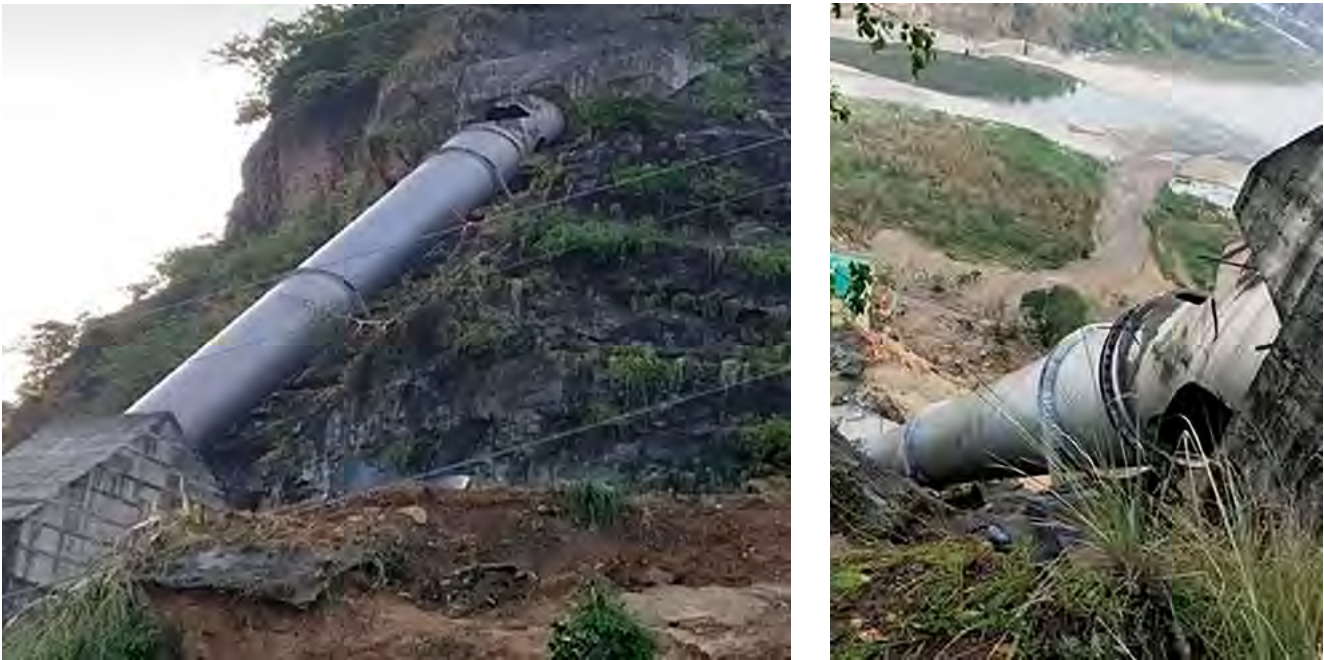
*During the trial run as the 3*33.3 MW generating units were loaded for generation of 16 MW, the penstock 150 meters above the powerhouse burst and water gushed inside, badly damaging the machines.* Penstock of the power house is about 8 km long and runs overground down the hill from the storage dam. A hydropower expert, having remained associated with many large power projects in Himachal Pradesh and other states, claiming anonymity, informed that the penstock bursting was not the first such accident in Himachal Pradesh.

Penstock of the power house that was burst during the trial step
