Is Your Dam Safe?

An281	Andriolo, Francisco Rodrigues; Moreira, José Eduardo
	Is Your Dam Safe? – Vol. 1 / authors: Francisco Rodrigues Andriolo e José Eduardo Moreira. São Carlos, 2022.
	1394 p. il. color
	ISBN – 978-65-5668-011-8
	DOI – http://dx.doi.org/10.26626/9786556680118/2022B001
	1. Dams. 2. Training. 3. Quality. 4. Repairs. 5.Controls. 6. Cement. I. Orgs. II. Title.
	CDD 370

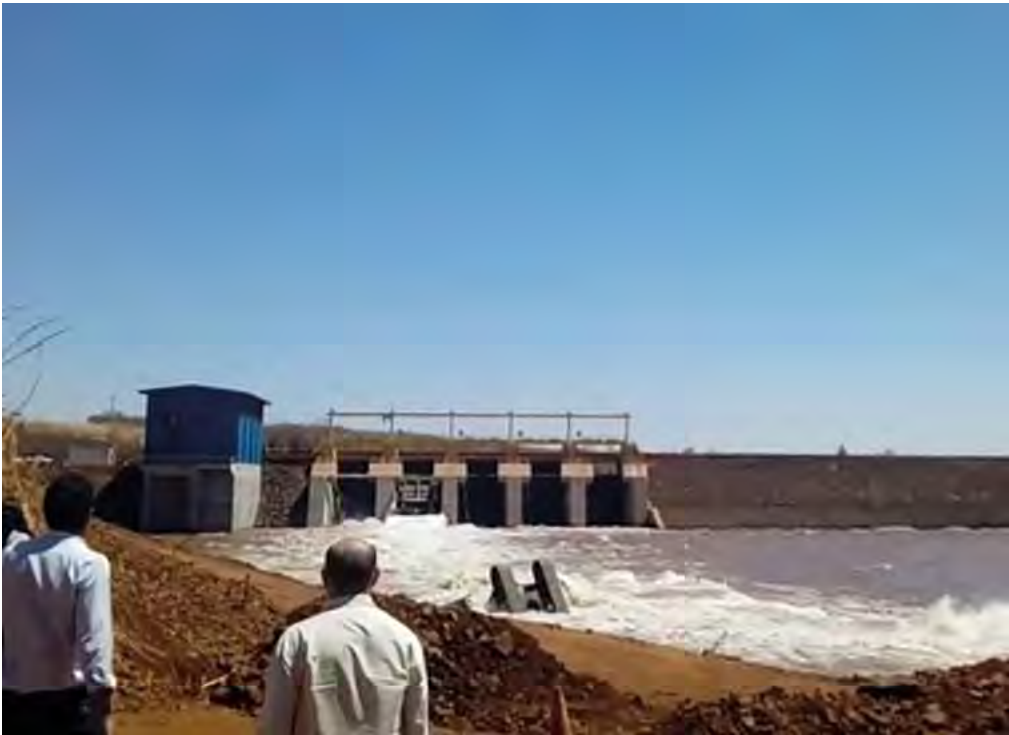
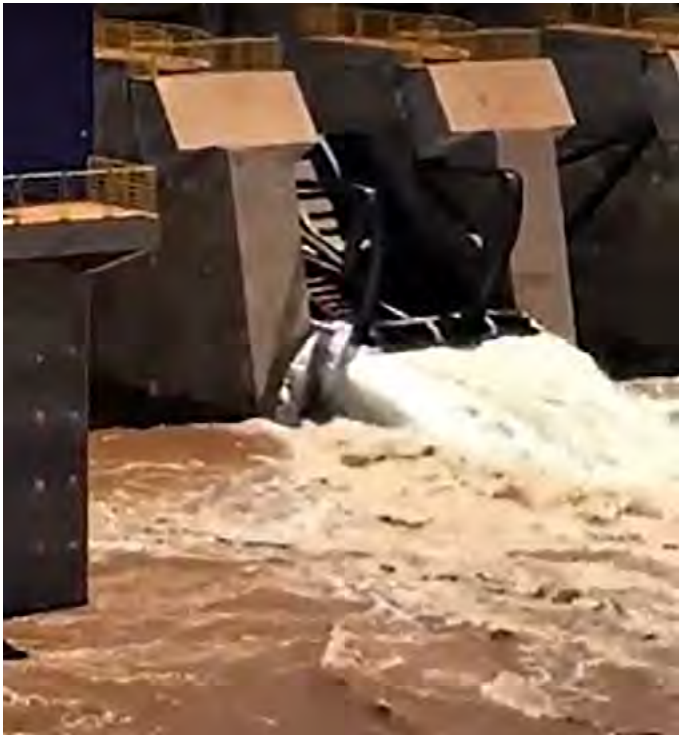
One of the gates of the spillway of the Ype dam of the Verdão River, in the municipality of Santa Helena de Goiás, broke and in September 2017.

Moment of the Rupture of the Ype Dam Spillway

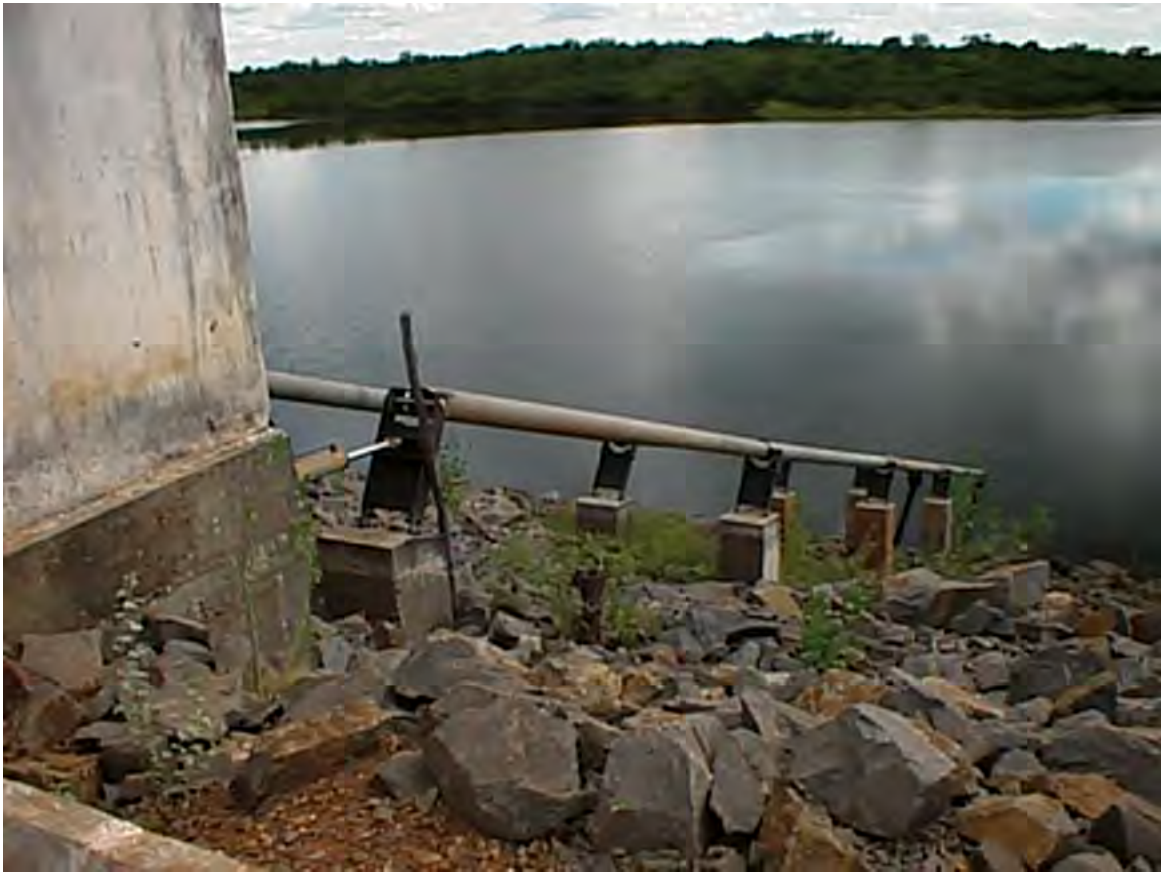
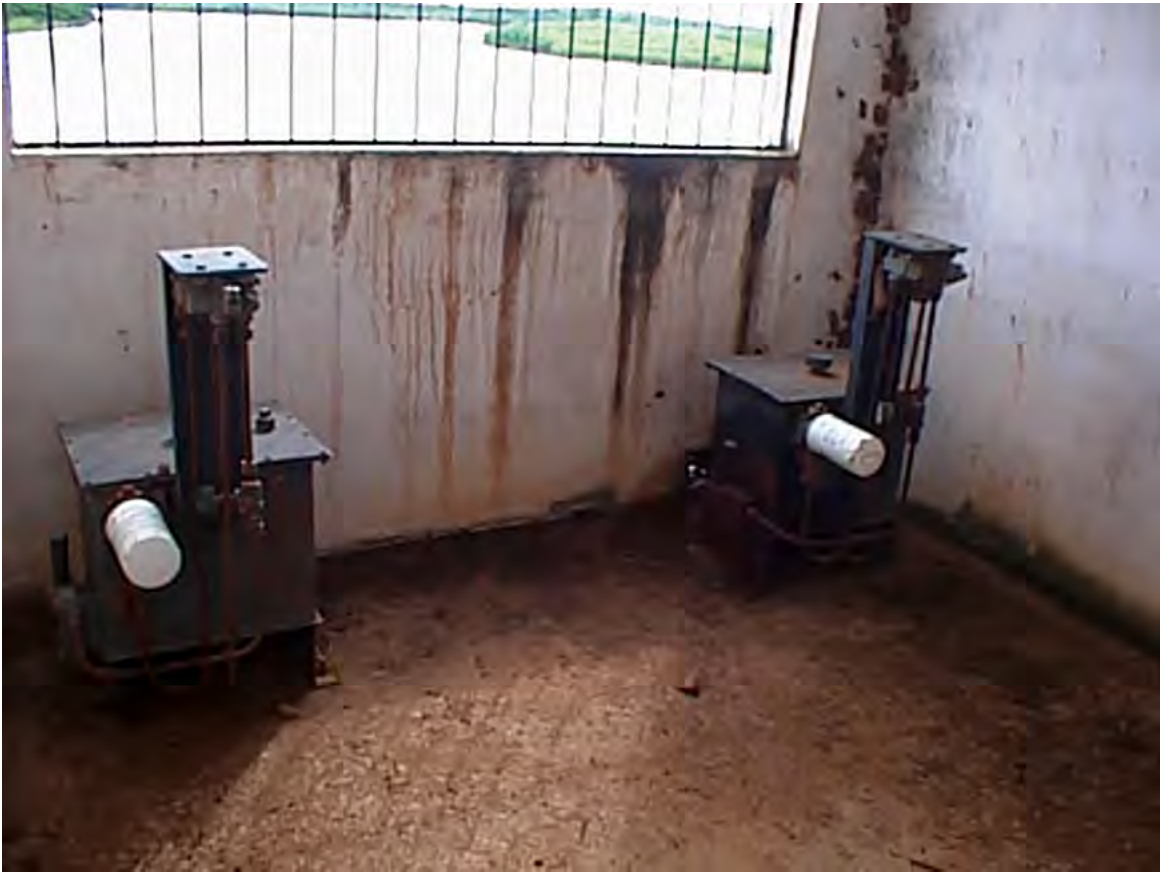
Vandalism on equipment (Andriolo’s Archive)

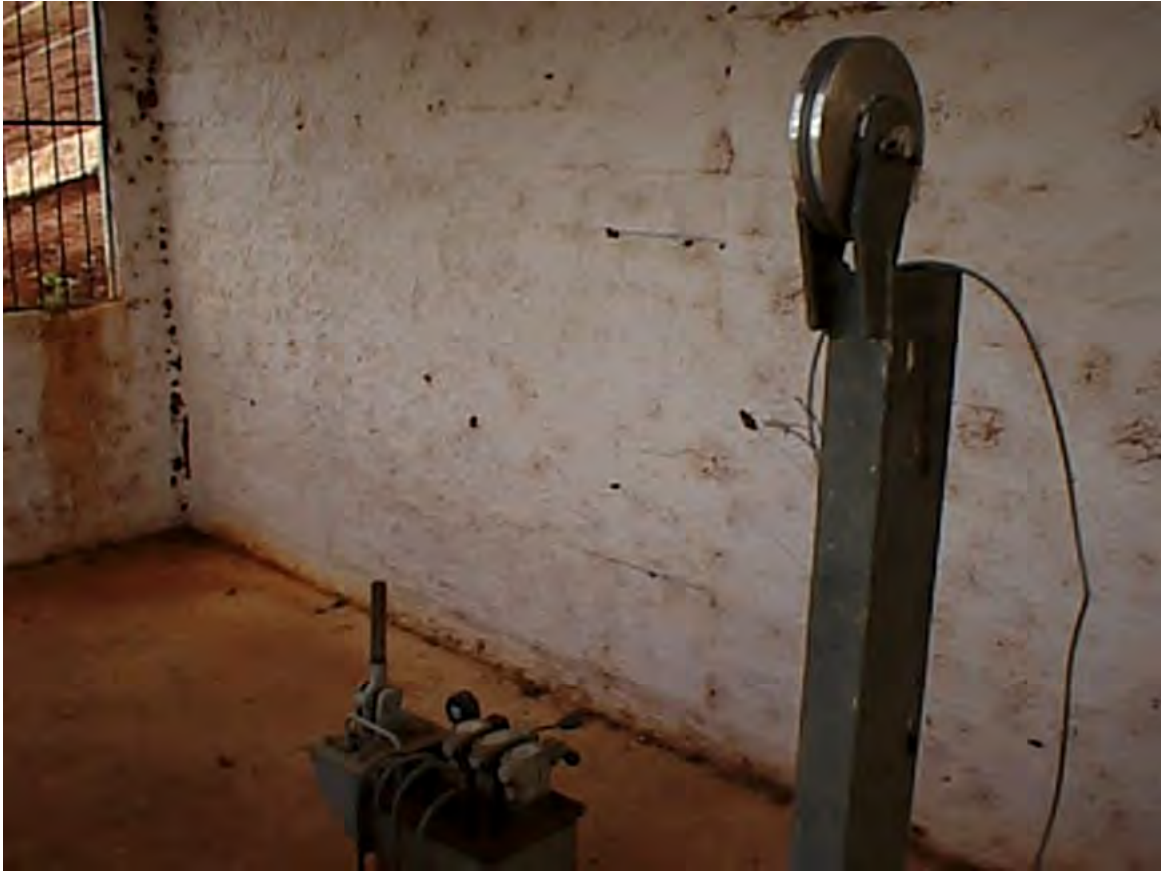
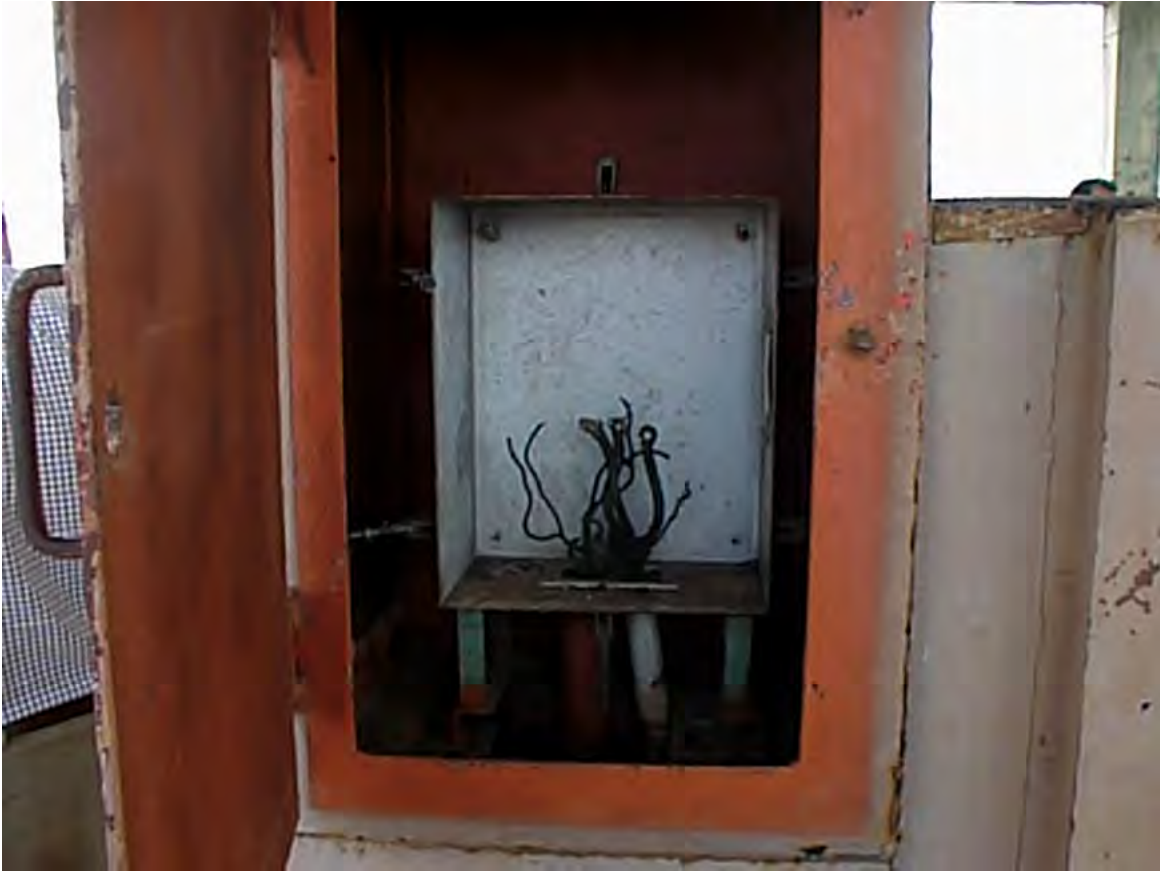
Vandalism on equipment (Andriolo’s Archive)

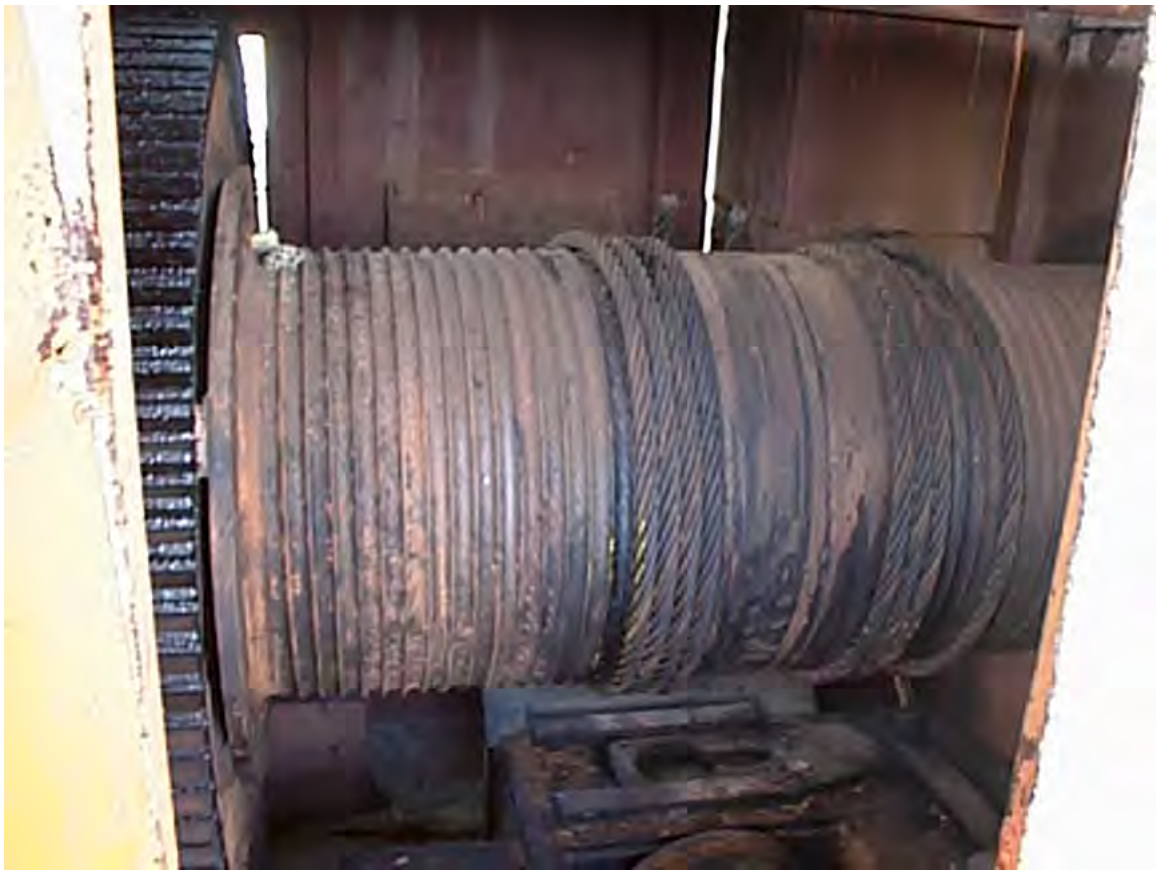
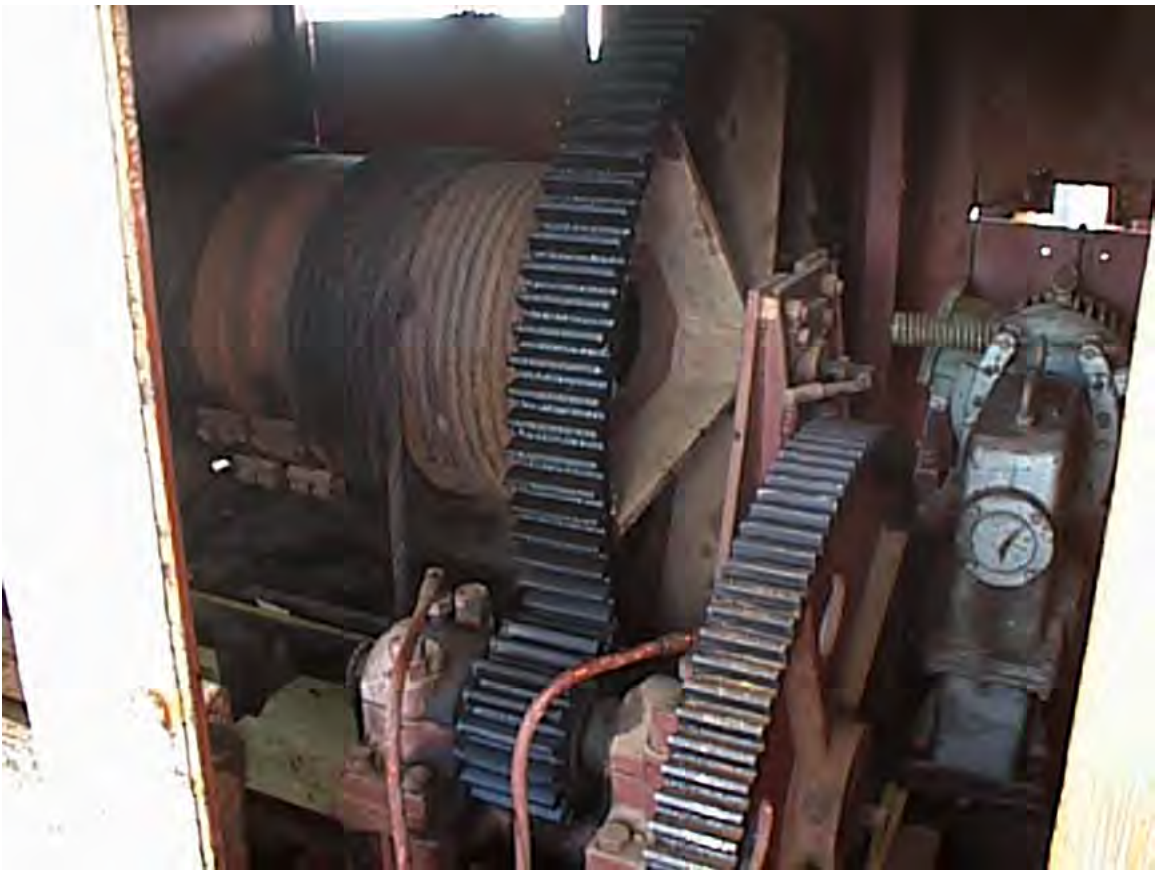
Vandalism on equipment (Andriolo's Archive)

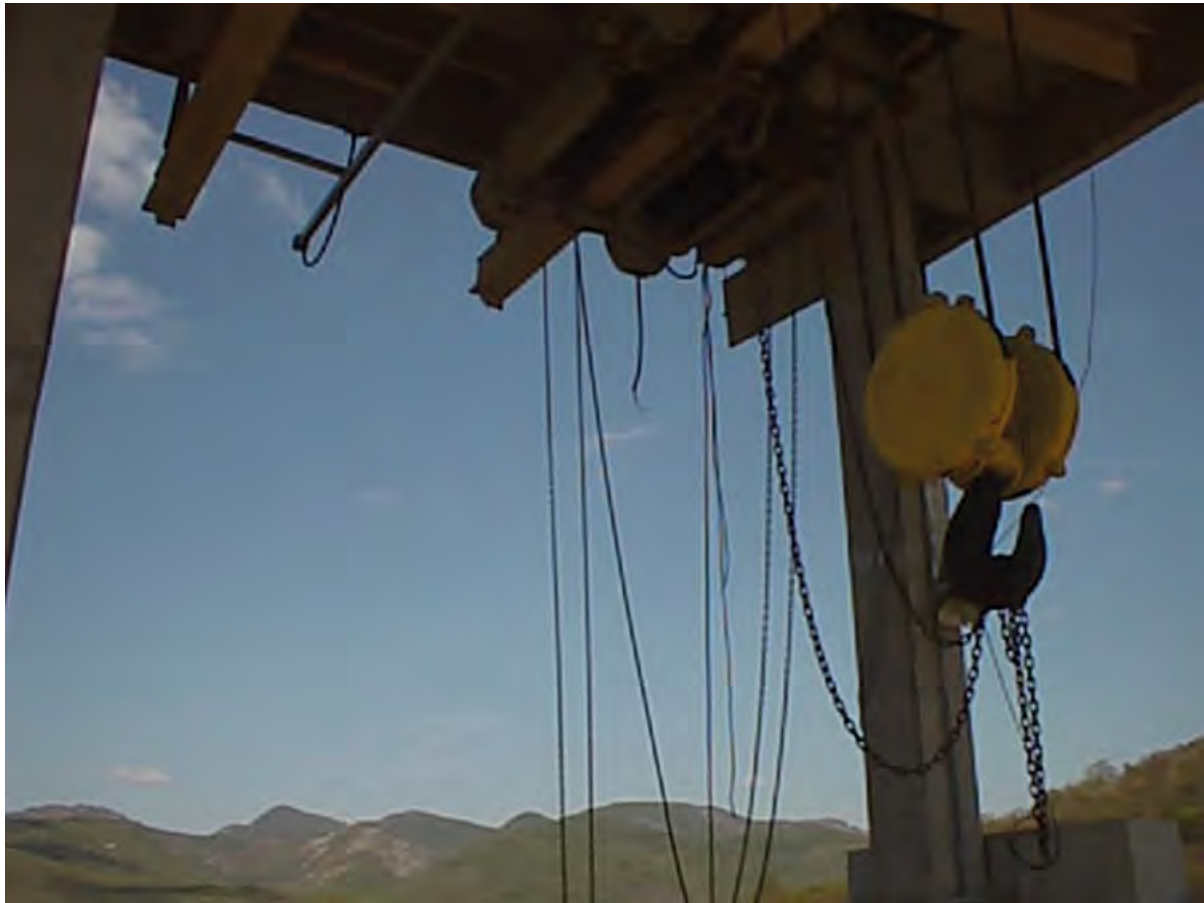
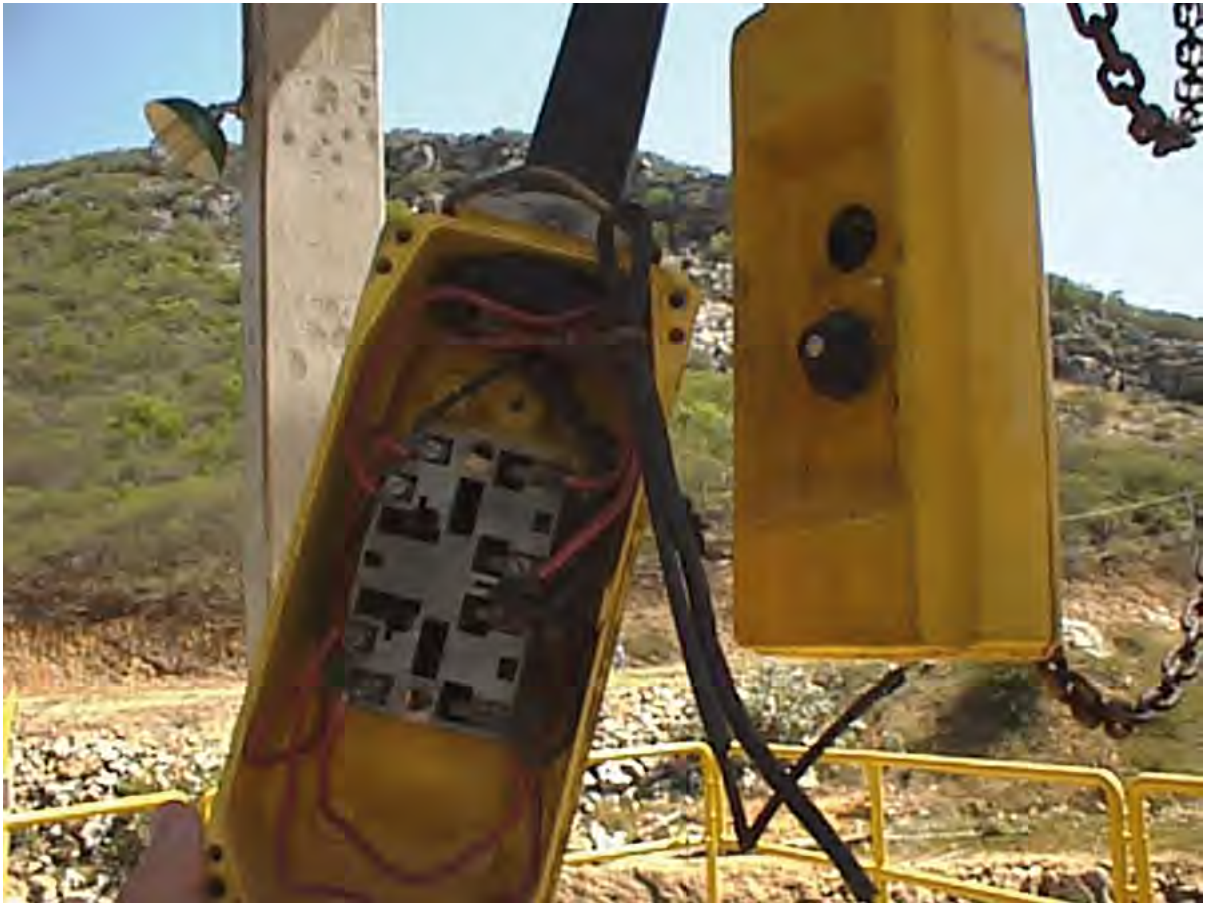
Vandalism on equipment (Andriolo’s Archive)

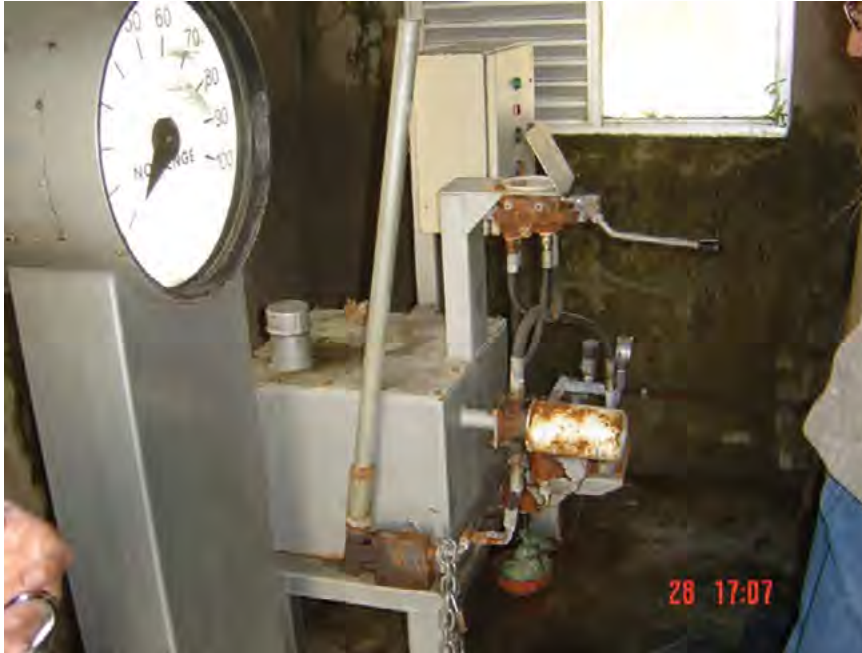
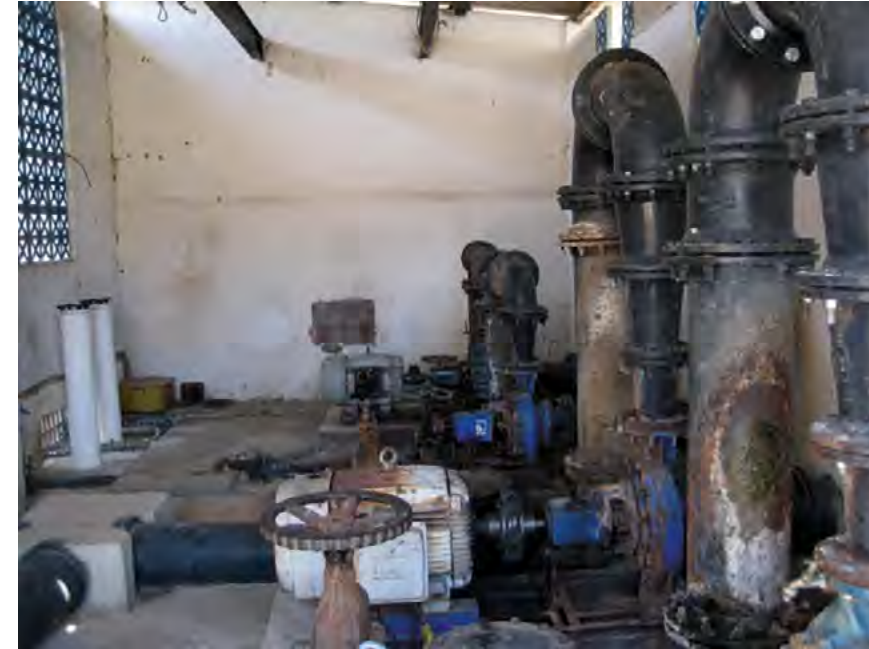
Vandalism on equipment (Andriolo's Archive)

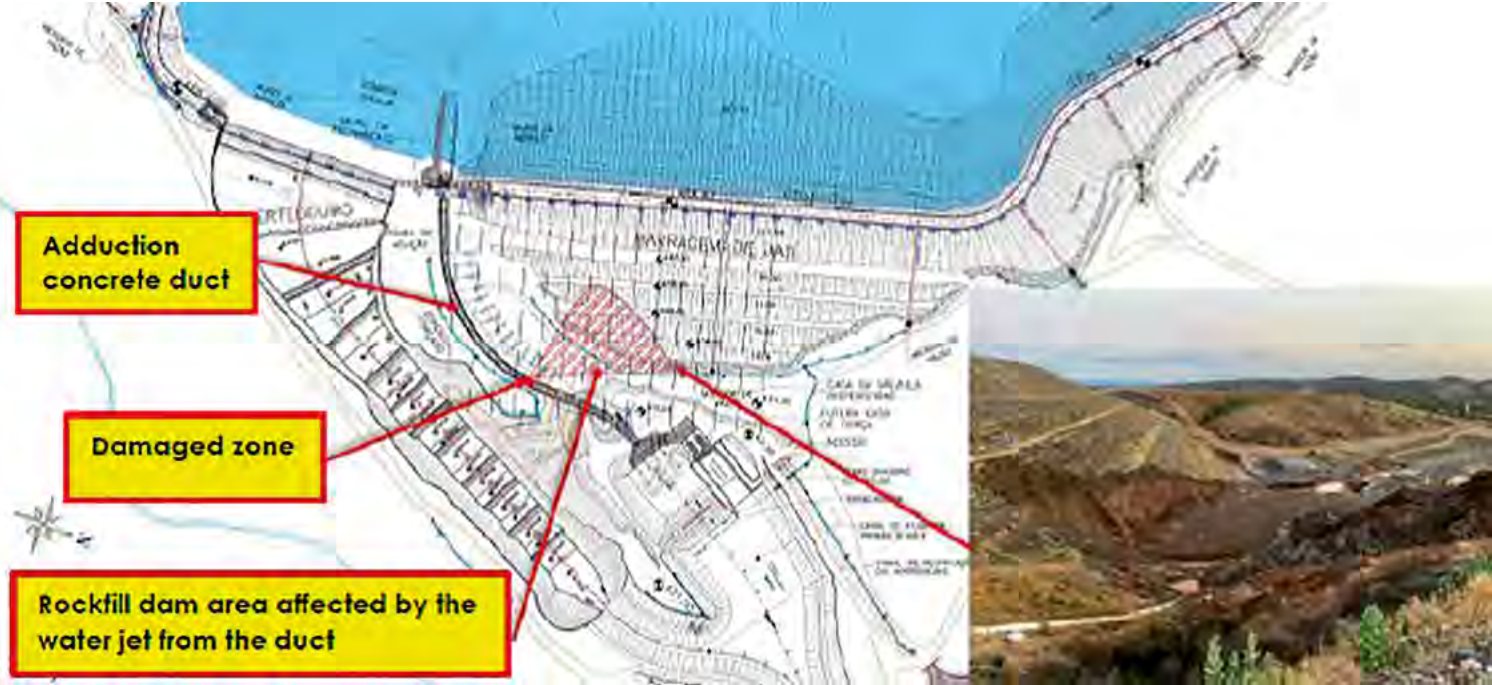
The project is part of the northern axis of the transposition of the São Francisco River - Inter Basin Transfer Project - which was put into operation on 2020/June-26th. On 2020/August- 22nd, the damage occurred in the concrete conduit that fed the flow of water from the water intake to the adduction of the valve system to supply a Basin Transfer channel and a future hydroelectric plant.

Jati Dam - Auxiliary Structures and damaged area - From the References

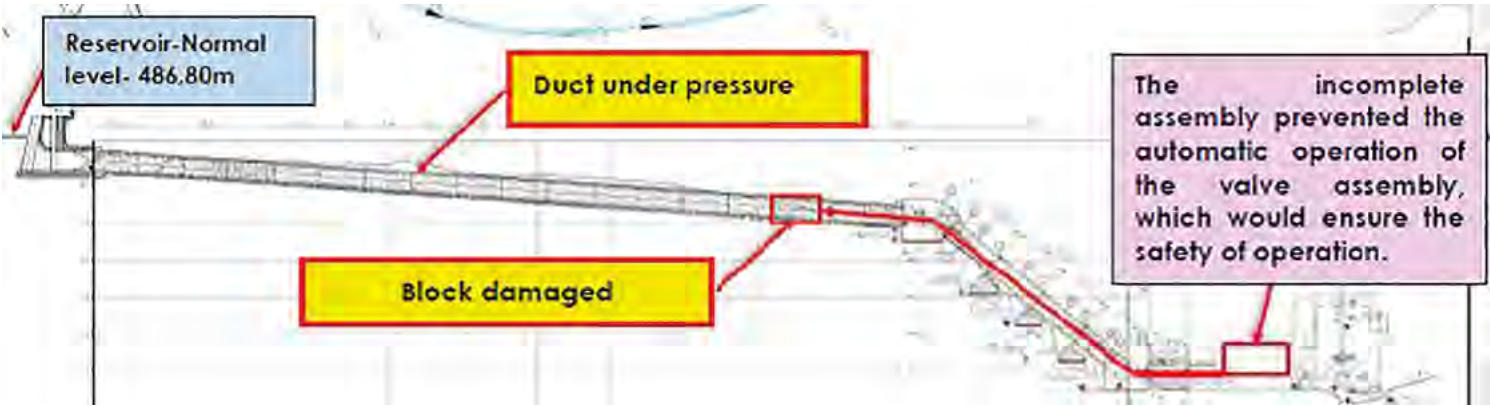
Jati Dam and damage information - From the References

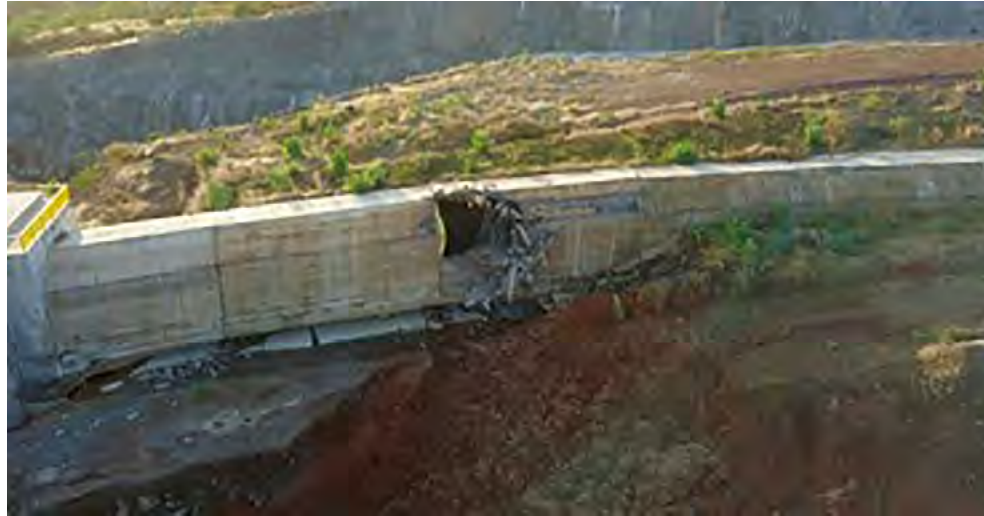
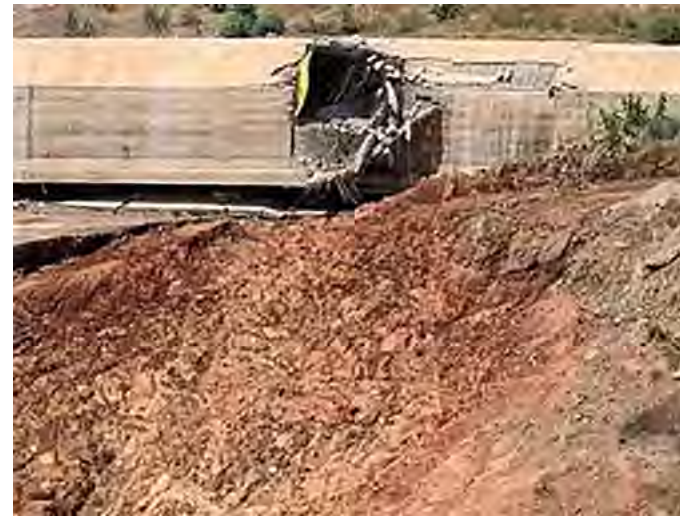
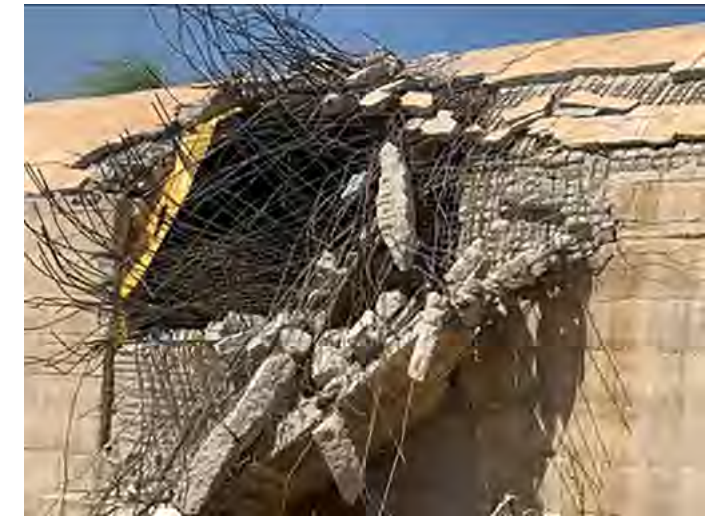
- ⇒ That there was a **failure in the assembly and commissioning of the valve assembly**. The operation of the spherical valve, whose installation and subsequent operation did not occur according to the standards and standards determined by the manufacturer itself,

caused its inopportune closure and, as a consequence, ***the hydraulic transient that exceeded the design values***, leading to the collapse of the concrete conduit;

Concrete conduit failure, and concrete aspect after the damage - From the References

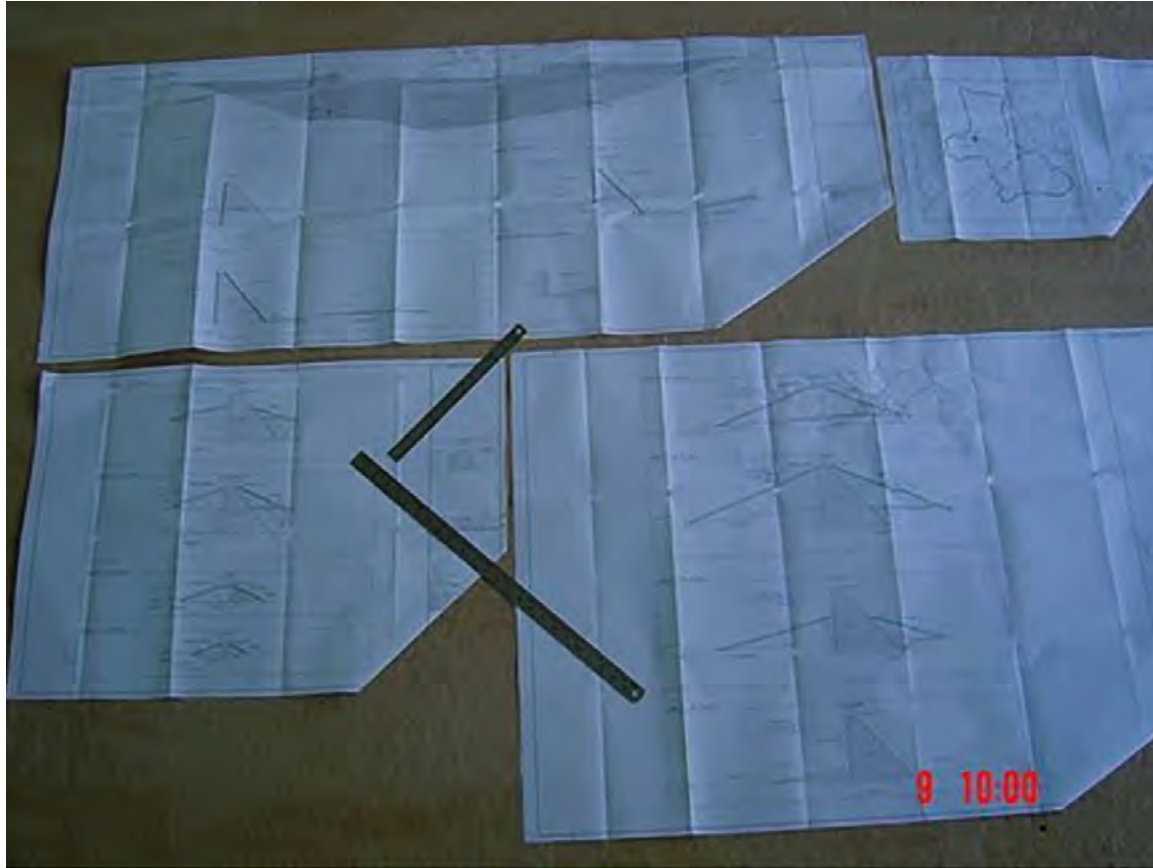
Drawings in different and no Standard format-dimensions, showing a “poor” discipline-organization (From Andriolo’s Archive)

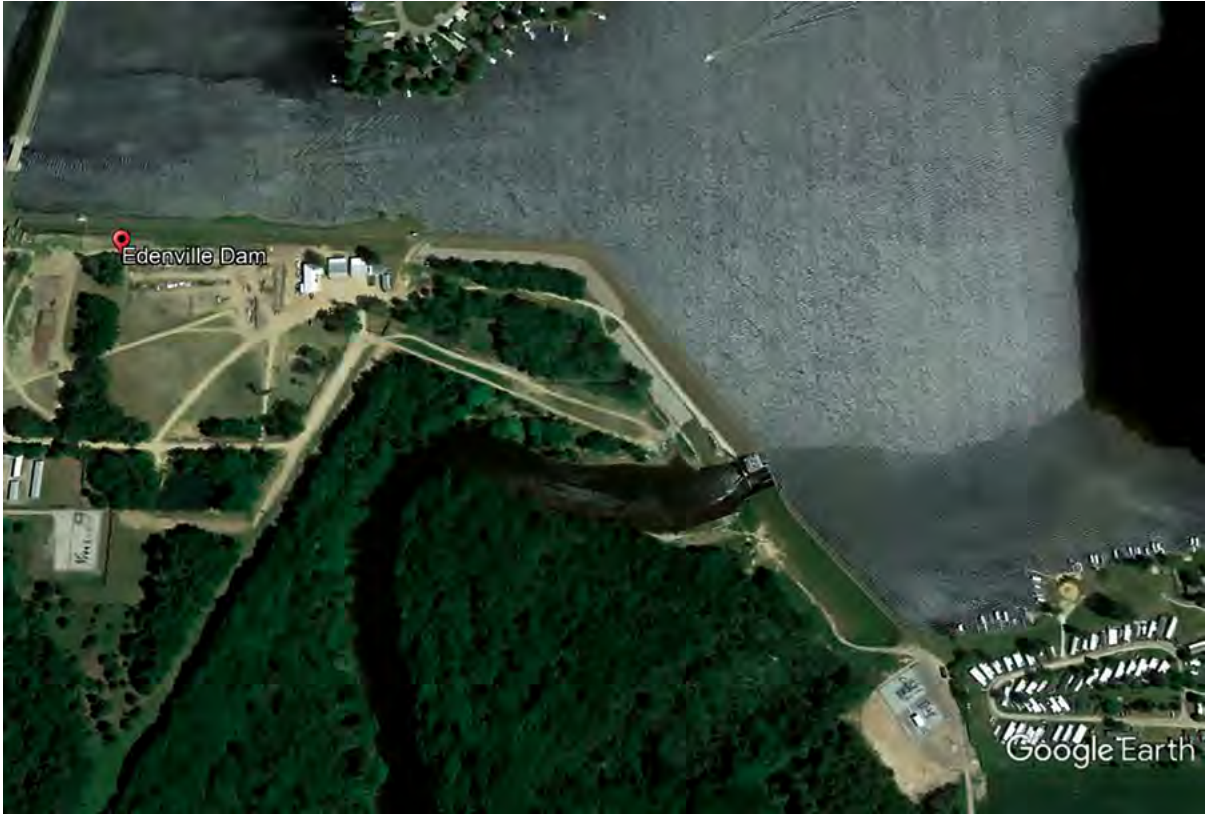
Edeville Dam

- ⇒ **Edenville Dam** – was built in 1924 for hydroelectric power and for flood control. The dam was equipped with two 2.4 MW turbines capable of generating 4.8 MW of electricity in total. In May 2020, after heavy rains, the Edenville Dam breached and the downstream Sanford Dam overflowed, which caused major flooding in Midland County, including the city of Midland. On May 19, 2020, 5:46 p.m., due to flooding on the Tittabawassee River, the eastern side of the dam collapsed, prompting immediate evacuations in the town of Edenville and the city of Midland. The Sanford Dam, about 16 km downstream of the Edenville Dam and 9.7 km upstream of the city of Midland, subsequently overflowed.

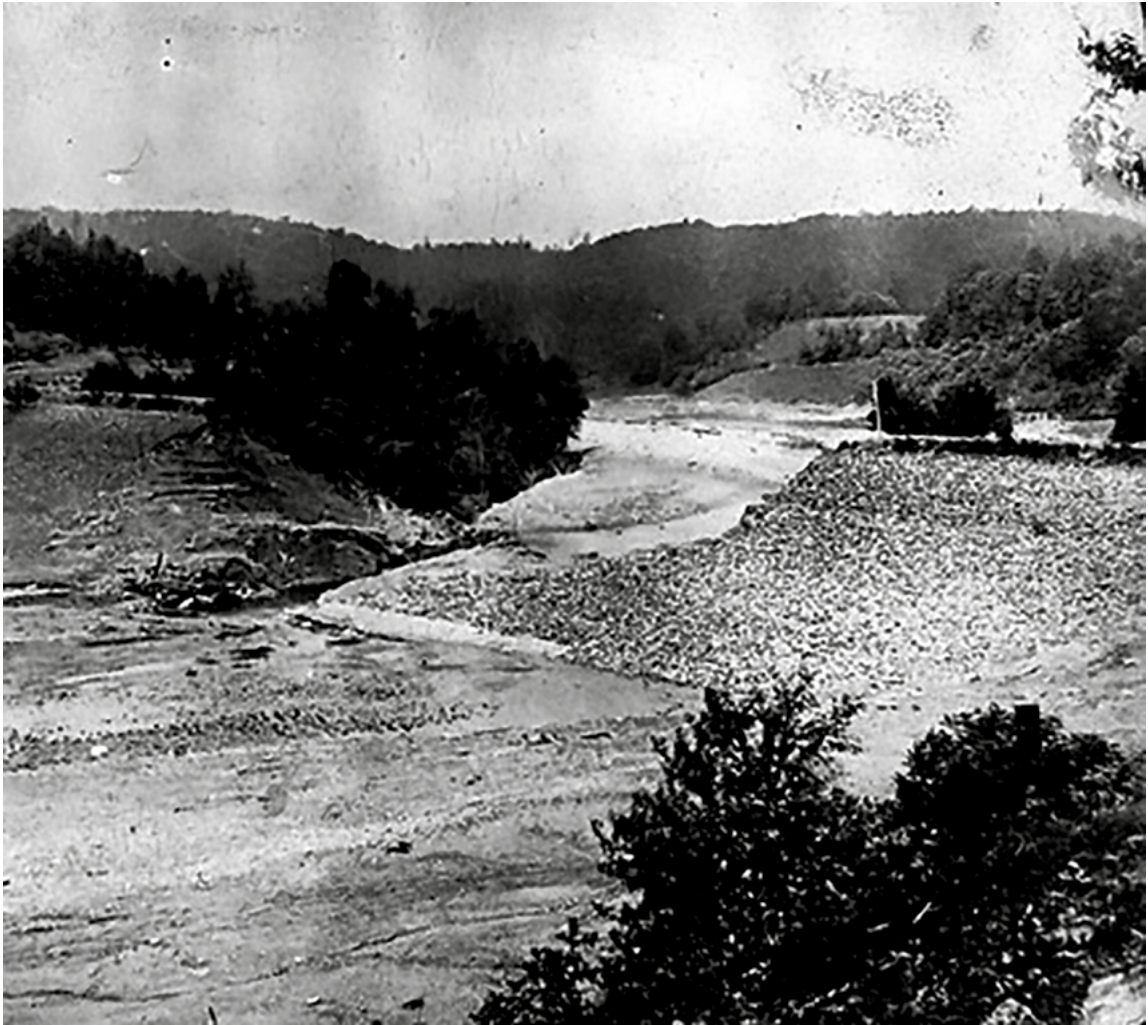
Event: The dam’s discharge works consisted of a stone-lined culvert with five valves for releasing varying amounts of flow as well as a spillway created by cutting into the rock along the east abutment. As a result of *poor maintenance*, the outlet works culvert collapsed and a portion of the dam washed out in 1862.

South Fork Dam after failure in 1889 (Picture from Internet)

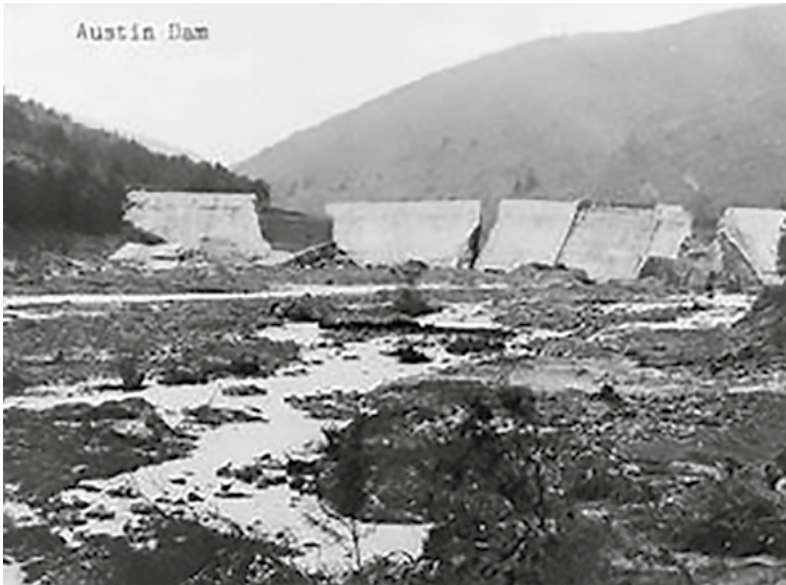
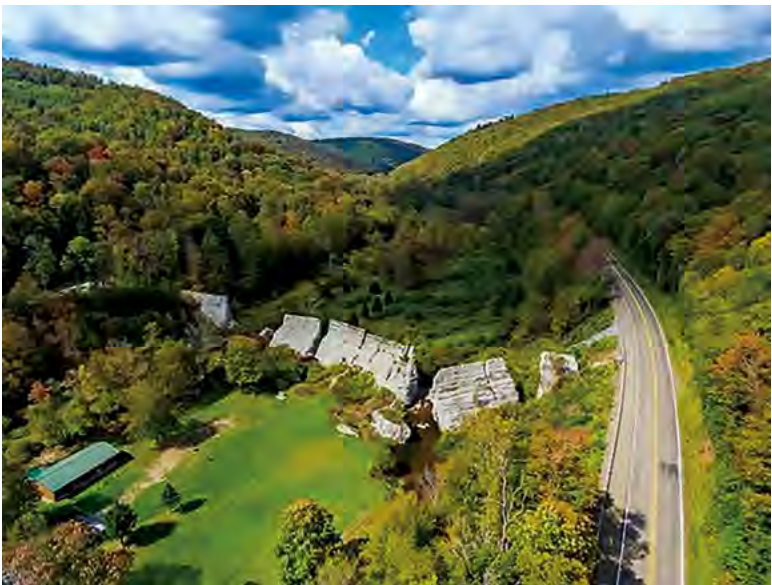
Event: Austin Dam was designed to *be thirty feet thick but was built only twenty feet thick*. Within only a few months of its completion, problems were detected. The dam bowed more than 36 under the pressure of the water it was holding, and the concrete started cracking. The bowing was alleviated by using dynamite to blast a 4 m space for the excess water to spill over. The cracking was claimed to be normal because of the drying cement. On September 30, 1911, the dam failed and destroyed the Bayless Pulp and Paper Mill as well as much of the town of Austin. It also resulted in the deaths of 78 people. The Paper Mill and Dam were subsequently rebuilt, but the mill was lost in a fire in 1933. The new dam failed in 1942 with no loss of life. The dam was not replaced after the second failure.

Remnants of Austin (Bayless) Dam one day after failure and recently (Pictures from Internet)

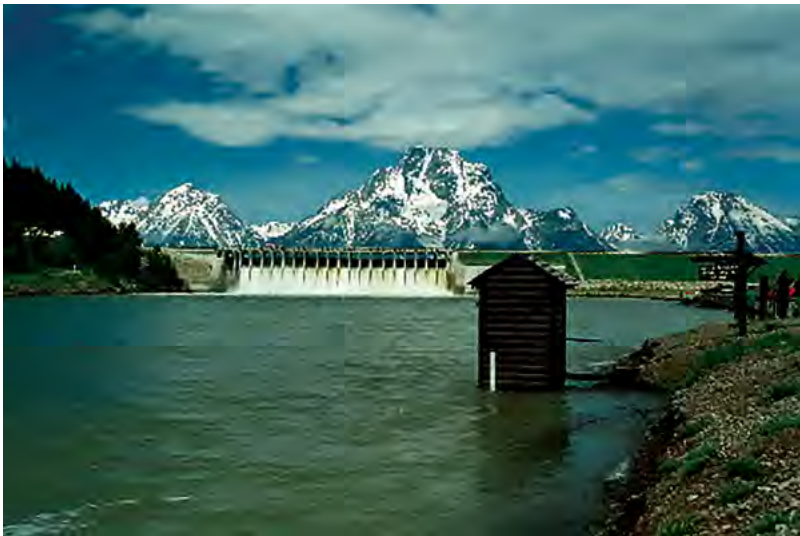
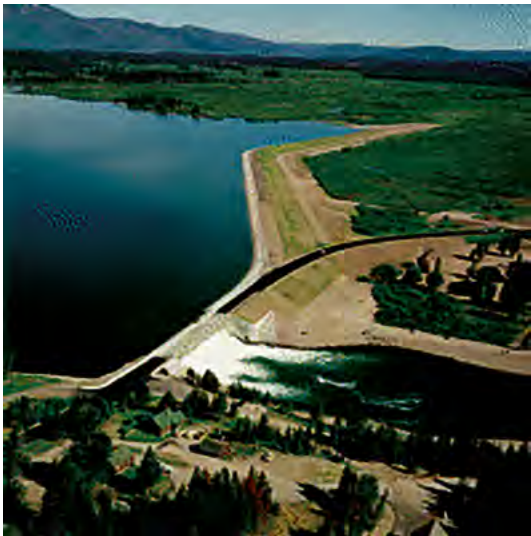
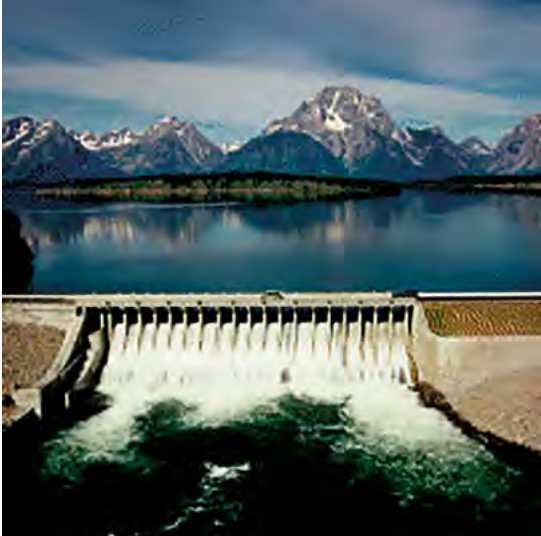
Event: The first Jackson Lake Dam was a log-crib dam constructed in 1906–07 across the outlet of Jackson Lake, a natural lake. That dam raised the lake level by 6.7 m, but the dam failed in 1910. A new concrete and earthen dam was constructed in stages between 1911 and 1916, raising the maximum lake level to 9 m above the lake’s natural elevation. The U.S. Bureau of Reclamation conducted studies on dams in 1976 and determined that Jackson Lake Dam was susceptible to failure in case of an earthquake of magnitude 5.5 or greater. Following the Borah Peak earthquake of 1983 in Idaho, the dam was upgraded during 1986-1989, and the Bureau of Reclamation believed it could withstand the “maximum credible earthquake”, a magnitude 7.5 quake on the Teton fault. Since then, various studies have cast doubt on this belief.

Jackson Lake Dam views (Pictures from Internet)

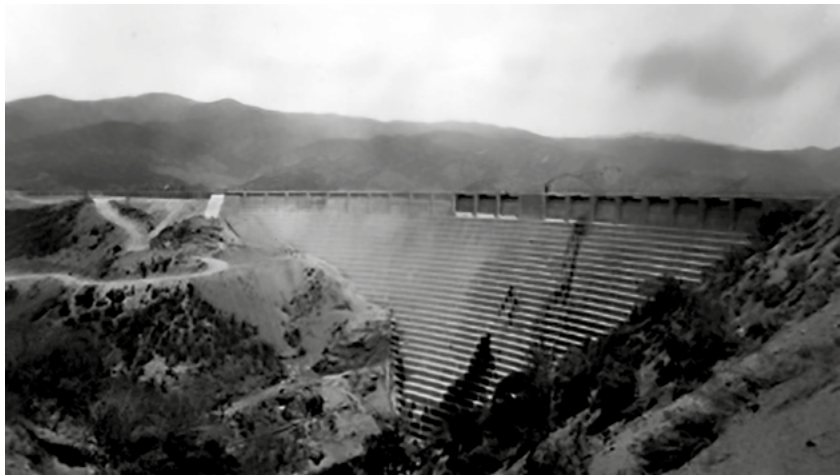
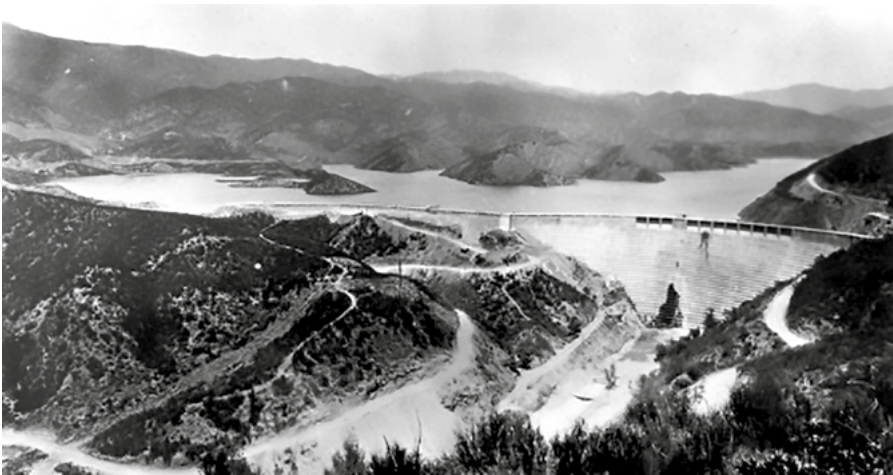
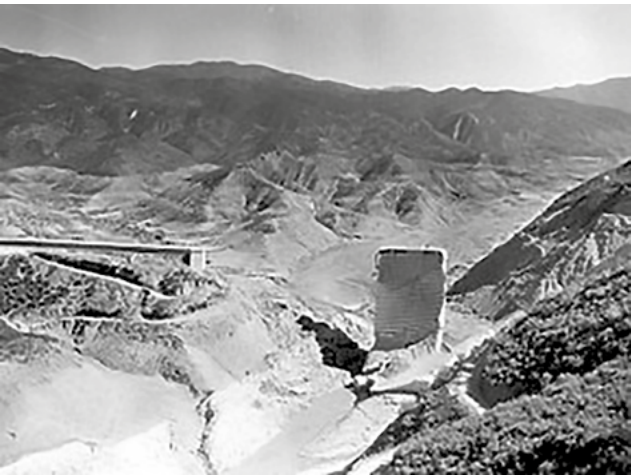
Event: Water began to fill the reservoir on March 12, 1926. It rose steadily and rather uneventfully, although several temperature and contraction cracks did appear in the dam and a minor amount of seepage began to flow from under the abutments. At 11:57 p.m. on March 12, 1928, the dam catastrophically failed, and the resulting flood took the lives of an estimated at least 431 people. The collapse of the St. Francis Dam is considered to be one of the worst American civil engineering disasters of the 20th century and remains the second-greatest loss of life in California’s history, after the 1906 San Francisco earthquake and fire.

Initial views of St. Francis dams before the collapse and after the damages (Picture from the references)

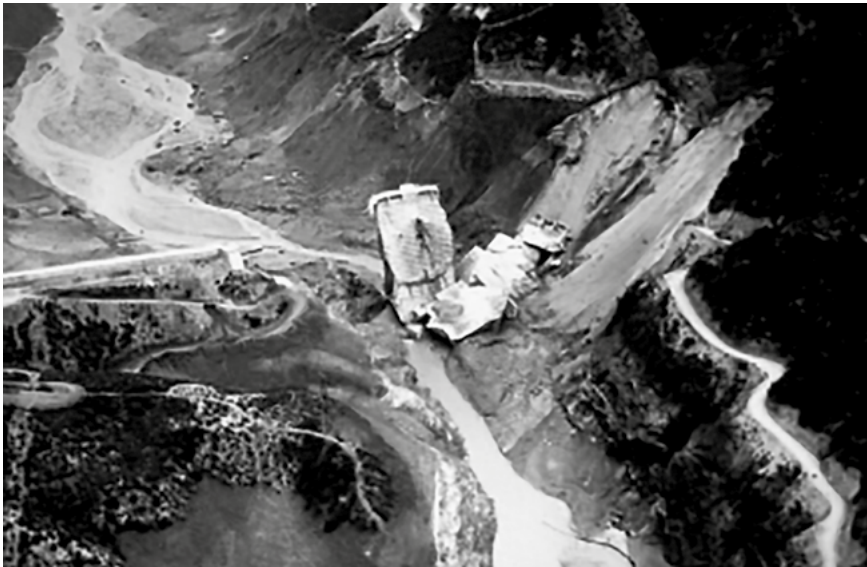
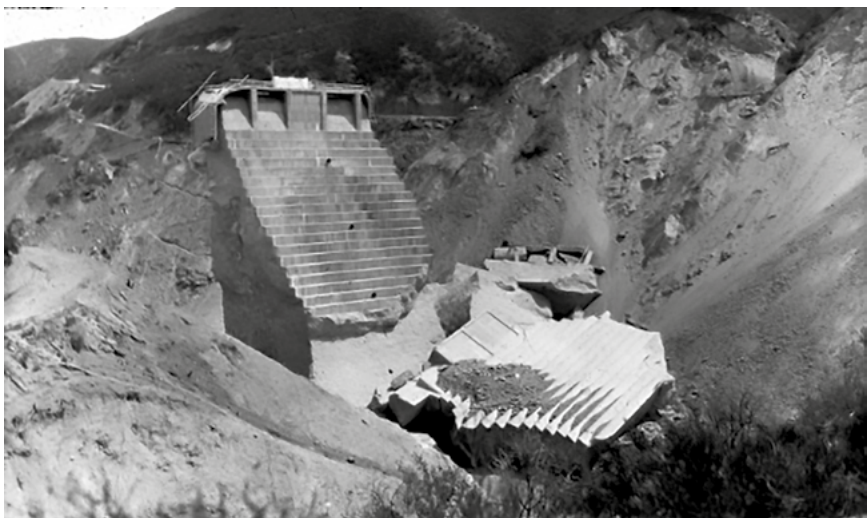
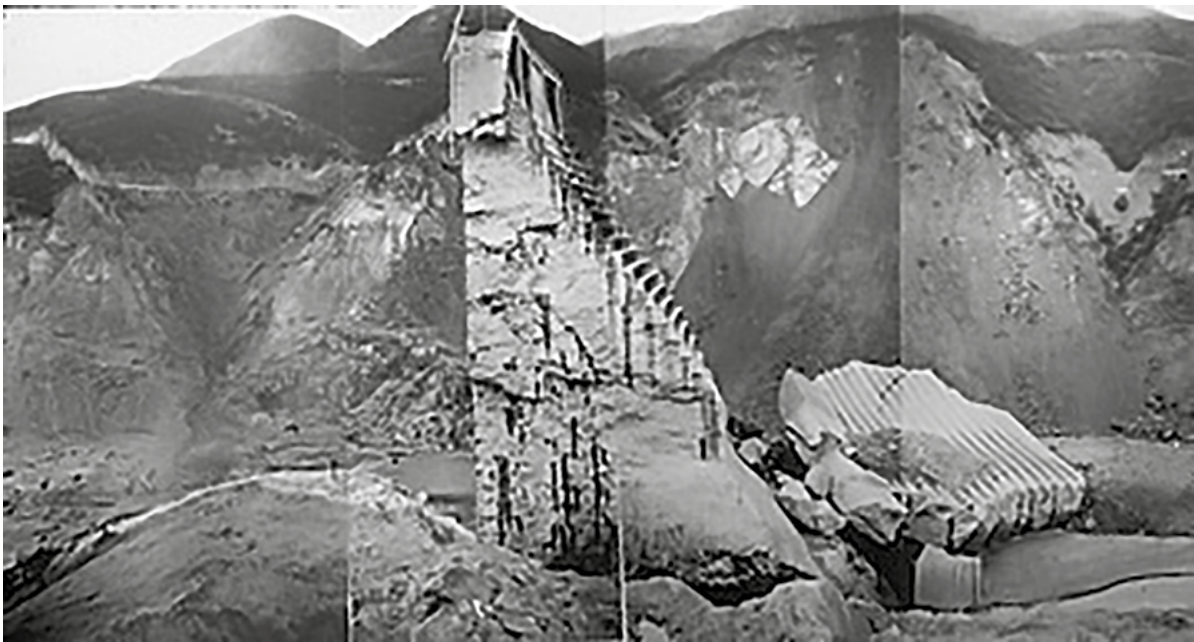
Initial views of St. Francis dams before the collapse and after the damages (Picture from the references)
