Is Your Dam Safe?

An281	Andriolo, Francisco Rodrigues; Moreira, José Eduardo
	Is Your Dam Safe? – Vol. 1 / authors: Francisco Rodrigues Andriolo e José Eduardo Moreira. São Carlos, 2022.
	1394 p. il. color
	ISBN – 978-65-5668-011-8
	DOI – http://dx.doi.org/10.26626/9786556680118/2022B001
	1. Dams. 2. Training. 3. Quality. 4. Repairs. 5.Controls. 6. Cement. I. Orgs. II. Title.
	CDD 370

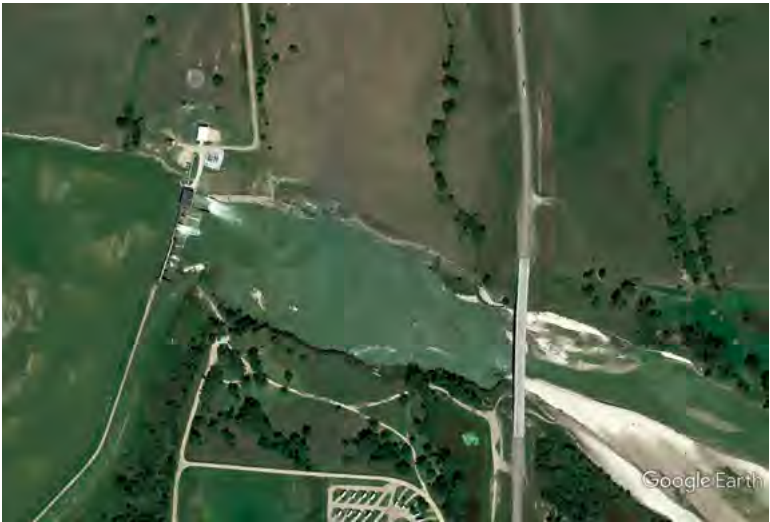
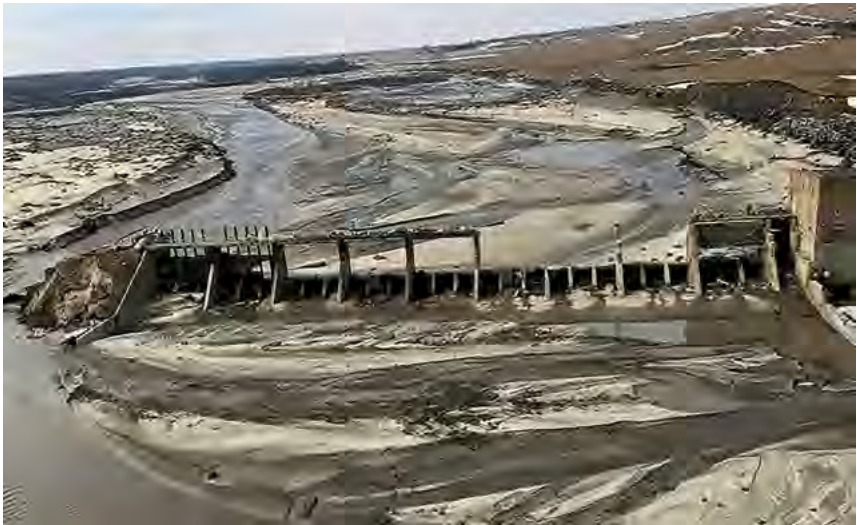
Event: The dam was constructed in several sections. The powerhouse was located on the north bank of the river. The spillway consisted of four tainter gates and five stoplog gates to the south of the powerhouse. In 1935 the dam was partially breached after an ice jam broke upstream. It was reconstructed in 1940. Both after its initial construction and after its rebuilding in 1940, the dam was filled with sediment within a few years. Heavy precipitation during an early morning of March 14, 2019, the dam was breached by snowmelt and ice breakage caused the Niobrara River to swell. The earth embankment was washed out in two locations, while the spillway remained partially intact.

Views of Spencer Dam and Spillway after the collapse

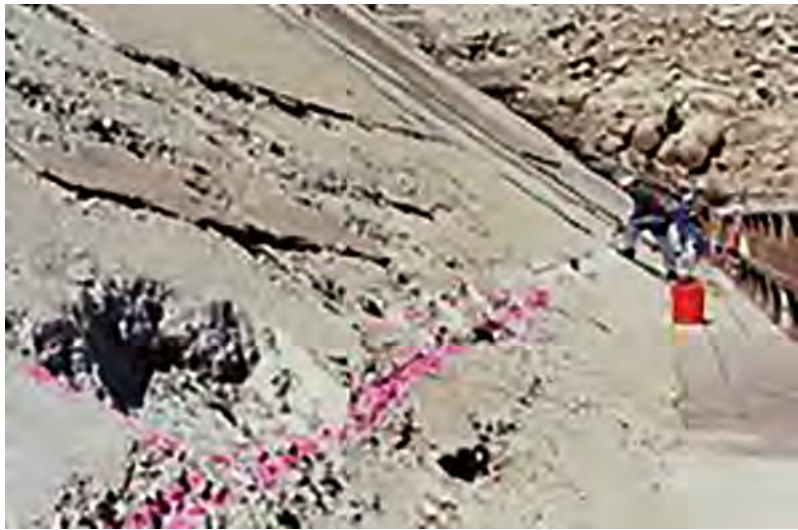
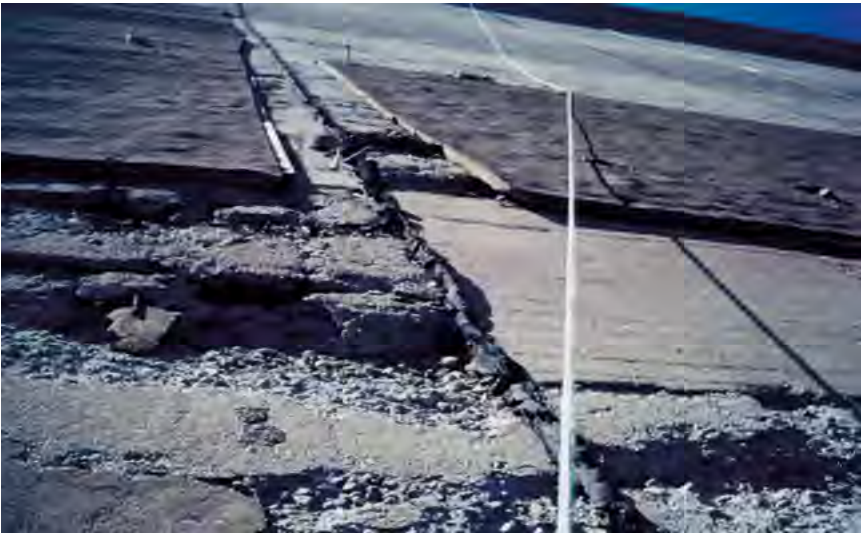
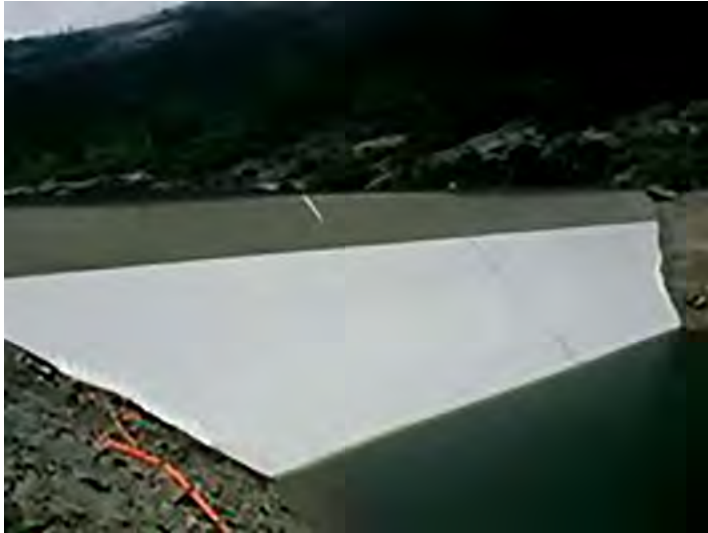
Event: The dam has a history of settlement problems caused by poor consolidation of the rocks during construction. The concrete face has been cracked many times by the movement, causing leaks. The surface of the dam consisted of cracks, craters and shotcrete overlays. It was decided to use a flexible geomembrane to cover the portions of the dam with the greatest leakage. The installation of the membrane was completed in 2005.

Views of the damages of the concrete face on Salt Springs Dam and the repair using a PVC Membrane

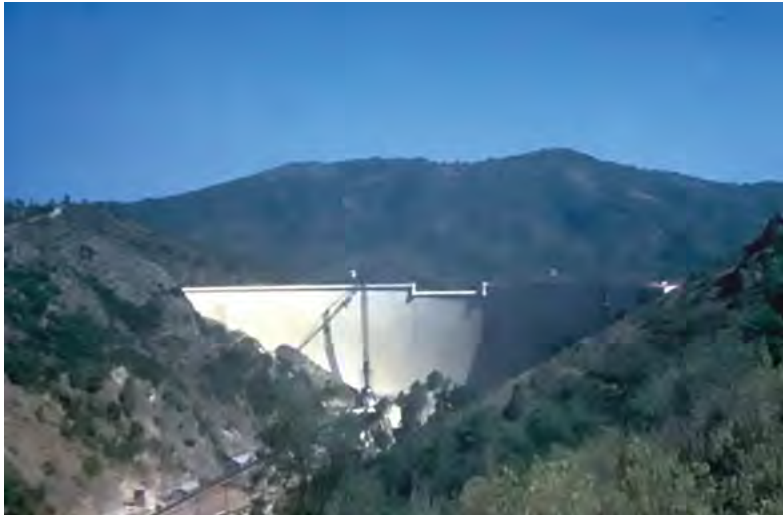
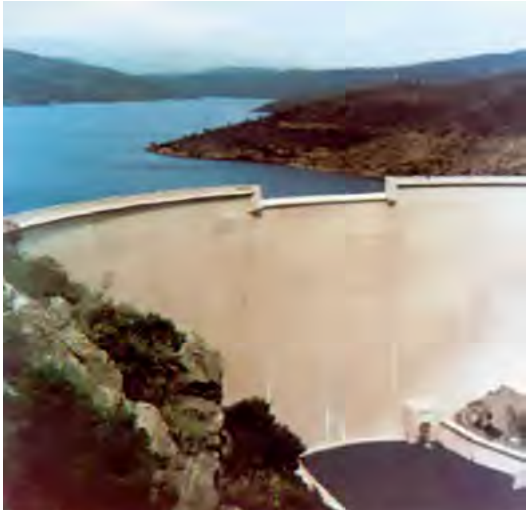
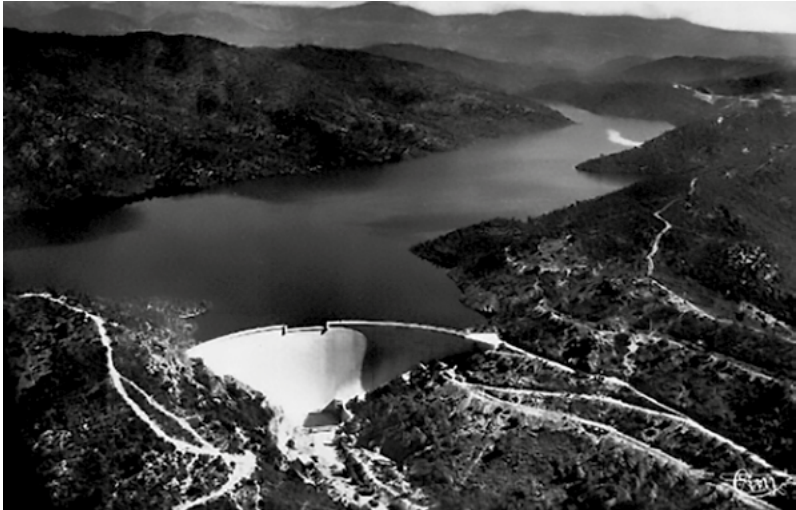
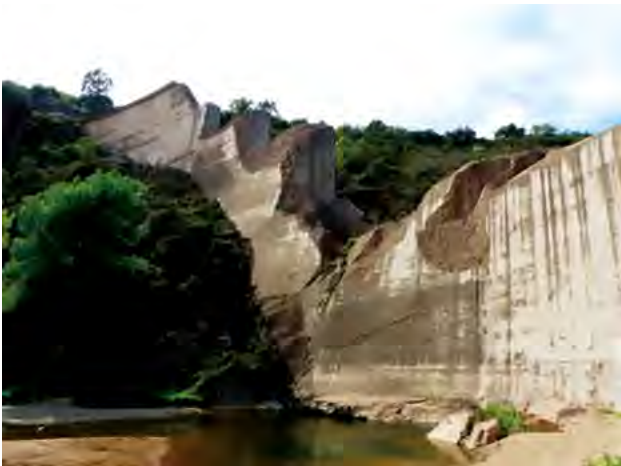
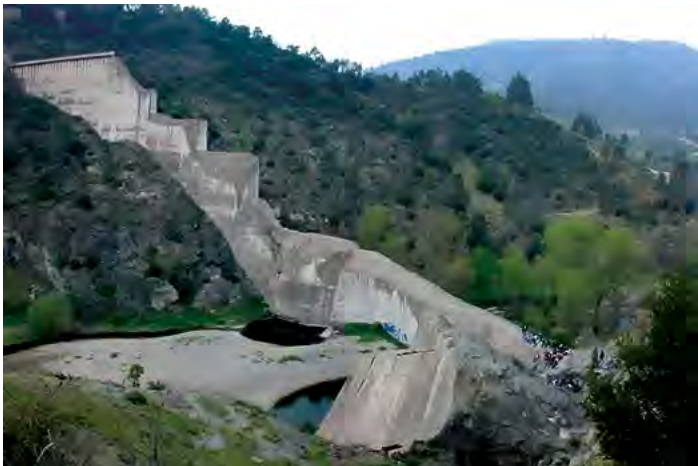
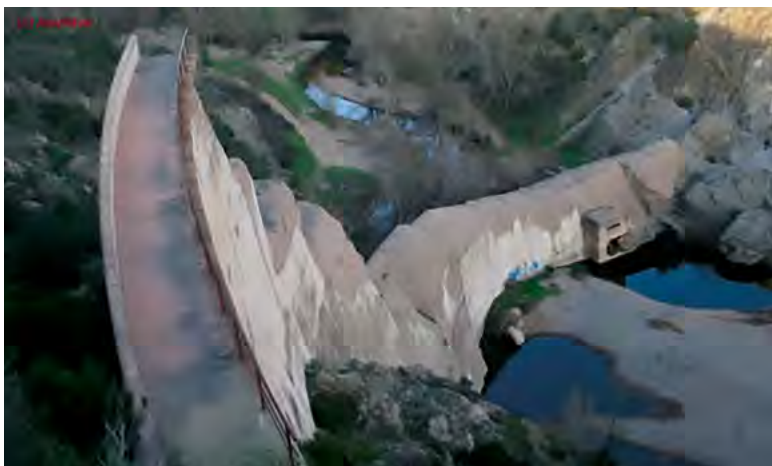
Event: It collapsed on December 2, 1959, killing 423 people in the resulting flood. During November 1959, there were the first warning signs: a “trickle of clear water observed high on the right [side]” and then cracks were noticed later in the month in the concrete apron at the dam toe.

A tectonic fault was later found as the most likely cause of the disaster. Other factors contributed as well; the water pressure was aimed diagonally towards the dam wall and was not found initially. As a consequence, water was collected under a wall and was unable to escape through the ground due to the impermeability of the gneiss rock underneath the dam. Weeks before the breach, some cracking noises were heard, but they were not examined. It is not clear when the cracking noises started. The right side of the dam had some leaks in November 1959.

Views of the Malpasset Dam after construction, as operating, and after the collapse

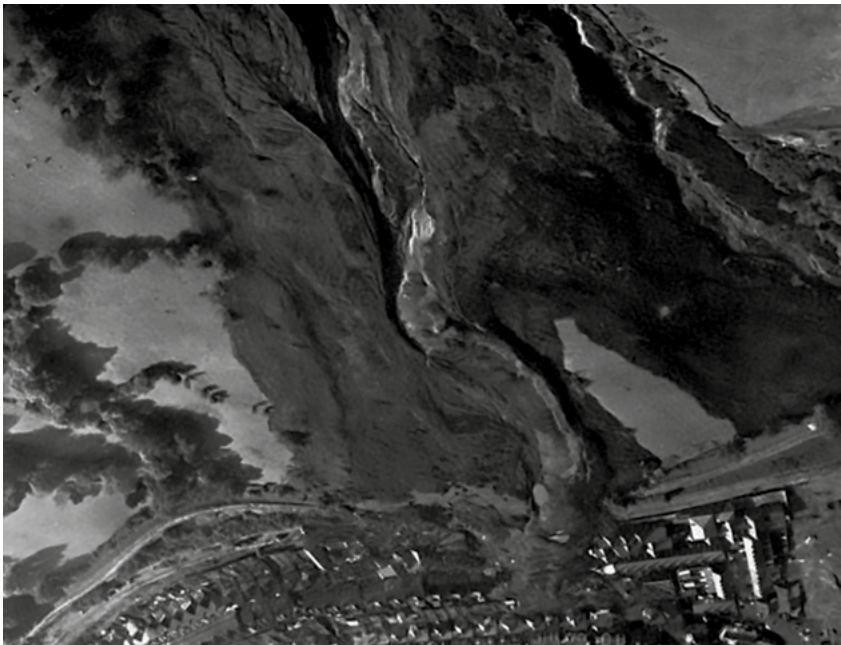
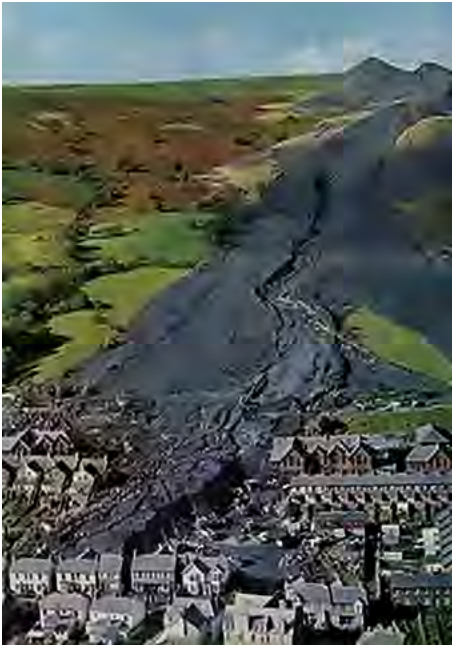
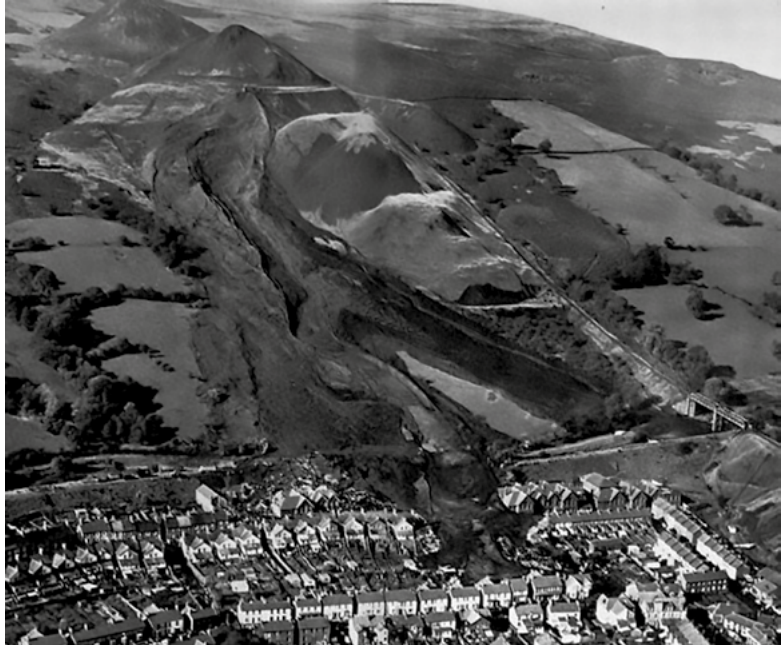
Event: After three weeks of heavy rain the tip was saturated and approximately 110,000 m³ of spoil slipped down the side of the hill over a distance of about 500 meters and onto a village. In total the Aberfan Disaster claimed 144 lives.

Views of the Aberfan Tailings Dam after the disaster

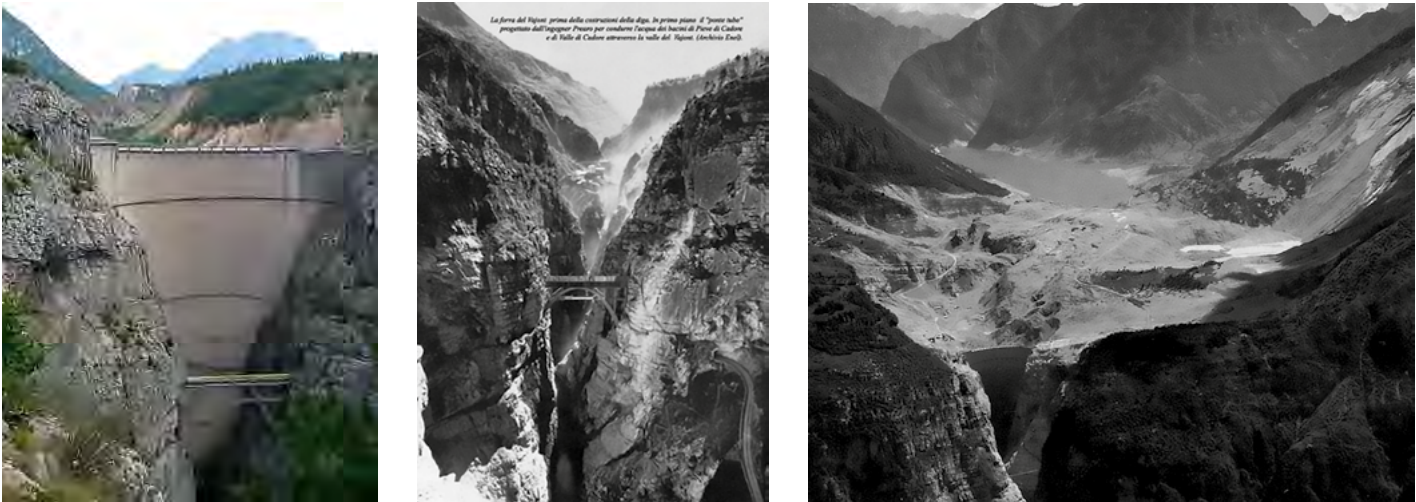
Event: It was described as *‘the tallest dam in the world’*, intended to meet the growing demands of industrialization. On 9 October 1963, during initial filling, a landslide caused a mega-tsunami in the lake in which 50 million m³ of water overtopped the dam in a wave of 250 m leading to the complete destruction of several villages and towns, and 1.917 deaths. This event occurred when the company and the Italian government dismissed evidence and concealed reports describing the geological instability of Monte Toc on the southern side of the basin, and other early warning signs reported prior to the disaster. Numerous warnings, signs of danger, and negative appraisals had been disregarded, and the eventual attempt to safely control the landslide into the lake by lowering its level came when the landslide was almost imminent and was too late to prevent it. Although the dam itself remained almost intact, and two-thirds of the water was retained behind it, the landslide was much larger than expected and the impact brought massive flooding and destruction to the Piave valley below.

Views of the Vajont Dam before and after the disaster

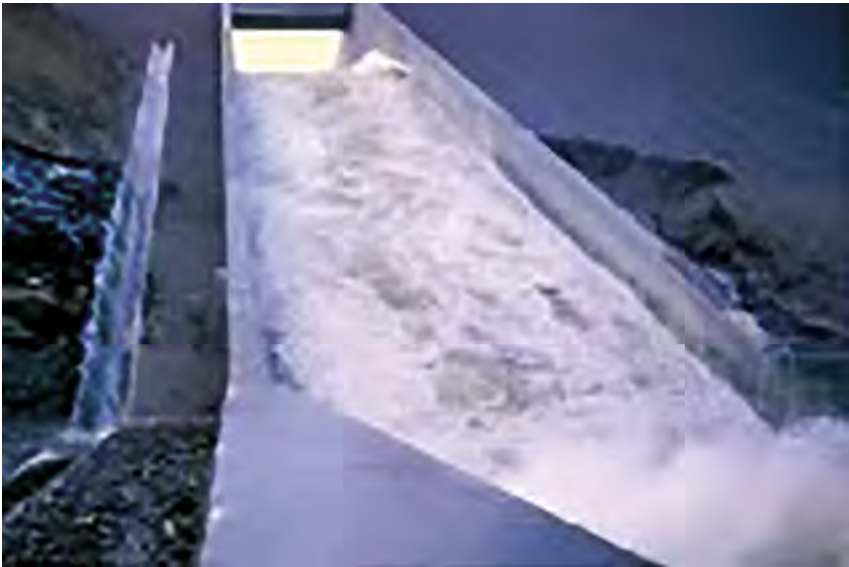
The second embankment slide to the right of the spillway on June 27, 1965

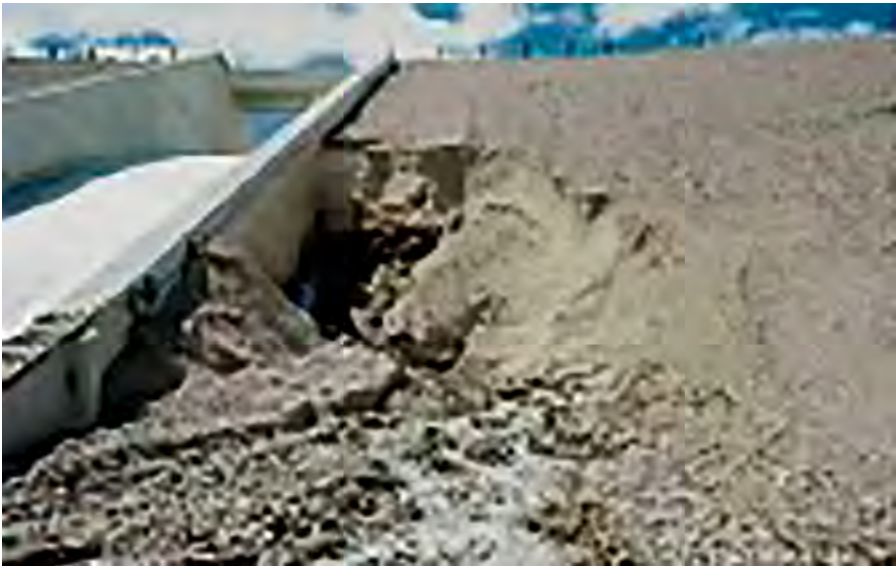
The third embankment slide on July 27, 1965

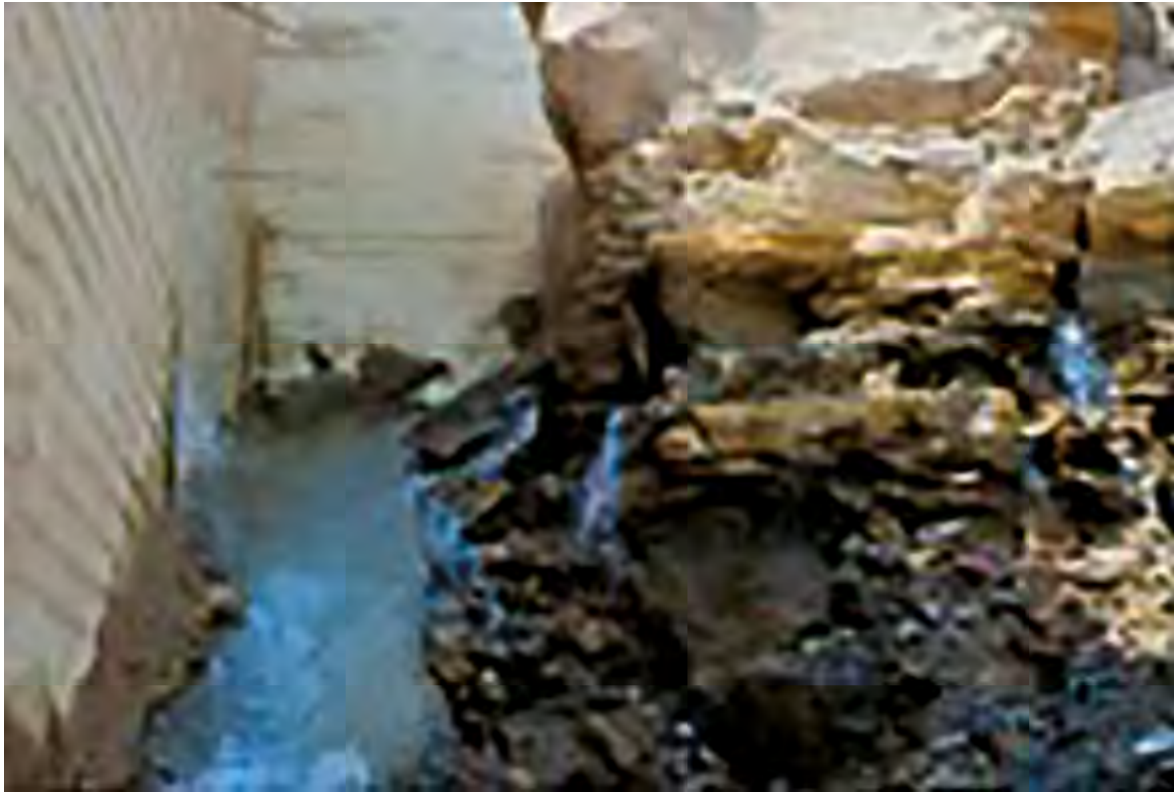
Third embankment slide. Seeps issuing from vertical cracks in sandstone.

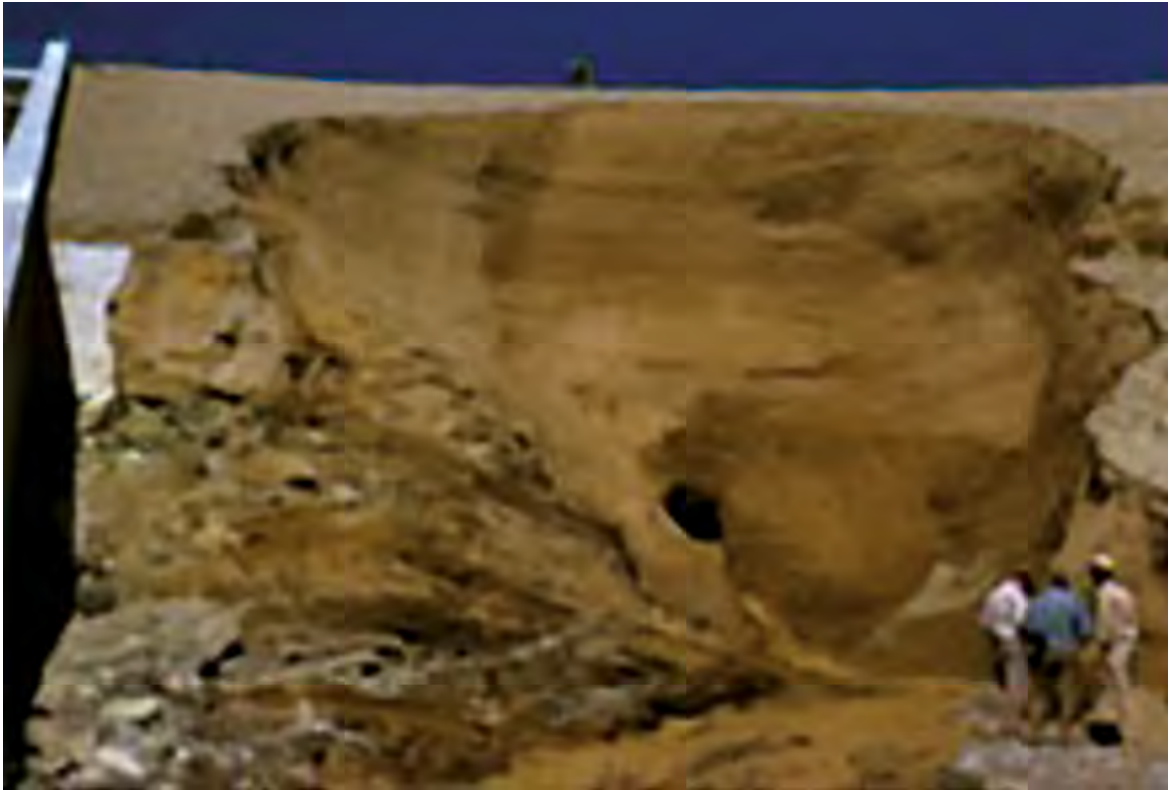
The erosion hole about noon on Saturday September 4. Note 1,2m-diameter leak exit tunnel adjacent to the right abutment rock.

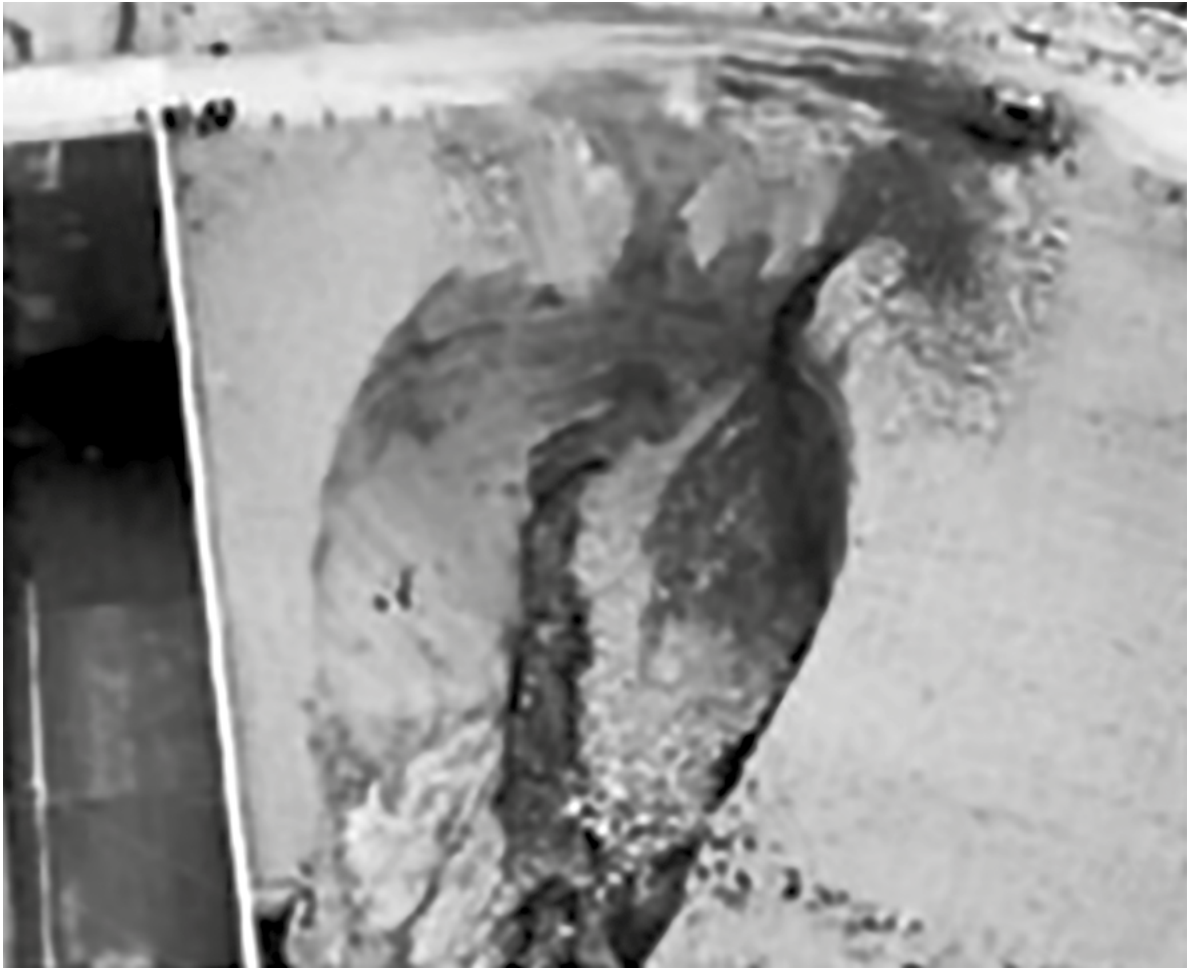
By Sunday morning September 5th a large rock berm was created in the left side of the erosion hole.

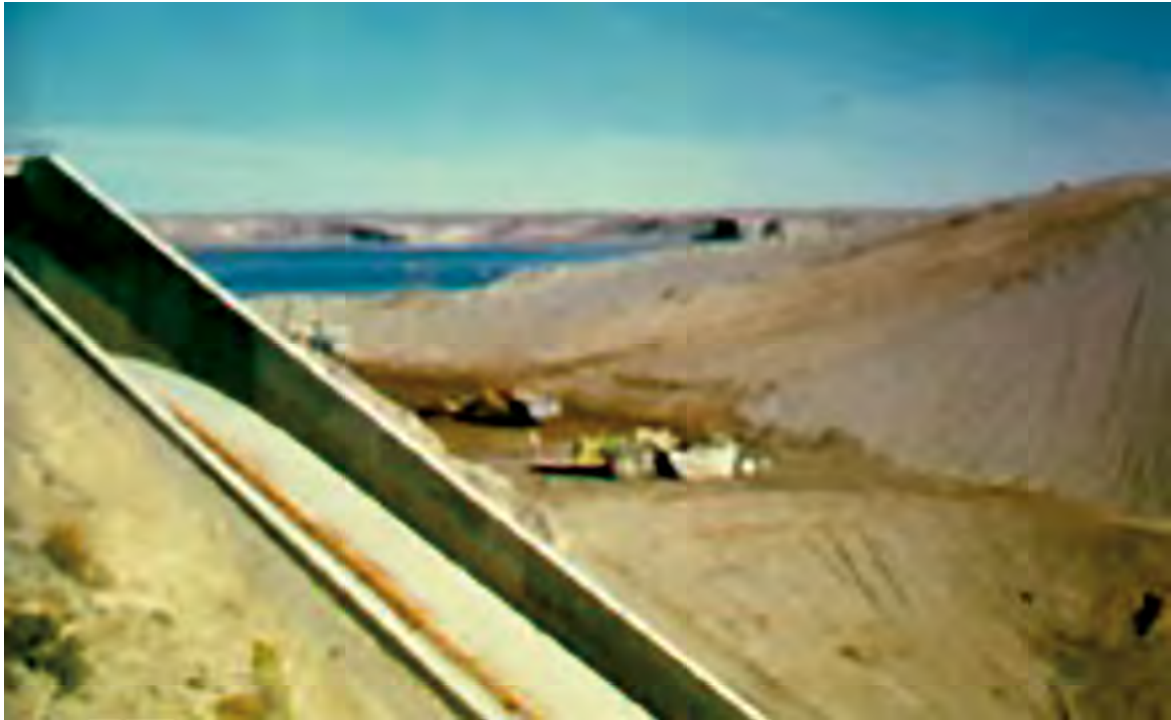
Section of dam removed for investigation and repair.

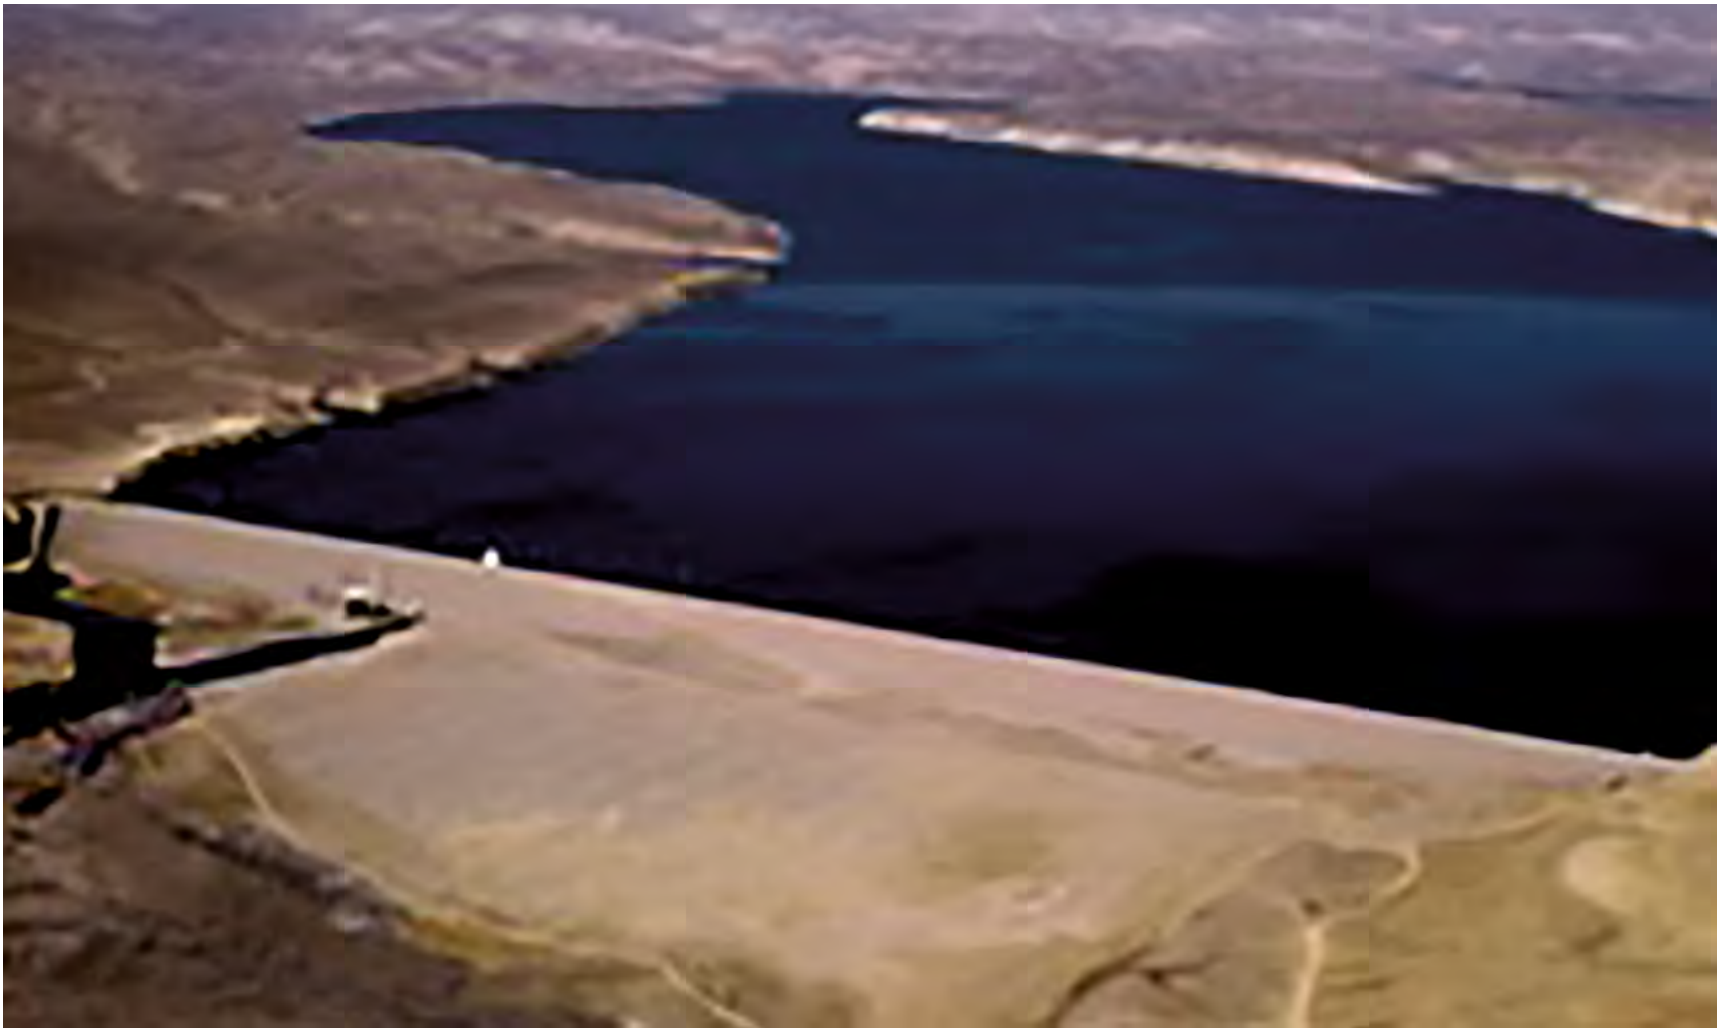
Fontenelle Dam after repairs

Event: The dam suffered a significant failure in 1965, when the dam’s right abutment developed a leak. Emergency releases from the dam flooded downstream properties, but repairs to the dam were successful. However, in 1983 the dam was rated “poor” under Safety Evaluation of Existing Dams (SEED) criteria, due to continuing seepage, leading to an emergency drawdown. A concrete diaphragm wall was built through the core of the dam to stop leakage.

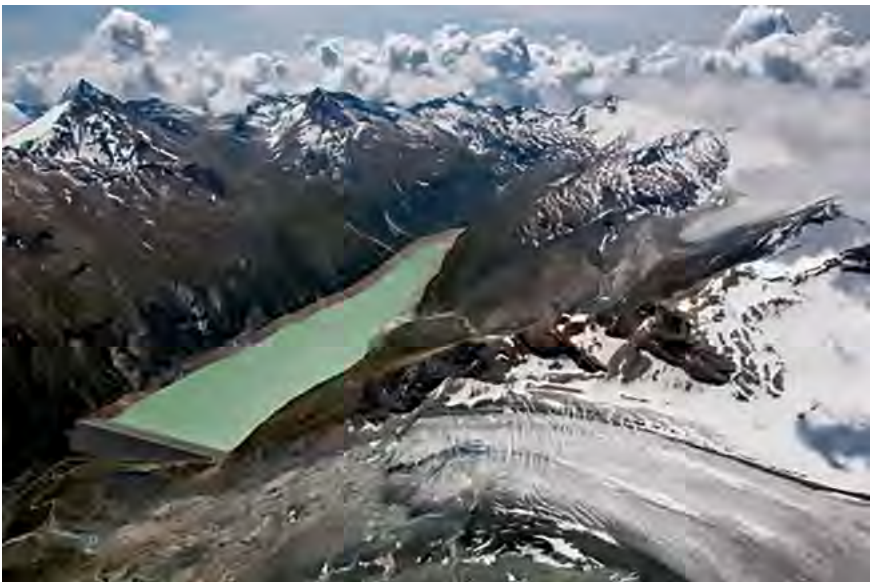
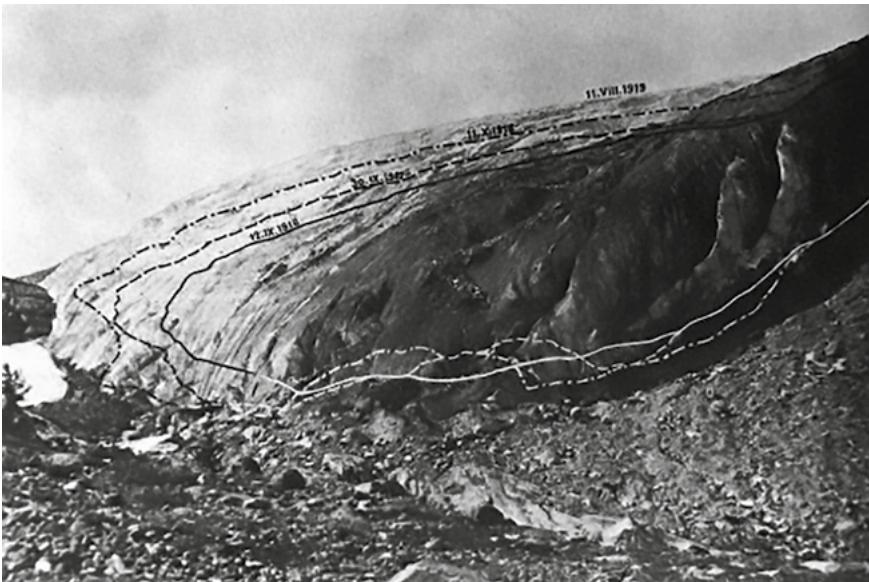
Event: On August 30, 1965, 2.000.000 m³ of ice and debris broke off the Allalin glacier in canton Valais, engulfing the Mattmark dam construction site. Eighty-eight people lost their lives. Many questions remain unanswered about the worst disaster in recent Swiss history. Its wild and unpredictable nature has repeatedly threatened the existence of the Saas population. The glacier originates on the 4,190-meter-high Strahlhorn, which, along with the Allalinhorn, the Alphubel, and the Rimpfischhorn, belongs to the Allalin group.

The Allalin glacier ice tongue, as seen on August 11, 1919, with information on its historical movement, on Mattmark Dam

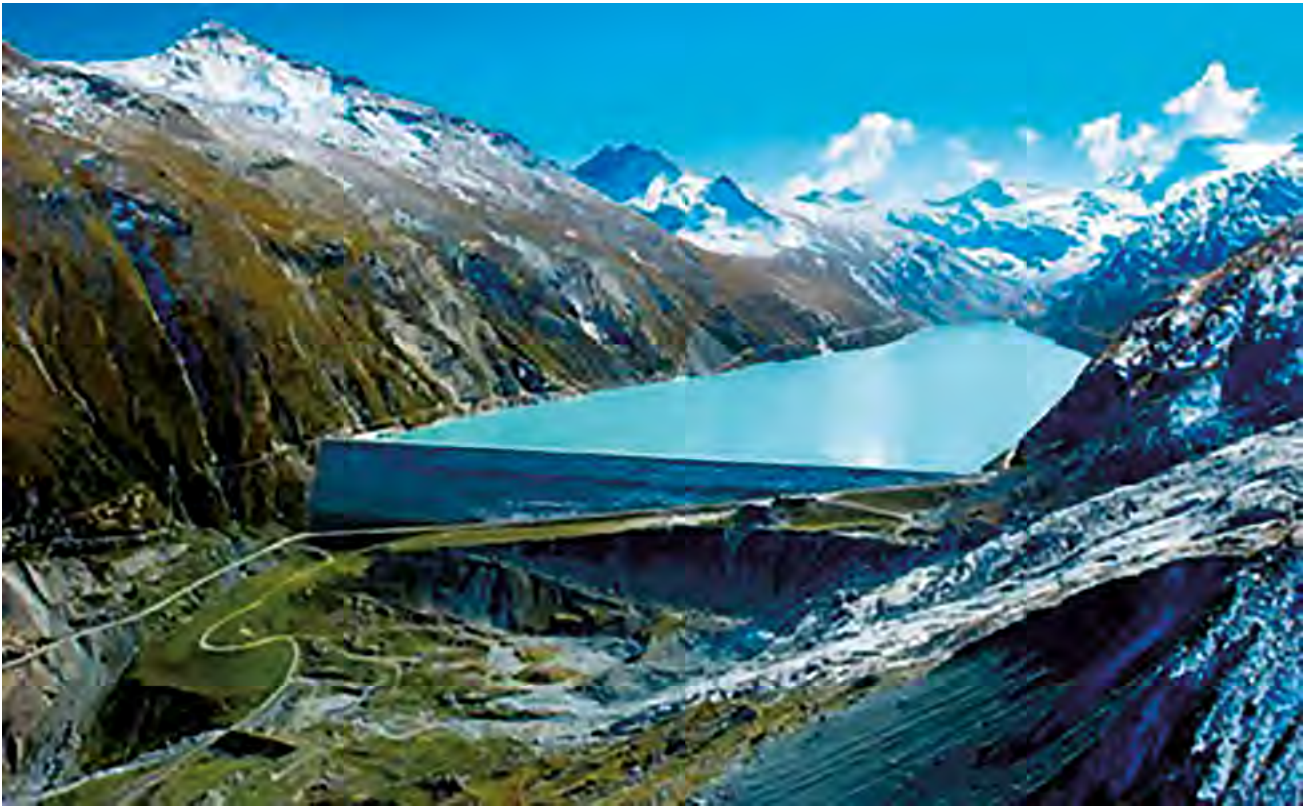
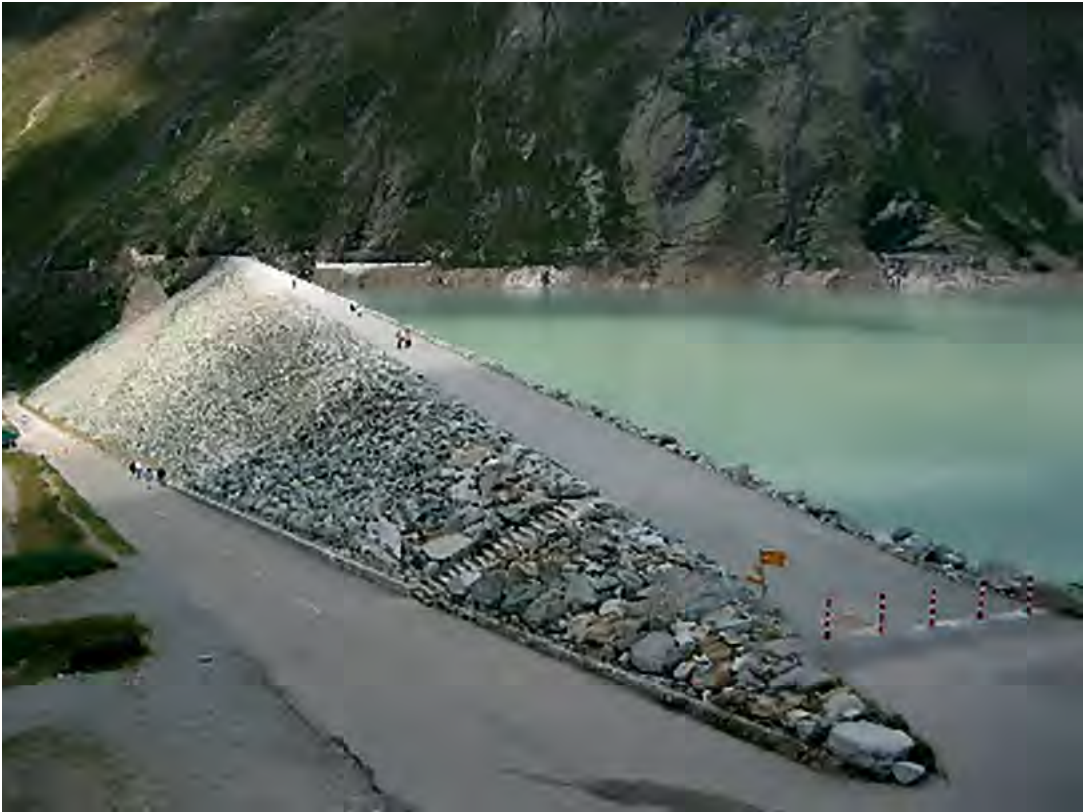
Mattmark Dam after repairs

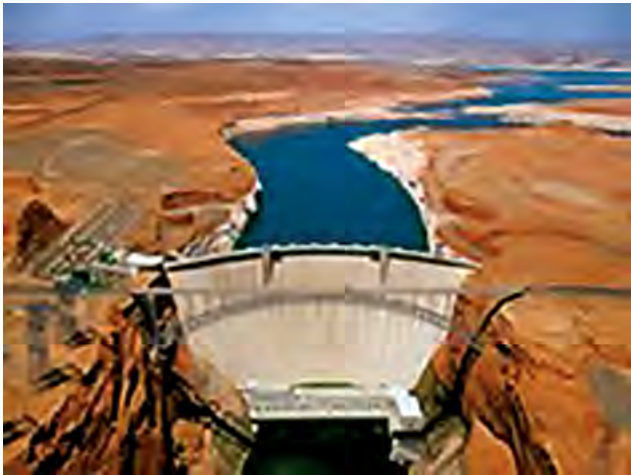
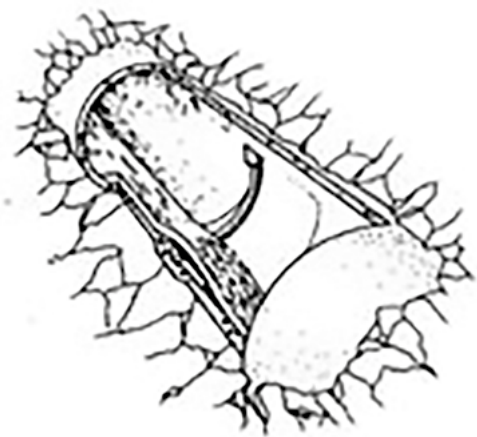
Event: An inspection of the tunnels following the test revealed minor cavitation damage to the liners. Vapor cavities occur in liquid when water pressure in a high-velocity flow is reduced by an irregularity in the flow surface. As these cavities move into a zone of higher pressure, they collapse, sending out high-pressure shock waves that cause cavitation.

Downstream view of the Glen Canyon Dam and a schematic view of the aeration outlet on the spillway tunnel

After analyzing the spillway flow, Bureau of Reclamation staff members decided to construct an aeration slot in each tunnel. The aerators were located in the conical reducing section of the tunnel about one-half of the way down the tunnel between the intake and the vertical bend.

Repair work began with the removal of the entire tunnel lining, including sections that were not damaged, to improve safety, speed construction, and to produce satisfactory, long-lasting results. Damaged and missing reinforcement was replaced. New reinforcement was manually welded to existing reinforcement in most cases. In areas where drainage water prevented welding, steel dowels were epoxied into drill holes in the liner and then wired to the existing reinforcing in a splicing technique.

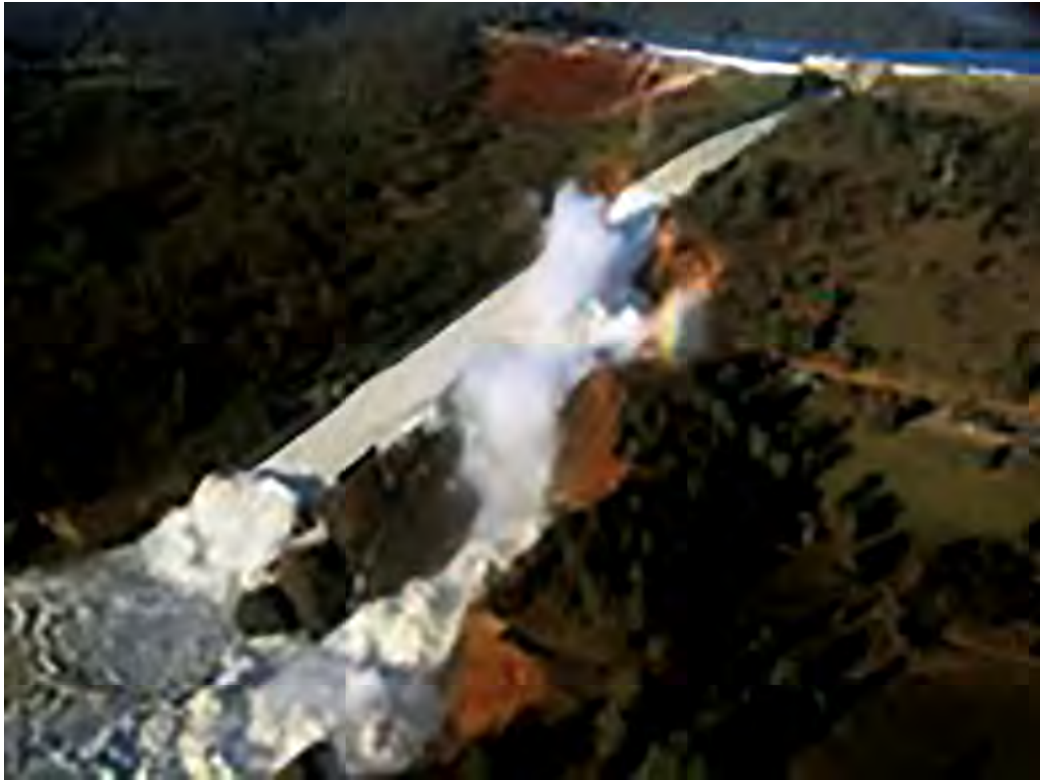
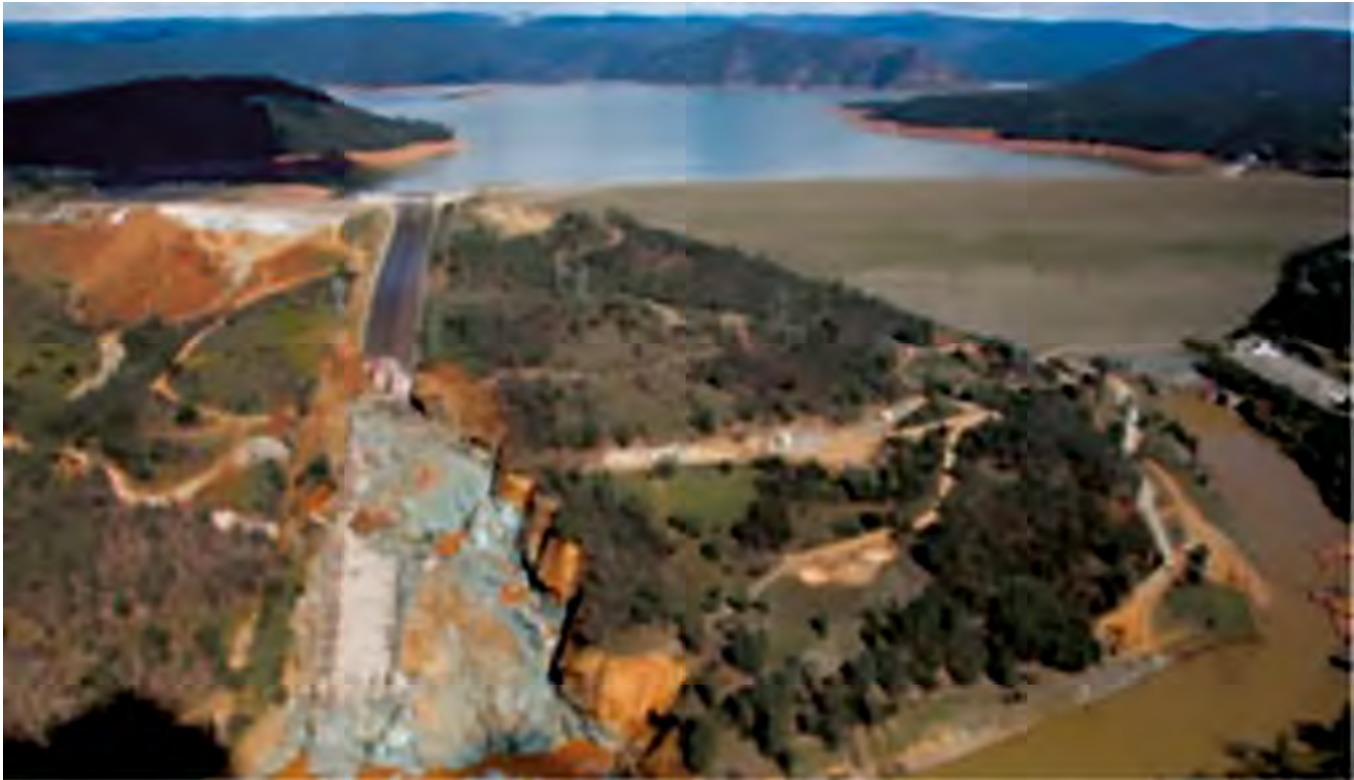
Heavy rainfall during the 2017 California floods damaged the main spillway on February 7, so the California Department of Water Resources (DWR, created in 1956) stopped the spillway flow to assess the damage and contemplate its next steps. The rain eventually raised the lake level until it flowed over the emergency spillway, even after the damaged main spillway was reopened. As water flowed over the emergency spillway, headward erosion threatened to undermine and collapse the concrete weir, which could have sent a 10 m wall of water into the Feather River below and flooded communities downstream. No collapse occurred, but the water further damaged the main spillway and eroded the bare slope of the emergency spillway.

There was no single root cause of the Oroville Dam spillway incident, nor was there a simple chain of events that led to the failure of the service spillway chute slab, the subsequent overtopping of the emergency spillway crest structure, and the necessity of the evacuation order. Rather, the incident was caused by a complex interaction of relatively common physical, human, organizational, and industry factors, starting with the design of the project and continuing until the incident. The physical factors can be placed into two general categories:

- Inherent vulnerabilities in the spillway designs and as-constructed conditions, and subsequent chute slab deterioration;
- Poor spillway foundation conditions in some locations.

The large flow and the damage in the Oroville Spillway

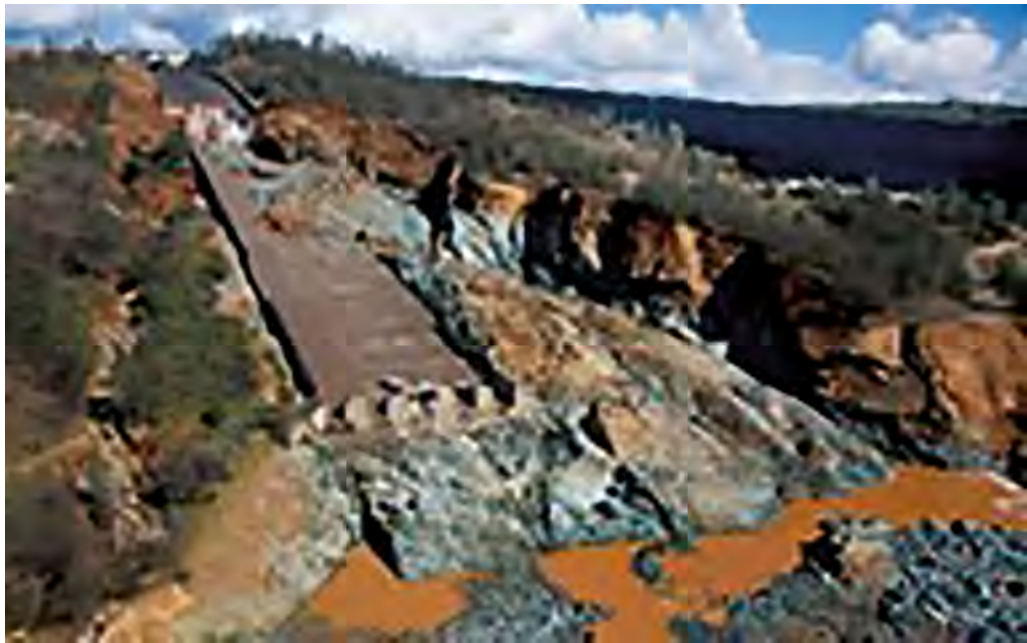
The large flow and the damage in the Oroville Spillway

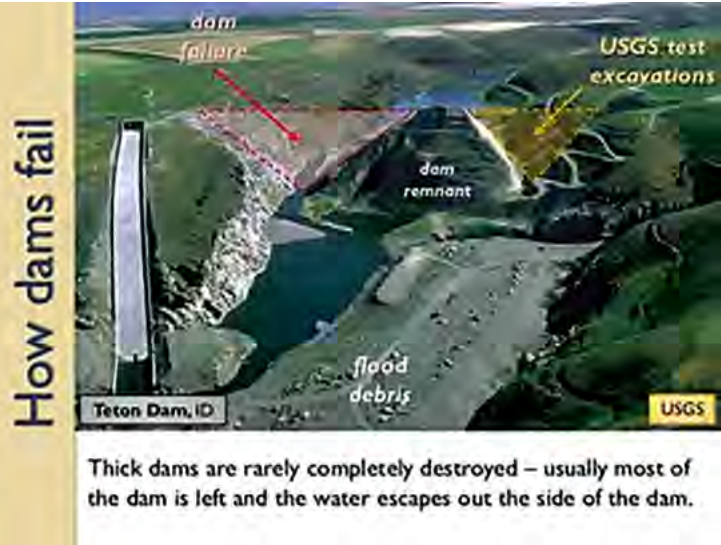
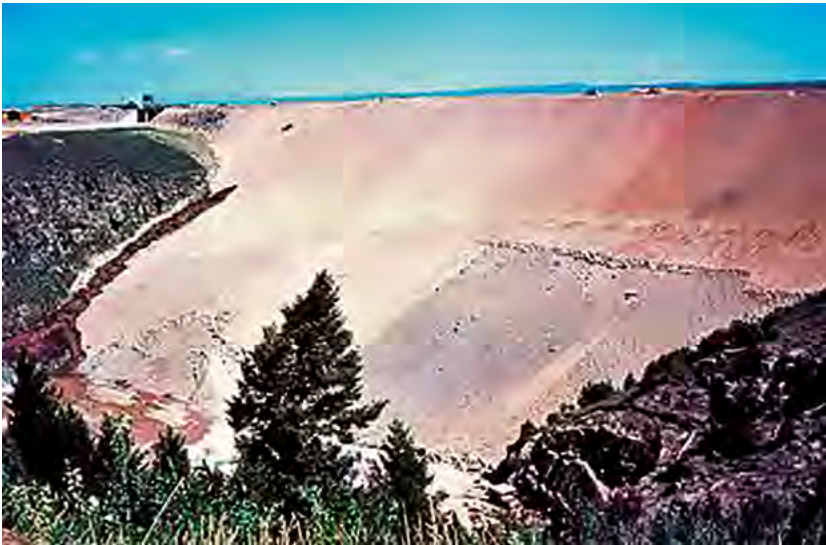
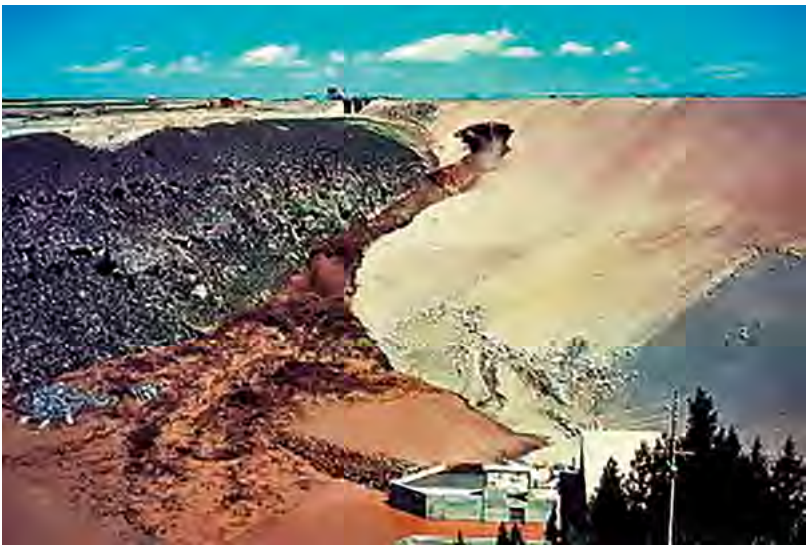
Study of the dam’s environment and structure placed blame for the collapse on the permeable loess soil used in the core and on fissured (cracked) rhyolite in the abutments of the dam that allowed water to seep around and through the earth fill dam. The permeable loess was found to be cracked. It is postulated that the combination of these flaws allowed water to seep through the dam and led to internal erosion, called piping, that eventually caused the dam’s collapse.

An investigating panel had quickly identified piping as the most probable cause of the failure, then focused its efforts on determining how the piping started. Two mechanisms were possible. The first was the flow of water under highly erodible and unprotected fill, through joints in unsealed rock beneath the grout cap and development of an erosion tunnel. The second was “cracking caused by differential strains or hydraulic fracturing of the core material”. The fundamental cause of failure may be regarded as a combination of geological factors and design decisions that, taken together, permitted the failure to develop.

The sequence of the Teton Dam collapse (Courtesy from Bureau of Reclamation)
