Is Your Dam Safe?

An281	Andriolo, Francisco Rodrigues; Moreira, José Eduardo
	Is Your Dam Safe? – Vol. 1 / authors: Francisco Rodrigues Andriolo e José Eduardo Moreira. São Carlos, 2022.
	1394 p. il. color
	ISBN – 978-65-5668-011-8
	DOI – http://dx.doi.org/10.26626/9786556680118/2022B001
	1. Dams. 2. Training. 3. Quality. 4. Repairs. 5.Controls. 6. Cement. I. Orgs. II. Title.
	CDD 370

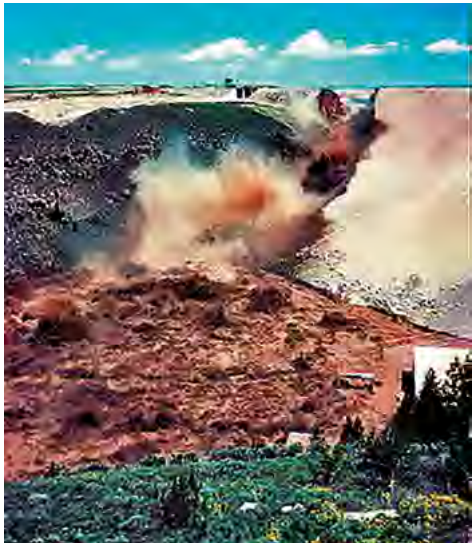
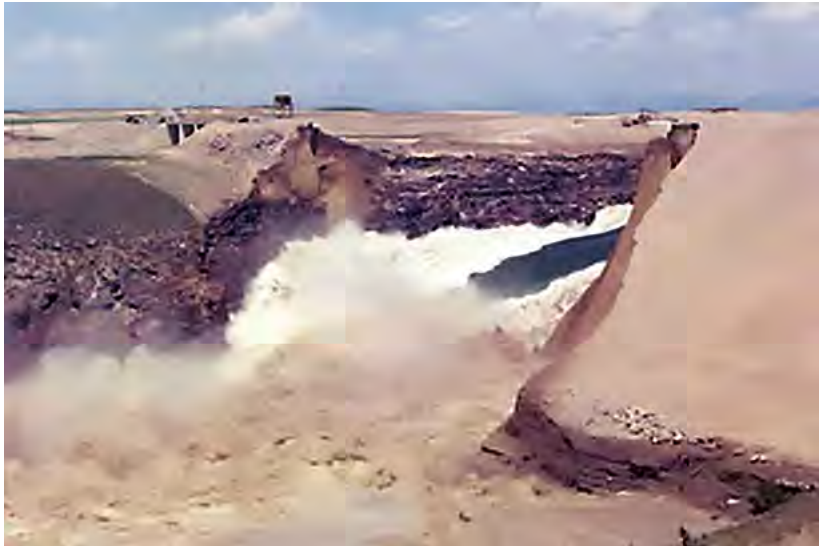
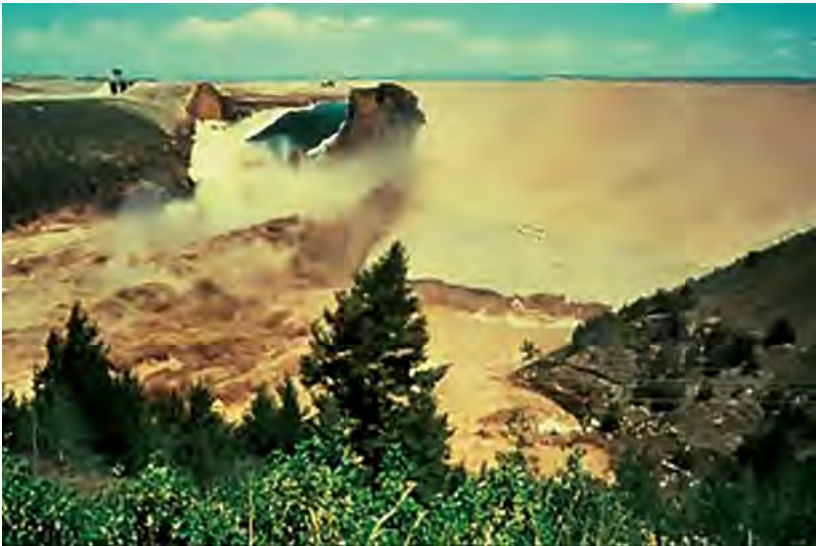
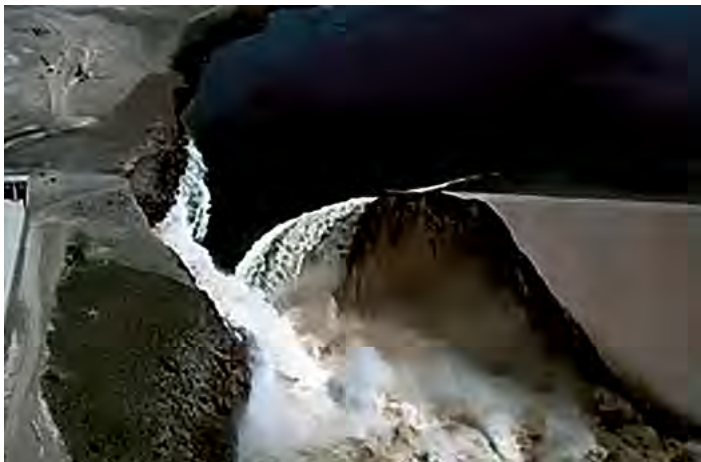
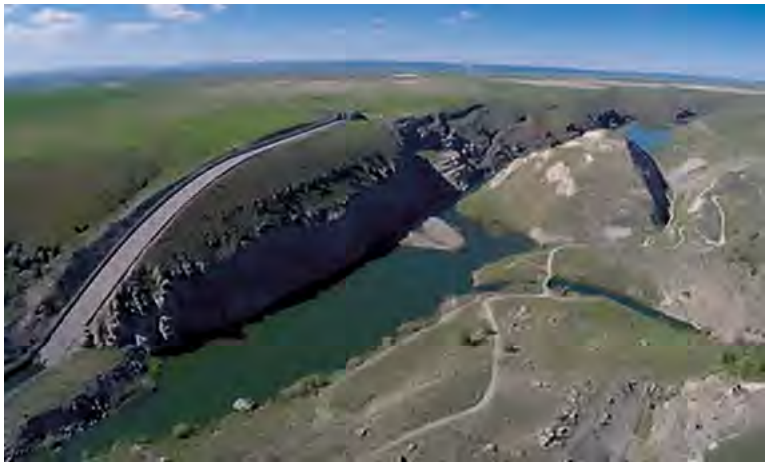
The sequence of the Teton Dam collapse (Courtesy from Bureau of Reclamation)

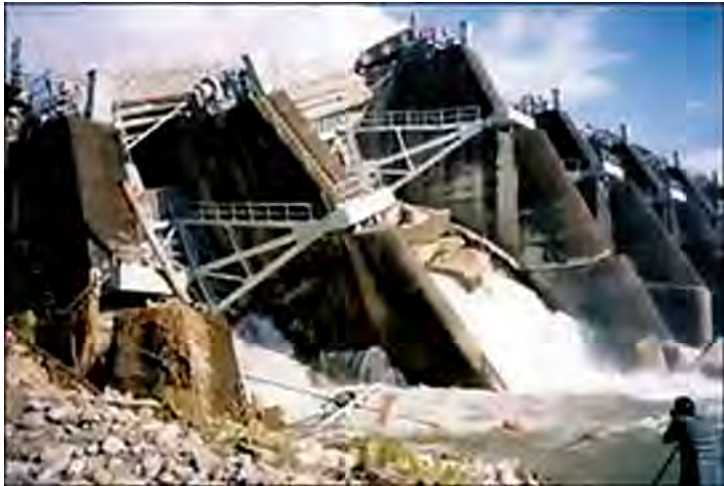
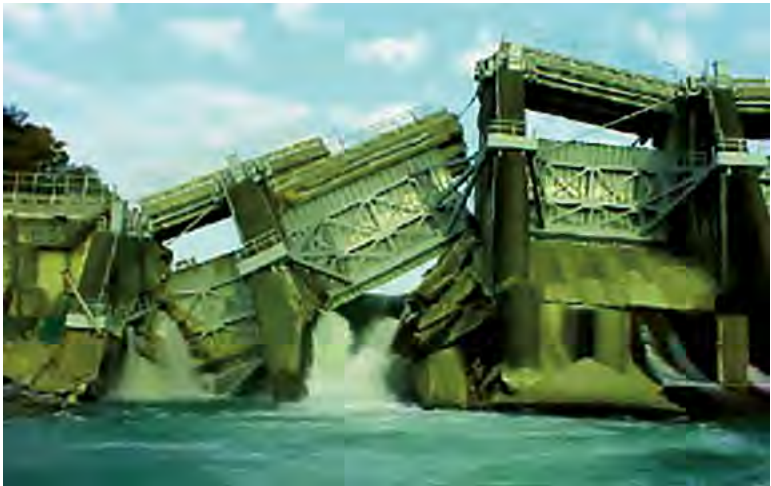
Event: On September 21, 1999, an earthquake happened in the central region of Taiwan. Shih-Kang Dam was damaged by marvelous surface ruptures of Che-Lung-Pu fault, strong surface deformation, and great ground motion. Since the Shih-Kang dam is the first concrete dam to be directly damaged by the active fault in the history of the hydraulic structures, the damage of Shih-Kang dam becomes very unique. The Shih-Kang Dam design was based on the traditional design concept of the pseudo static earthquake acceleration. The design horizontal earthquake acceleration coefficient was $K_h=0.15$ and the effect of the vertical motion was neglected. Considering the existing active fault on the dam site, the long-term solution to the damaged Shih-Kang Dam and Tai-Chung area water resource is to build a new reservoir in the upstream of Shih-Kang dam to substitute the damaged one.

The damage caused by earthquake in the Spillway Shih-Kang Dam

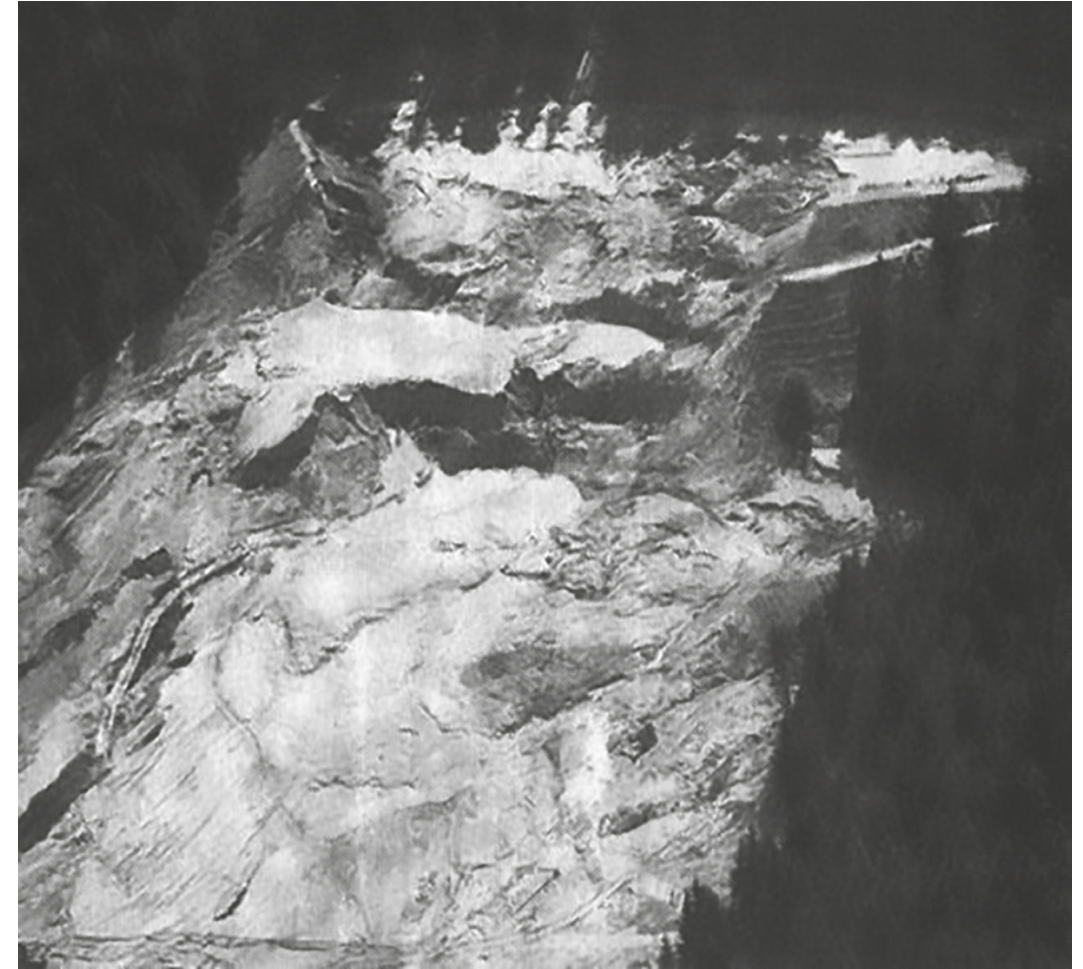
Event: The dam collapse occurred on July 19, 1985, when two tailings dams above the village of Stava-Italy failed, killing 268 people, destroying 63 buildings, and demolishing 8 bridges. The upper dam broke first, leading to the collapse of the lower dam. Around 180.000 m³ of mud, sand, and water were released into the Rio di Stava valley and toward the village of Stava at a speed of 90 km/h.

Pictures and schematic view of Stava Tailings Dam, and after the collapse (From [07-55]).

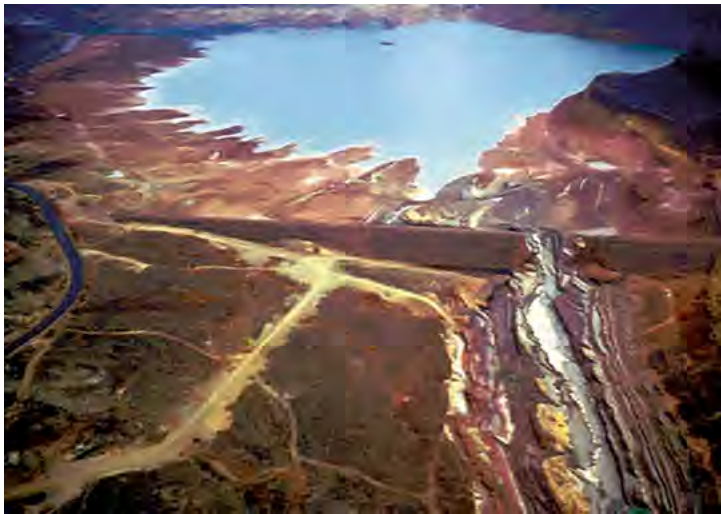
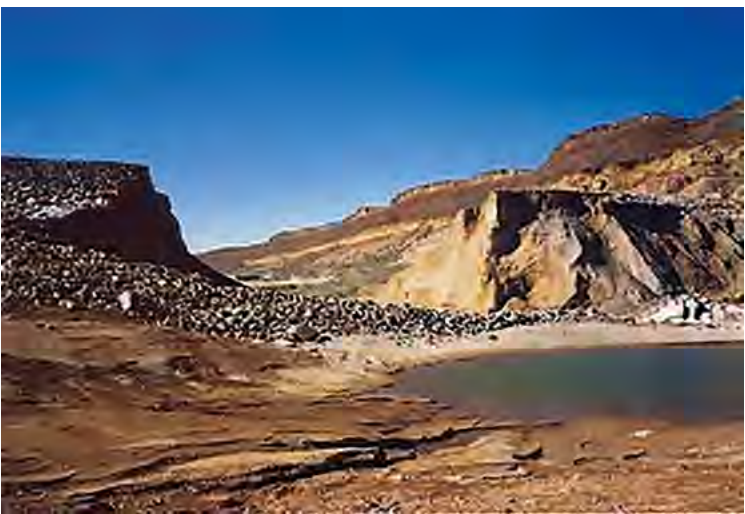
Event: As the reservoir filled in June 1987, seepage at the downstream toe began to increase. Additionally, a two-foot diameter *sinkhole* was discovered at the downstream toe on June 25th. During the summer of 1988, as the reservoir was held, seepage continued to increase. On September 21, a major opening was identified. With the seepage apparently under control the owner began to fill the reservoir through the month of December. On the morning of December 31, 1988, cloudy seepage was observed at the downstream toe. Between 11:00 and 11:30 p.m., a wedge 15 m wide suddenly dropped, blocking flow temporarily until flow resumed and began removing the collapsed material. Erosion continued toward the reservoir until at 12:30 a.m. on January 1, 1989, the Quail Creek Dike failed. A new roller-compacted concrete (RCC) dam was built to replace the failed Quail Creek Dike.

Quail Creek Embankment collapse

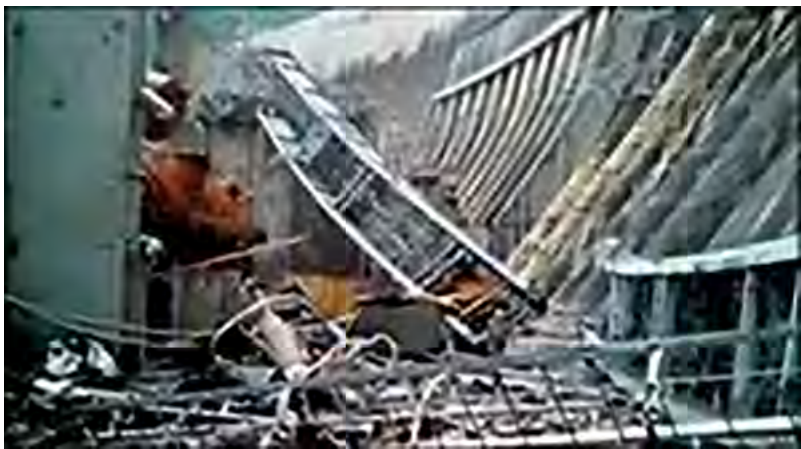
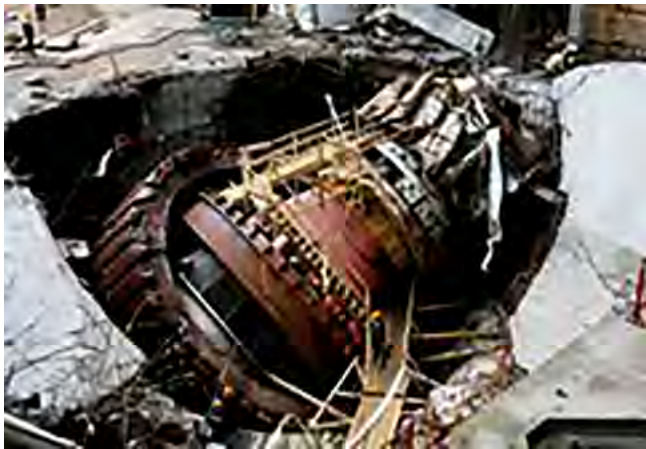
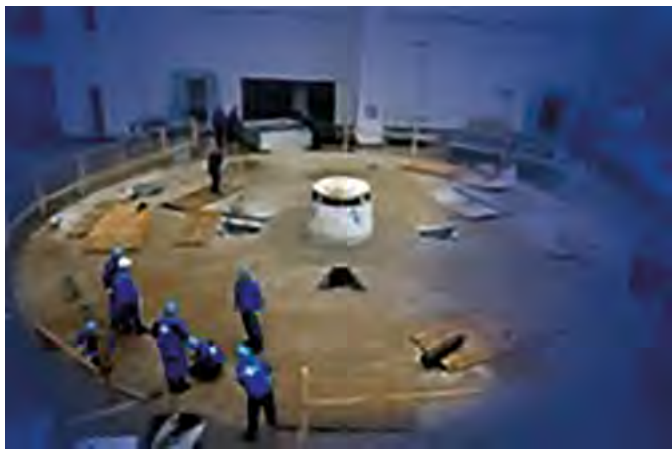
Event: On August 17, 2009, a catastrophic accident took place in the turbine and transformer rooms of the hydroelectric plant of the Sayano-Shushenskaya dam. Initially, the accident was lightly reported in the west, both in the mainstream and the technical press. Over the ensuing months, the early internet postings of photographs, videos and narratives from witnesses and technical experts in Russia were supplemented with studies, opinions, and speculations from writers both inside and outside of Russia about the causes. Both the official reports issued after the incident, and several technical discussions that followed, have drawn very general conclusions that attributed the incident to heavy vibration and poor maintenance associated with failed studs in the turbine head cover of a turbine in the plant.

Pictures from Sayano Shushenskaya after the damages (from Internet)

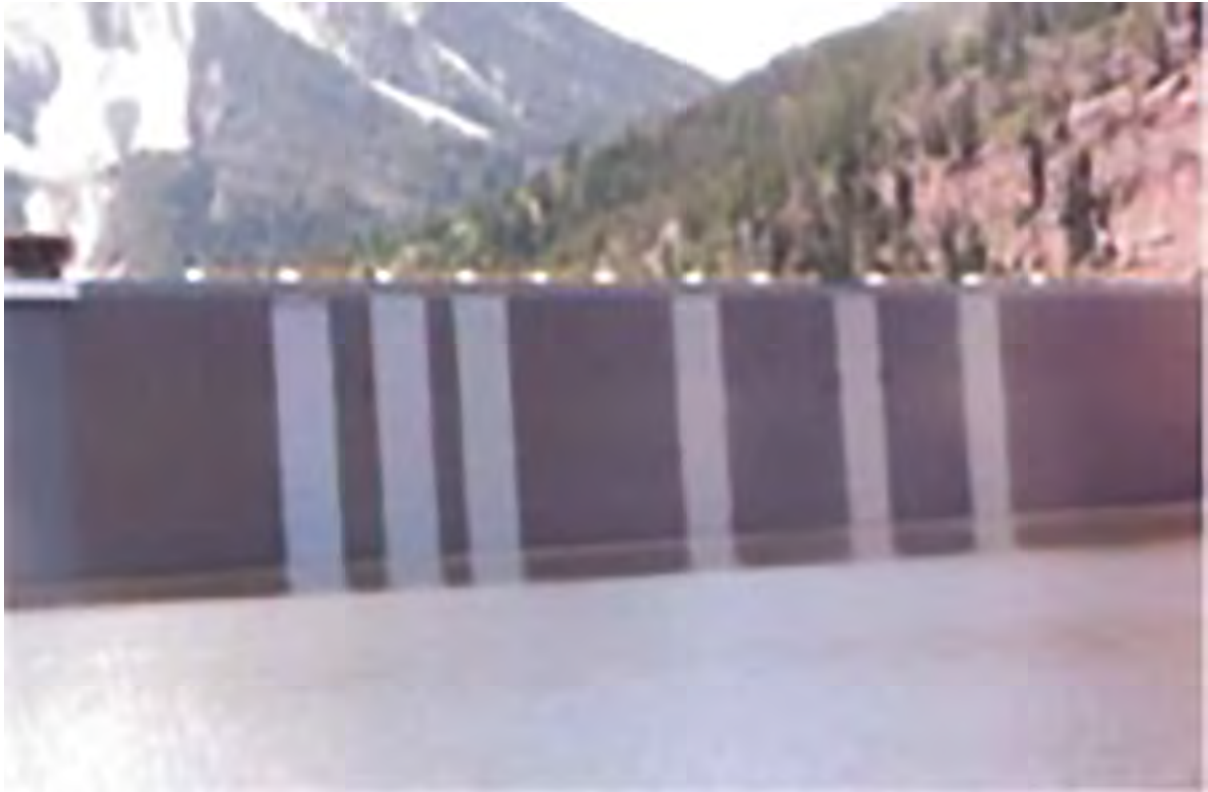
Shrinkage/temperature cracks, some of which extended continuously through the parapets, crest, galleries, and downstream face, resulted in significant leakage in at least 15 distinct locations.

These cracks, one of which was up to a 6 mm wide, was probably aggravated by the relative downstream foundation movement since some displacement could be seen at the large crack. Leakage rates at the worst crack reached 126 l/s, while others recorded leakage rates around 9.5 l/s. Extensive remedial grouting and crack repair was required to reduce the leaks.

Remedial actions on Upper Stillwater Dam (Pictures from the references above)

The Bureau of Reclamation repaired this and other similar but smaller cracks at various stations. Due to the potential for crack movement with seasonal reservoir level changes, a flexible hydrophilic polyurethane resin was selected for injection into the cracks. The selected repair procedure was to inject the crack with polyurethane resin in 3 stages.

Work for the first two stages was executed from the gallery and the downstream face at elevations below the reservoir water level. When the flow of water was controlled, a urethane resin pump system was connected to the injectors, and resin was pressure injected into the crack.

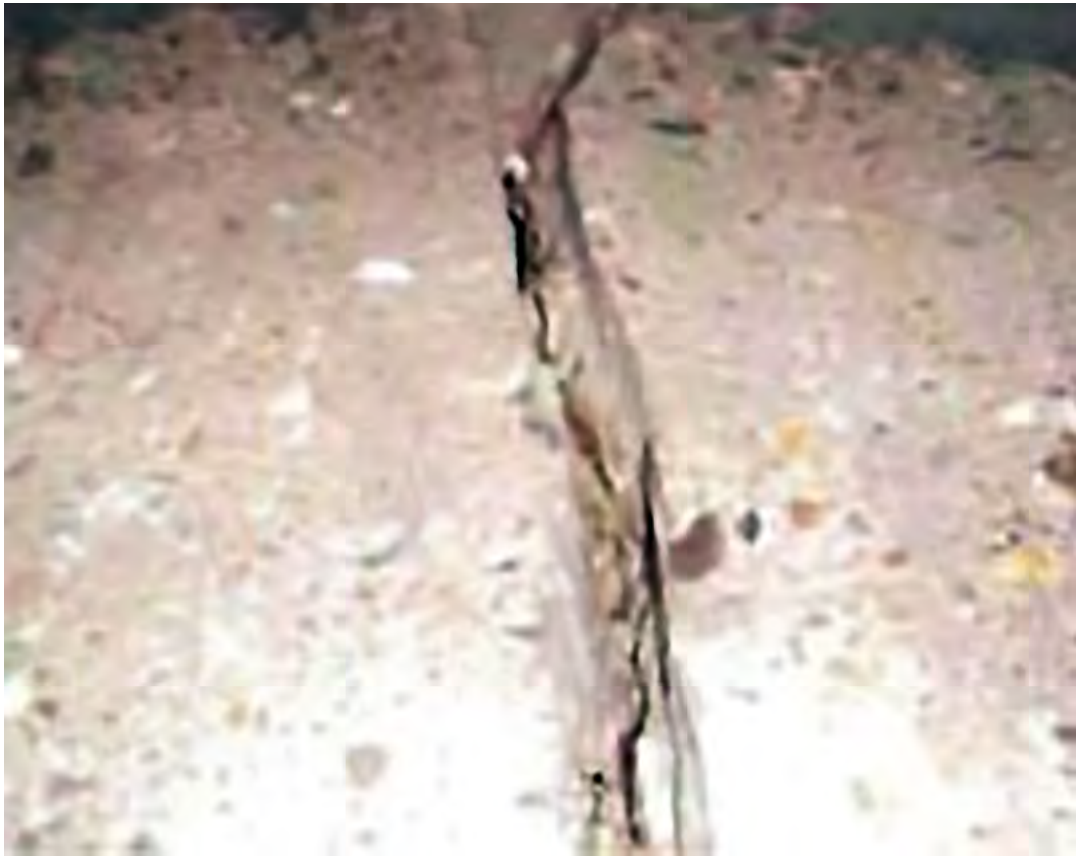
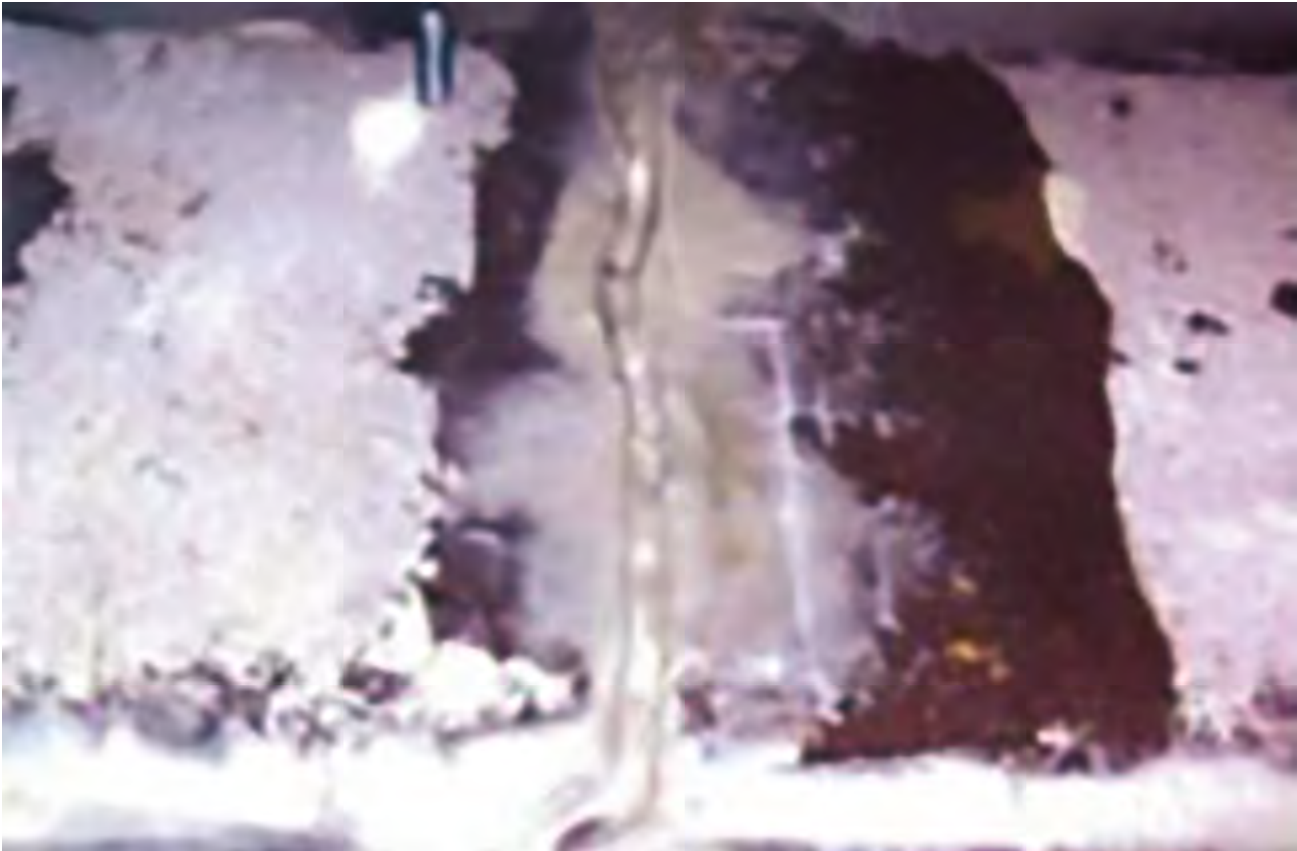
Remedial actions on Upper Stillwater Dam (Pictures from the references above)

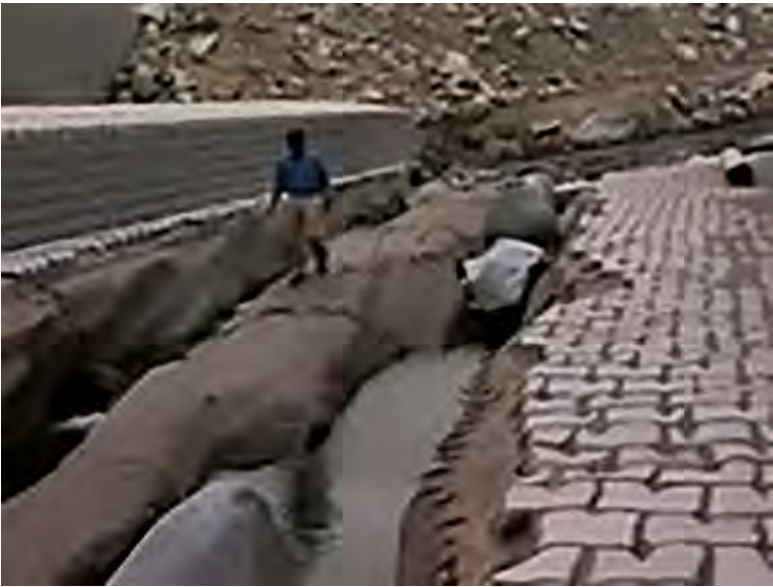
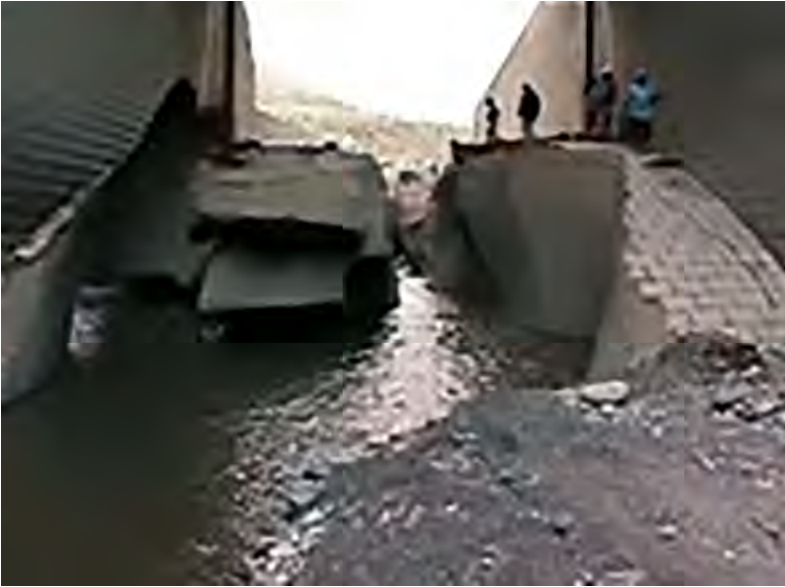
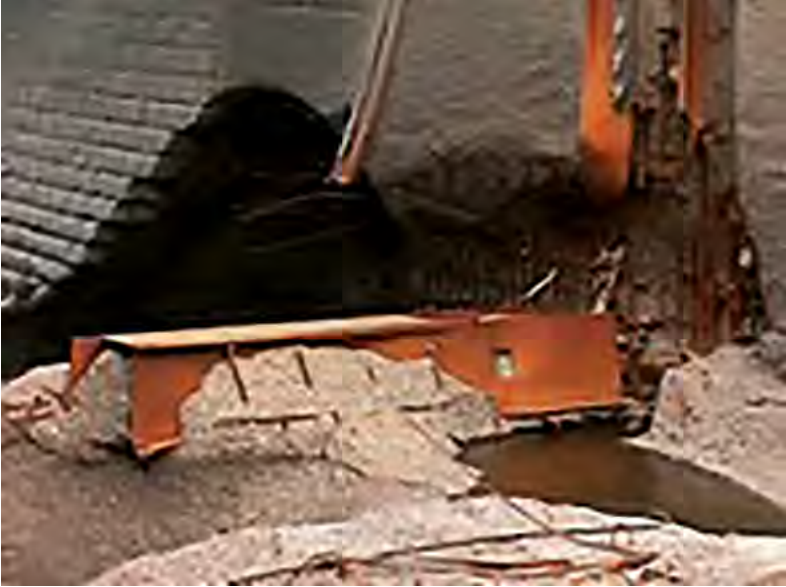
Damages in the structures and gates of Chavimochic Dam Spillway (Pictures from Andriolo's Archive)

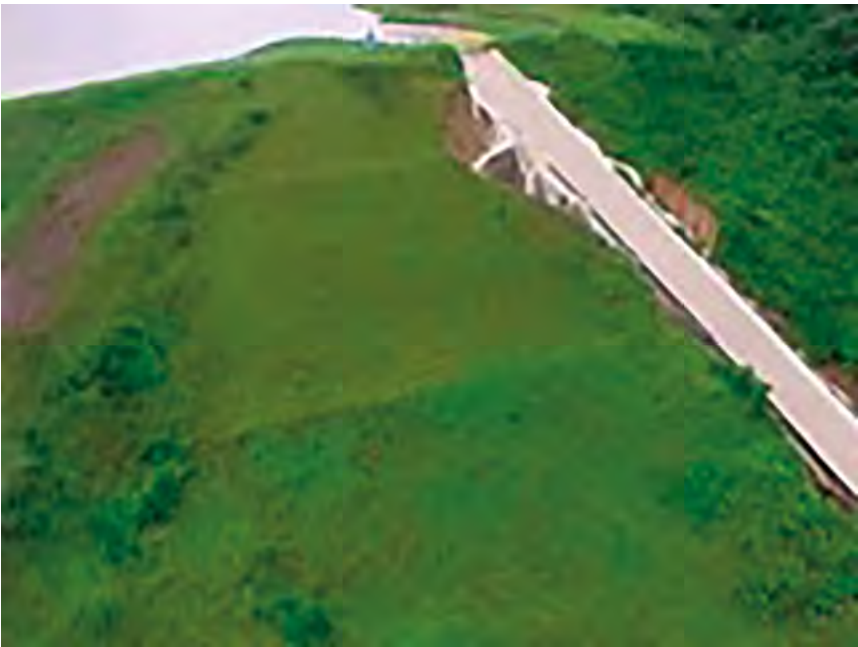
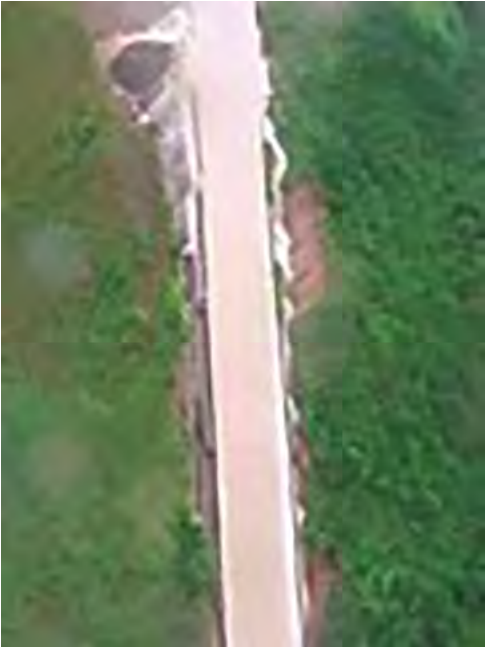
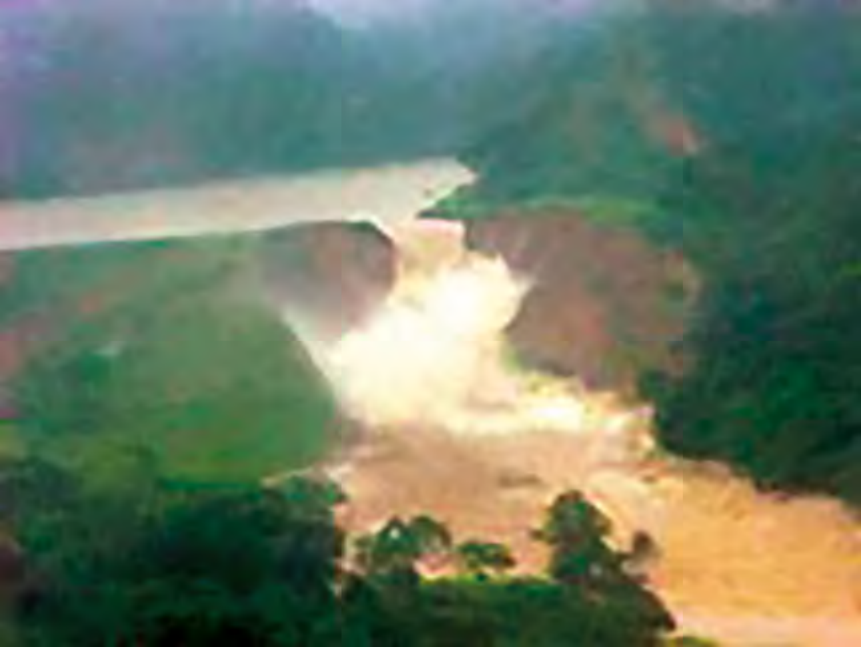
Event: During heavy rainfall in 1999, the dam on the Guapo river suffered serious damage and collapsed. A new RCC concrete spillway was constructed, and the embankment was repaired.

Damages in the El Guapo Dam around the Spillway (Pictures from the reference above)

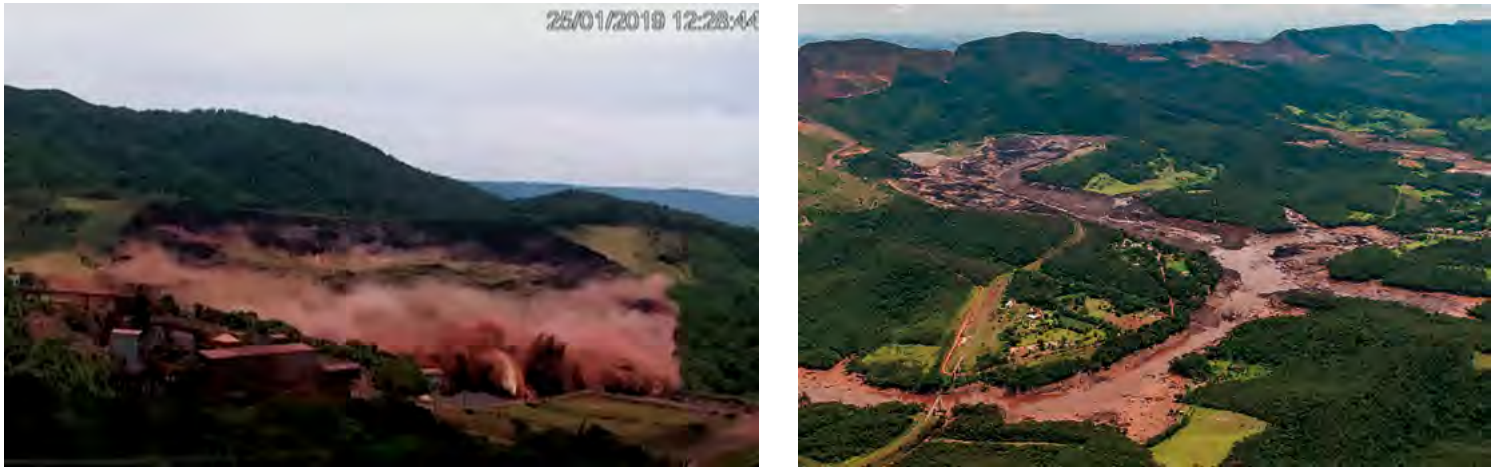
Event: The Brumadinho dam disaster occurred on January 25, 2019 when Dam I, a tailings dam at the Córrego do Feijão iron ore mine, suffered a catastrophic failure. The dam released a mudflow that advanced through the mine offices, including a cafeteria during lunchtime, along with houses, farms, inns, and roads downstream. 270 people died as a result of the collapse, of whom 259 were officially confirmed dead.

A Review Panel Board concluded that the rupture occurred due to structural instability with liquefaction. The most relevant technical aspects for the rupture were inadequate internal drainage and high groundwater level in the reservoir; slow deformation of the rejects reaching the peak of resistance in the non-drained condition and loss of suction in the material above the groundwater level; dam structure not designed to contain liquefied material; and inadequate consideration of stability issues identified during dam existence.

The Brumadinho Tailings Dam collapse (Pictures from Internet)

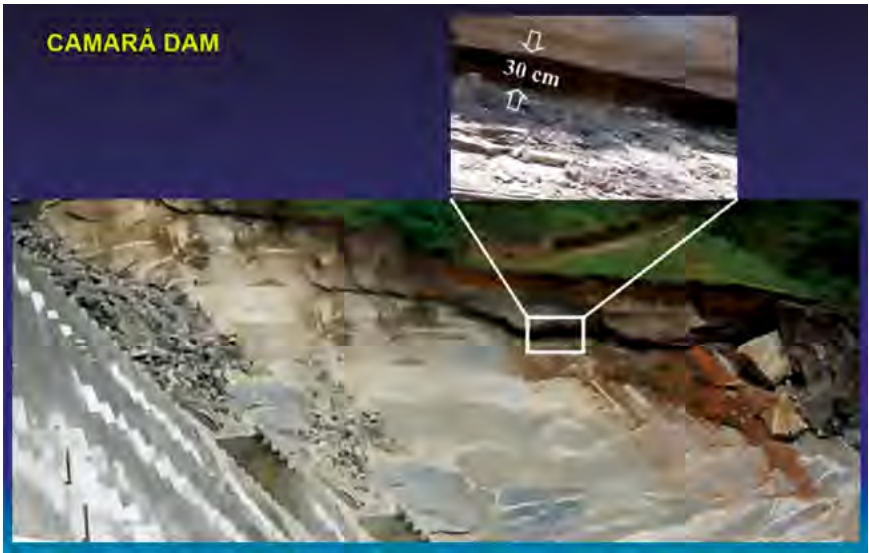
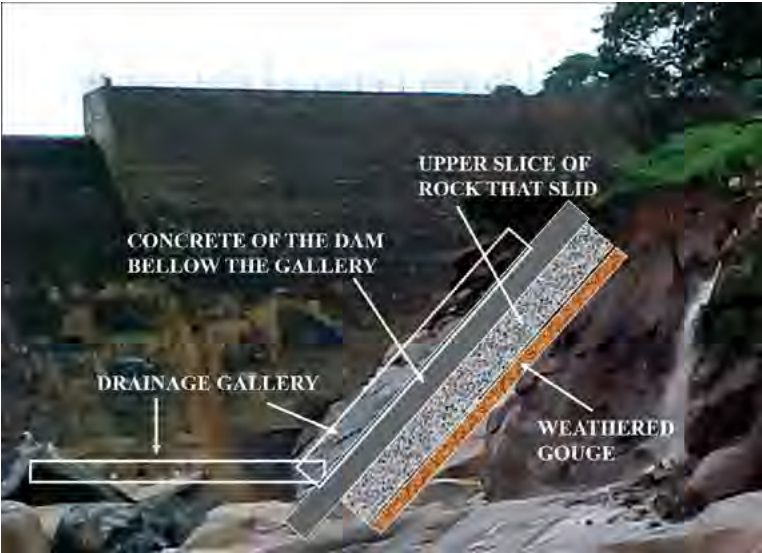
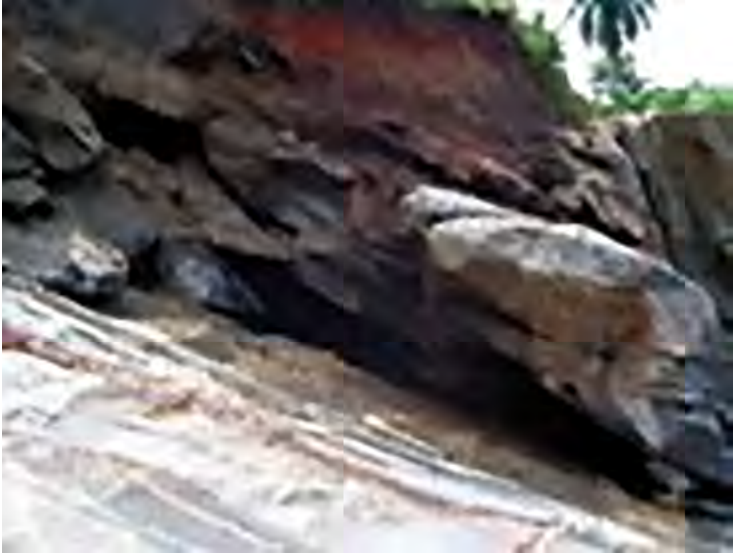
Event: On the night of June 17, 2004, the dam broke after a foundation failure, reaching part of the territories and inhabitants of the municipalities of Alagoa Nova, sand and the urban sites of two cities, where the disaster took on bigger dimension.

The Camará Dam as was constructed (at left above) and the damages due to the foundation collapse (Pictures from the Reference)

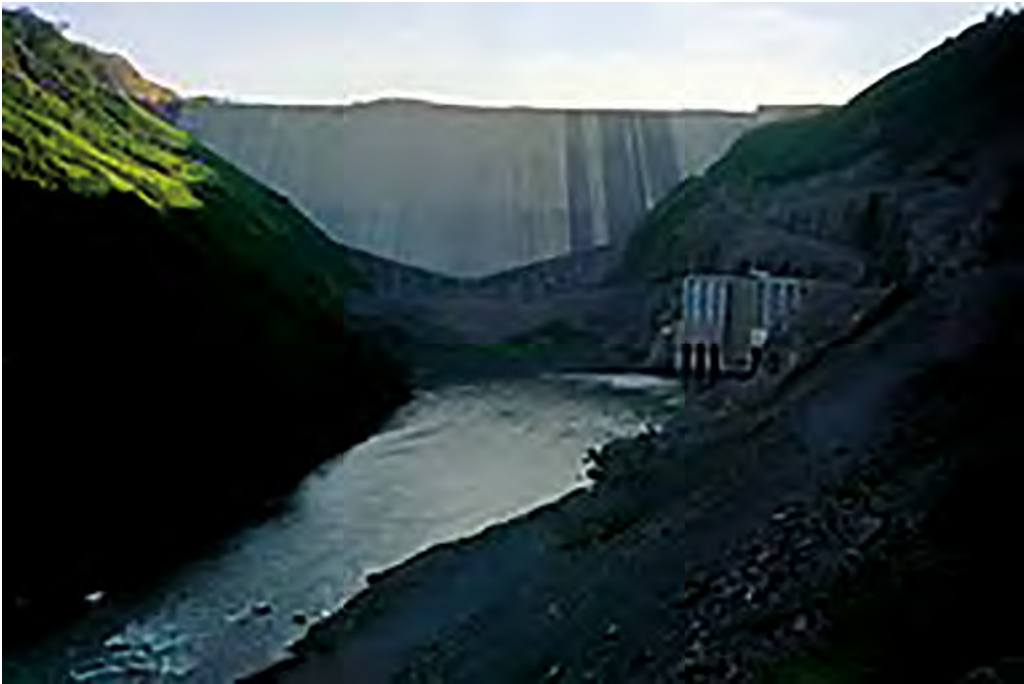
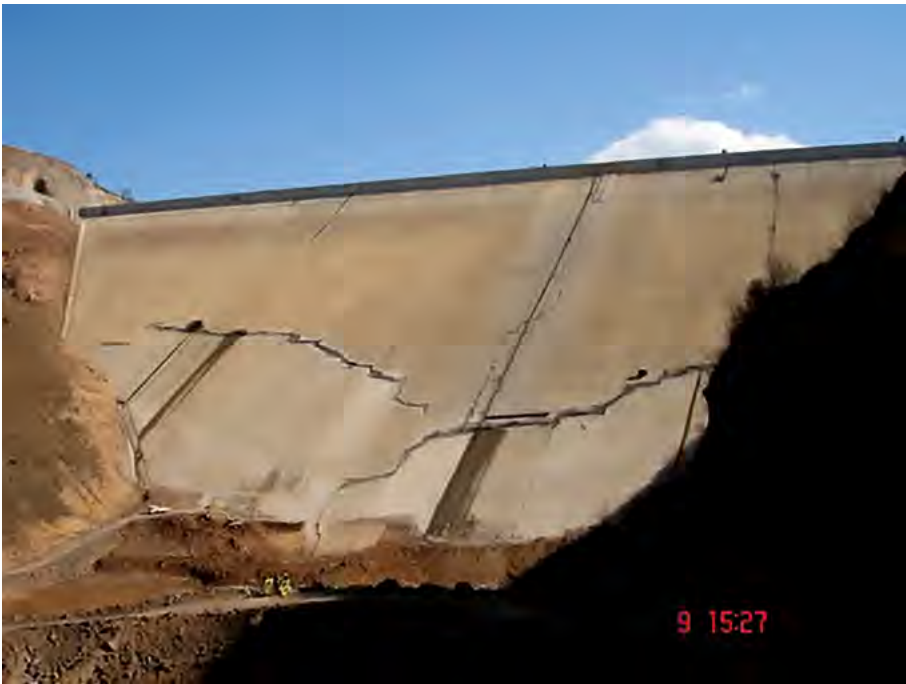
Event: A major rupture caused the water to begin to run out, after a tunnel collapsed on June 20, 2006, and the reservoir was dropped down.

Campos Novos Dam at the end of construction and after the damage, and reservoir as drop down (Pictures from Internet)

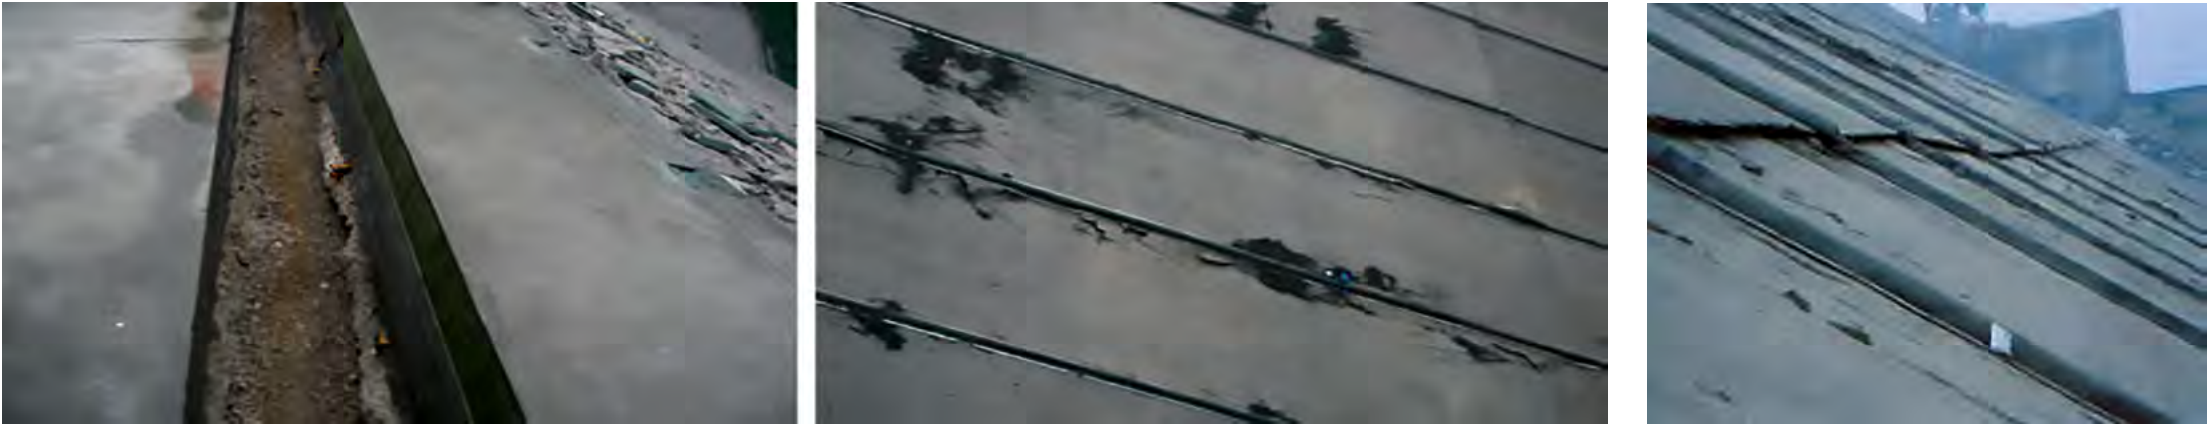
- Deformation of the lower face of the dam, an area of approximately 1000 m²;
- Deviations and deformations of the construction elements throughout the face of the dam;
- Widening of construction joints (approximately 15 cm on the upper face);
- Extended massive landslides throughout the reservoir; and
- Landslides on both left and right abutments of the dam causing further damages to secondary constructions.

The Earthquake hit Zipingpu Dam hard and rendered a maximum permanent settlement of 100 cm and a horizontal displacement of 60 cm to the dam.

Damages on Zipingpu Dam (pictures from the References)

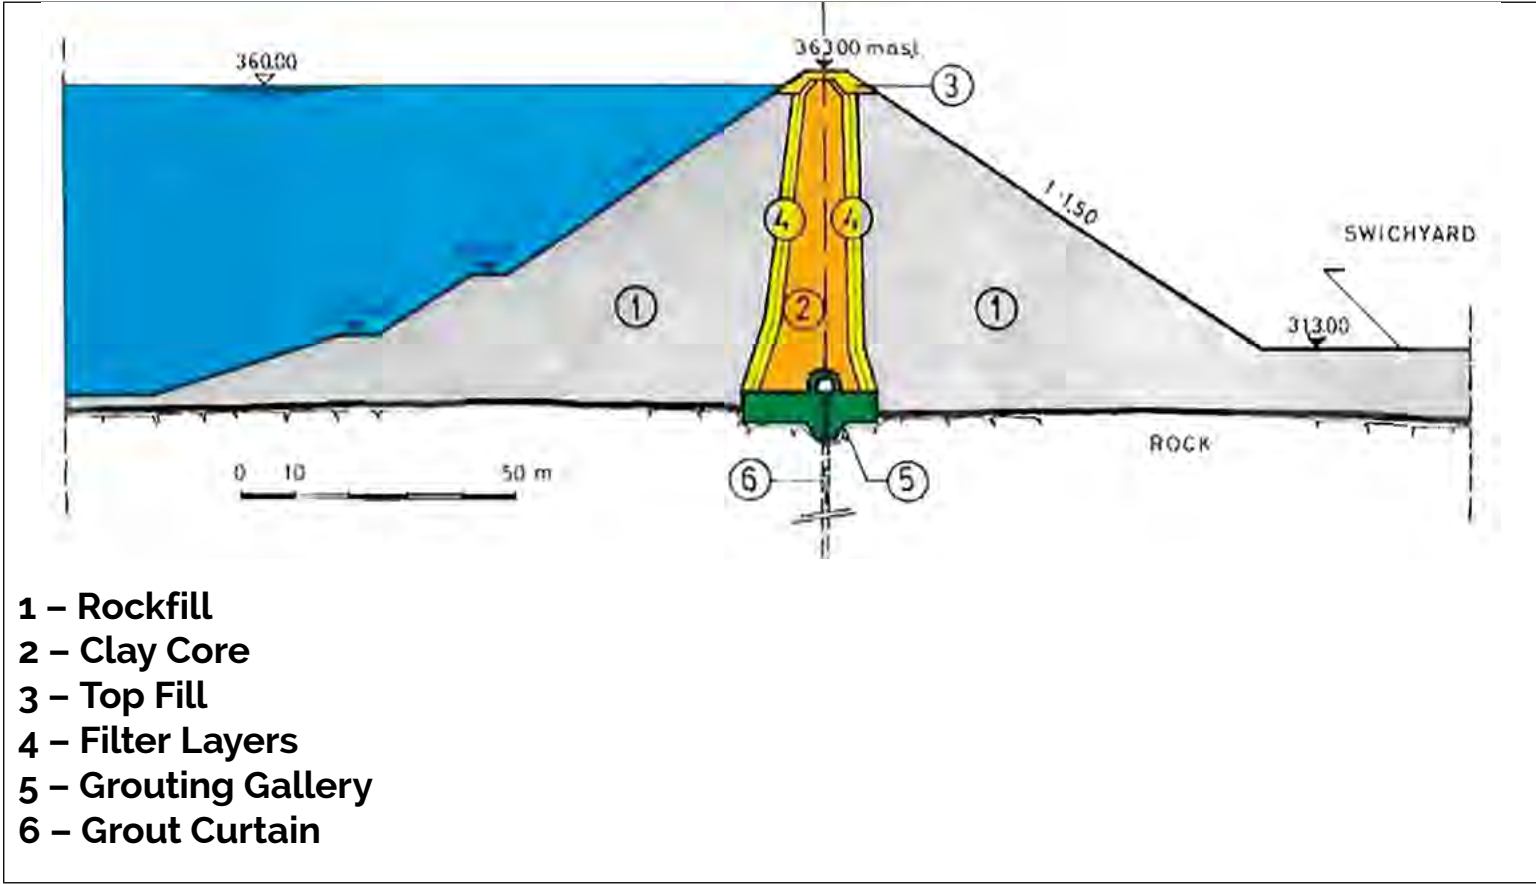
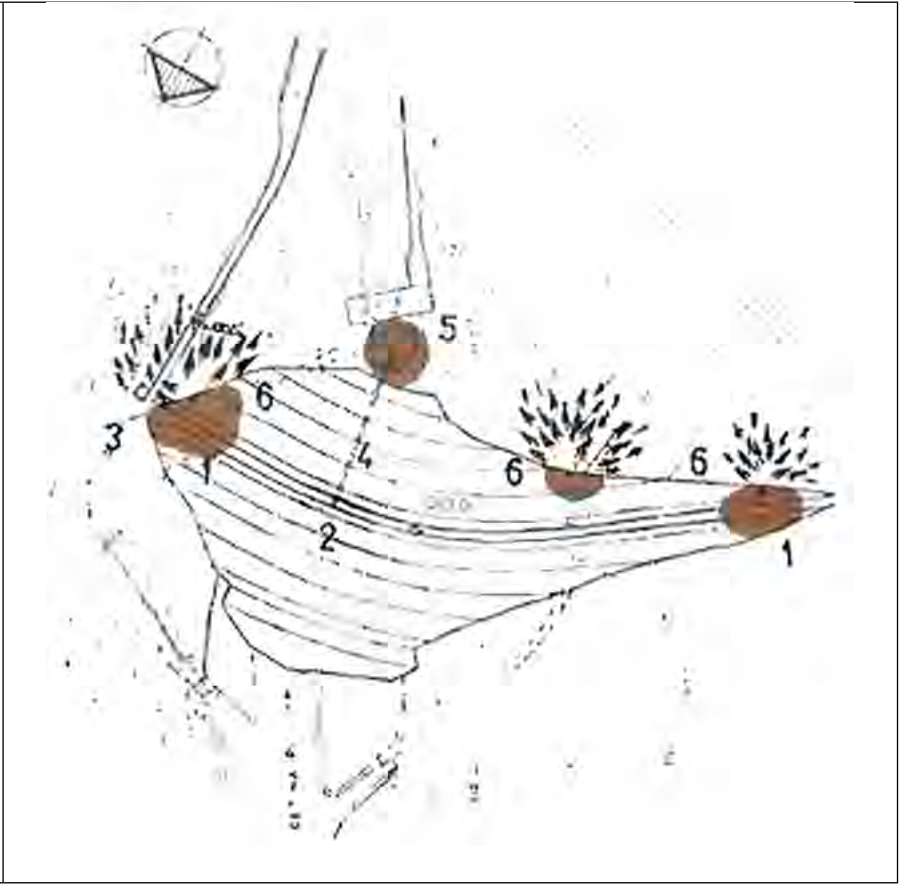
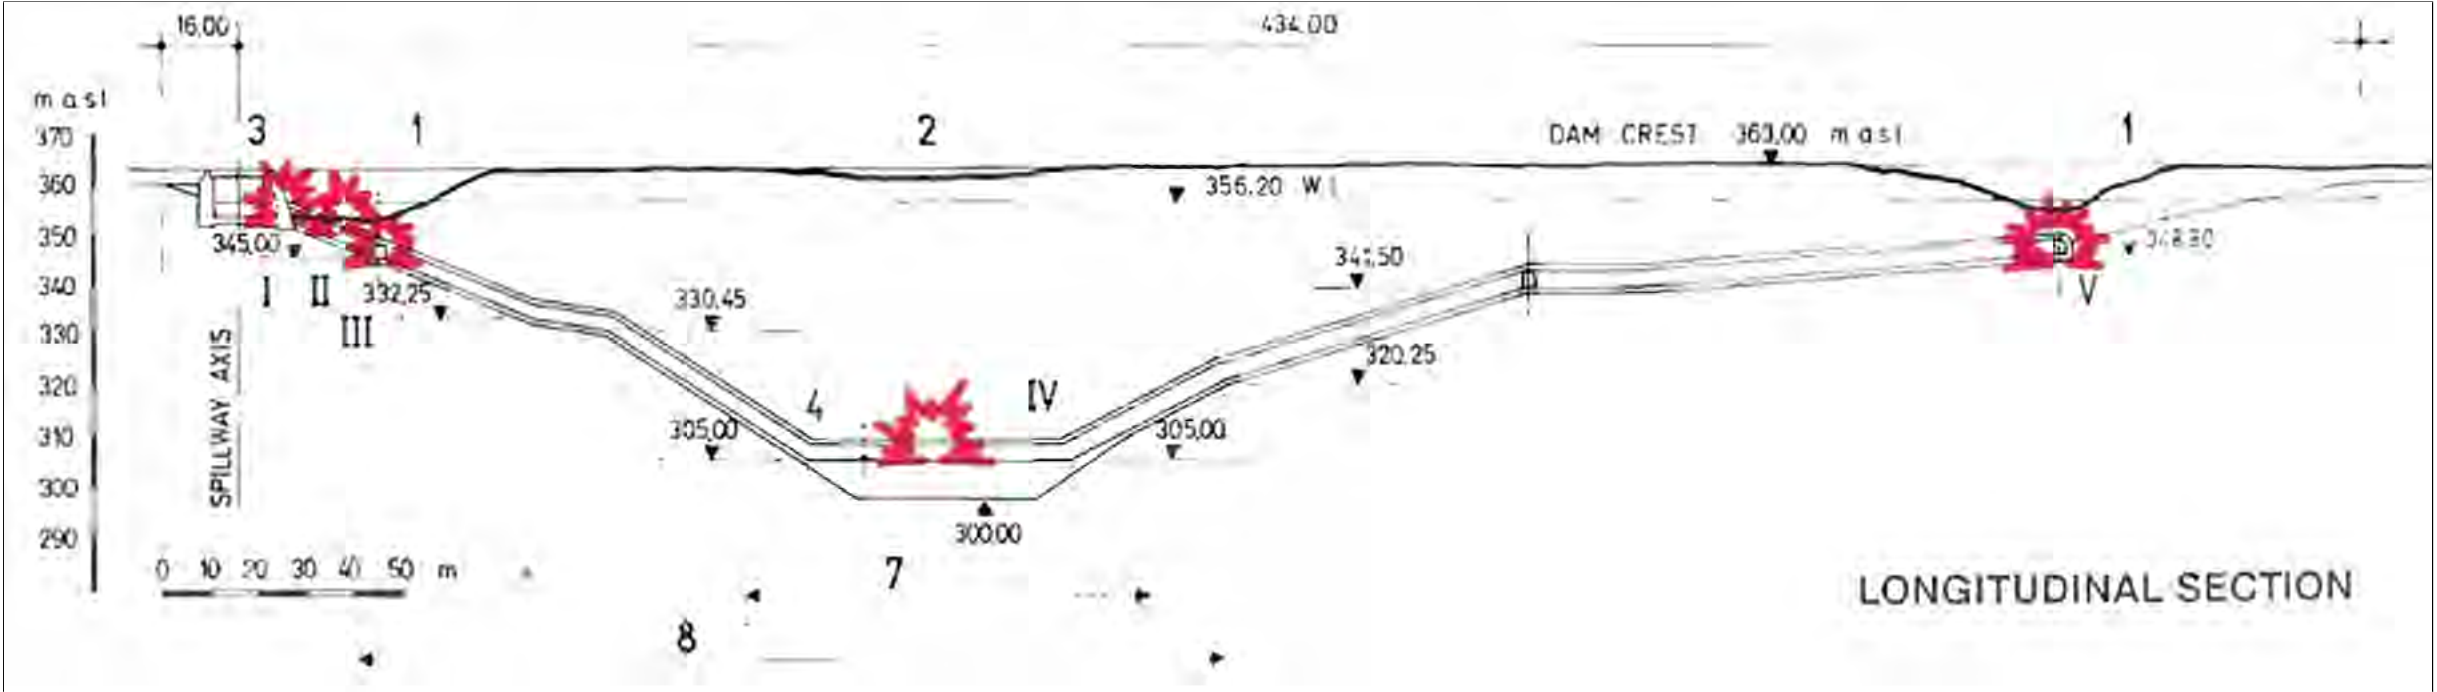
Peruca dam layout and longitudinal section^[07-69]

1 – Craters on the right and left dam ends	5 – Chunks of clay core
2 – Subsidence in the central dam section	6 – Caved -in gallery entrances
3 – Spillway	7 – Gallery completely destroyed
4 – Drain age outlet	8 – Gallery completely filled with clay
I, II, III, IV, V – ASSUMED BLASTING POINTS

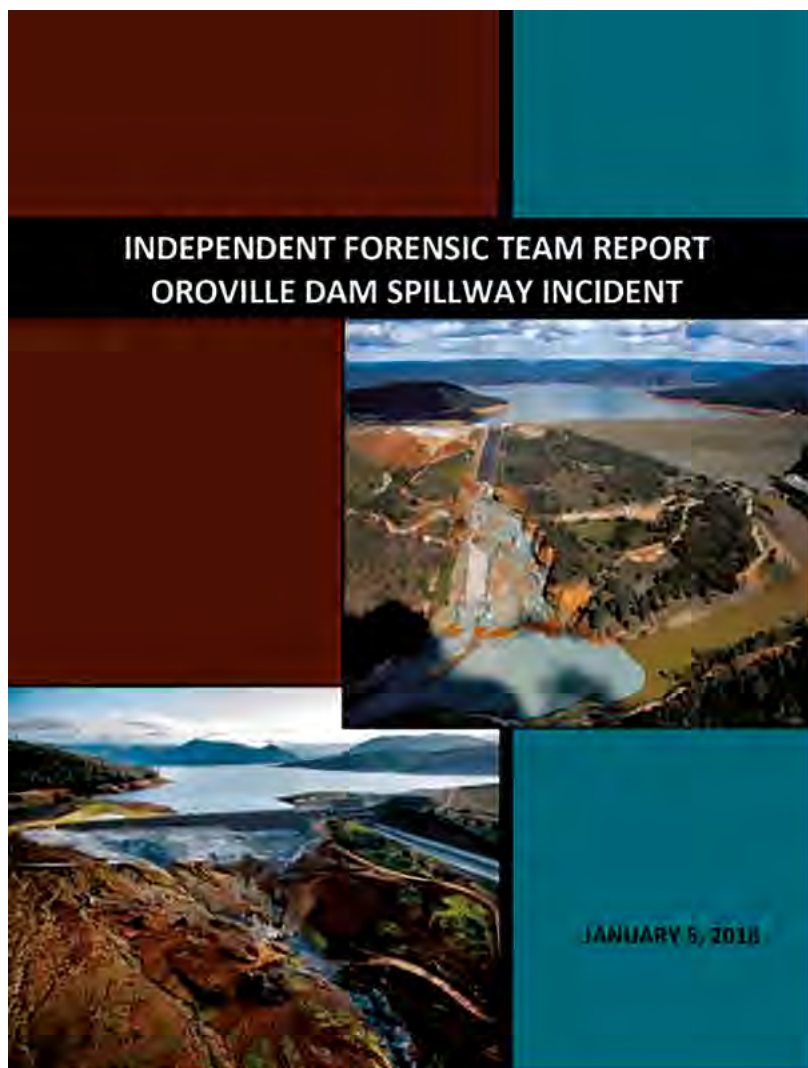
In February 2017, the main and emergency spillways threatened to fail, leading to the evacuation of 188,000 people living near the dam. After deterioration of the main spillway *largely stabilized and the water level of the dam's reservoir dropped below the top of the emergency spillway*, the evacuation order was lifted. The Independent Forensic Team Reports mentioned:

During service spillway operation on February 7, 2017, water injection through both cracks and joints in the chute slab resulted in uplift forces beneath the slab that exceeded the uplift capacity and structural strength of the slab, at a location along the steep section of the chute. The uplifted slab section exposed the underlying poor quality foundation rock at that location to unexpected severe erosion, resulting in removal of additional slab sections and more erosion.
