Is Your Dam Safe?

An281	Andriolo, Francisco Rodrigues; Moreira, José Eduardo
	Is Your Dam Safe? – Vol. 1 / authors: Francisco Rodrigues Andriolo e José Eduardo Moreira. São Carlos, 2022.
	1394 p. il. color
	ISBN – 978-65-5668-011-8
	DOI – http://dx.doi.org/10.26626/9786556680118/2022B001
	1. Dams. 2. Training. 3. Quality. 4. Repairs. 5.Controls. 6. Cement. I. Orgs. II. Title.
	CDD 370

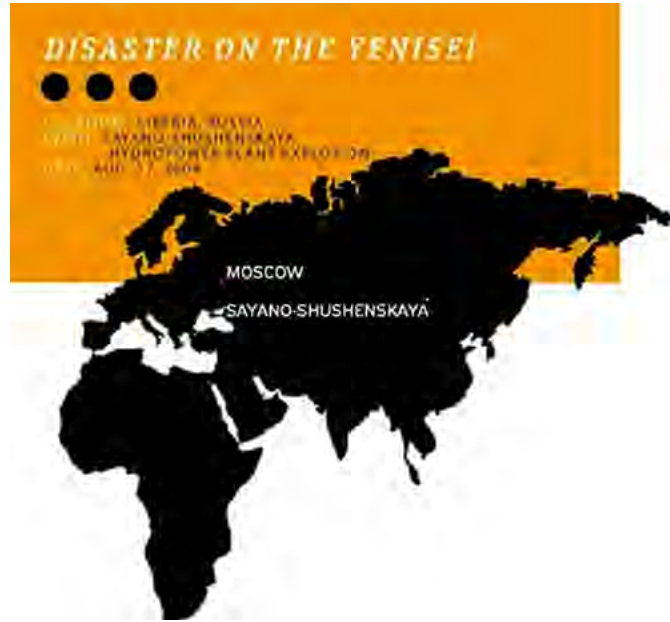
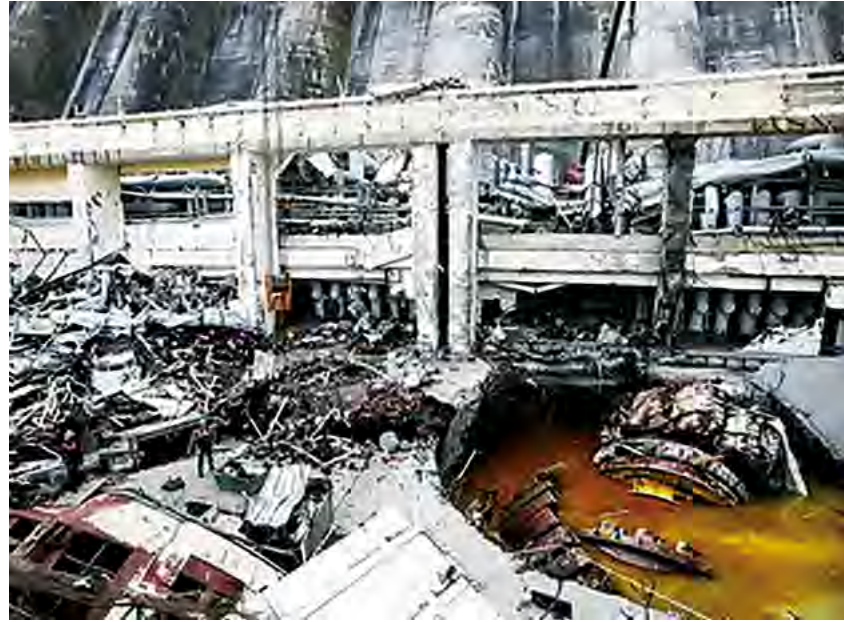
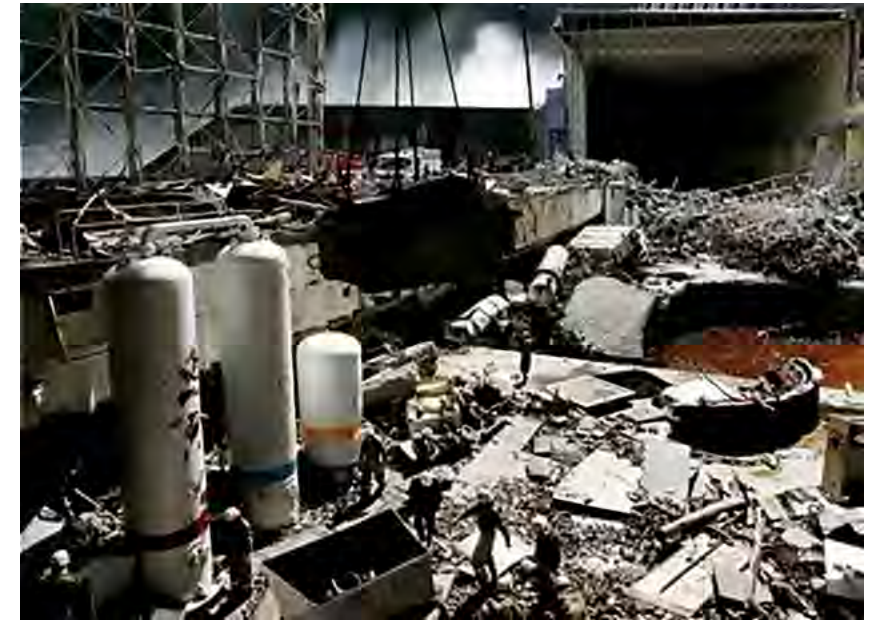
"...On August 17, 2009 August, a major failure occurred at Sayano-Shushenskaya hydroelectric dam in Russia. 75 people were killed, many were injured, and 40 tons of oil were spilled in the Yenisei River.

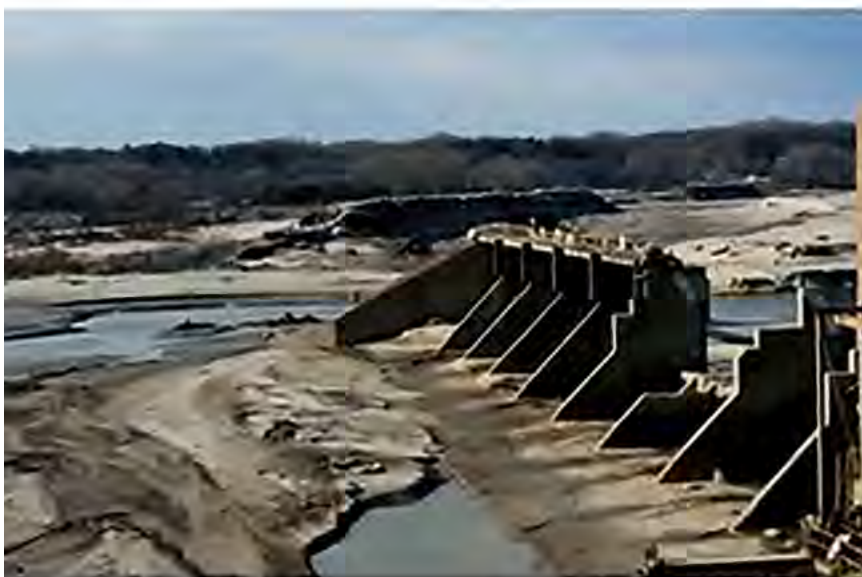
In the early morning hours of March 14, 2019, Spencer Dam on the Niobrara River in northern Nebraska failed during a major flood and ice run on the river. An independent investigative panel was formed to examine the failure on April 2020.
